RPV Head 12 RFO Inspection Results

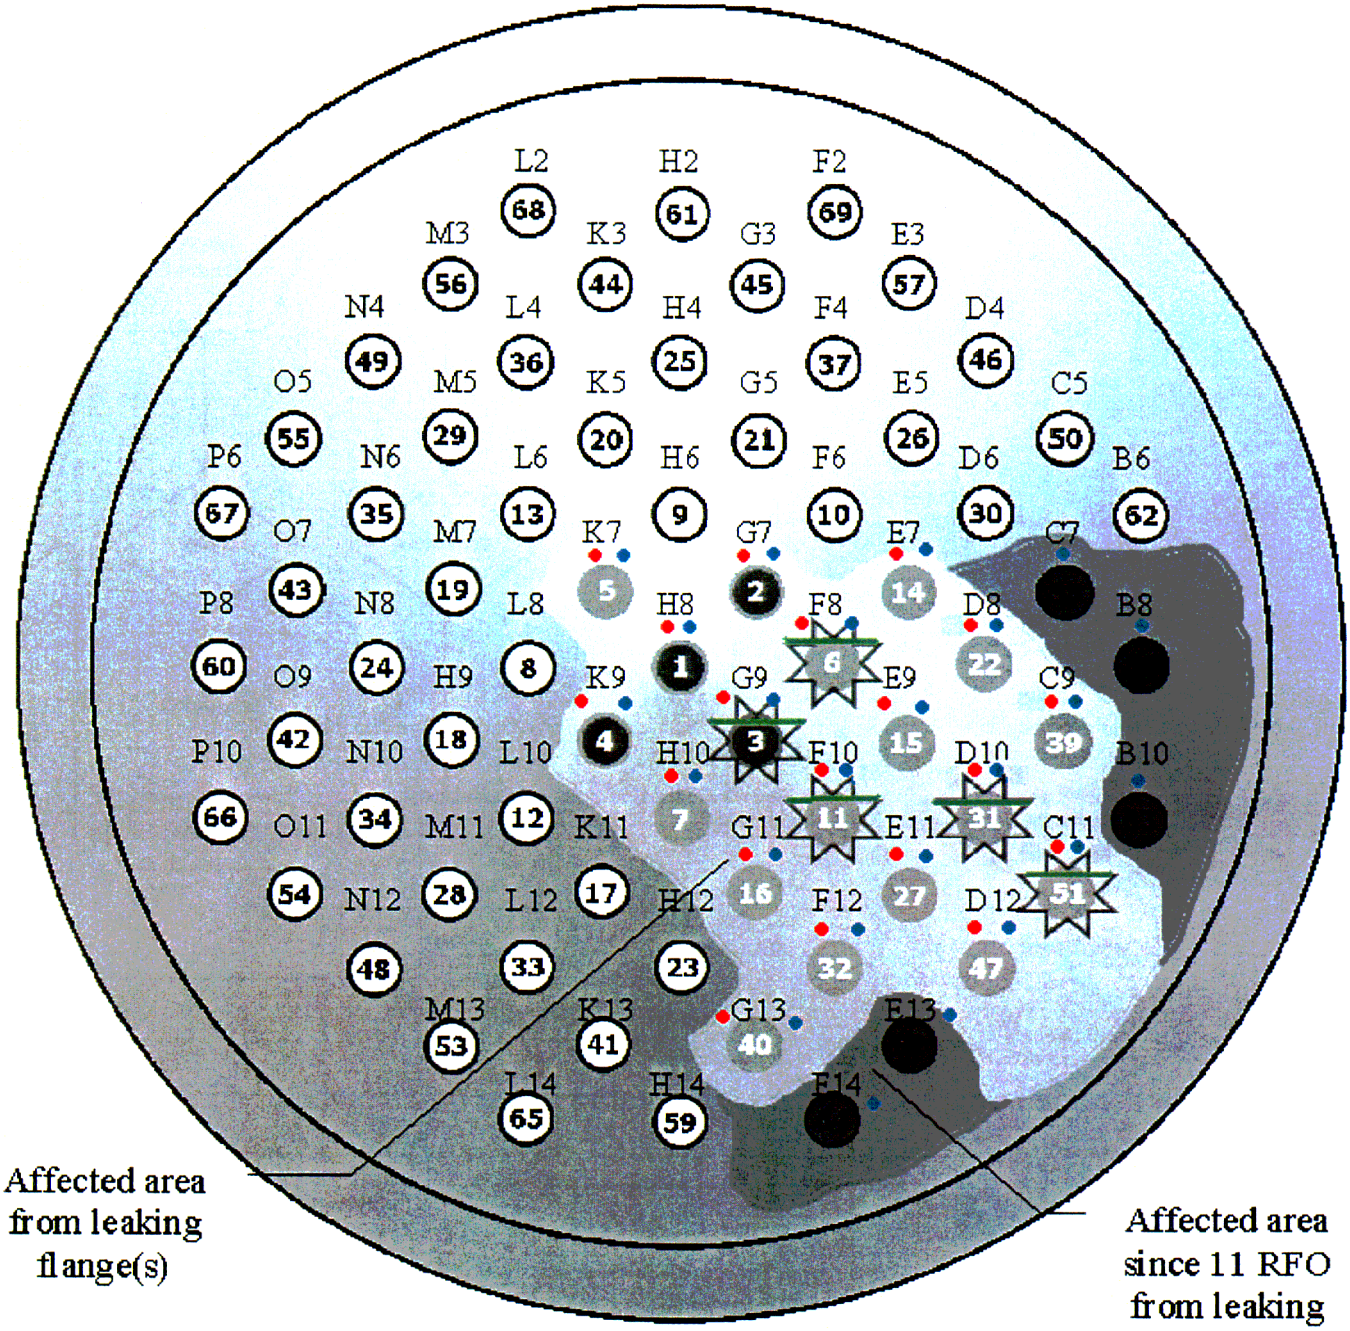
- 61 - No leakage identified
- 4 - Evaluated not to have sufficient gap to exhibit leakage
- 3 - Insufficient gap with leaking flange
- 5 - Nozzle obscured by boron
- 6 - Nozzle obscured by boron with leaking flange
- - Newly affected, since 11 RFO, by leaking flange(s)

- Noticed in 11RFO
- Noticed in 12RFO
- Repaired in 12RFO
