Timeline of Key Events Related to Reactor Vessel Head Boric Acid Wastage

Rev. 3 March 13, 2002

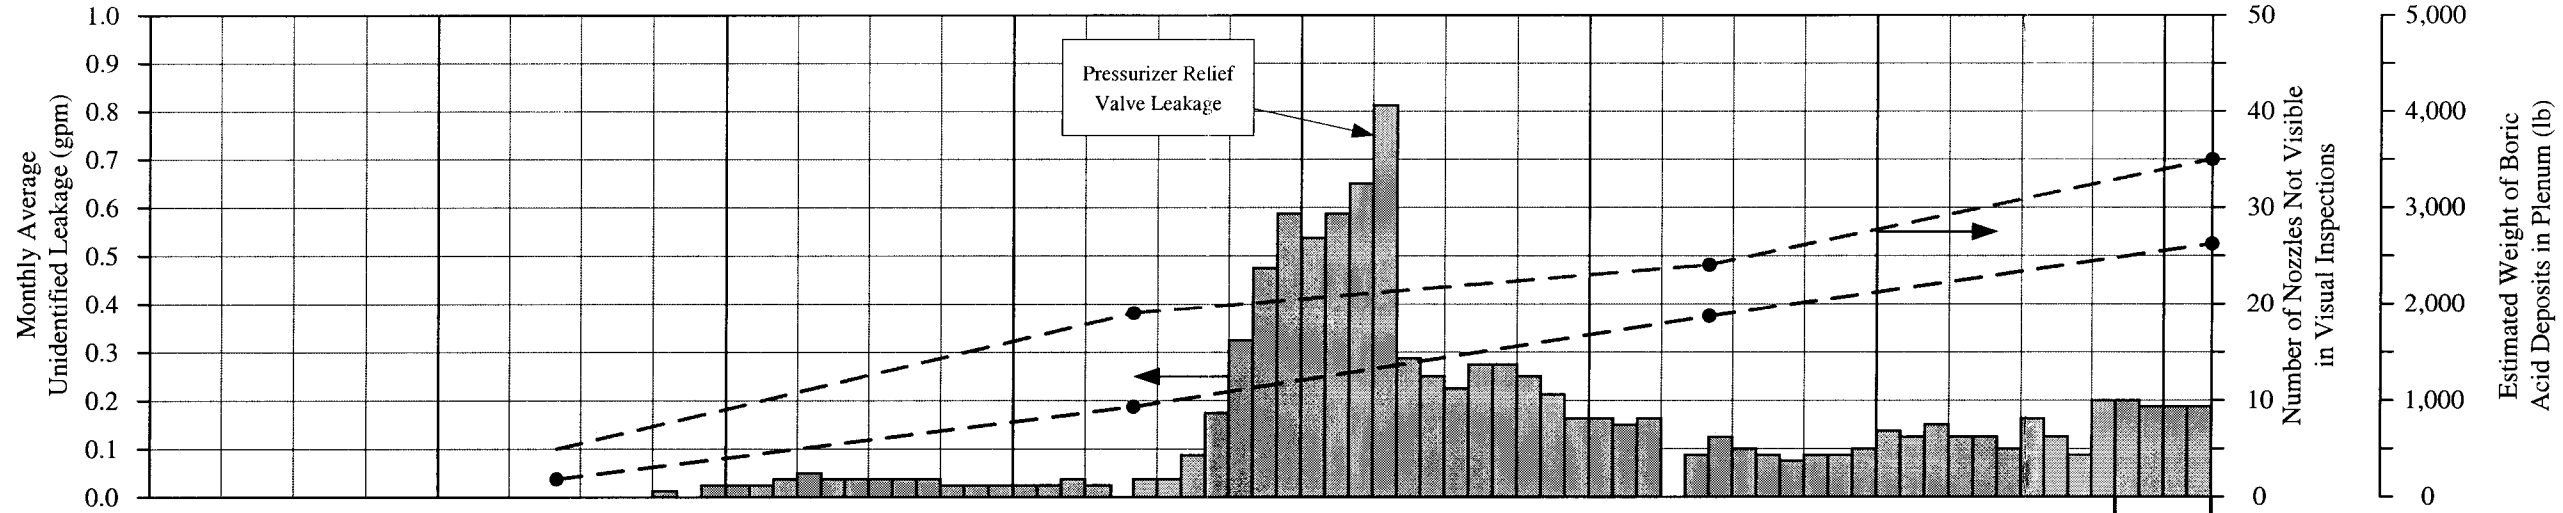
Replacement rate due to low flow SwRI test showed iron oxide concentration

Portable HEPA filters installed in containment to remove iron oxide

"Abnormally" dark deposits on filter

Replacement rate due to Iodine saturation

Significant Information Prior to RF-10	RF-10	RF-11	RF-12	RF-13	
		1) N-31 leaks but gasket not changed	1) Replaced gaskets N-3, 5, 6, 11, 31 2) No "red" deposits under N-3 flange 3) Bottom of flange N-3 not inspected due to hard BA (A.S. 4/19/00)	1) No leakage from flange gaskets 2) "Red" deposits under N-3 flange 3) Difficult to get camera in place. 3-4" of hard, brown, boric acid	CRDM Nozzle Flange Conditions
				Significant flow of boric acid deposits from weepholes centered under N-3	Flow From Shroud Weep Holes

1) Visual inspection 65/69 nozzles 2) Typical minor BA deposits 3) Possible popcorn at N-2?	1) Visual inspect 50/69 nozzles 2) Loose BA piling up behind some outer nozzles 3) No photos of 14 in affected zone	1) Visual inspect 45/69 nozzles 2) "Lighting and camera created orange coloration" 3) No sign of "popcorn" deposits	1) Visual inspect 34?/69 nozzles N-1: leak [N-5 & N-47 cracked] N-2: leak, circ & minor wastage N-3: leak & major wastage	RPV Head Condition
