Timeline of Key Events Related to Reactor Vessel Head Boric Acid Wastage

Rev. 5 March 15, 2002

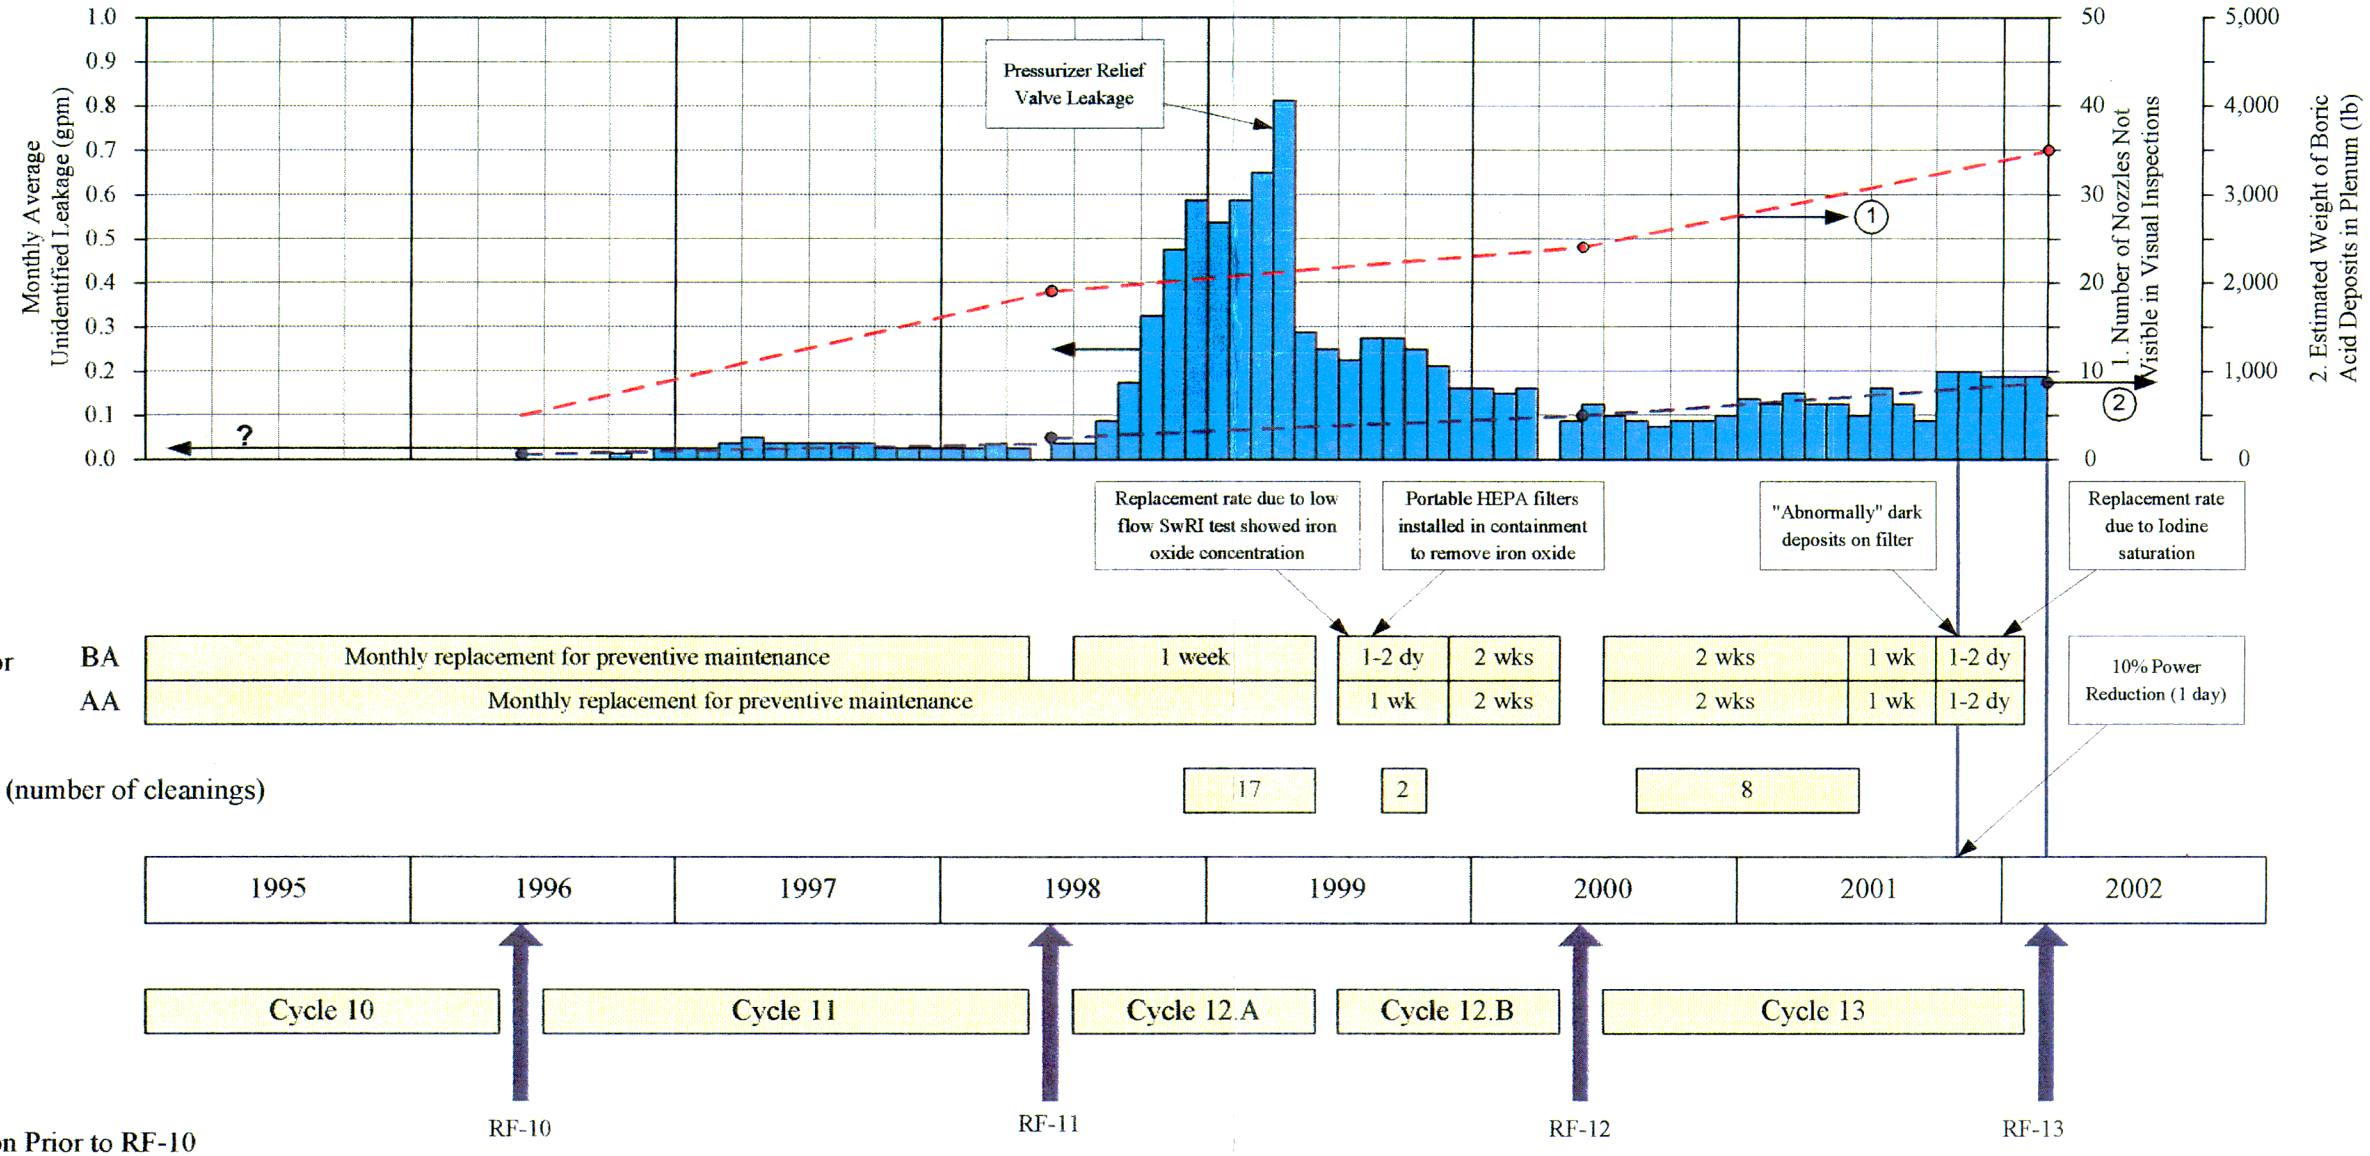
Significant Information Prior to RF-10	RF-10	RF-11	RF-12	RF-13
CRDM Nozzle Flange Conditions	1) N-66 gasket replaced at RF-7&RF-8		1) N-31 leaks but gasket not changed 2) BA is powder and white	1) Replaced gaskets N-3, 5, 6, 11, 31 2) No "red" deposits under N-3 flange 3) Bottom of flange N-3 not inspected due to hard BA	1) No leakage from flange gaskets 2) "Red" deposits under N-3 flange 3) Difficult to get camera in place. 3-4" of hard, brown, boric acid
Flow From Shroud Weep Holes			First indication of red colored boric acid deposits from mouseholes in quadrant of N-3	Significant flow of red colored boric acid deposits from mouseholes, piling to 6" deep behind studs in sector of N-3	Significant flow of boric acid deposits from weepholes centered under N-3
RPV Head Condition	1) Head reported "clean" at RF-8	1) Visual inspection 65/69 nozzles 2) Minor BA deposits around outer nozzles of RV Head 3) BA deposits at center of head	1) Visual inspect 50/69 nozzles 2) Loose BA piling up behind outer nozzles 3) BA brittle, breaks easily	1) Visual inspect 45/69 nozzles 2) BA definitely red and hard to break up (needed crowbar) "lava-like"	1) Visual inspect 34?/69 nozzles N-1: leak [N-5 & N-47 cracked] N-2: leak, circ & minor wastage N-3: leak & major wastage
