3/11/02

RPV Head ~~12~~ 13 RFO Inspection Results

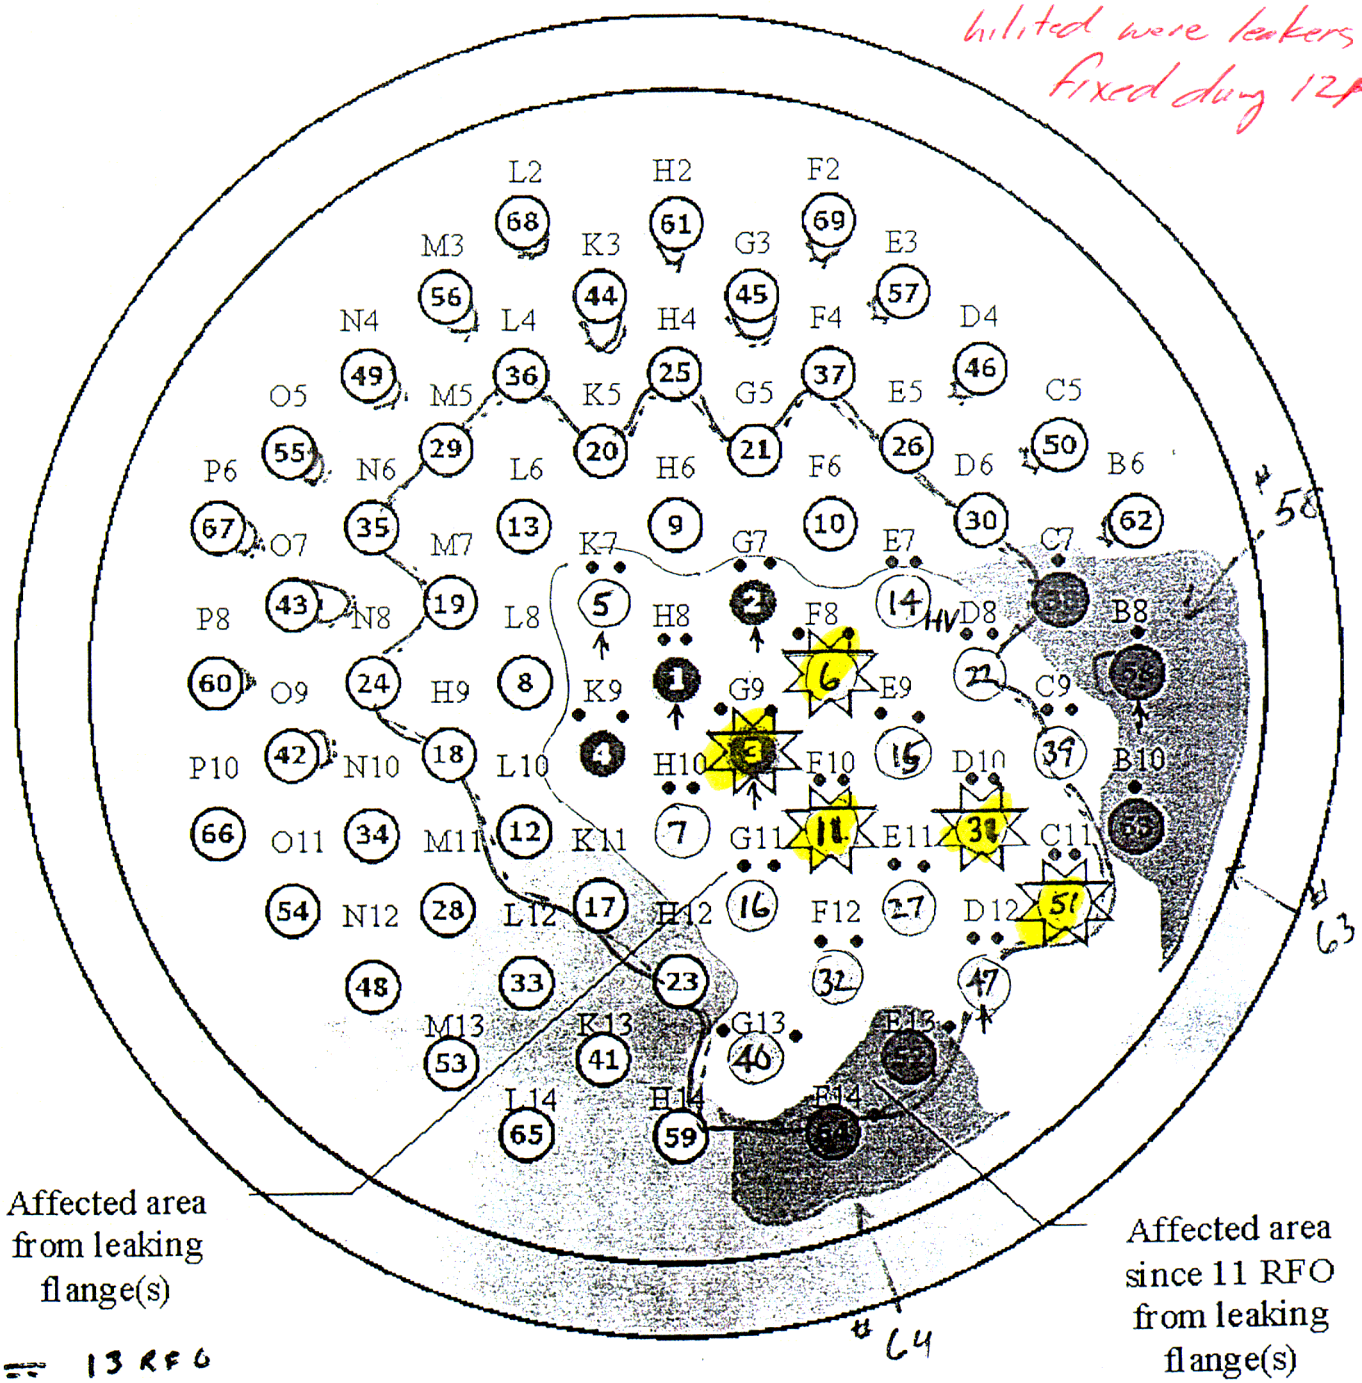
Per Andrew, the hilited were leakers fixed during 12RFO

- (61) - No leakage identified
- (4) - Evaluated not to have sufficient gap to exhibit leakage
- (3) - Insufficient gap with leaking flange
- (5) - Nozzle obscured by boron
- (6) - Nozzle obscured by boron with leaking flange
- (●) - Newly affected, since 11 RFO, by leaking flange(s)

- Noticed in 11RFO
- Noticed in 12RFO
- Repaired in 12RFO
