UNITED STATES
NUCLEAR REGULATORY COMMISSION
REGION I
475 ALLENDALE ROAD
KING OF PRUSSIA, PENNSYLVANIA 19406-1415

MEMORANDUM TO FILE: Westinghouse Electric Corporation
Bloomfield, New Jersey

SUBJECT: VISIT TO WESTINGHOUSE ELECTRIC CORPORATION SITE IN BLOOMFIELD, NEW JERSEY

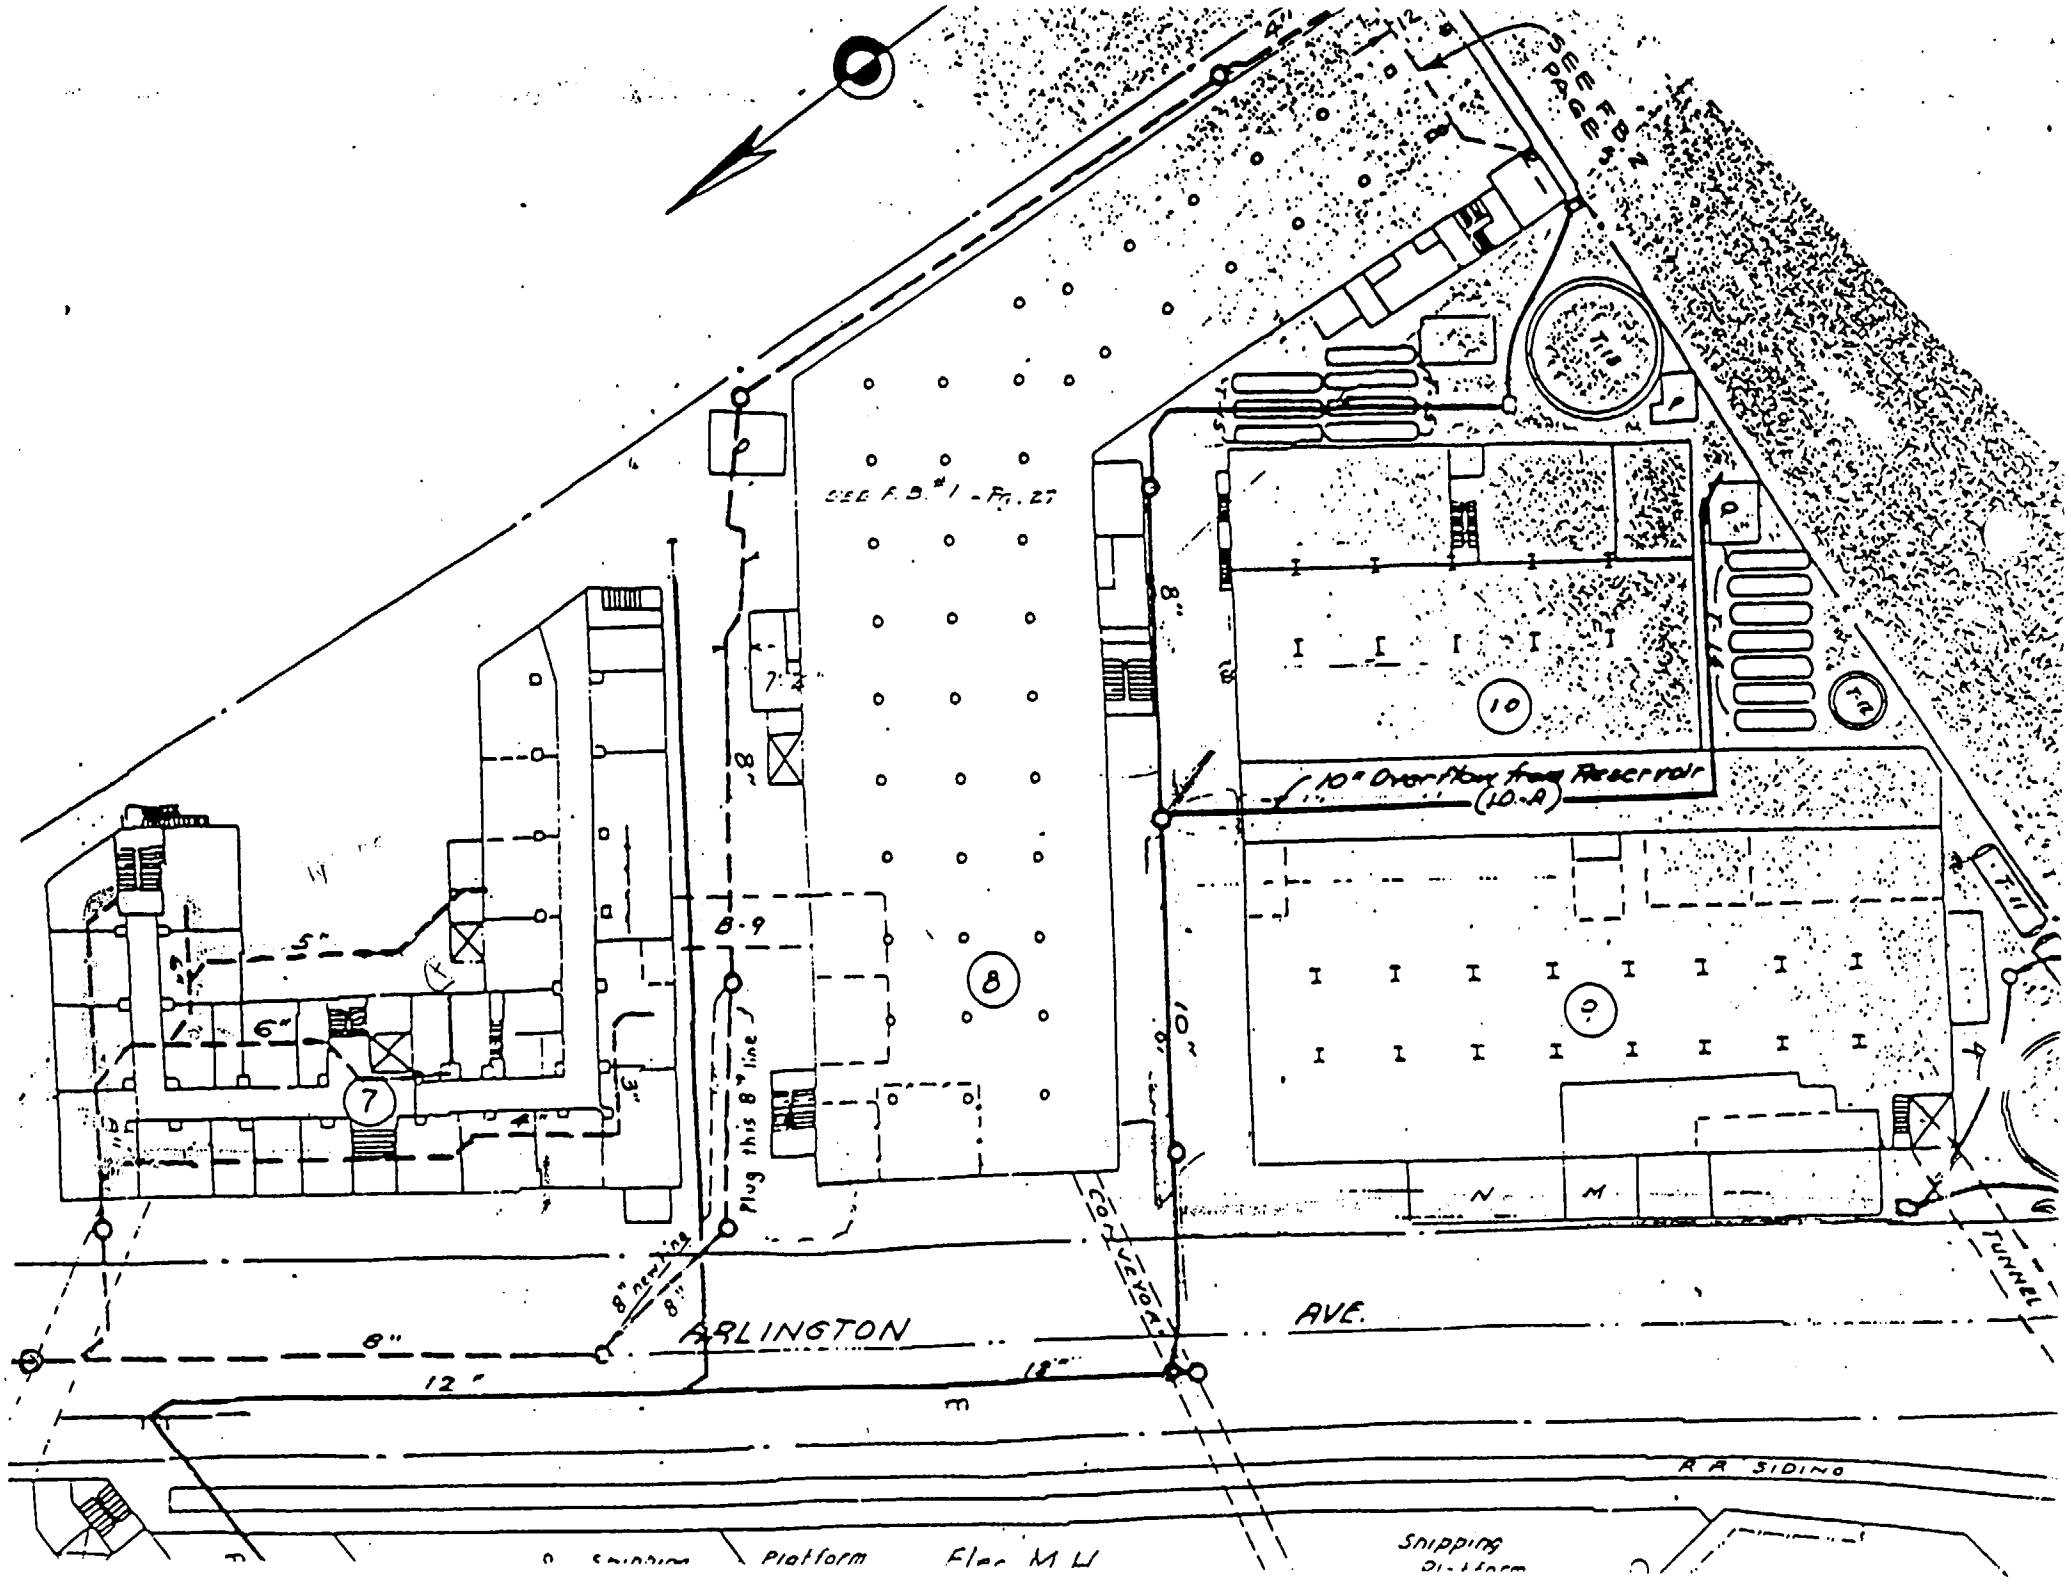
Attachment:
As-Built Drawing

The SEG representative estimated that the remaining remediation and final surveys will take another few months to complete. Following completion of the remediation and surveys, SEG must complete the final remediation and survey report. In my estimate, the facility will be available for a confirmatory survey no earlier than the end of this calendar year. Open excavations may be sampled sooner; however, SEG has archived all of the soil samples that it has taken for the final surveys. These samples should be available for future analysis from areas that have or will be backfilled. Ten shipments of waste (approximately 6,500 ft^2) have been sent out during the SEG remediation effort and about ten more shipments will be required. The SEG representative provided a copy of an old as-built diagram that shows some of the drain and sewer system that has been remediated.
