SUBJECT: Entergy Nuclear Operations, Inc.
Pilgrim Nuclear Power Station
Docket No. 50-293
License No. DPR-35

License Renewal Application, Amendment 2

LETTER NUMBER: 2.06.049

Pilgrim Nuclear Power Station Drywell Shell Information

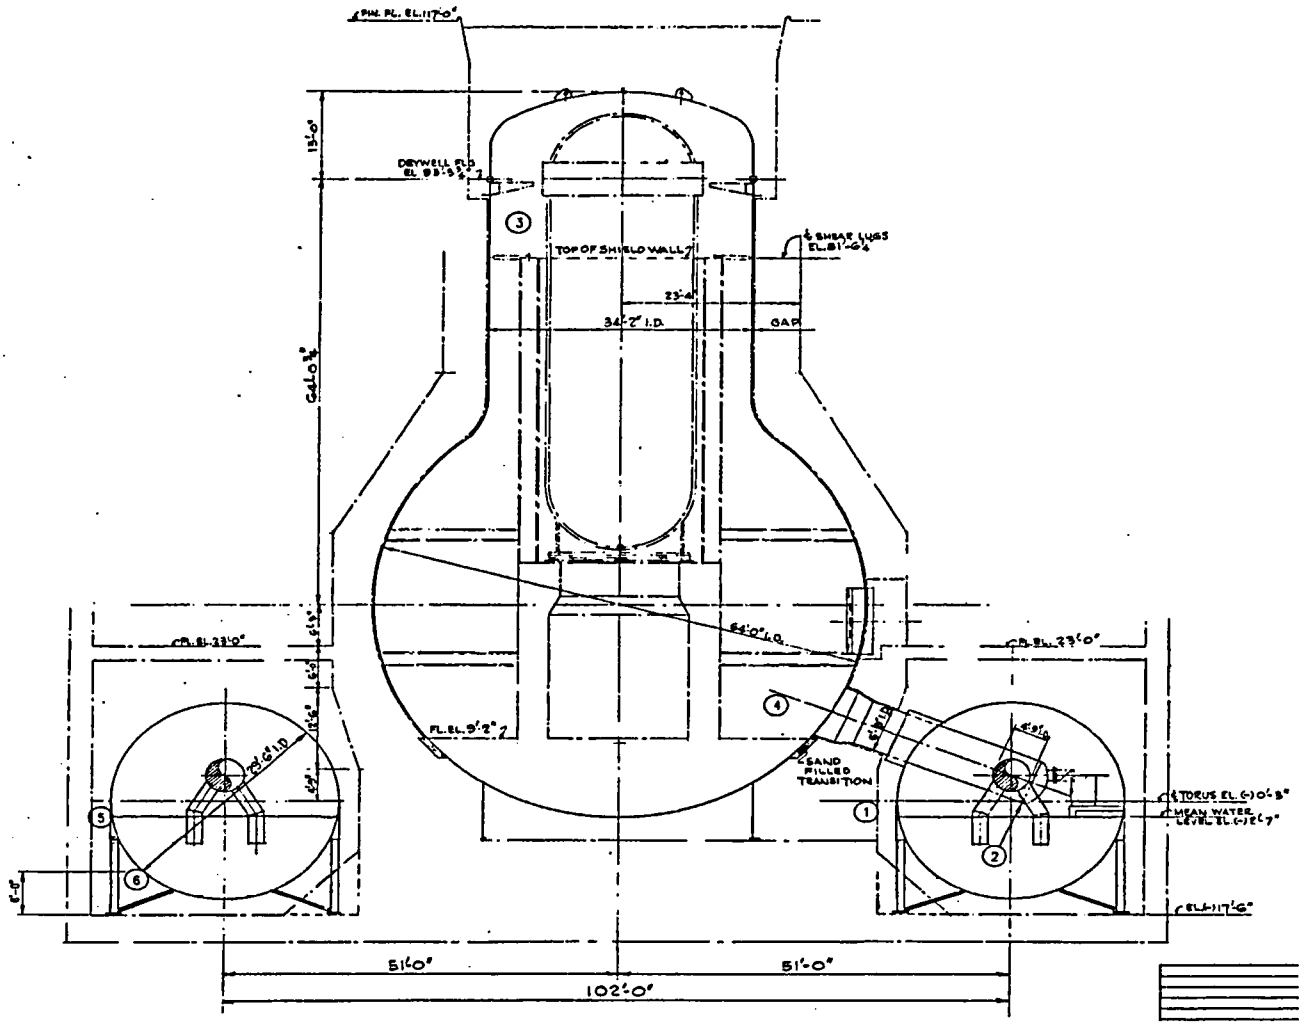
Taken from ISIIWEAUG1

PNPS performed additional UT thickness measurements adjacent to the sand cushion region at the 9 foot 1 inch elevation in 1999 and 2001. The sand cushion region of the drywell shell is inaccessible unless concrete is removed. For the examinations in 1999 and 2001, concrete at the periphery of the 9 foot 2 inch elevation was chipped away to allow UT wall thickness measurements of the drywell shell to be taken at the level of the upper sand cushion. These examinations are destructive in nature and are performed in a high radiation area. The areas were then re-grouted prior to resuming operations. The observed wall thickness readings showed the drywell wall thickness in these areas to be essentially as-built. Based on the following four factors, PNPS removed UT thickness measurements in the sand cushion region from the IWE program after the 2001 outage:

- Satisfactory results from monitoring for leakage from the annulus air gap drains.
- Satisfactory drywell wall thickness at the 9 foot 1 inch elevation sand cushion region (and upper drywell) after 27 years of operation (as of 1999).
- High radiation exists in areas of sand cushion UT exams.
- The potential for damage to the drywell shell from concrete removal tools used to facilitate the examinations.

The code requires owners to identify locations they believe are suspect or potential problem areas for augmented inspection. After a review of PNPS drywell construction methods, PNPS identified various locations for augmented examination. The presence of ethafoam rings left in place at certain elevations of the drywell caused a concern that they could trap and hold leakage from the bellows or fuel pool and cause corrosion of the shell outer surface. For this reason, augmented UT examinations in the upper drywell at elevations 72 feet and 83 feet (four locations at each elevation) were performed in vertical strips to ensure the region of interest was examined. The examinations performed in 1999 and 2001 revealed no degradation of the drywell shell thickness in the upper drywell.

- UT thickness examinations will continue to be performed under the PNPS IWE program at two locations in the upper drywell immediately adjacent to the fuel pool due to the potential for leakage from the fuel pool liner.

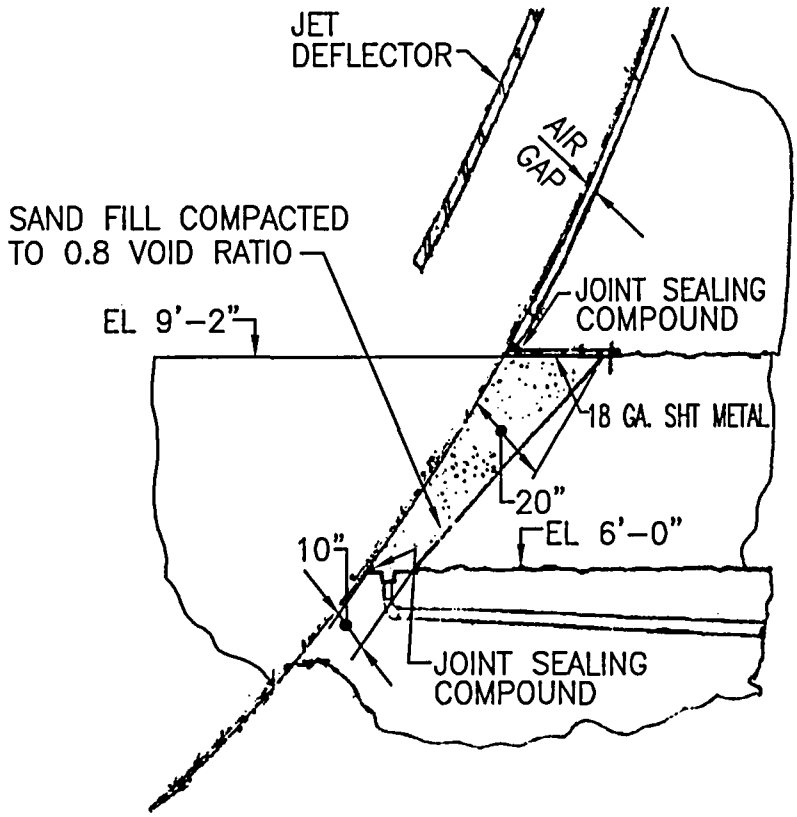
TAKEN FROM PNPS DWG. C-71

The sand cushion at the base of the drywell is designed to provide a smooth transition to reduce thermal and mechanical discontinuities. The sand provides lateral support to the drywell in this region. The sand cushion area is drained to protect the exterior surface of the drywell shell at the sand cushion interface from water that might enter the air gap.

The coating specified for the PNPS drywell shell exterior surfaces was an alkyd-base primer (red lead or zinc chromate). No degradation of this coating in the sand cushion area was noted in 1987 when fiberscopes were used to examine the 4 inch annulus air gap drain lines.

PNPS verified that the annulus air gap drain lines are unobstructed. In 1987, access holes were machined in the drain line elbows on all four drain lines to allow access for remote visual examination using fiberscopes. This inspection determined that the four annulus air gap drains are unobstructed and found no signs of corrosion on visible portions of the drywell surface.

SAND POCKET
