Subject: Braidwood Station, Unit 1, 60-Day Response to First Revised NRC Order EA-03-009, "Issuance of First Revised NRC Order (EA-03-009) Establishing Interim Inspection Requirements for Reactor Pressure Vessel Heads at Pressurized Water Reactors"

Attachments: 1) A1R12 Reactor Pressure Vessel Head Visual Inspection Results
2) Braidwood Unit 1 – A1R12 Reactor Vessel Head Penetration Examination/Westinghouse Report WDI-PJF-1303195-FSR-001

"Braidwood Unit 1 – A1R12
Reactor Vessel Head Penetration Examination
April 2006"

WDI-PJF-1303195-FSR-001

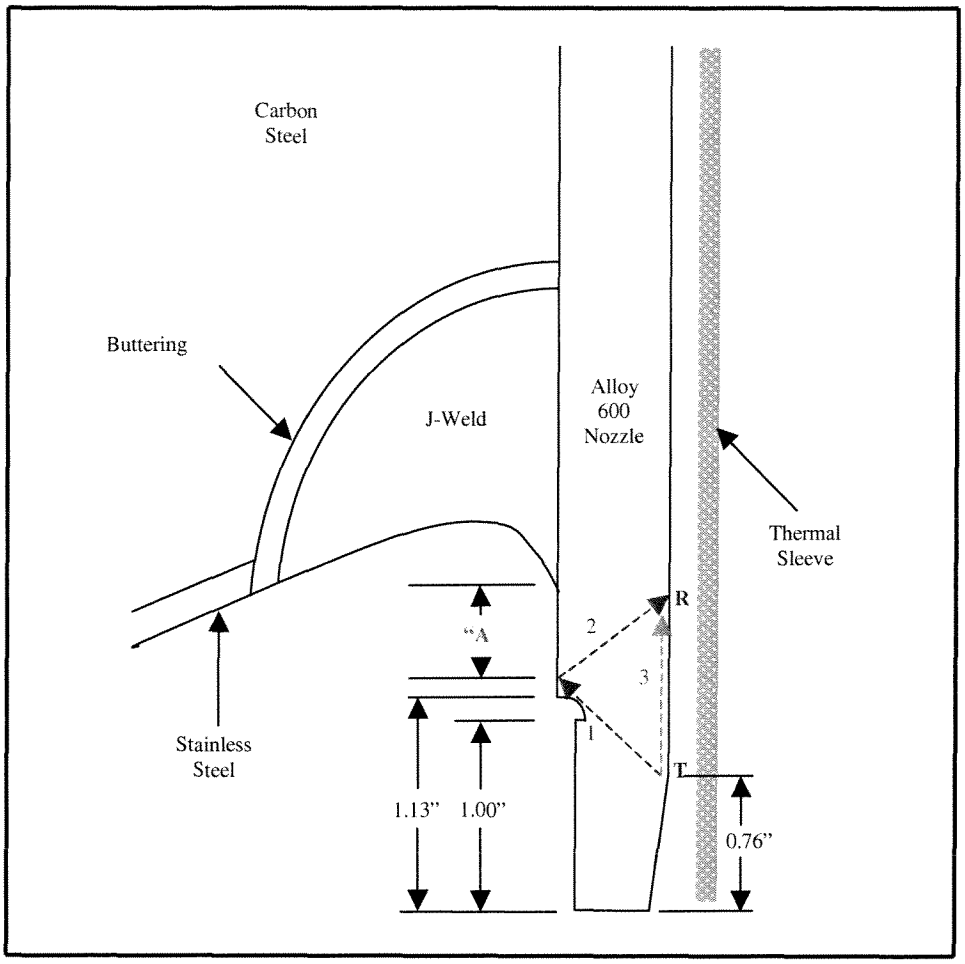
The configuration of a sleeved Braidwood CRDM penetration tube is illustrated in Figure 4-1. This figure represents the tube-to-head geometry at the penetration 0° azimuth, or "downhill" side of the tube. The bottom ends of all penetration tubes are threaded on the OD surface and have a chamfer on the ID surface. The threads extend from the bottom of the tube to an elevation of approximately 1.00" where a thread relief is machined. The top of the thread relief is 1.13" above the bottom of the tube. The distance from the top of the thread relief to the bottom of the fillet of the J-groove weld, identified as "A", varies based on location of the penetration in the head. These distances are generally longer for penetrations at "inboard" locations and become progressively shorter for penetrations located further away from the center of the head. The ID surface chamfers are machined at a 20^0 angle from the bottom of the tube to an elevation of 0.76".

Figure 4-1: Illustration of Axially Oriented TOFD Examination Coverage on Braidwood Unit 1 Penetration Geometry at 0° (Downhill Side)

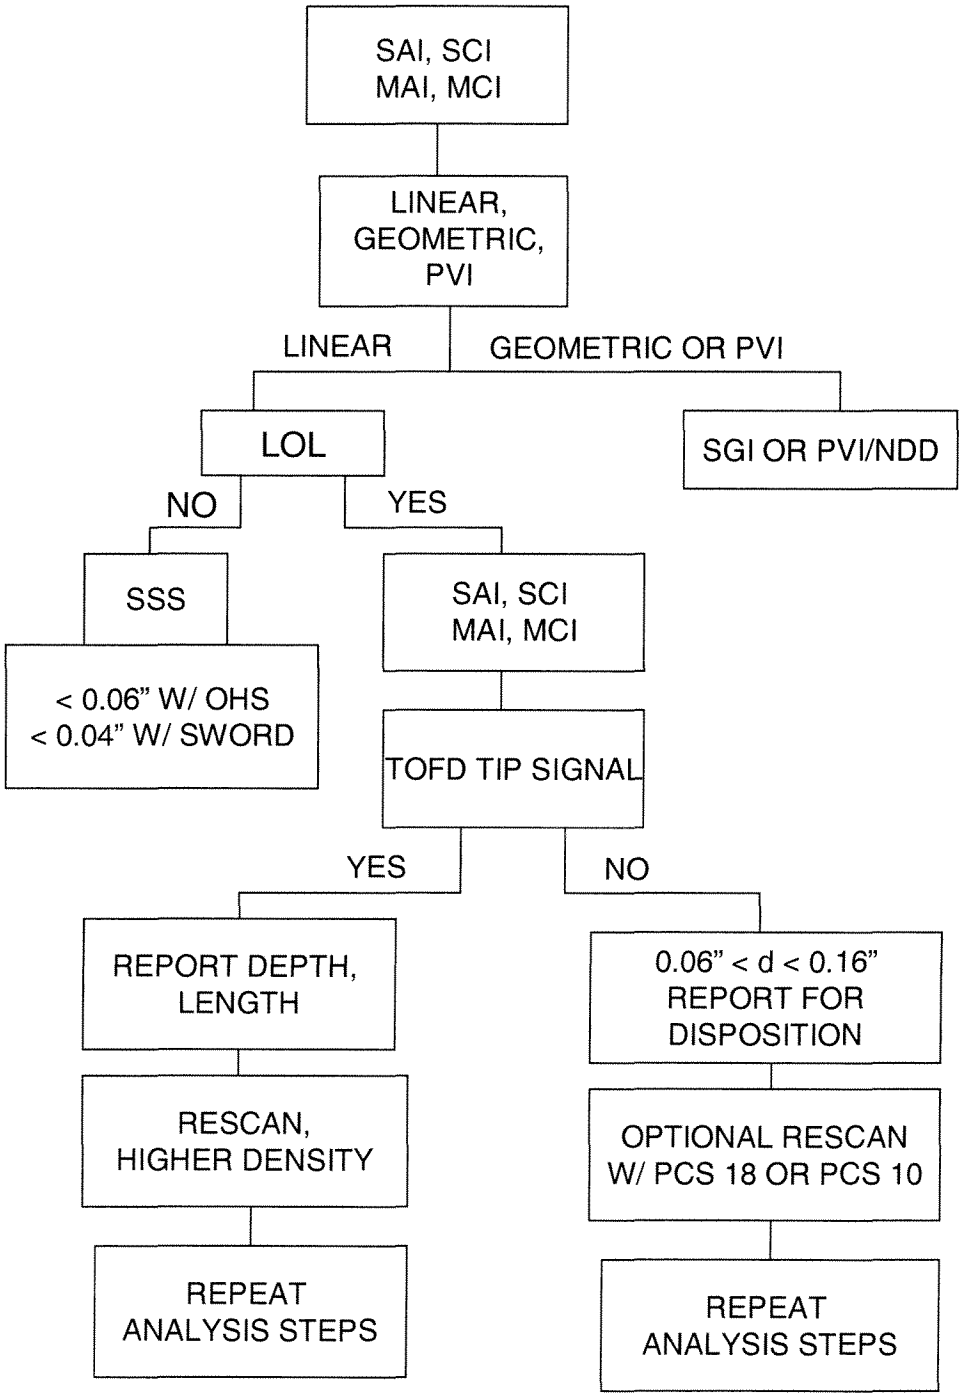
Figure 5-1 - Penetration Tube ID Indication Screening

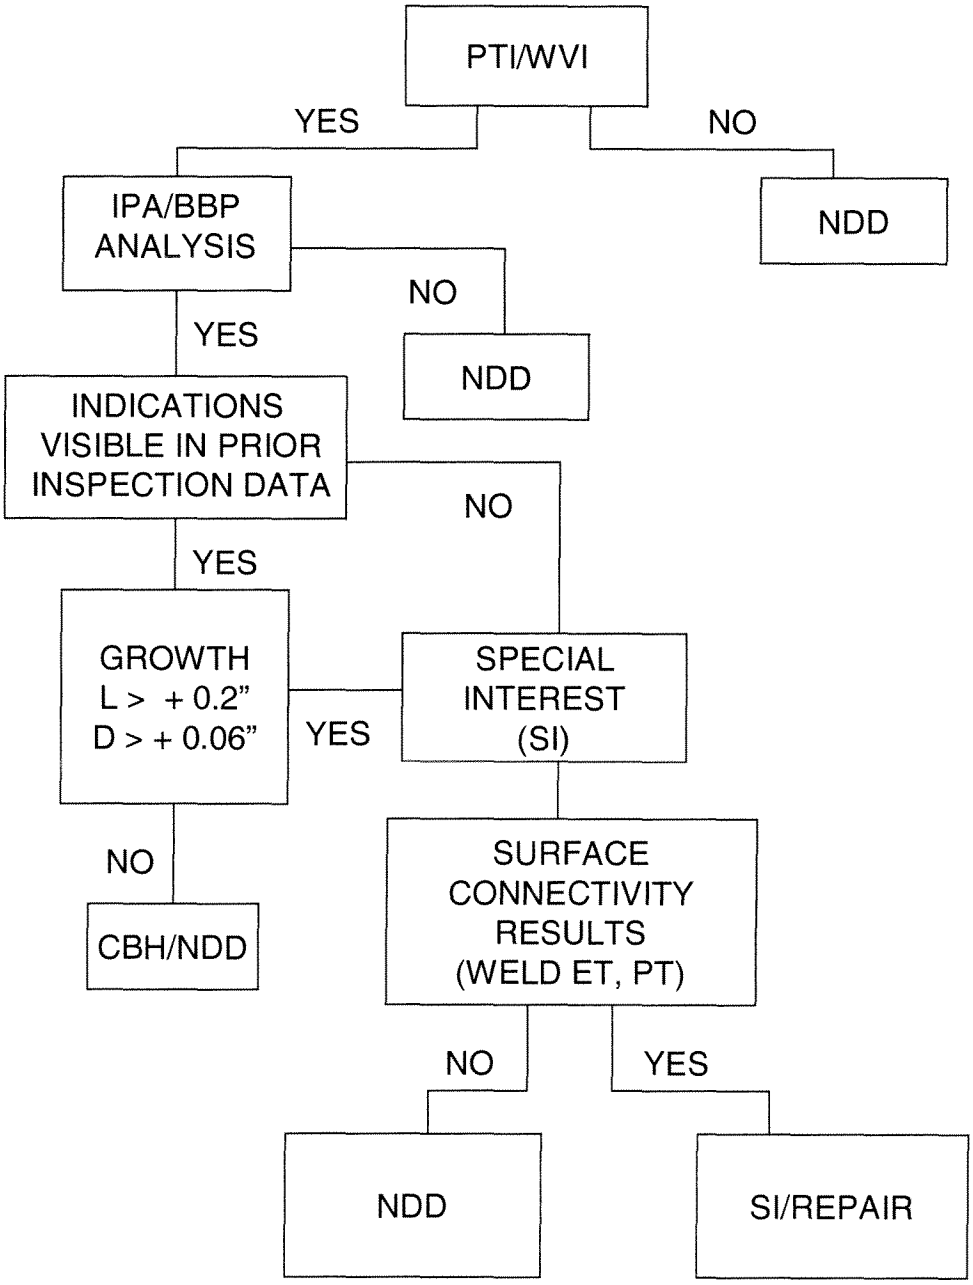
Figure 5-2 - Penetration Tube OD Indication Screening Within Weld Zone

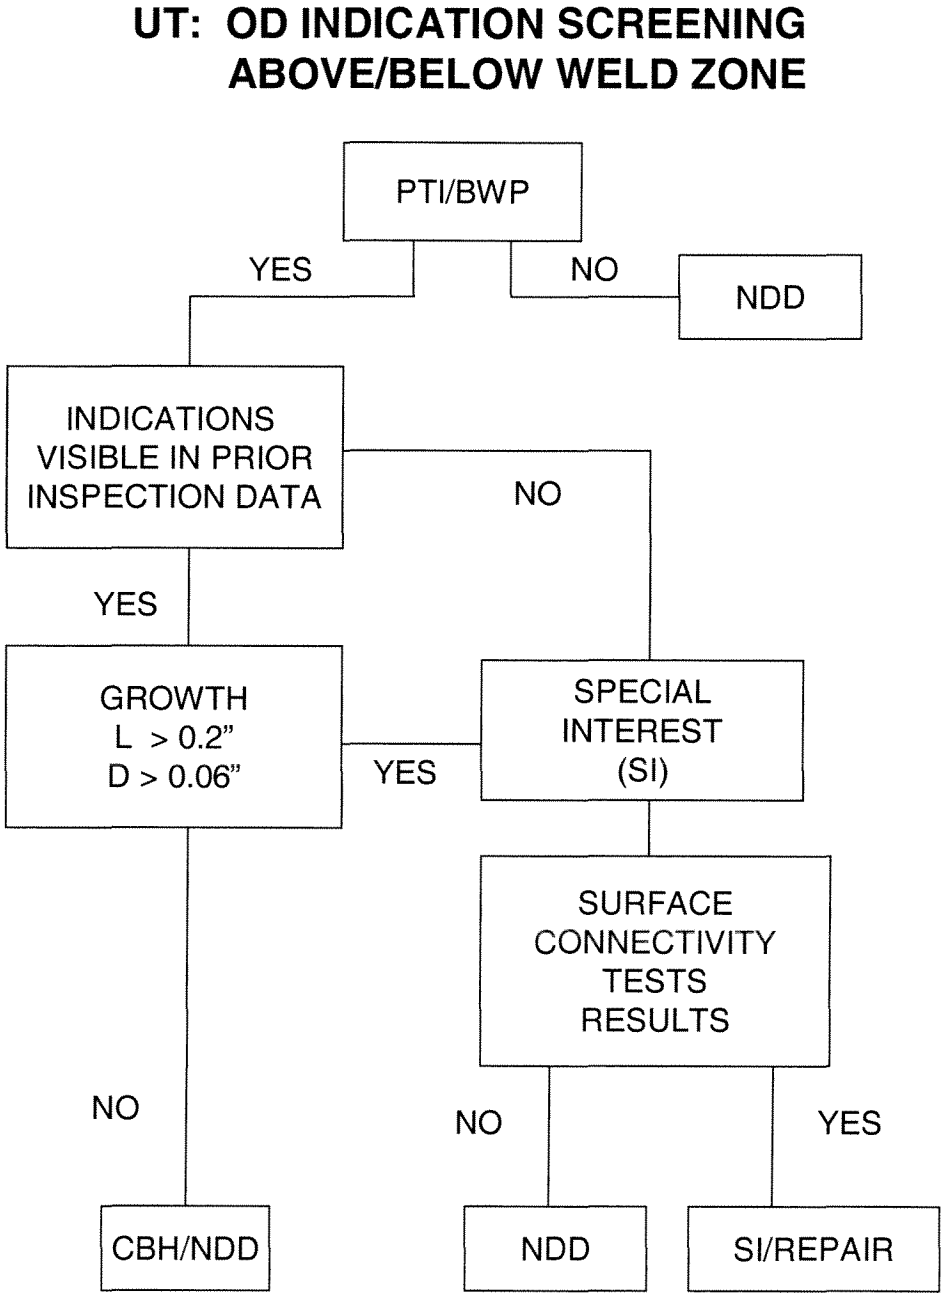
Figure 5-3 - Penetration Tube OD Indication Screening Above or Below Weld Zone
