Subject: Duke Power Company LLC
Oconee Nuclear Station, Unit 3
Docket Nos. 50-287
Third Ten Year Inservice Inspection Interval
Request for Relief No. 05-ON-002, Rev 1

TECHNICAL LETTER REPORT
REQUEST FOR ADDITIONAL INFORMATION
ON THIRD 10-YEAR INSERVICE INSPECTION INTERVAL
REQUEST FOR RELIEF 05-ON-002
FOR
DUKE POWER COMPANY
OCONEE NUCLEAR STATION, UNIT 3
DOCKET NUMBER 50-287

05-ON-002
Revision 1

Limited Examinations
on Reactor Vessel

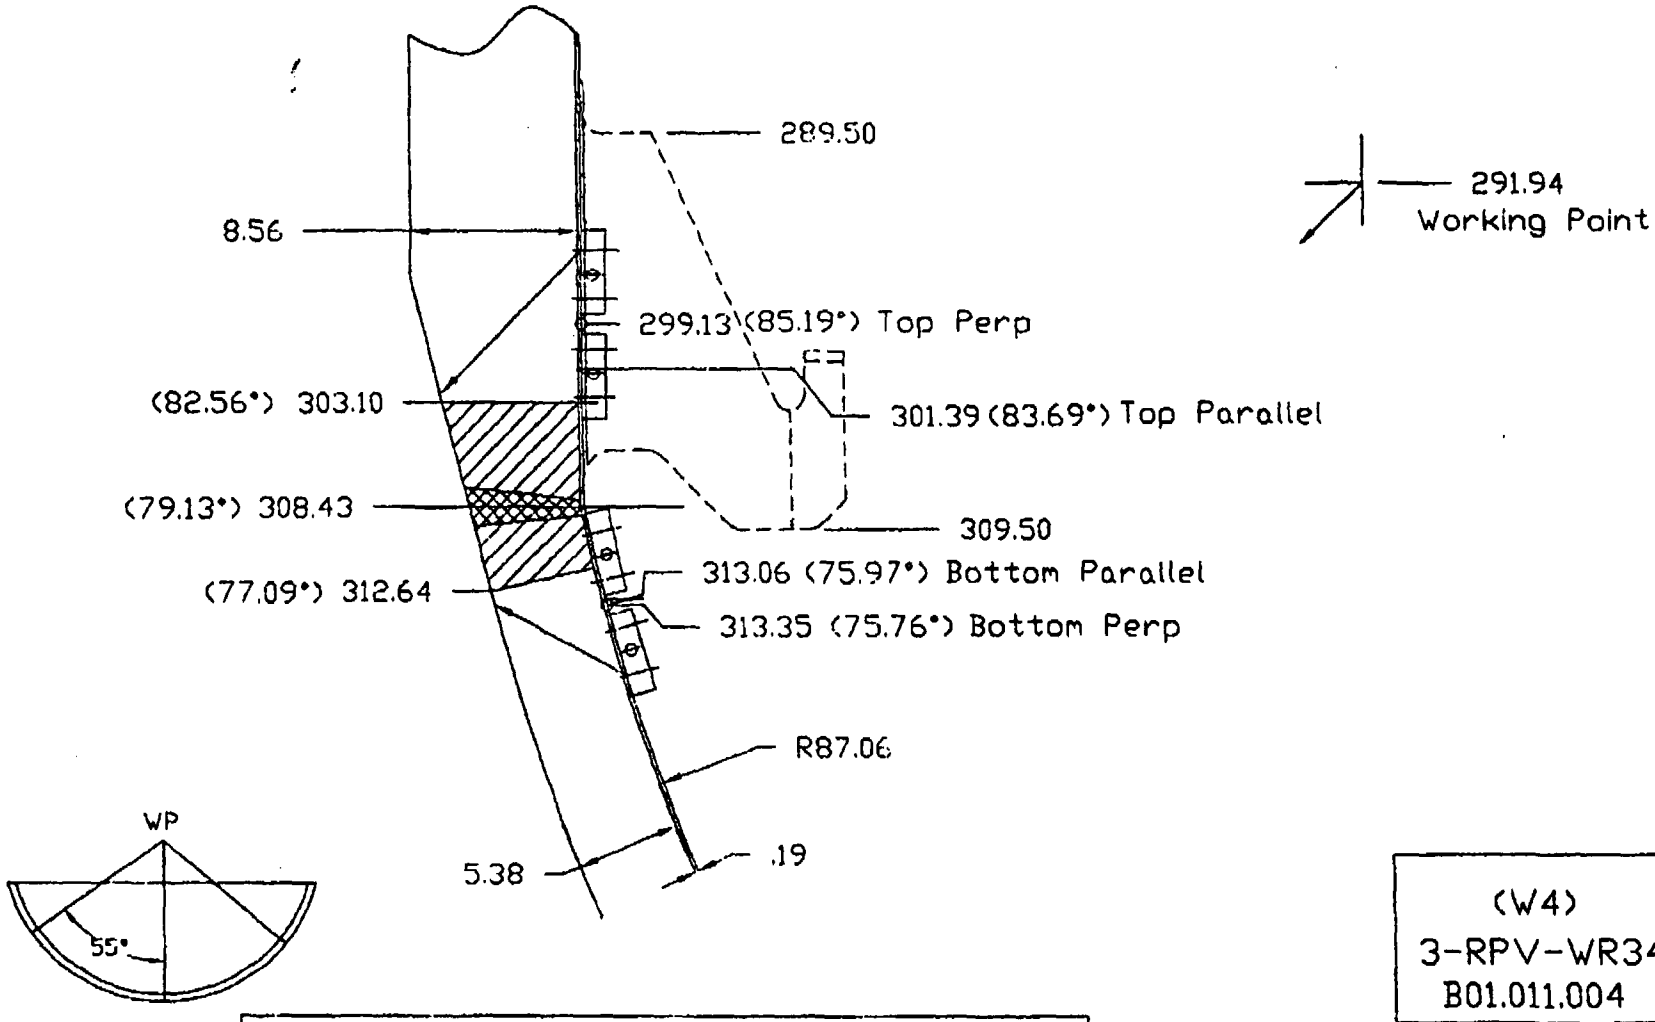
(W4)
3-RPV-WR34
B01.011.004

During ultrasonic examination, 100% coverage of the required examination volume could not be obtained. Twelve core guide lugs restrict the scanning surface, as shown on the Attachment B drawing, causing limitations that resulted in 44.5% coverage. The percentage of coverage reported represents the aggregate coverage from all scans parallel and perpendicular to the weld. The weld and adjacent base material were examined using 45° refracted shear waves and 45° refracted longitudinal waves. Examination volumes directly below the core guide lugs received no coverage when scanned parallel to the weld. Additionally no scans were performed perpendicular to the weld directly below the core guide lugs. Scans parallel to the weld were restricted to 7.6 inches on either side of each core guide lug and scans perpendicular to the weld were restricted to 4.7 inches on either side of each core guide lug. In order to achieve more coverage, the core guide lugs would have to be moved to allow greater access, which is impractical. There were no recordable indications found in the areas that were examined.

Parallel Scan Limits +/- 4.6° Either Side of Core Guide Lugs
Perp Scan Limits +/- 3.1° Either Side of Core Guide Lugs
No Scans Performed Below Core Guide Lugs

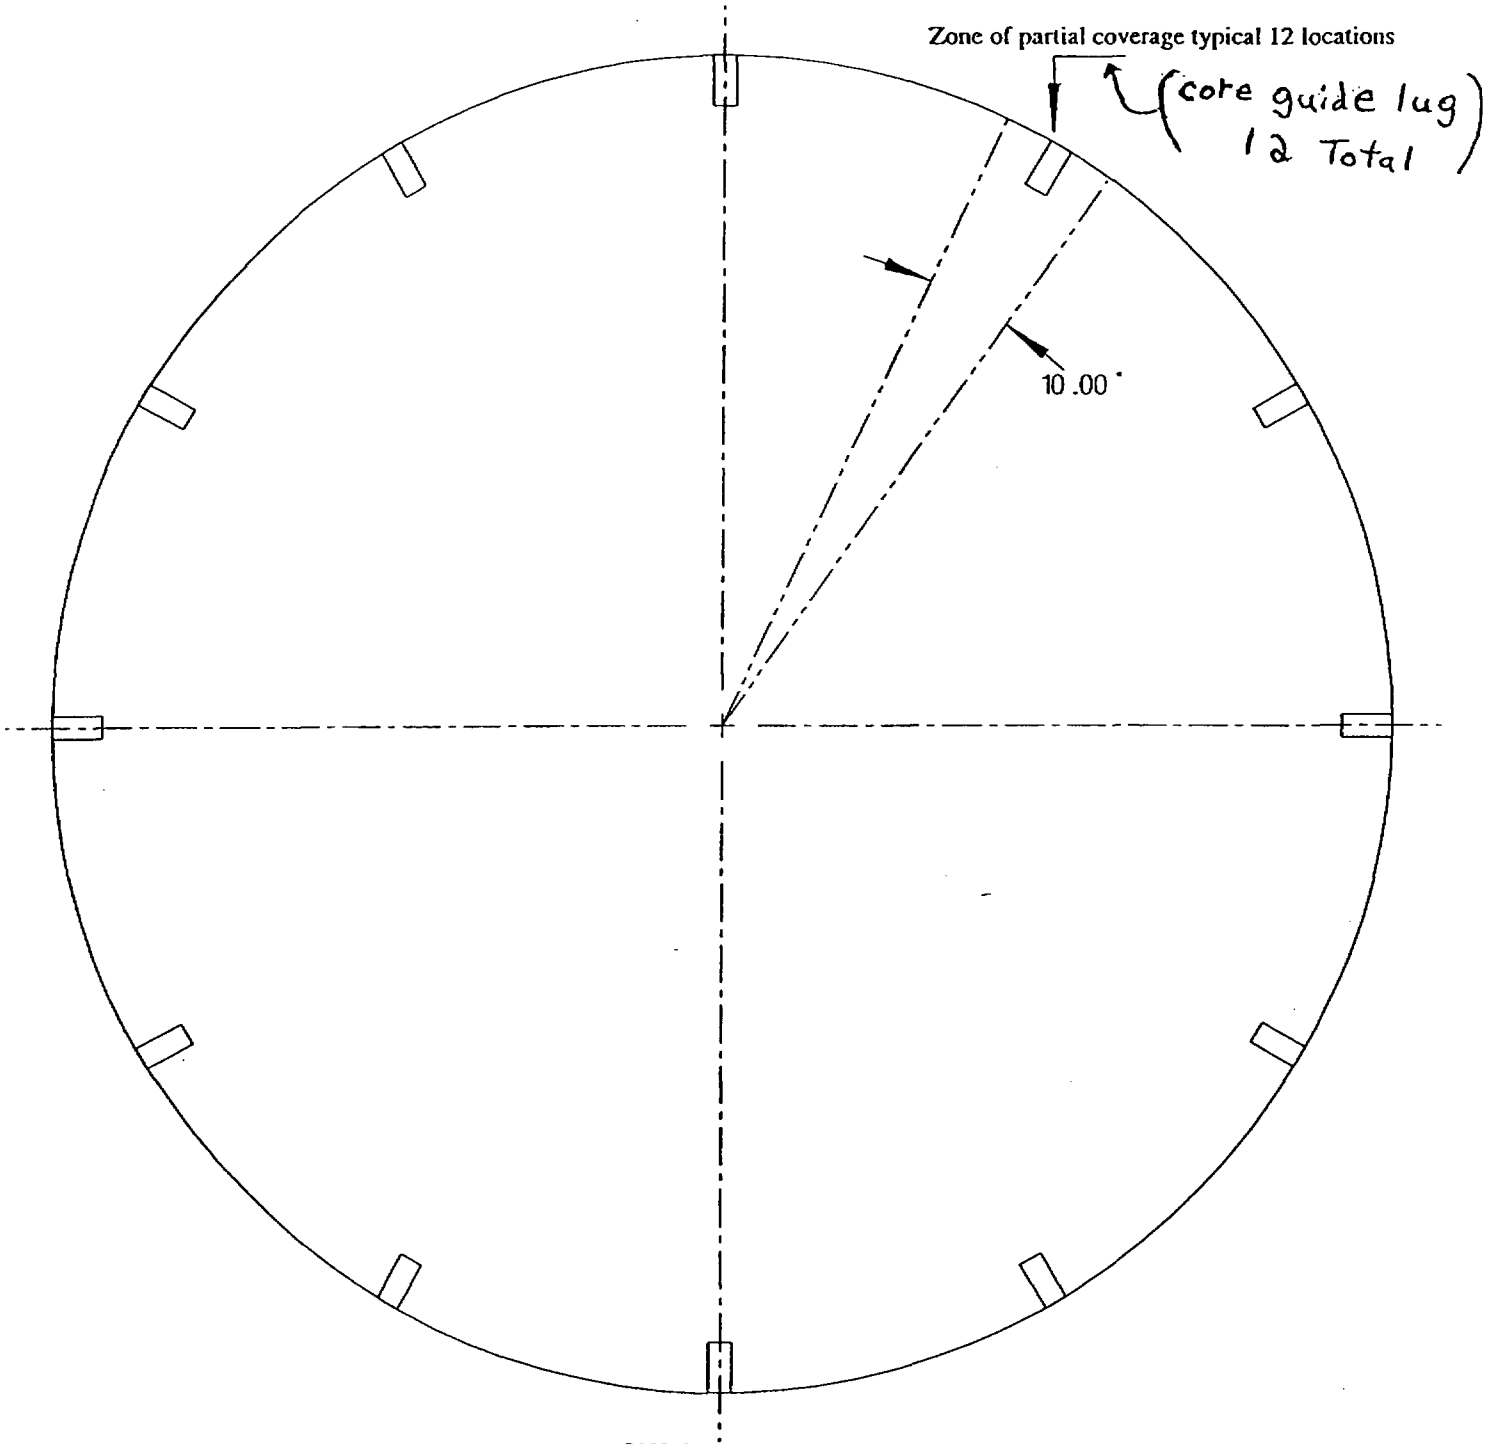
ONS-3
3-RPV-WR34

54% of the weld and base material volume received coverage in two directions perpendicular to the weld.

35% of the weld and base material volume received coverage in two directions parallel to the weld.

55.50% of the weld and base material volume received no coverage.

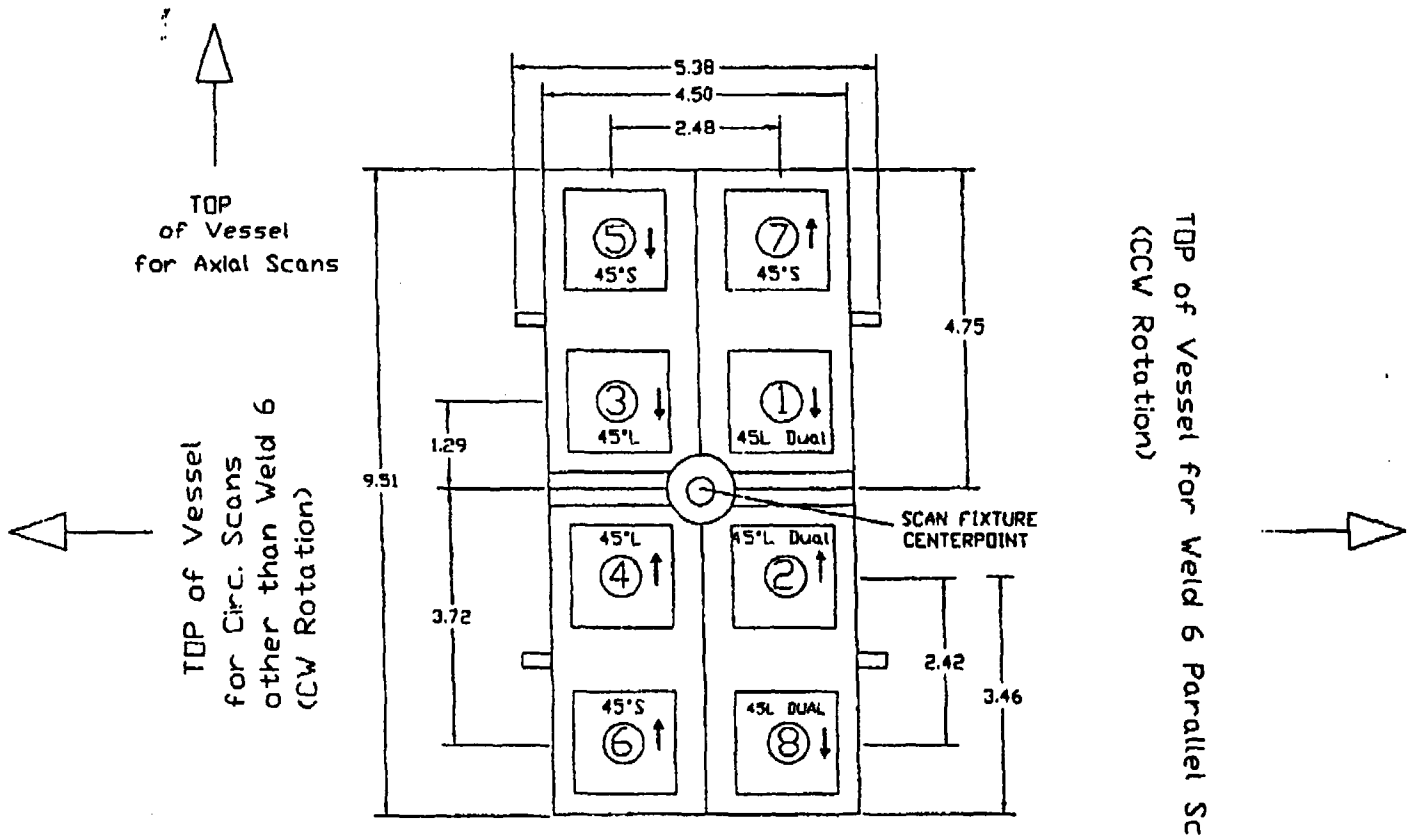
During ultrasonic examination, 100% coverage of the required examination volume could not be obtained. The examination coverage was limited to 50%. The percentage of coverage reported represents the aggregate coverage from all scans parallel and perpendicular to the weld. The flow stabilizers, core guide lugs and in-core nozzles that restrict the scanning surface, as shown on the Attachment C drawing, caused the limitations. The weld and adjacent base material were examined using 45° refracted shear waves and 45° refracted longitudinal waves. There were no recordable indications found in the areas that were examined. In order to achieve more coverage the flow stabilizers, core guide lugs and in-core nozzles would have to be moved to allow greater access for scanning, which is impractical.

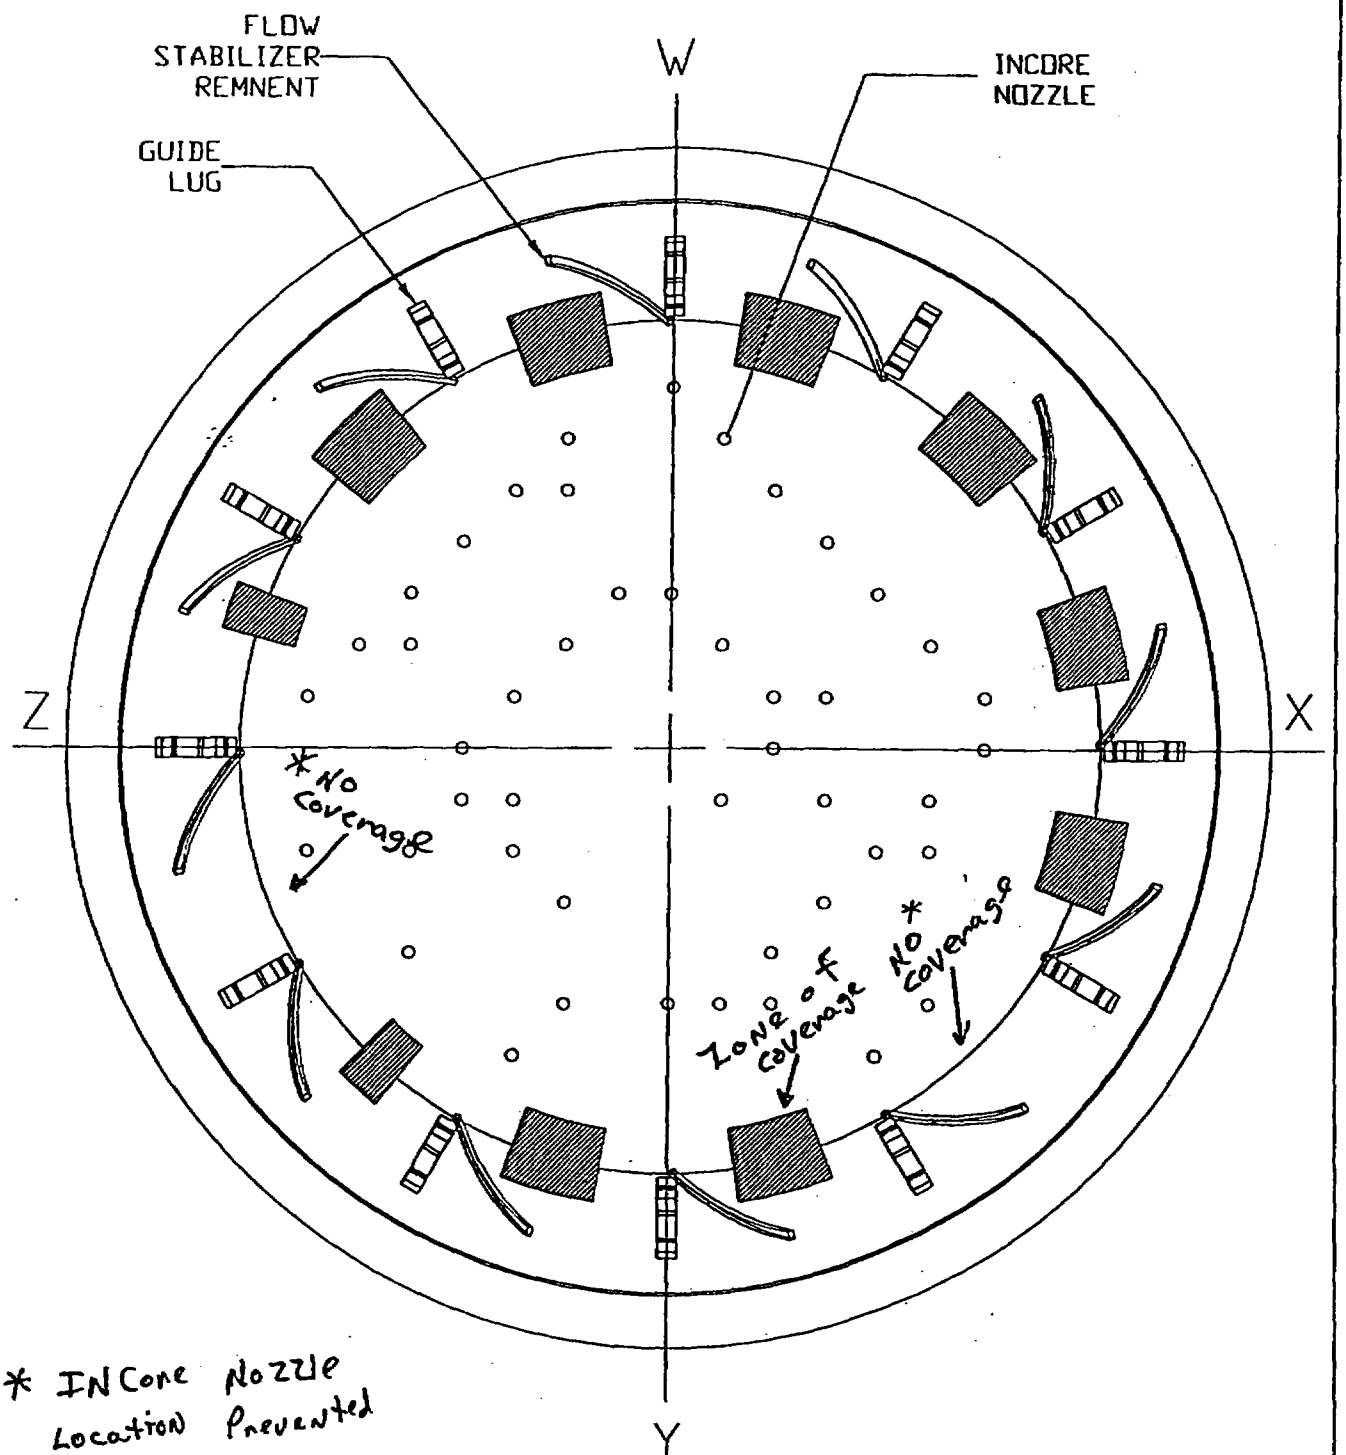
OCONEE-3
3-RPV-WR35
B01.021.003

* INCore Nozzle Location Prevented Scanning

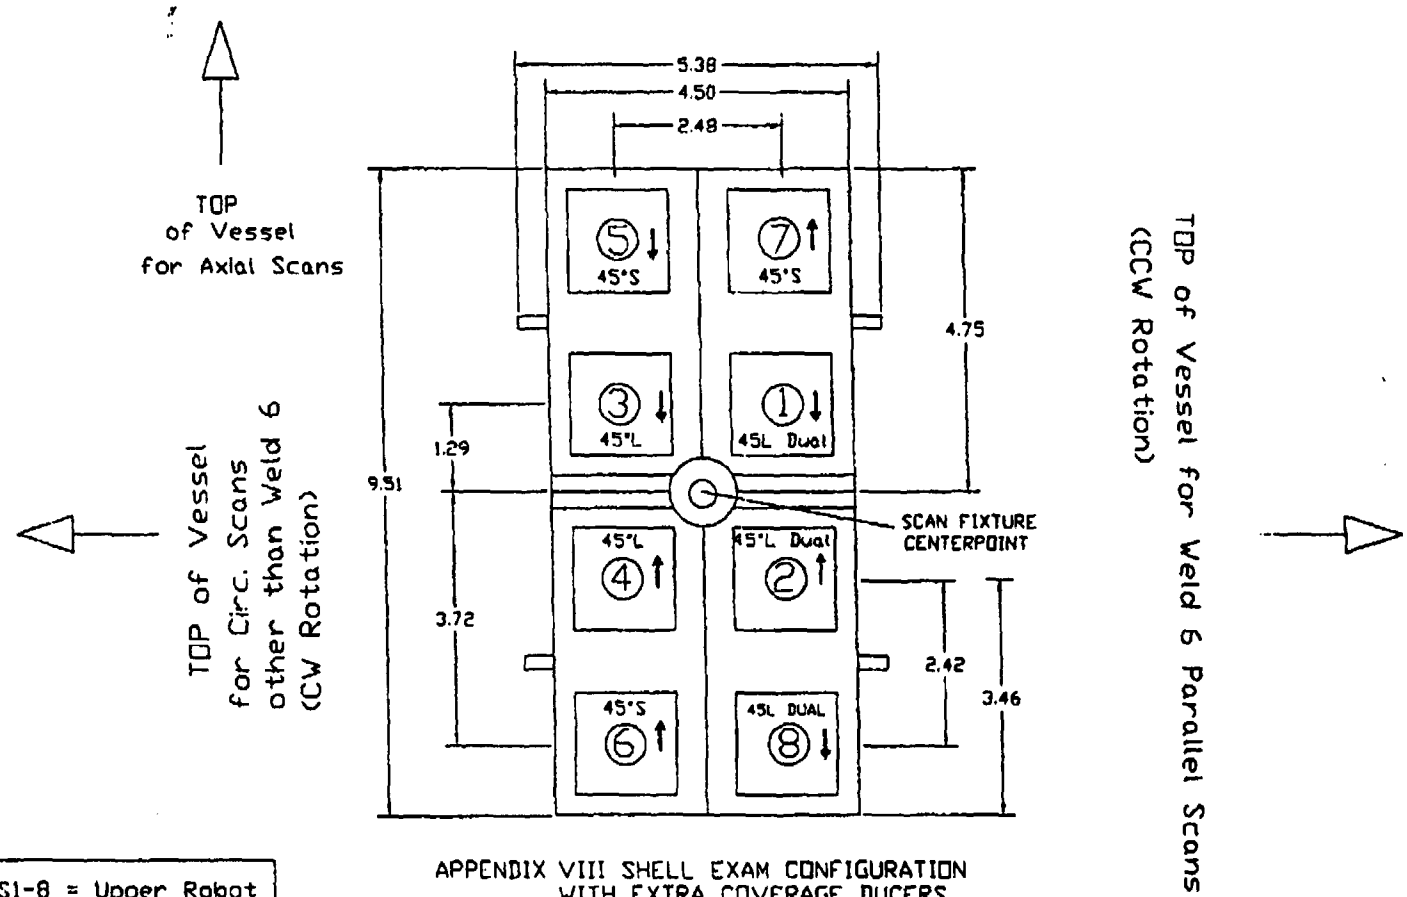
During ultrasonic examination, 100% coverage of the required examination volume could not be obtained. The examination coverage was limited to 85.8%. The percentage of coverage reported represents the aggregate coverage from all scans parallel and perpendicular to the weld. Limitations were caused by inside surface taper and the ledge shown in Attachment D. The percentage of coverage reported represents the aggregate coverage from all scans. The weld and adjacent base material were examined using 45° refracted shear waves and 45° refracted longitudinal waves. There were no recordable indications found in the areas that were examined. In order to achieve more coverage, the weld would have to be redesigned which is impractical.
(See Attachment D for exam information)

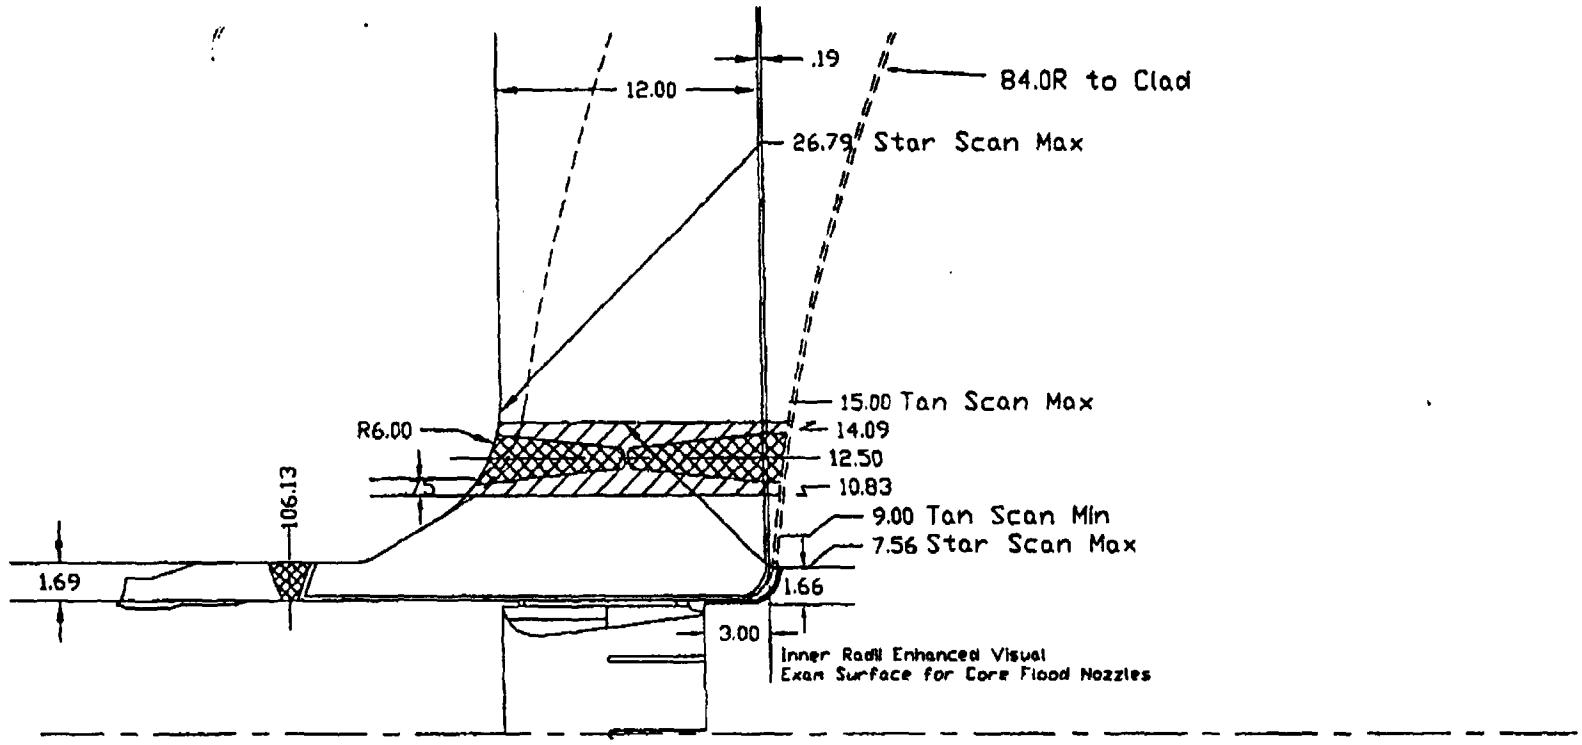
During ultrasonic examination, 100% coverage of the required examination volume could not be obtained. The examination coverage was limited to 84.2% of the required volume. The Core Flood Nozzles of a B&W 177 plant have several obstructions which limit ultrasonic examination coverage. In order of significance these are:

- The flow restrictor which is welded to the inner bore of the nozzle;
- The inlet nozzles located 30° on either side of each core flood nozzle;
- The taper above the core flood nozzles associated with the Core Support Ledge.

Core Flood Nozzle to Shell @ 0° - 3RPV-WR54 (B03.090.007)
Core Flood Nozzle to Shell @ 180° - 3RPV-WR54A (B03.090.008)

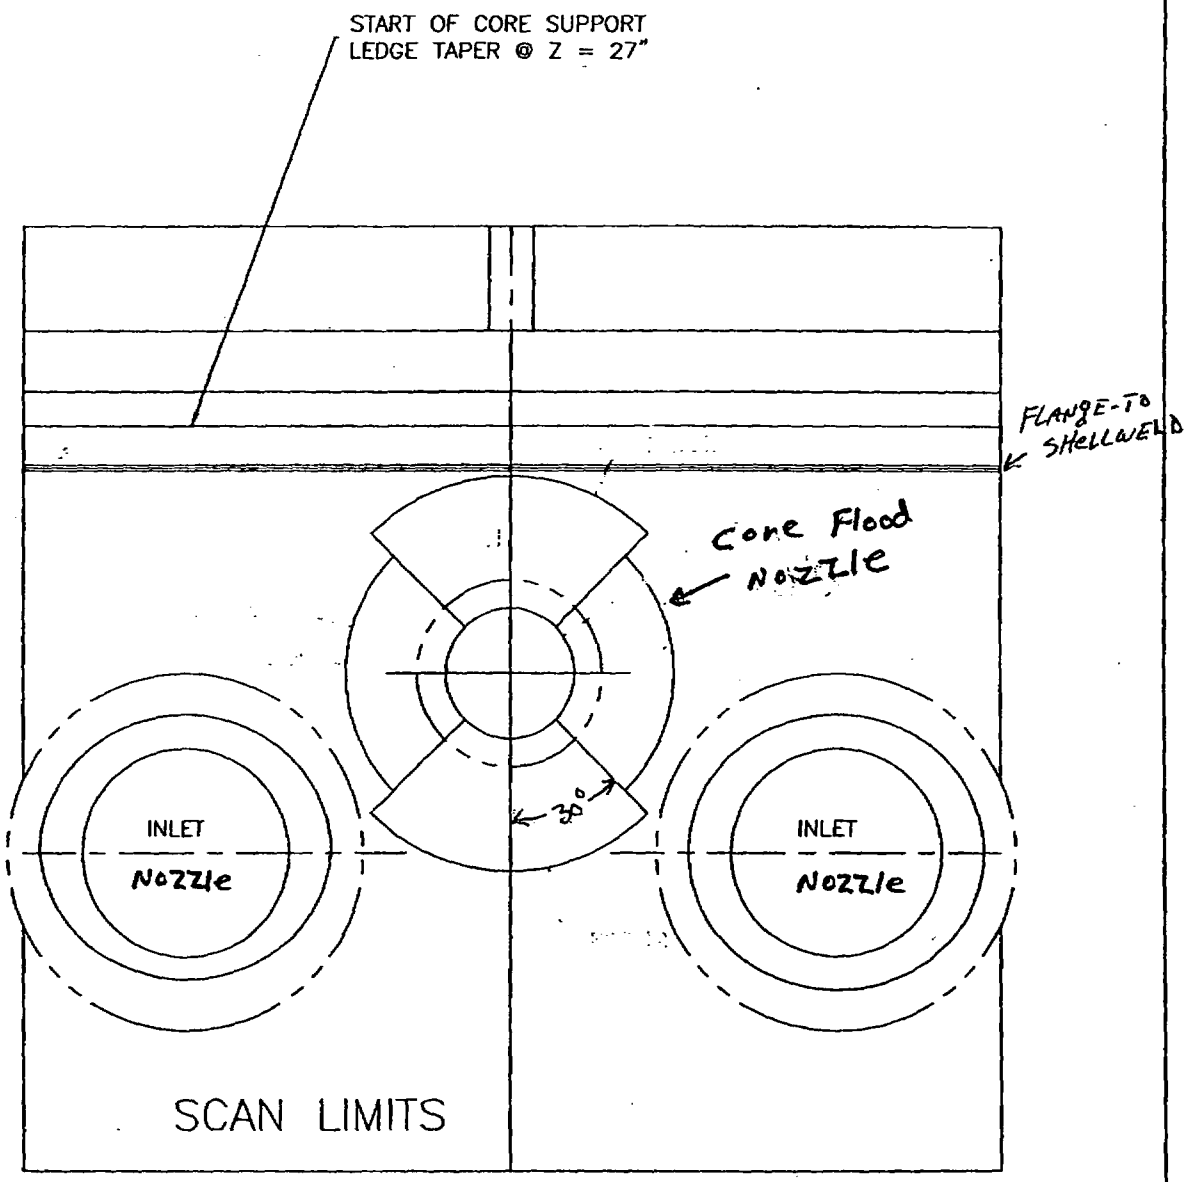
ATTACHMENT E

Weld and adjacent base material = 87.6% scanned parallel to the weld in two opposite directions and 72.9% scanned perpendicular to the weld centerline from the nozzle bore and the vessel inside surface.

There were no recordable indications found in the areas that were examined for either of these welds. In order to achieve more coverage, the inlet nozzles would have to be moved, and the taper on the flange would have to be redesigned to allow greater access for scanning, which is impractical. In addition, because of the proximity of the flow restrictors limited scanning was performed from the nozzle I.D. as shown in Attachment E. In order to achieve more coverage, the flow restrictor would have to be moved to allow access for scanning, which is impractical.

START OF CORE SUPPORT
LEDGE TAPER @ Z = 27"
FLANGE-TO
SHELLWELD
Core Flood
NOZZLE
30°
INLET
NOZZLE
INLET
NOZZLE
SCAN LIMITS
