UNITED STATES
NUCLEAR REGULATORY COMMISSION
WASHINGTON, D.C. 20555-0001

October 7, 1996

Licensee:	Maine Yankee Atomic Power Company
Facility:	Maine Yankee Atomic Power Station
Location:	Wiscasset, Maine
Docket No:	50-309
Onsite Evaluation Period:	July 15-26, 1996, and August 12-23, 1996
Team Manager:	Edward L. Jordan
Team Leader:	Ellis W. Merschoff
Administrative Assistant:	Ola B. West
Team Members:	Larry Bell John R. Boardman Russell L. Bywater, Jr. Harold O. Christensen George M. Hausman John V. Kauffman Kriss M. Kennedy G. Norman Lauben Ronald L. Lloyd Alan L. Madison Thomas O. Martin Peter J. Prescott Jack E. Rosenthal
State Representatives:	David Decrow Patrick Dostie Uldis Vanags
Contractors:	George Cha Robert Christie Cyril Crane Brian Haagensen Michael Shlyamberg Leonard Ward

Maine Yankee
Independent Safety Assessment Team

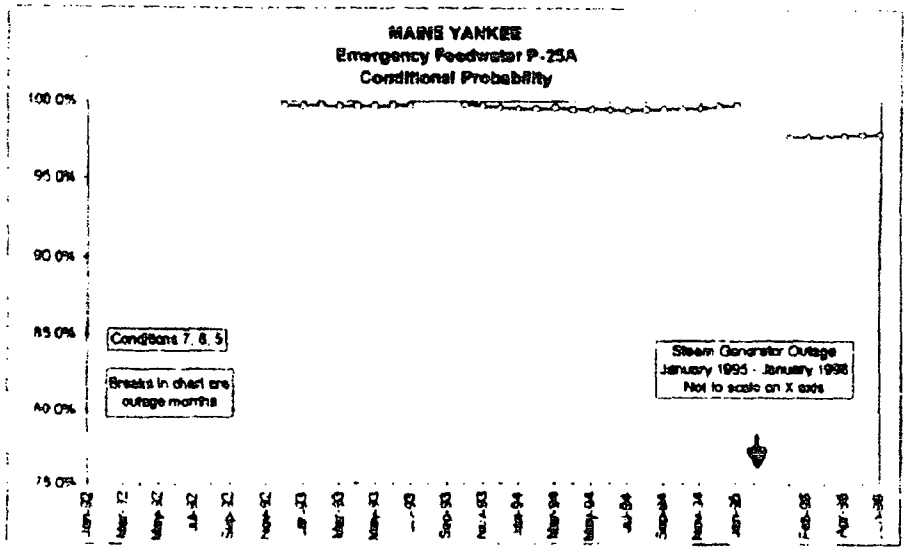
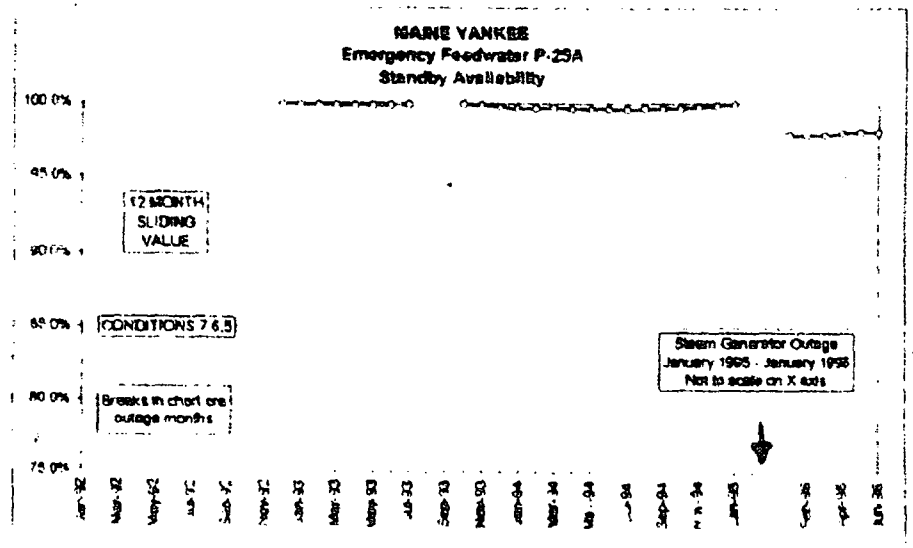
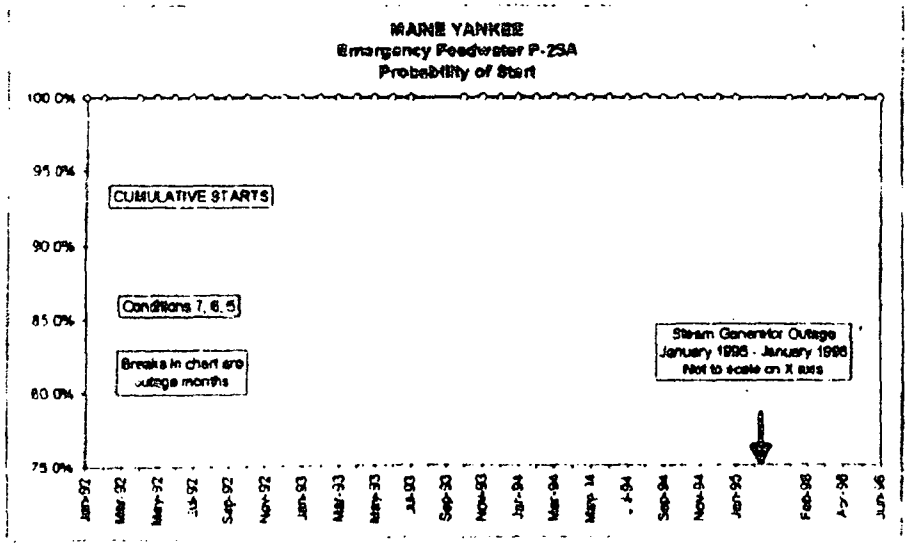
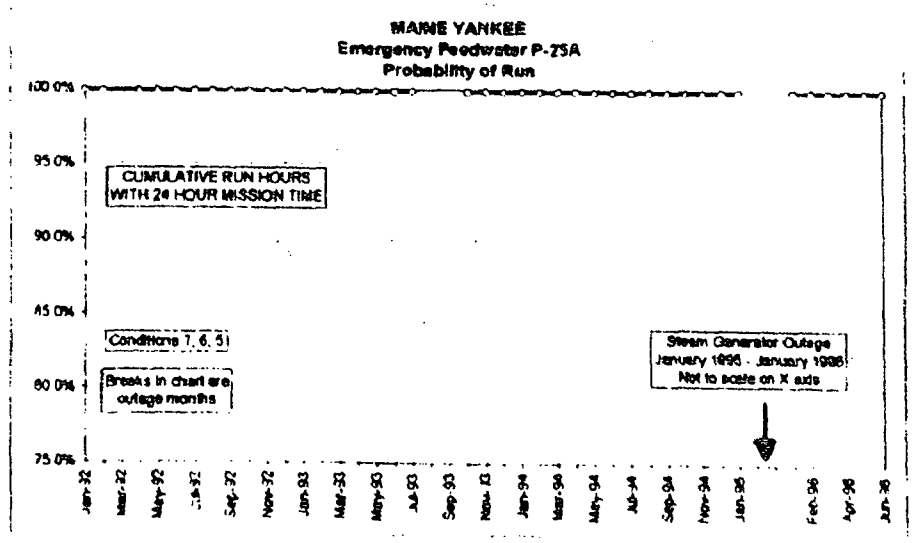
Figure 2

Total Starts	130
Successful Starts	130
Failures to Start	0
Total Run Hours	487
Run Failures	0
Planned Maintenance Hours	44.5
Unplanned Maintenance Hours	143.5

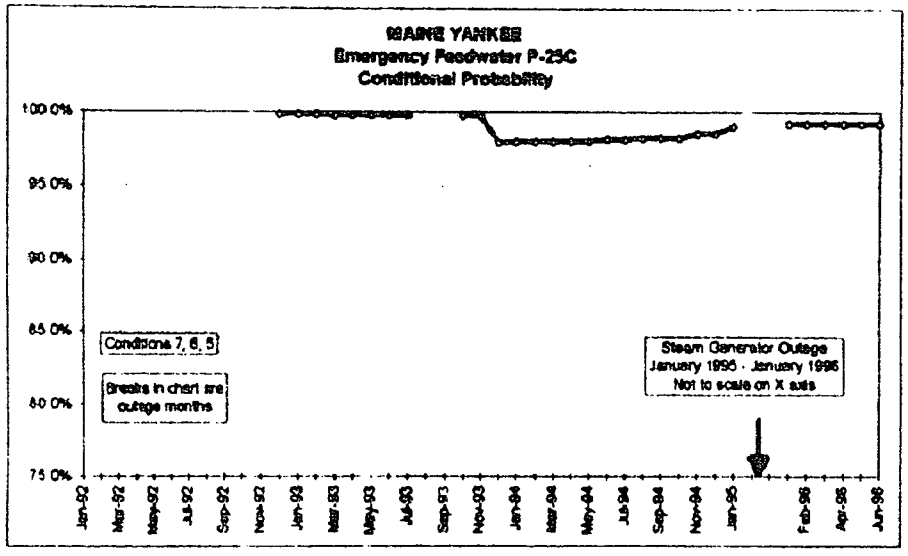
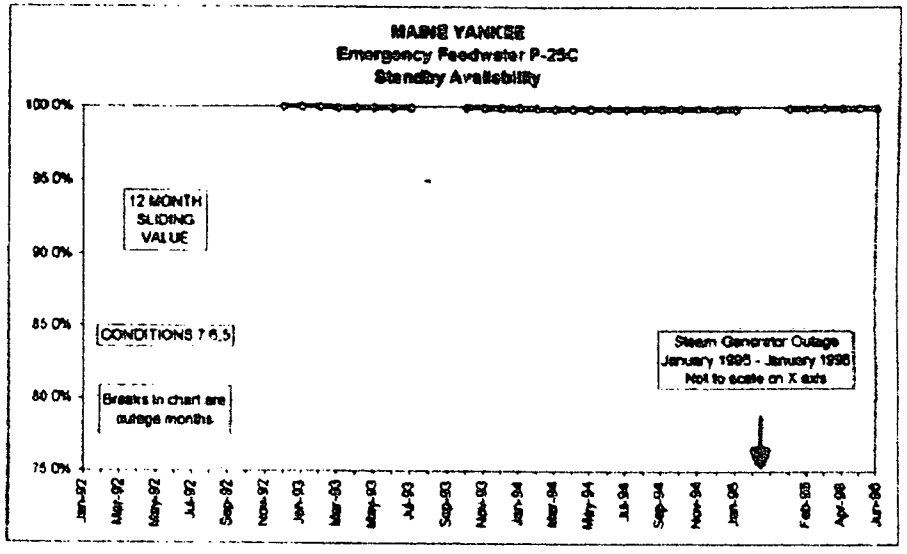
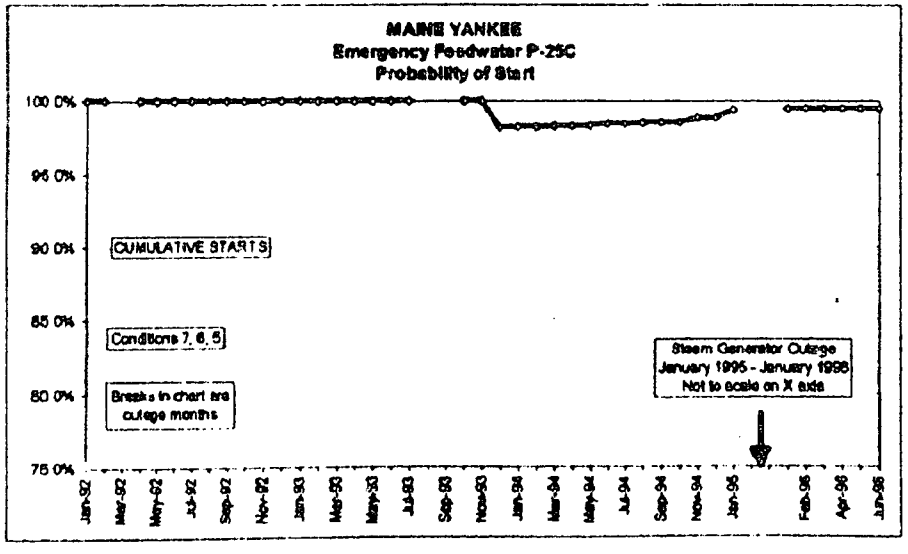
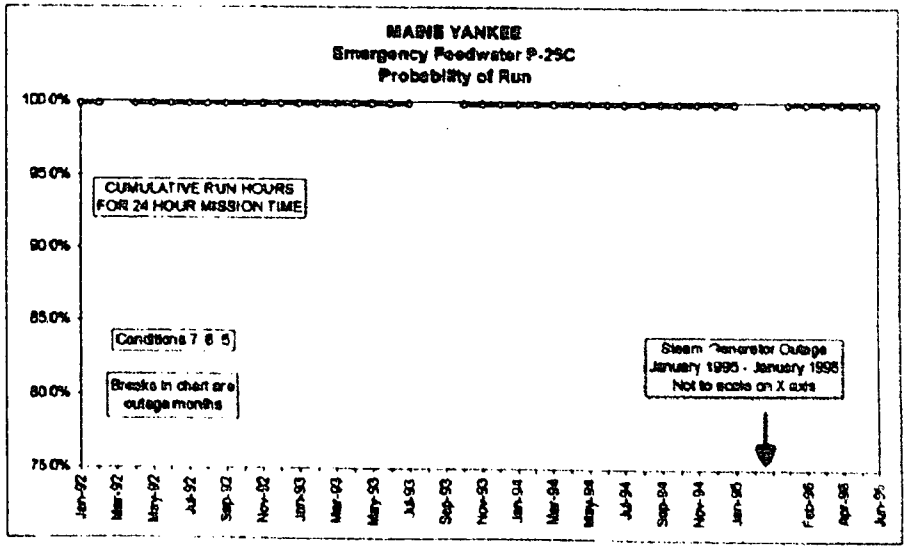
Figure 3

Total Starts	192
Successful Starts	191
Failures to Start	1
Total Run Hours	992
Run Failures	0
Planned Maintenance Hours	29.5
Unplanned Maintenance Hours	1.5

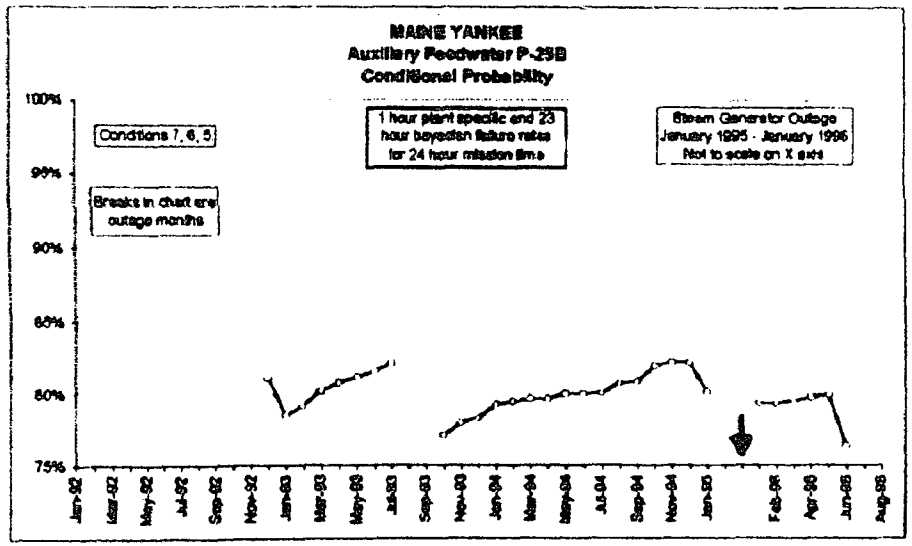
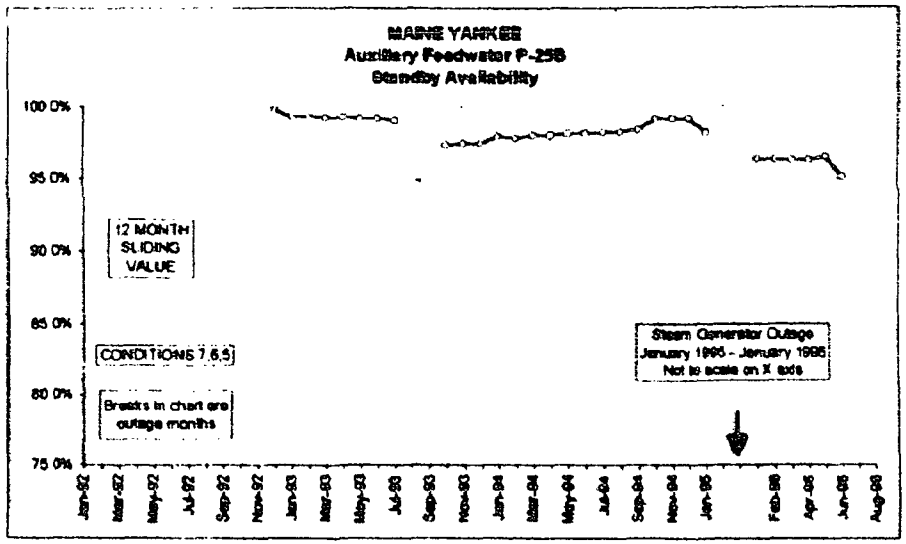
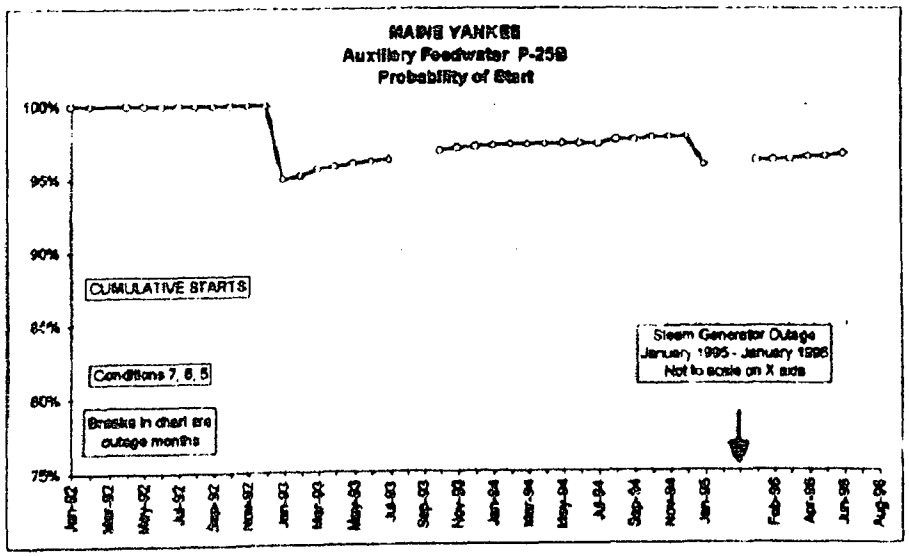
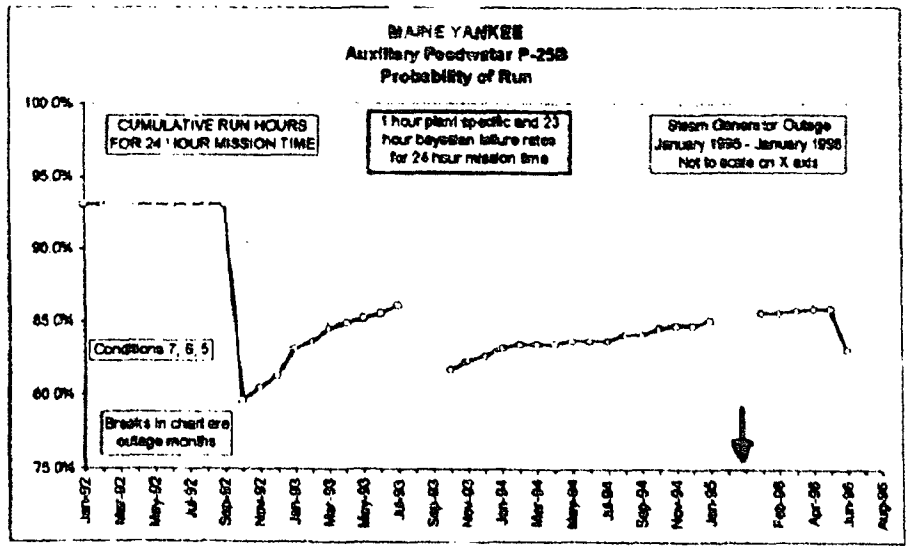
Figure 4

Total Starts	59
Successful Starts	57
Failures to Start	2
Total Run Hours	26.5
Run Failures	3
Planned Maintenance Hours	132.5
Unplanned Maintenance Hours	441.0

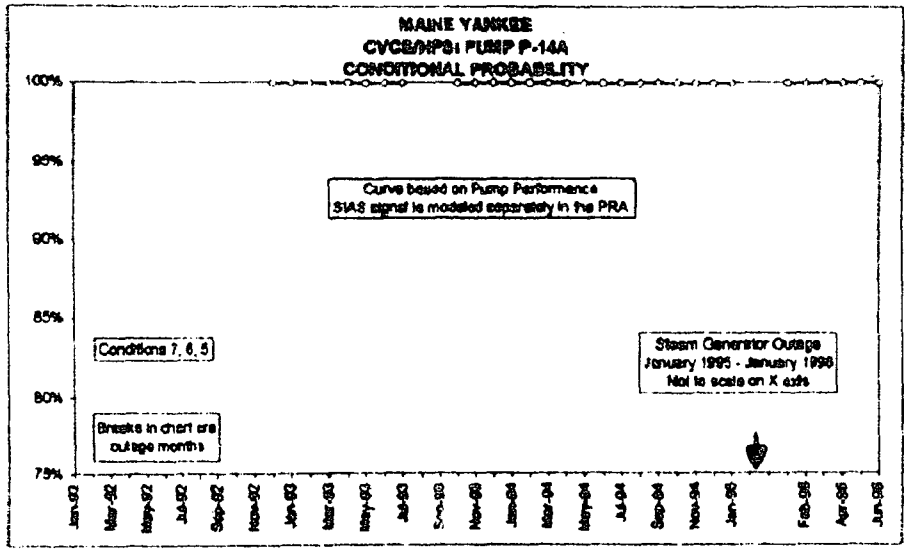
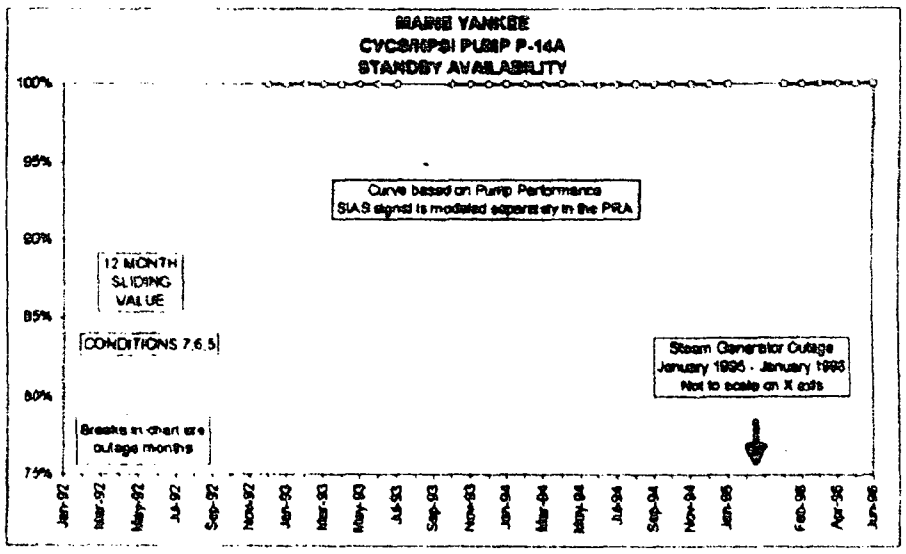
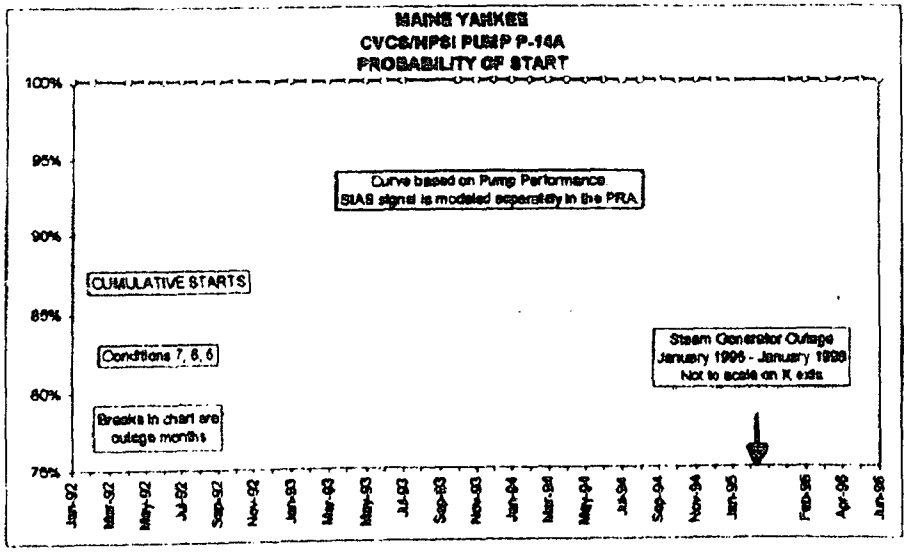
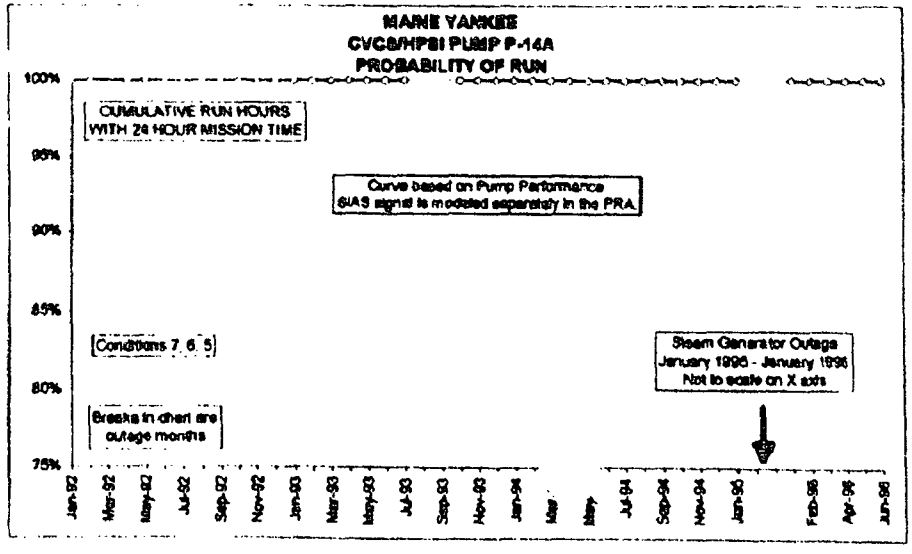
Figure 5

Total Starts	79
Successful Starts	79
Failures to Start	0
Total Run Hours	9.996
Run Failures	0
While aligned	
Planned Maintenance Hours	4.4
Unplanned Maintenance Hours	0.5

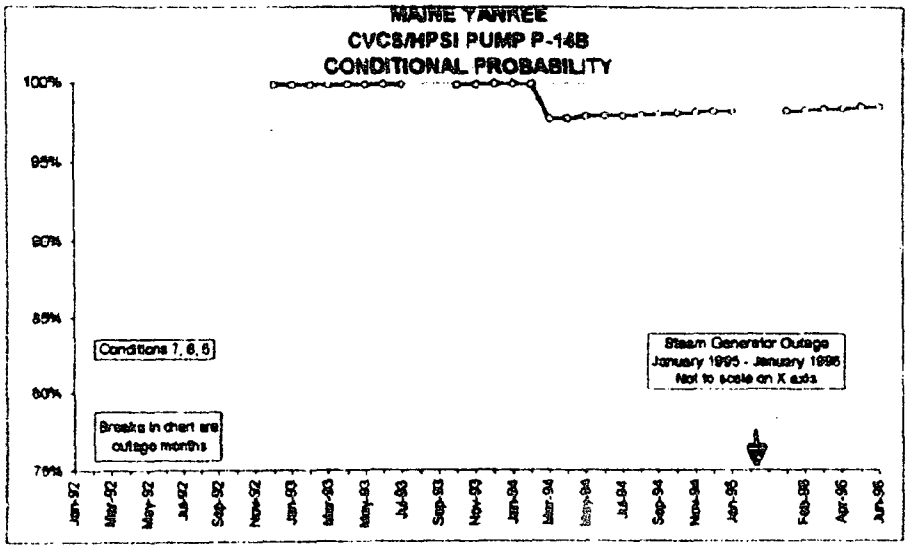
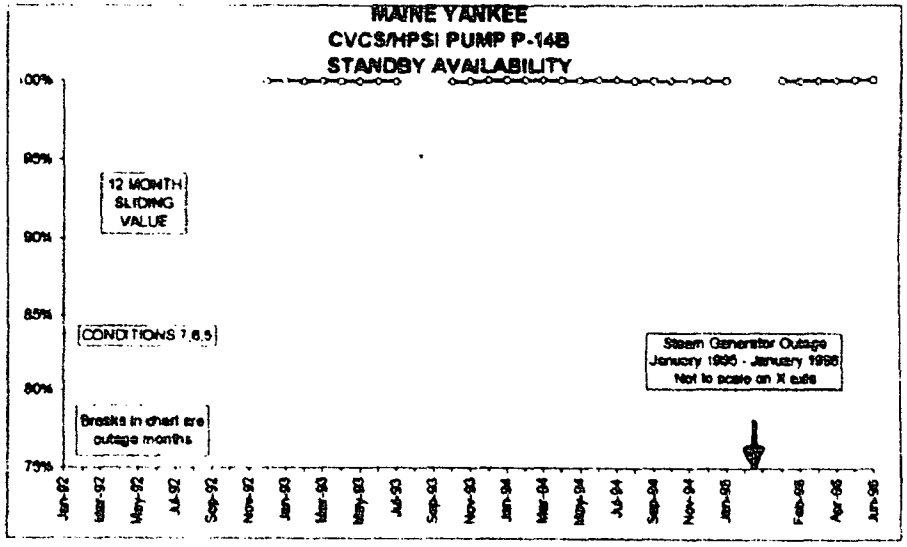
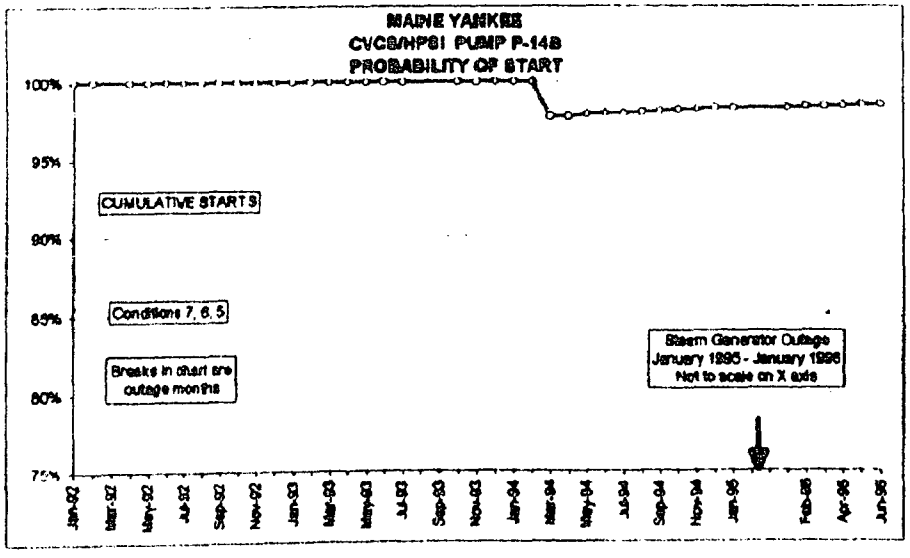
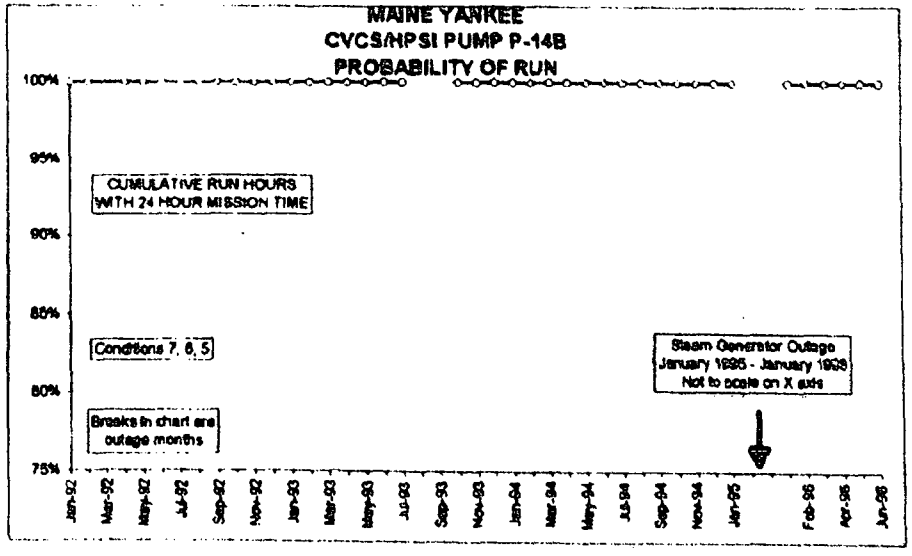
Figure 6

Total Starts	68
Successful Starts	68
Failures to Start	1
Total Run Hours	6,592
Run Failures	0
While aligned	
Planned Maintenance Hours	9.5
Unplanned Maintenance Hours	0.7

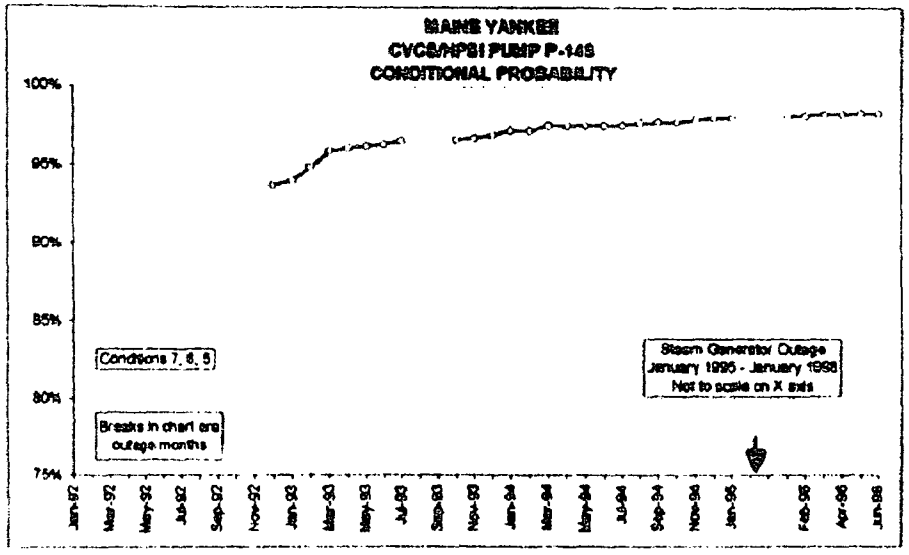
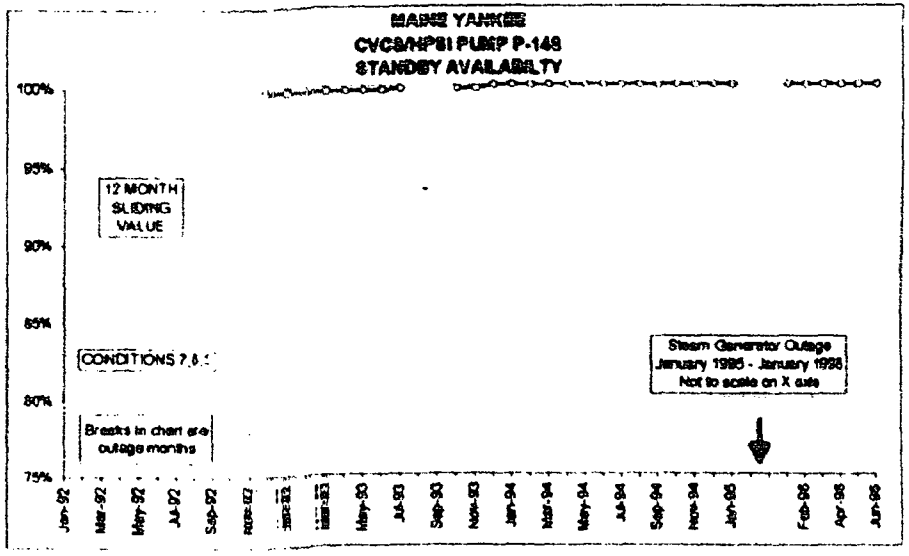
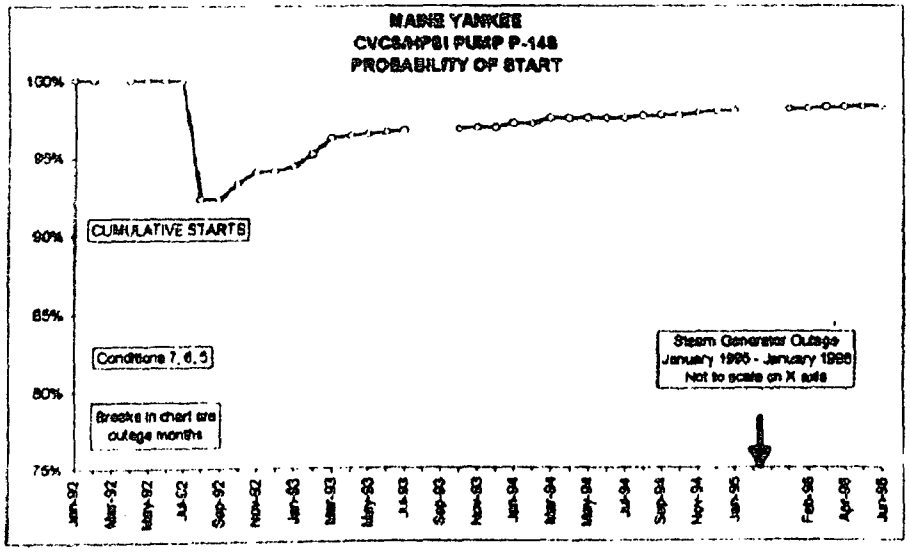
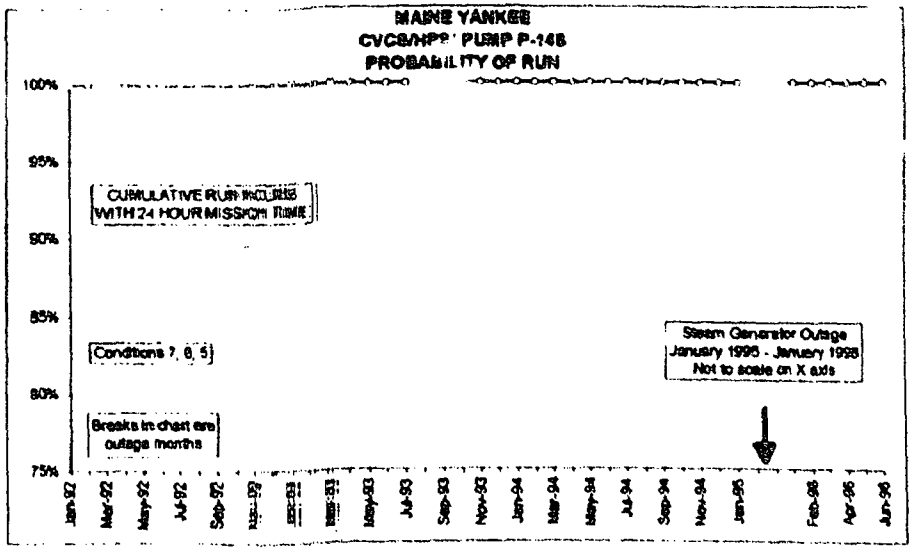
Figure 7

Total Starts	60
Successful Starts	59
Failures to Start	1
Total Run Hours	11,159
Run Failures	0
While aligned	
Planned Maintenance Hours	27.3
Unplanned Maintenance Hours	0.0

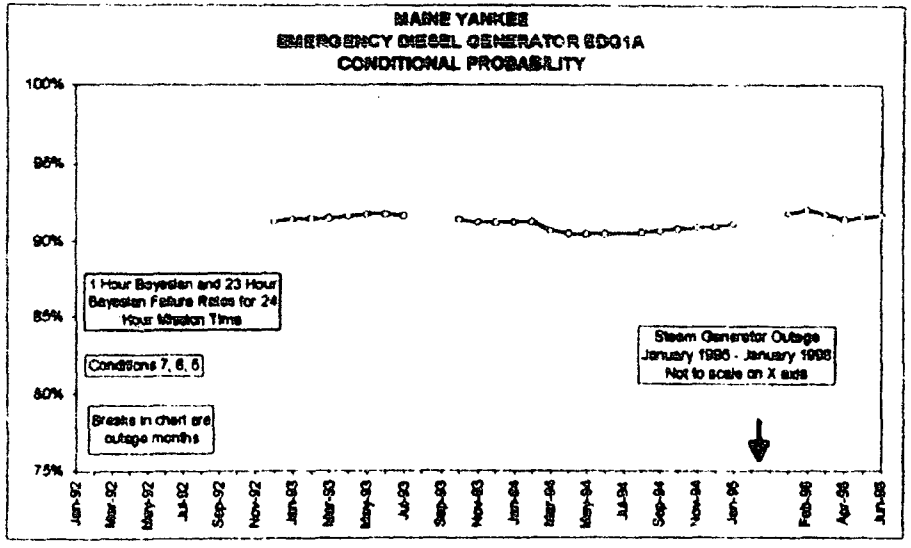
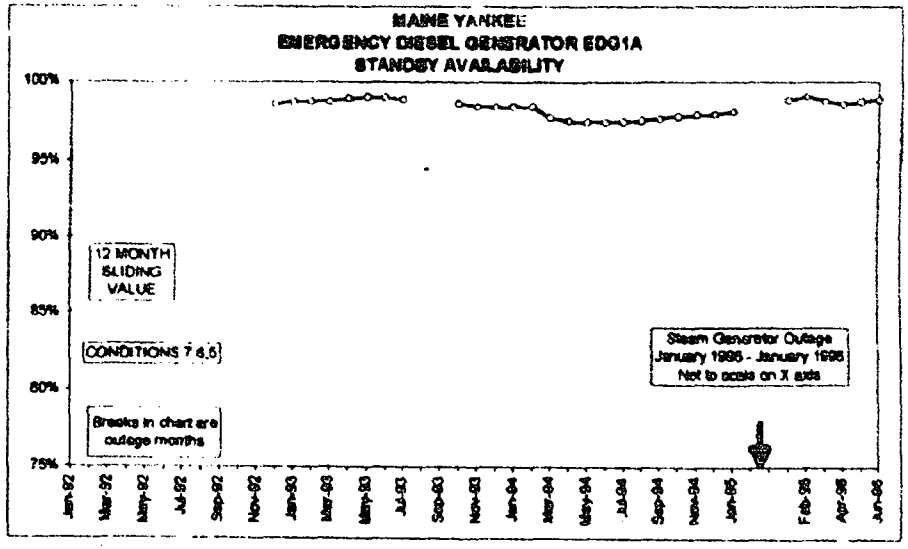
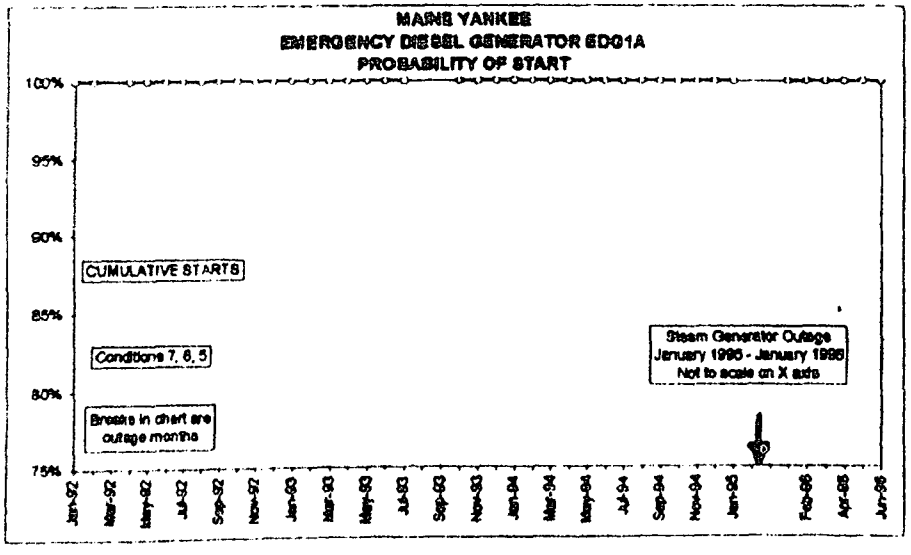
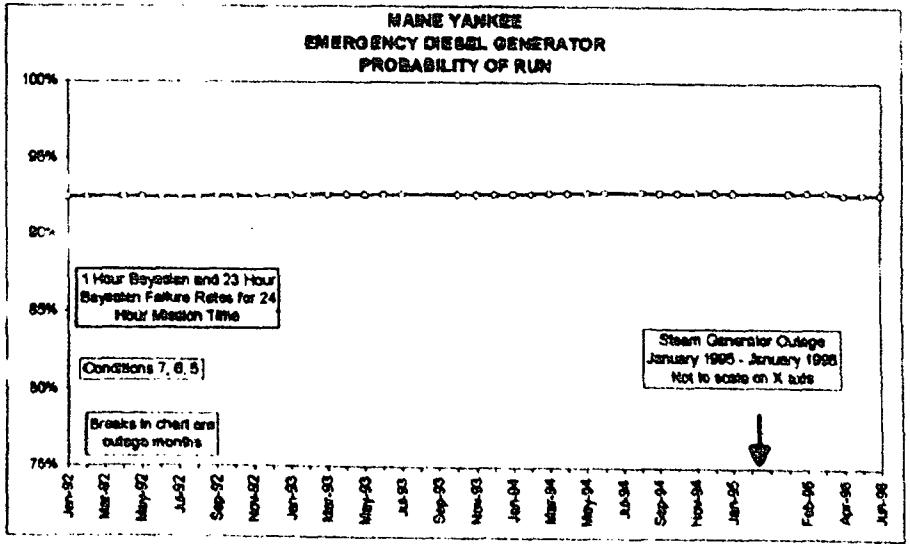
Figure 8

Total Starts	67
Successful Starts	67
Failures to Start	0
Total Run Hours	113
Run Failures	1
Planned Maintenance Hours	367.5
Unplanned Maintenance Hours	86.2

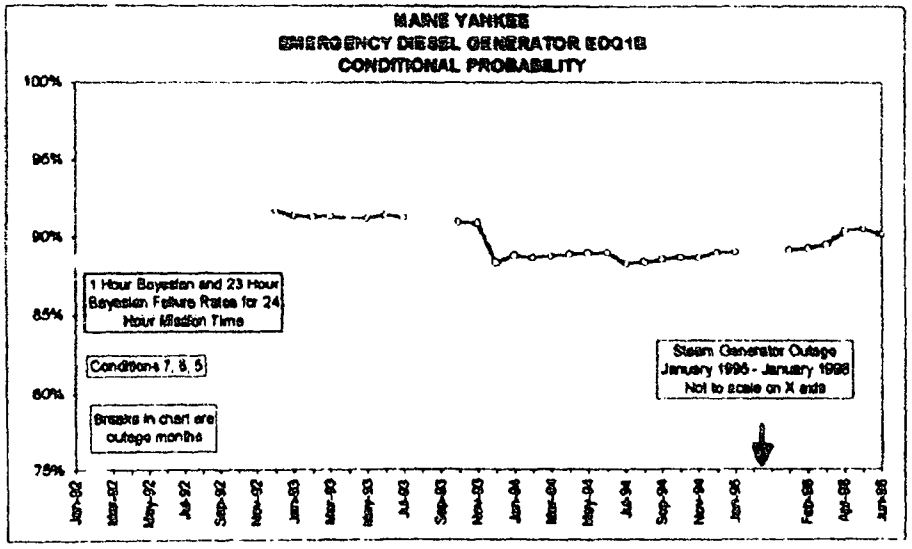
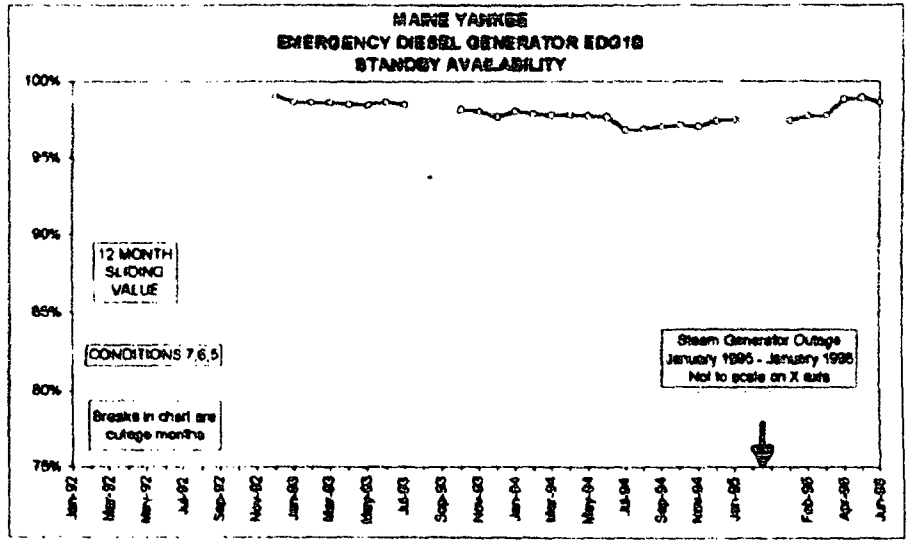
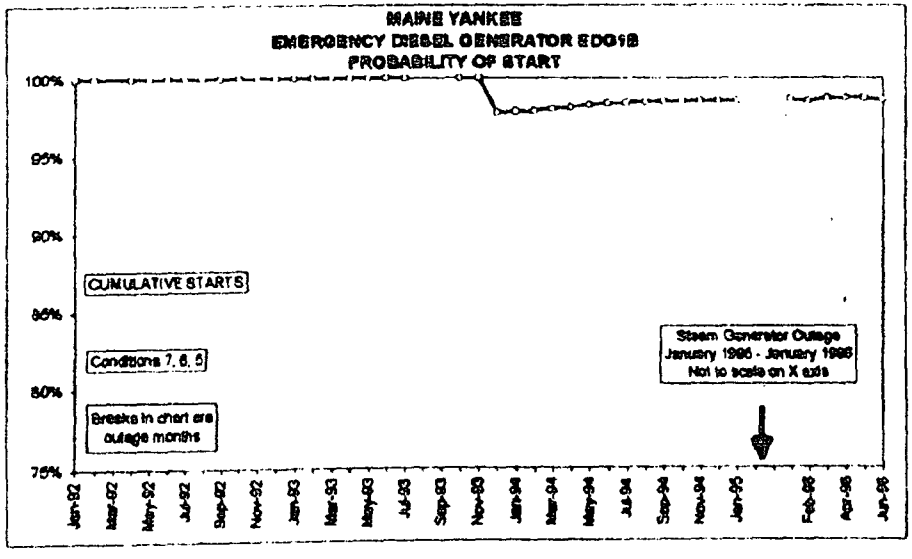
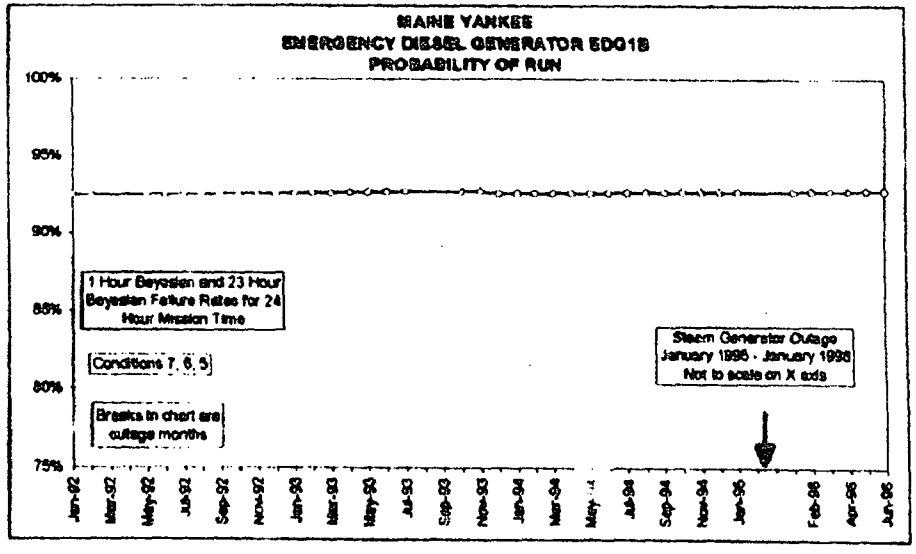
Total Starts	80
Successful Starts	79
Failures to Start	1
Total Run Hours	111
Run Failures	1
Planned Maintenance Hours	396.5
Unplanned Maintenance Hours	132.5
