APPENDIX R
MULTIPLE HIGH IMPEDANCE CABLE FAULT
FLAME TEST REPORT

MAY 27, 1988

PREPARED BY
PHILADELPHIA ELECTRIC COMPANY
PHILADELPHIA, PA. 19101
NUCLEAR ENGINEERING DEPARTMENT
ENGINEERING DIVISION
N2-1, 2301 MARKET STREET

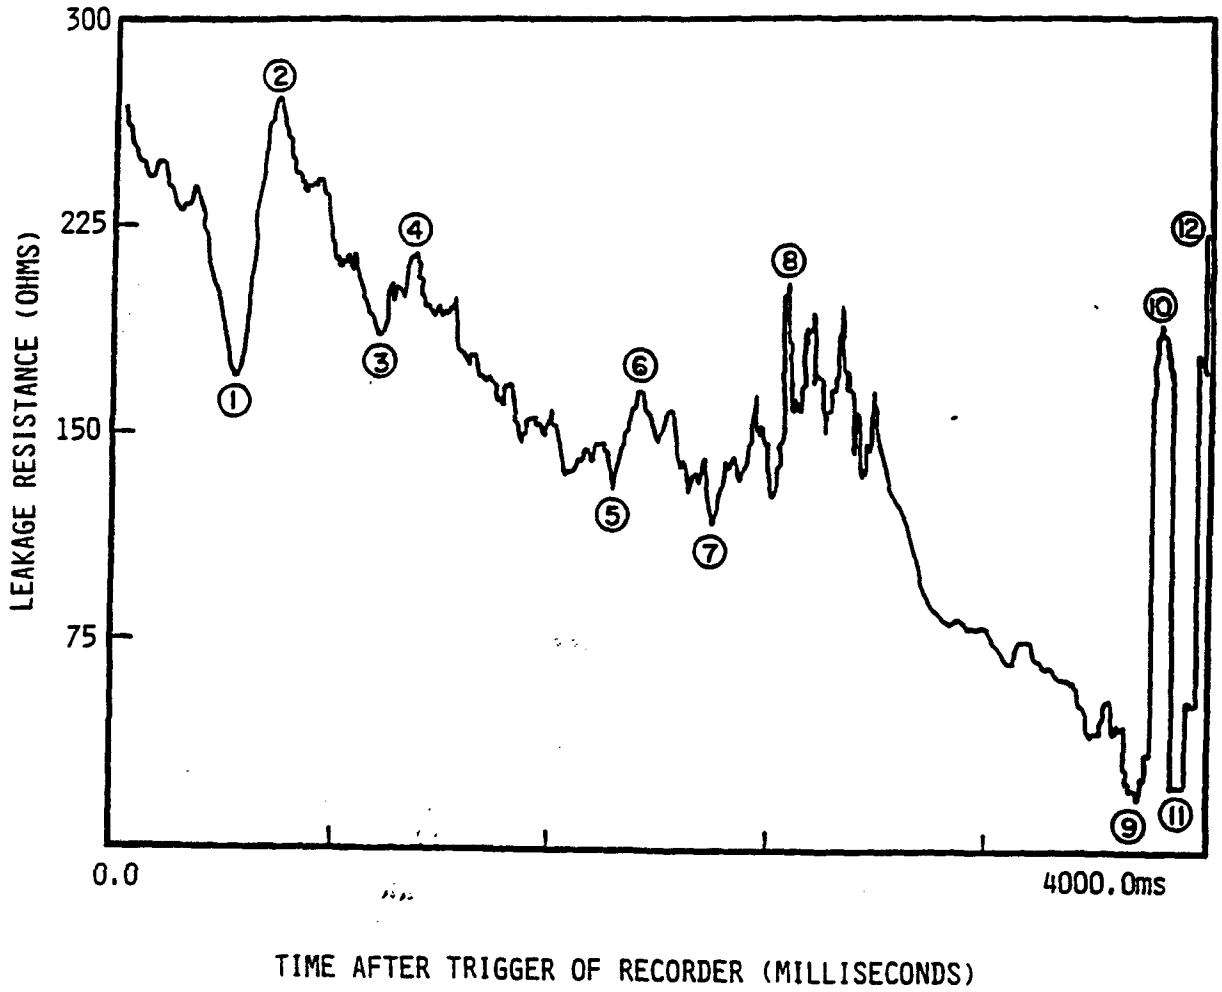
The analyzer triggered at 10 minutes from the start of the test. The analyzer was triggered at a cable insulation resistance value of 200 ohms between the energized conductors and neutral. Eight thousand data points were recorded during the four (4) second period. Figure 6 shows a graph of the cable insulation leakage resistance versus time for the recording period. The energized cable did not experience a short circuit. During the recorded period the maximum insulation leakage resistance between the energized conductor and neutral was 272 ohms which occurred at 601 MS and the minimum resistance was 18.57 ohms which occurred at 3752 MS. The maximum and minimum currents recorded were 5.508 Amps and 0.416 Amps. The following is a listing of various maximum and minimum points recorded.

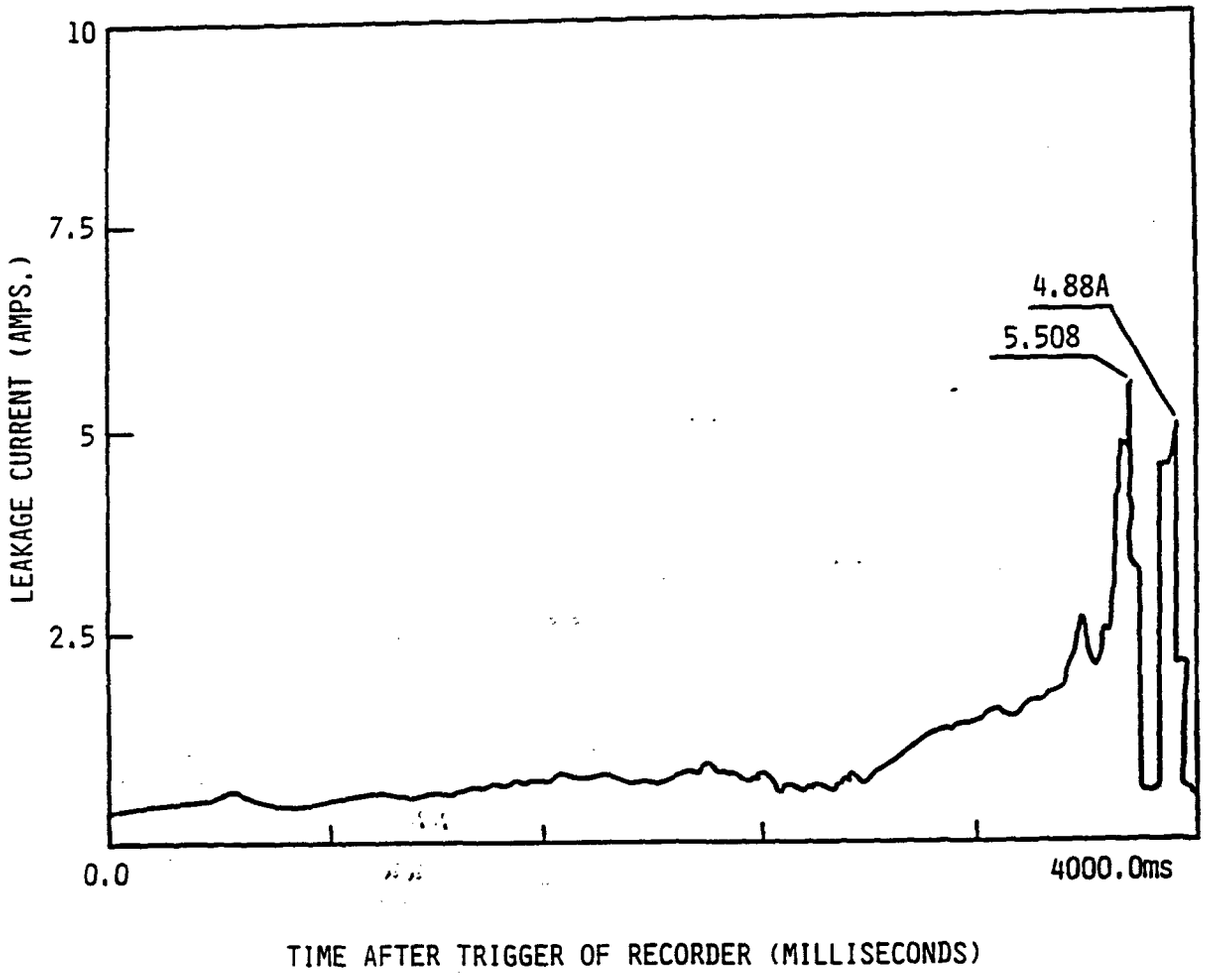
Figure 7 is a graph of the current through the energized conductor into the high impedance fault as a direct result of the cable flame damage to the insulation. The average current is 1.009 Amperes for the 4 second period. The maximum current peak of 5.508 Amps occurs at 3752 MS. and reaches that peak from an initial value of 2.055 Amps in 6.18 cycles. The peak then drops to 0.7310 Amps in 2.97 cycles demonstrating the transient nature of the fault resistance.

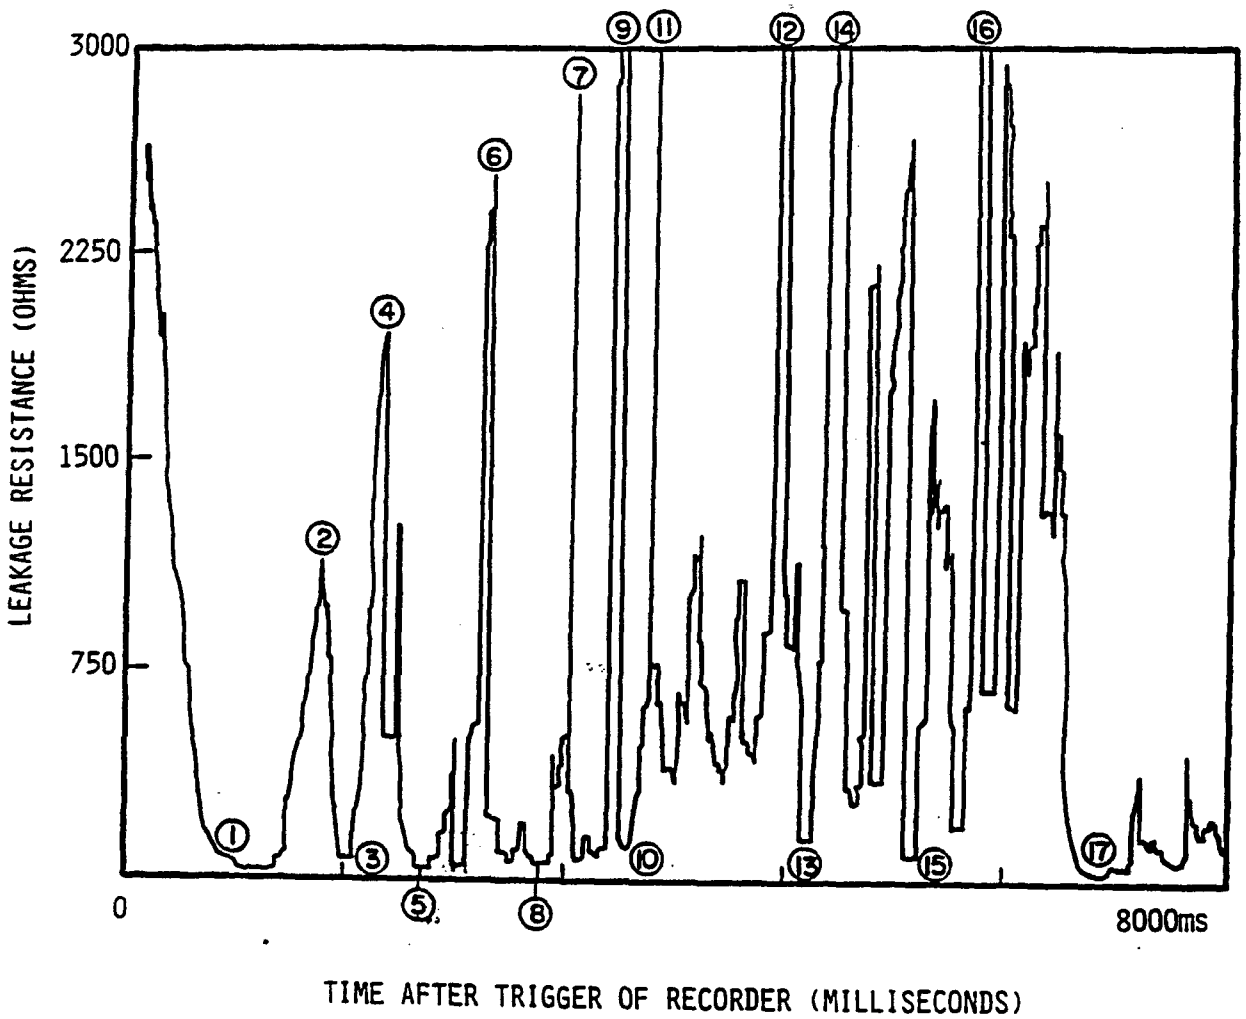
The analyzer triggered at 8 minutes and 5 seconds from the start of the test. Eight thousand data points were recorded during the eight (8) second interval after the analyzer triggered. Figure 8 is a graph of the cable insulation leakage resistance versus time. The energized cable did not experience a total short circuit.

During the recorded period the maximum insulation leakage resistance was 4969 ohms which occurred at 6146 MS and the minimum was 21.34 ohms which occurred at 7085 MS. The maximum and minimum insulation leakage currents were 4.893 amperes and 0.023 amperes. Although the following listing is not all inclusive it represents a large sample of maximum and minimum points.

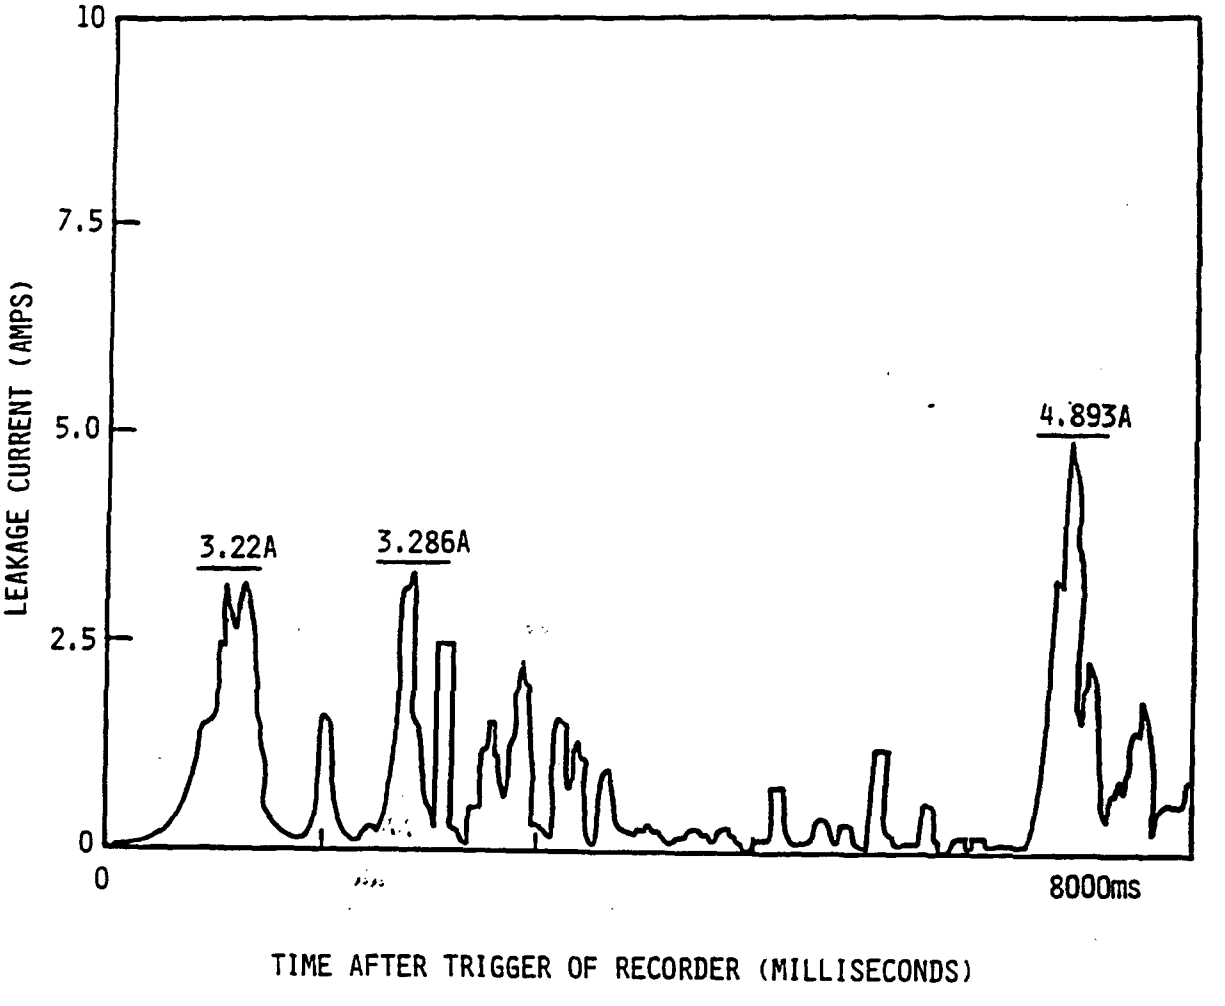
Figure 9 is a graph of the insulation leakage current through the energized conductor into the high impedance fault as a result of the cable flame damage. For the recorded duration, the average current is 0.7525 amperes for the 8 second period. The maximum current is 4.893 amperes which occurs at 7085 MS.

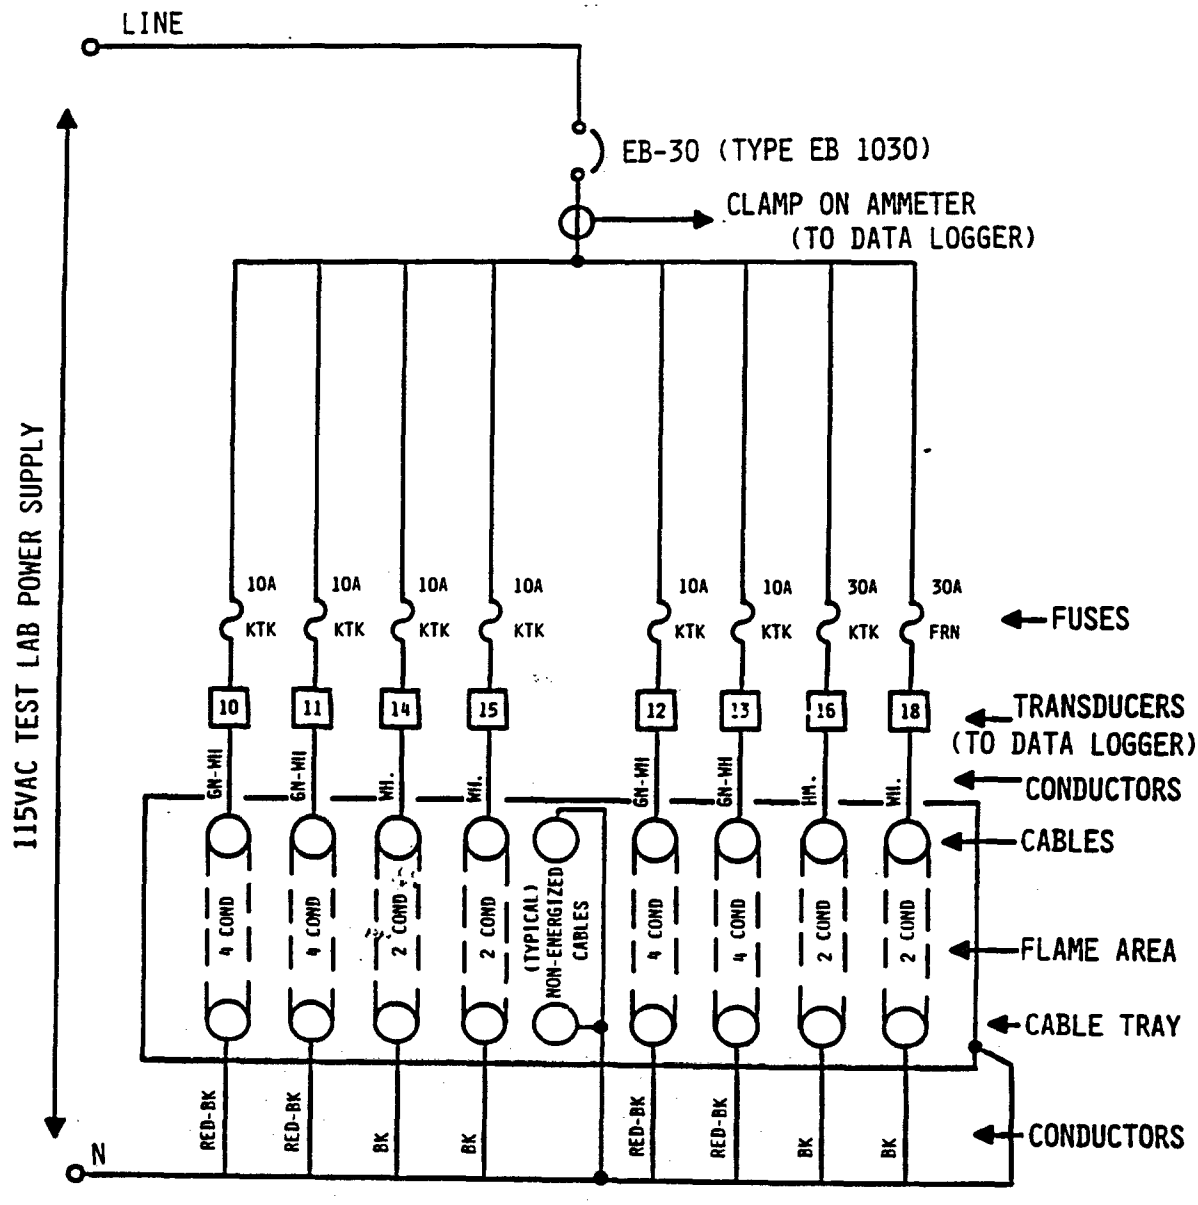
FIGURE NO. 10
TEST NO. 3
CIRCUIT CONNECTION

The circuit connections for test number 3 is shown on Figures 10 and 11. The test circuit was set-up to simulate a coordinated breaker and fuse panel arrangement. Each of eight (8) energized cables were separately fused and all were supplied through a common circuit breaker.

This test was performed with the same tray, cable and flame source configuration as the first two (2) tests. Eight (8) cables were energized and each was separately fused as shown in Figure No. 10. The current through each fuse was monitored as well as the total current through the supply circuit breaker. Other non-energized cables in the tray were connected to neutral.

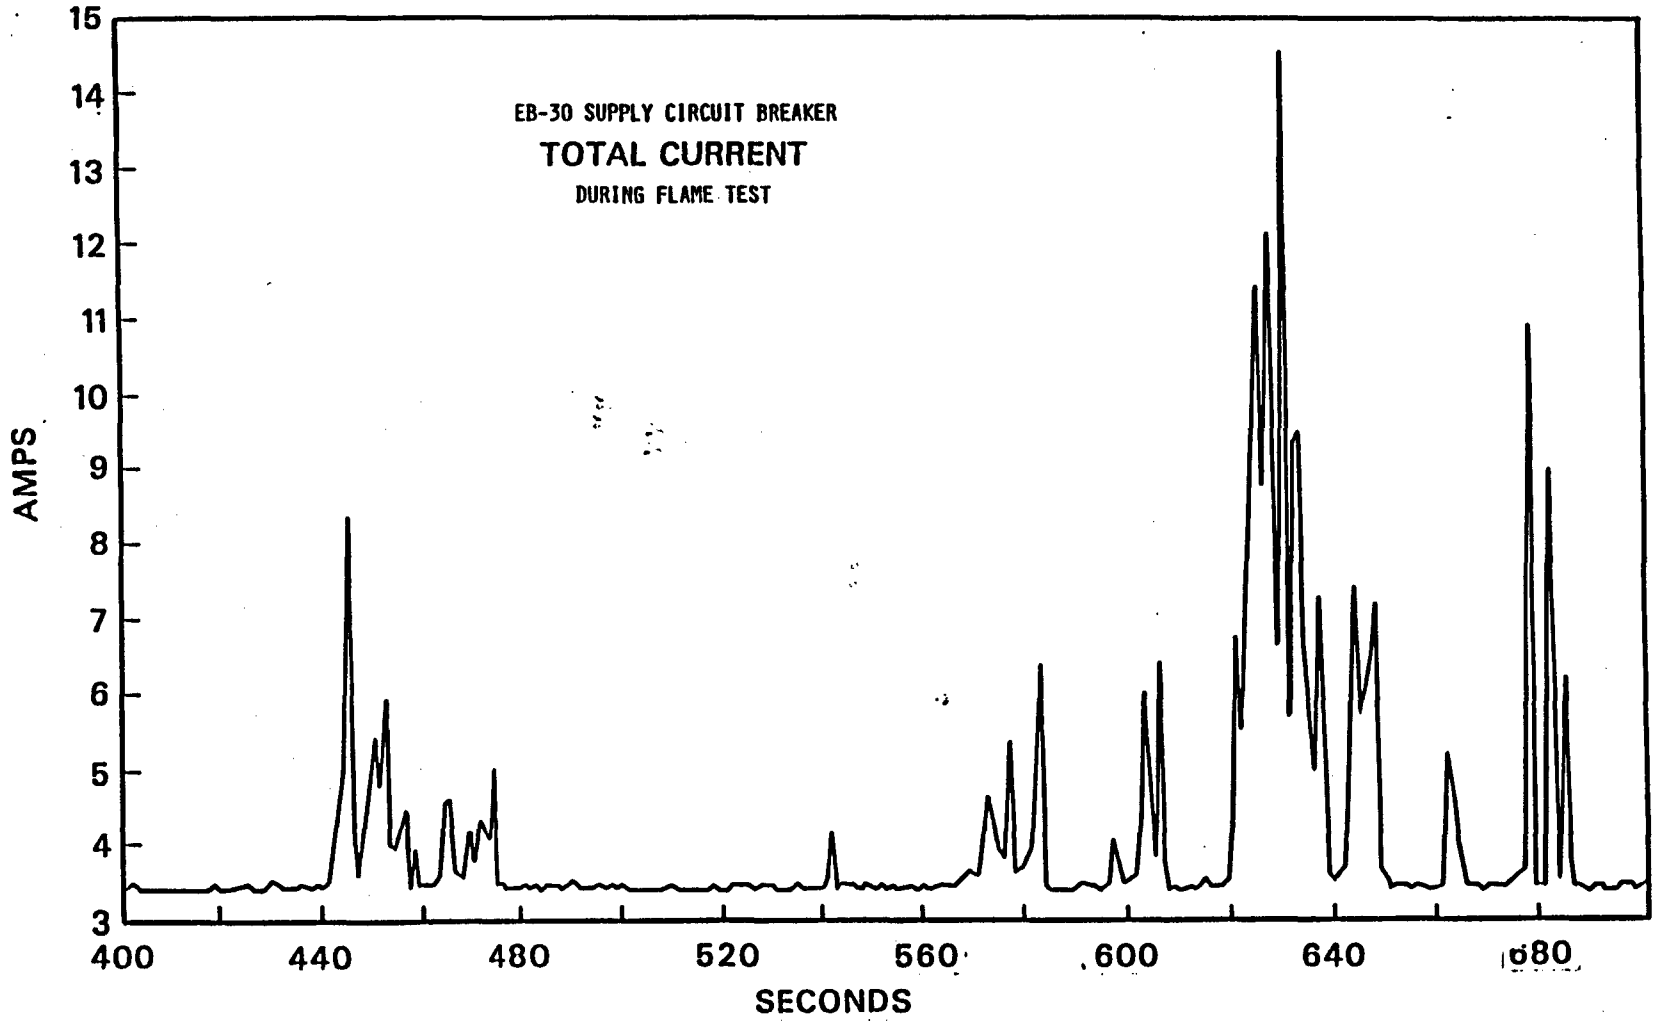
FIGURE NO 12
TEST NO 3
TOTAL SUPPLY BREAKER CURRENT VS. TIME
DURING FLAME TEST

As can be seen from Figure No. 12 "Total Supply Breaker Current Vs. Time During Flame Test" the circuit breaker was not in jeopardy of tripping due to cable fault high impedance short circuit currents. The current through the supply breaker was a combination of the fault current contributions from each of the energized cables.

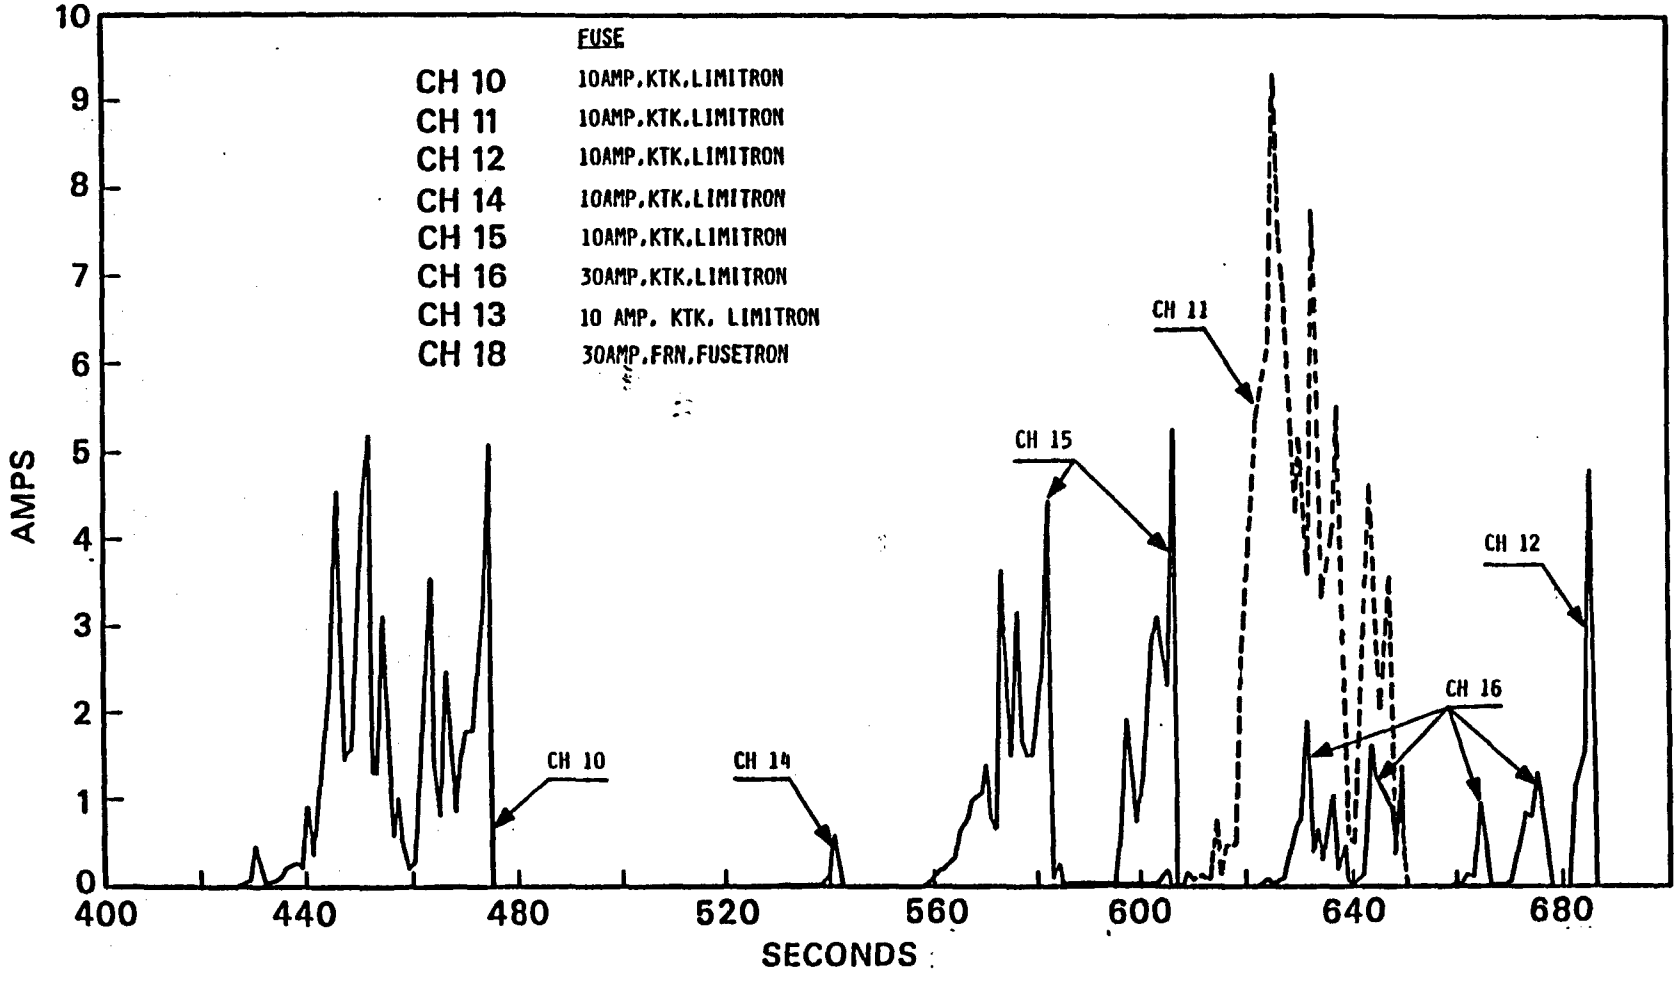
As shown in Figure No. 13 "Load Supply Fuse Current Vs. Time During Flame Test", the short circuit characteristic of each cable fault was similar. A high impedance fault period followed by a transition to low impedance and then fuse fault clearing. The fuses used were type KTK, non-time delay fast acting which provided high speed of response above the 1000 second rating of the fuses. Under all cases the high impedance short circuit peak current recorded was below the lowest fuse rating of 10 amperes. At the transition to low impedance the fuse failed immediately. The transition to low impedance was caused by conductor to conductor contact.

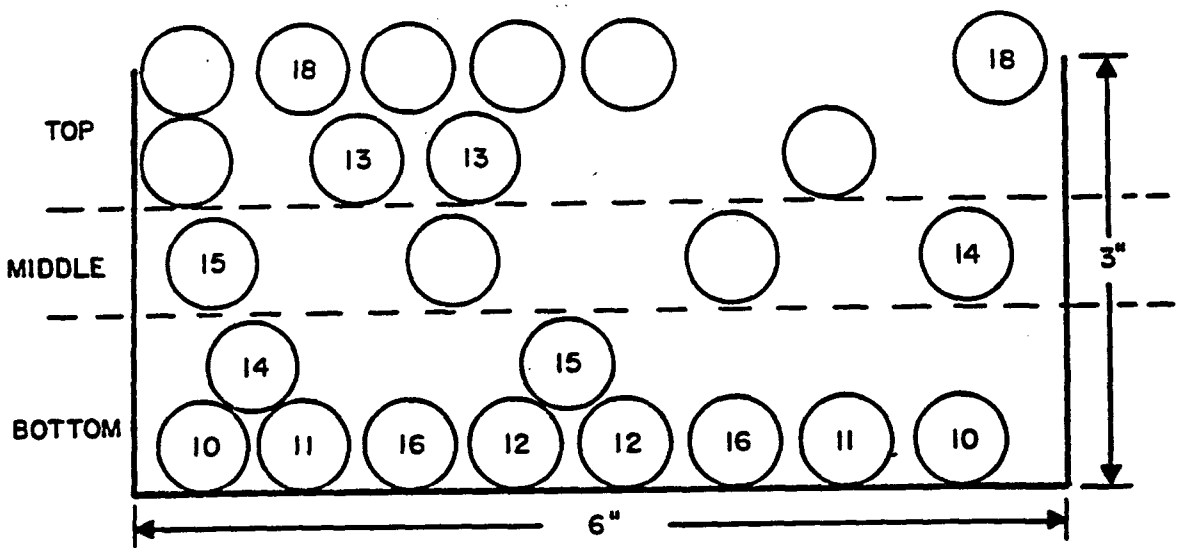
The cables were carefully removed from the tray and damage in the fire area was photographed for each separate cable. The relative position of the cable in the fire area was noted along with the channel number, cable type, fuse size and type, time until fuse failed and failure sequence. This information is shown in Figure No. 14.

Fuses associated with cables on Channel 13 and 18 did not fail. Figure 14 shows that these cables were located in the top most part of the tray. The cable damage to these circuits is shown in Pictures No. 25 and 26. All energized cables located in the bottom and middle sections of the tray blew their fuses and sustained major cable flame damage as can be seen in Pictures 19 to 24.

1) The occurrence of cable faults in a common tray are not simultaneous. Cables nearest the flame source develop flame damage related short circuits before cables further away. As a result, with the exception of cables 11 and 16 no simultaneous faults occurred during the test. Faults occurred simultaneously on cables 11 and 16 which were side by side in the bottom of the cable tray closest to the flame source as can be seen in Figure No. 14 "Cable Location In Flame Area Vs. Time To Blow Fuse".

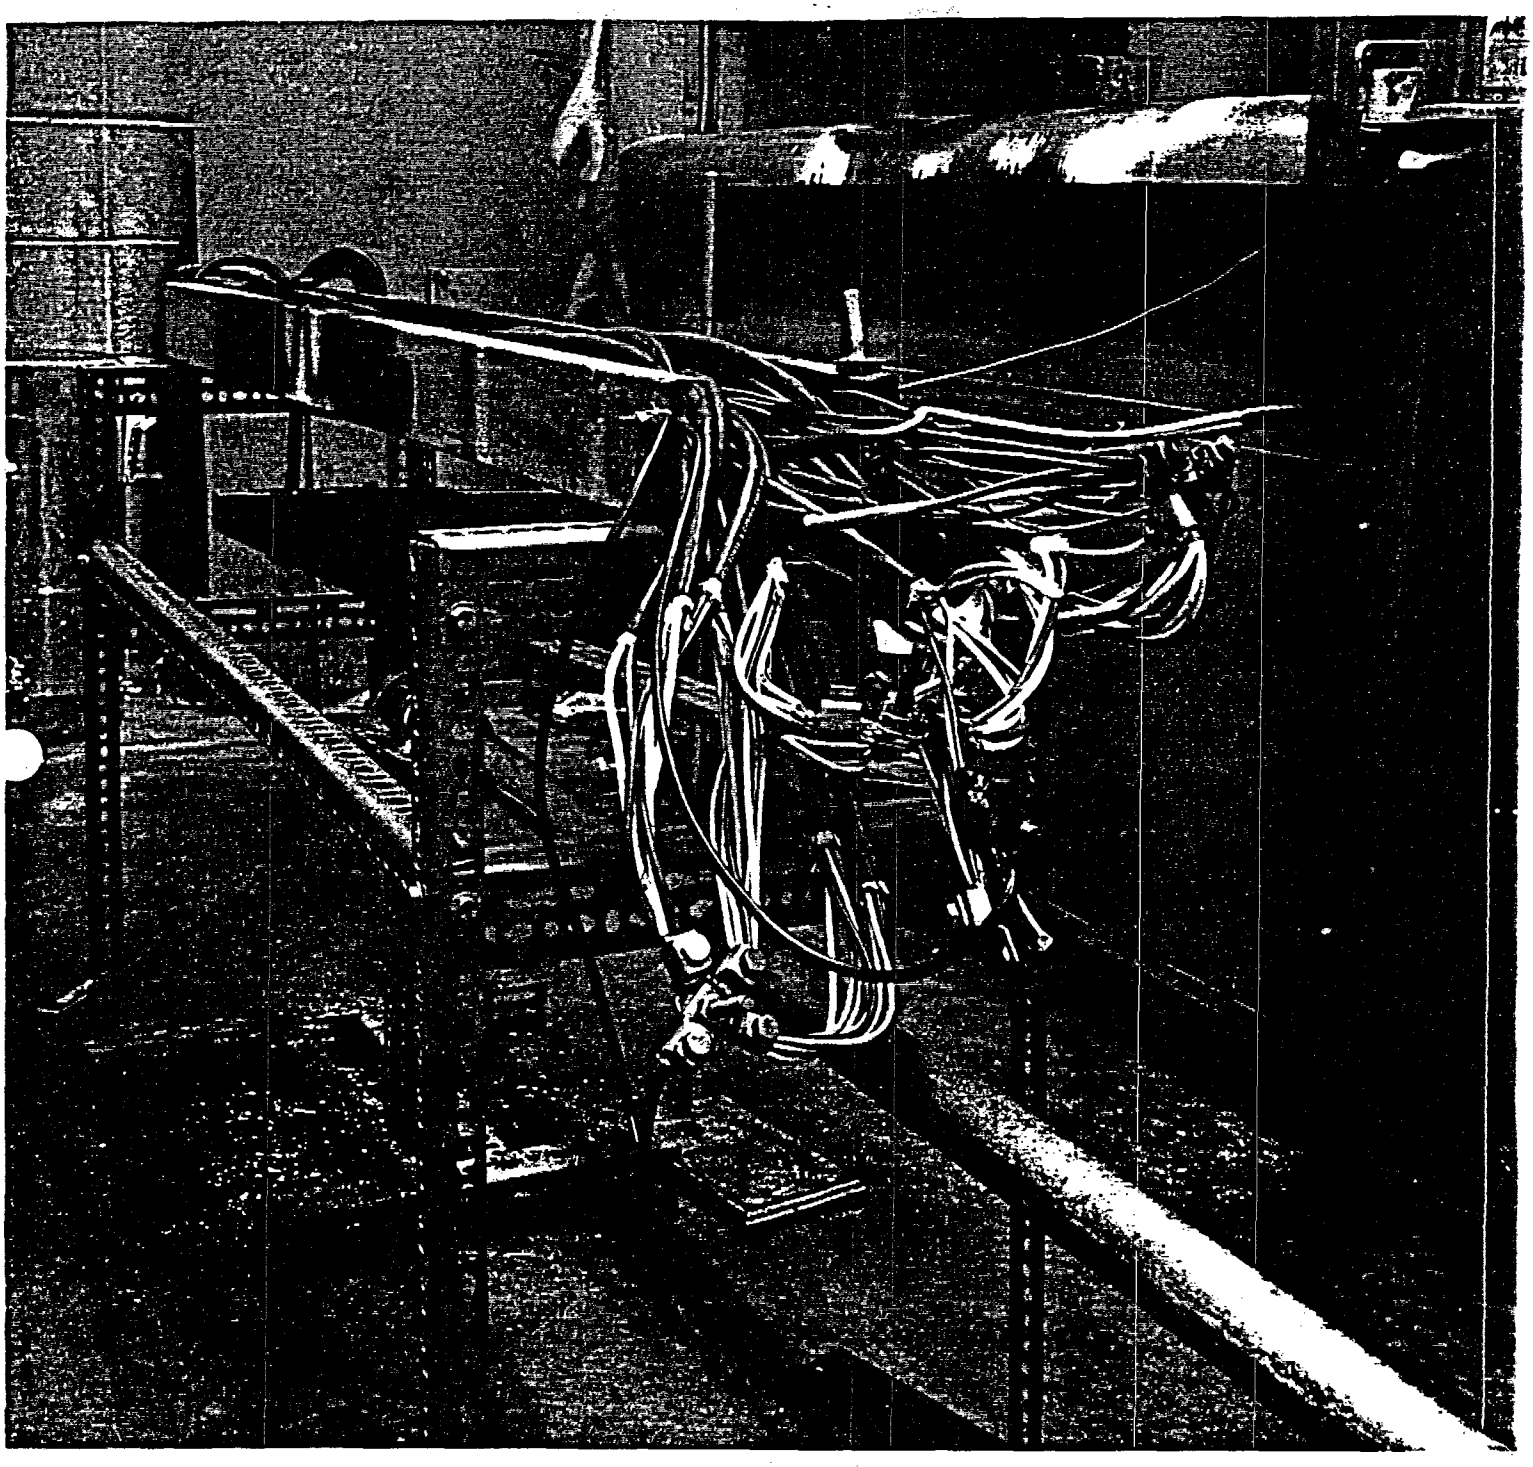
PICTURE NO. 3
Test No. 1 and 2
Flame Source, Cable Tray and Cable Connections

The single and multiconductor cables were installed in a loop with both ends exiting the same end of the tray to facilitate electrical connections. The percent fill of cable tray was 28.5%. The cable installation approximated three (3) levels of cables in the tray (bottom-middle-top), as shown in Figures 4 and Picture 3.

For tests 1 and 2,the non-energized cable conductors were connected together to the steel cable tray and tied to the power supply neutral. The cable tray was supported horizontally over the flame source (burner) using a four legged frame. The frame was isolated from ground using insulators under each of the four legs, as shown in Picture 3.

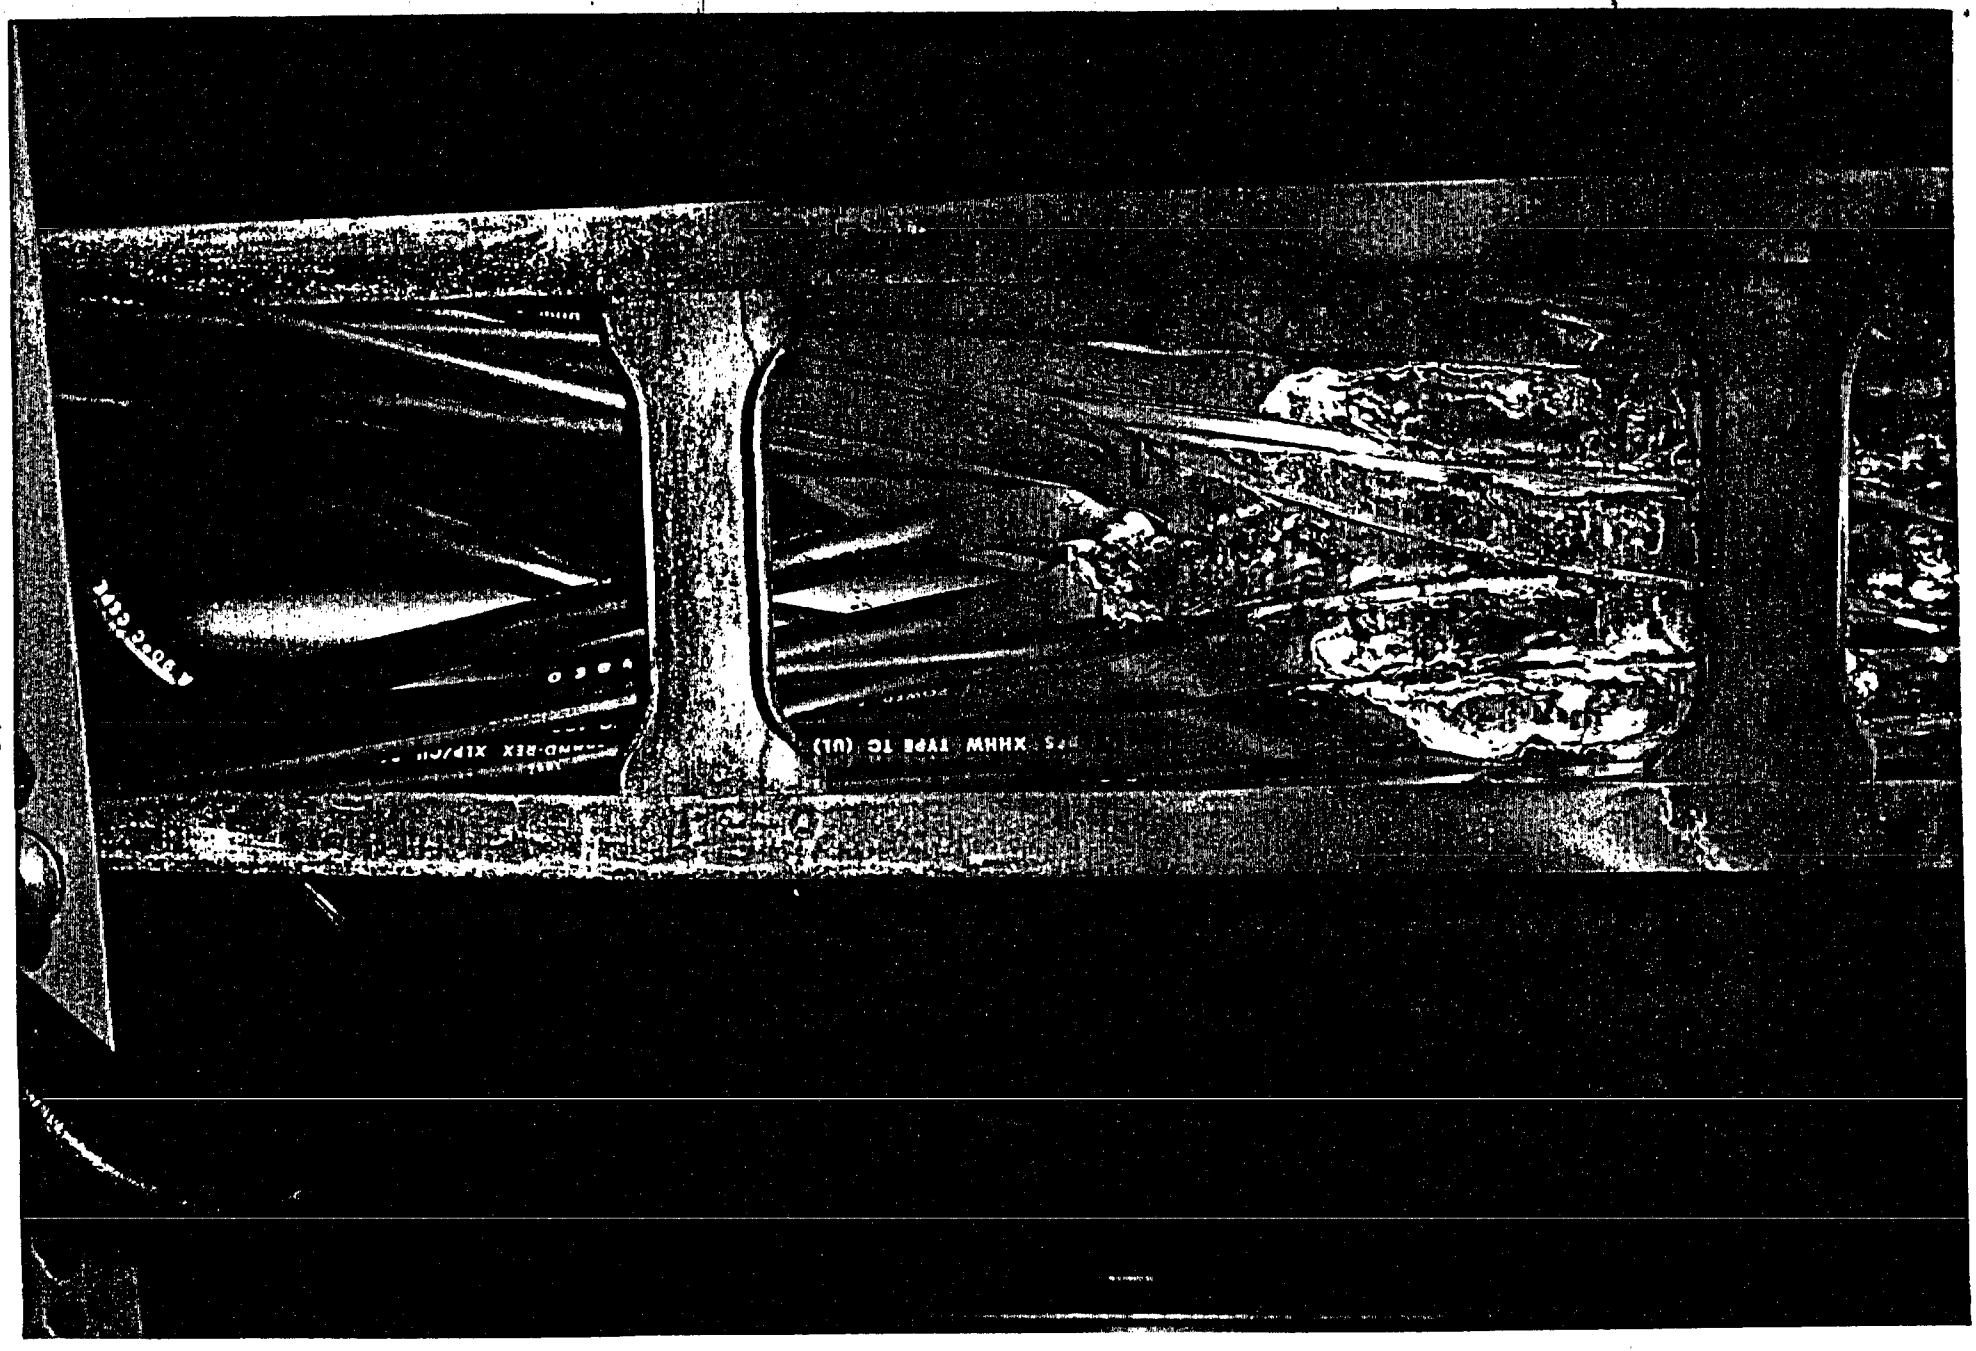
PICTURE NO. 4
Test No. 1
Cable Damage

Pictures 4 to 7 show the extensive cable insulation damage in the lower portion of the tray which is to be expected since they were closest to the flame source. In many cases the bare conductors were exposed. The top most cables experienced minor visible damage which is attributed to the non-propagating and flame retardant properties of the nuclear grade cable being tested.

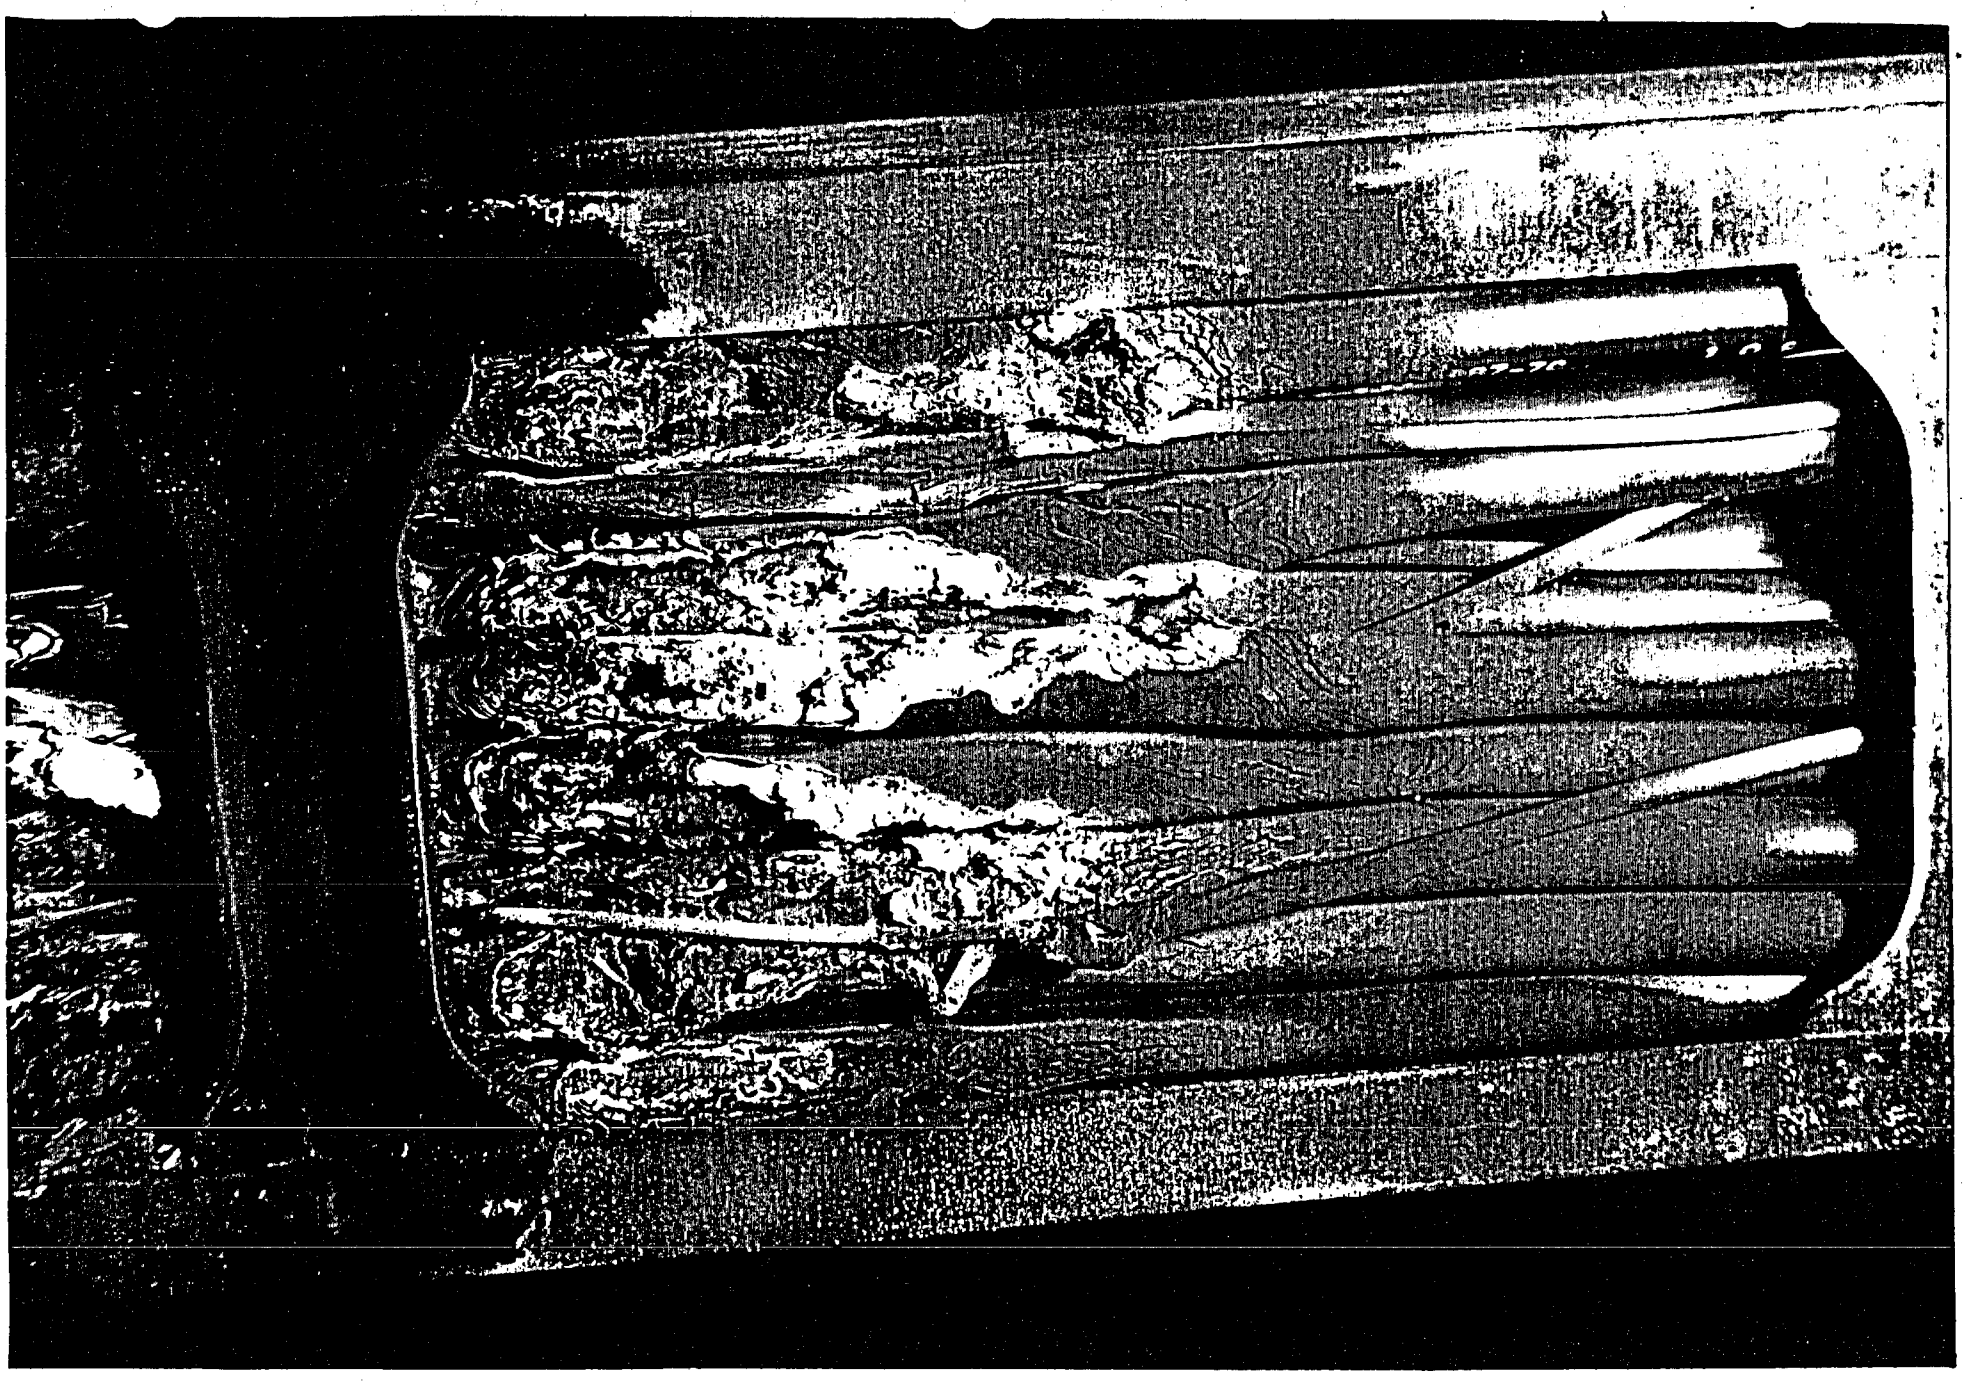
PICTURE NO. 9
Test No. 2
Cable Damage

Pictures 8 to 10 show the cable insulation damage to cables in the lower portion of the tray, closest to the flame source. The damage is very similar to that of test no. 1. As expected the top most cables experienced minor visible cable insulation damage which can be attributed to the non-propagating and flame retardant properties of the nuclear grade cables being tested. Conclusions resulting from the first test were supported by this test.

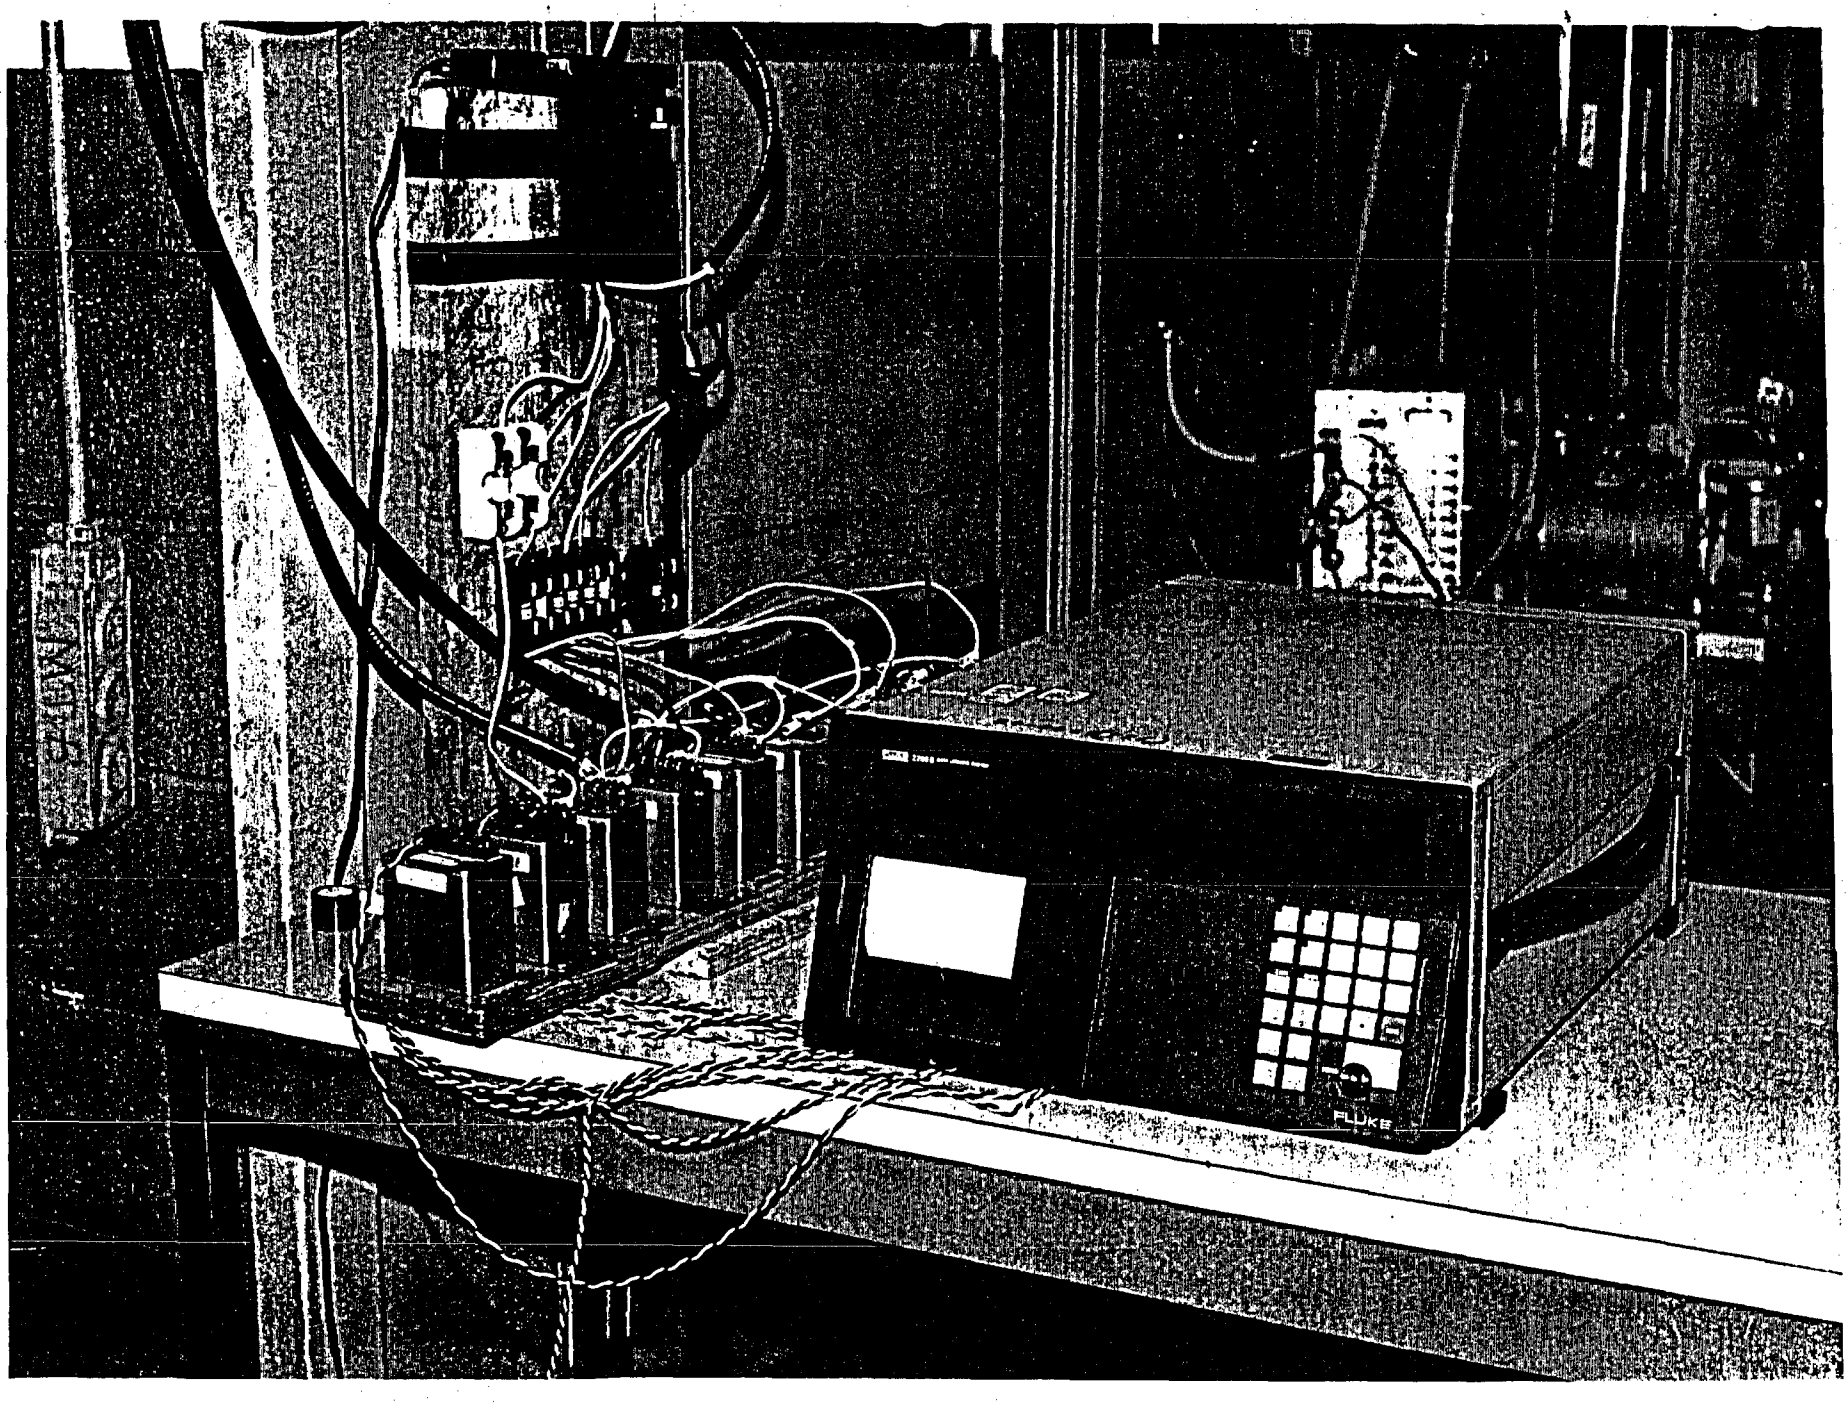
PICTURE NO. 11
Test No. 3

Six (6) of the energized circuits were fused with Bussmann, Type KTK, 10 Amp. fuses. The remaining two (2) circuits were fused with Bussmann, Type KTK and FRN 30 Amp. fuses, as shown in Figure 10 and Picture 11.
