APPENDIX R
MULTIPLE HIGH IMPEDANCE CABLE FAULT
FLAME TEST REPORT

MAY 27, 1988

PREPARED BY
PHILADELPHIA ELECTRIC COMPANY
PHILADELPHIA, PA. 19101
NUCLEAR ENGINEERING DEPARTMENT
ENGINEERING DIVISION
N2-1, 2301 MARKET STREET

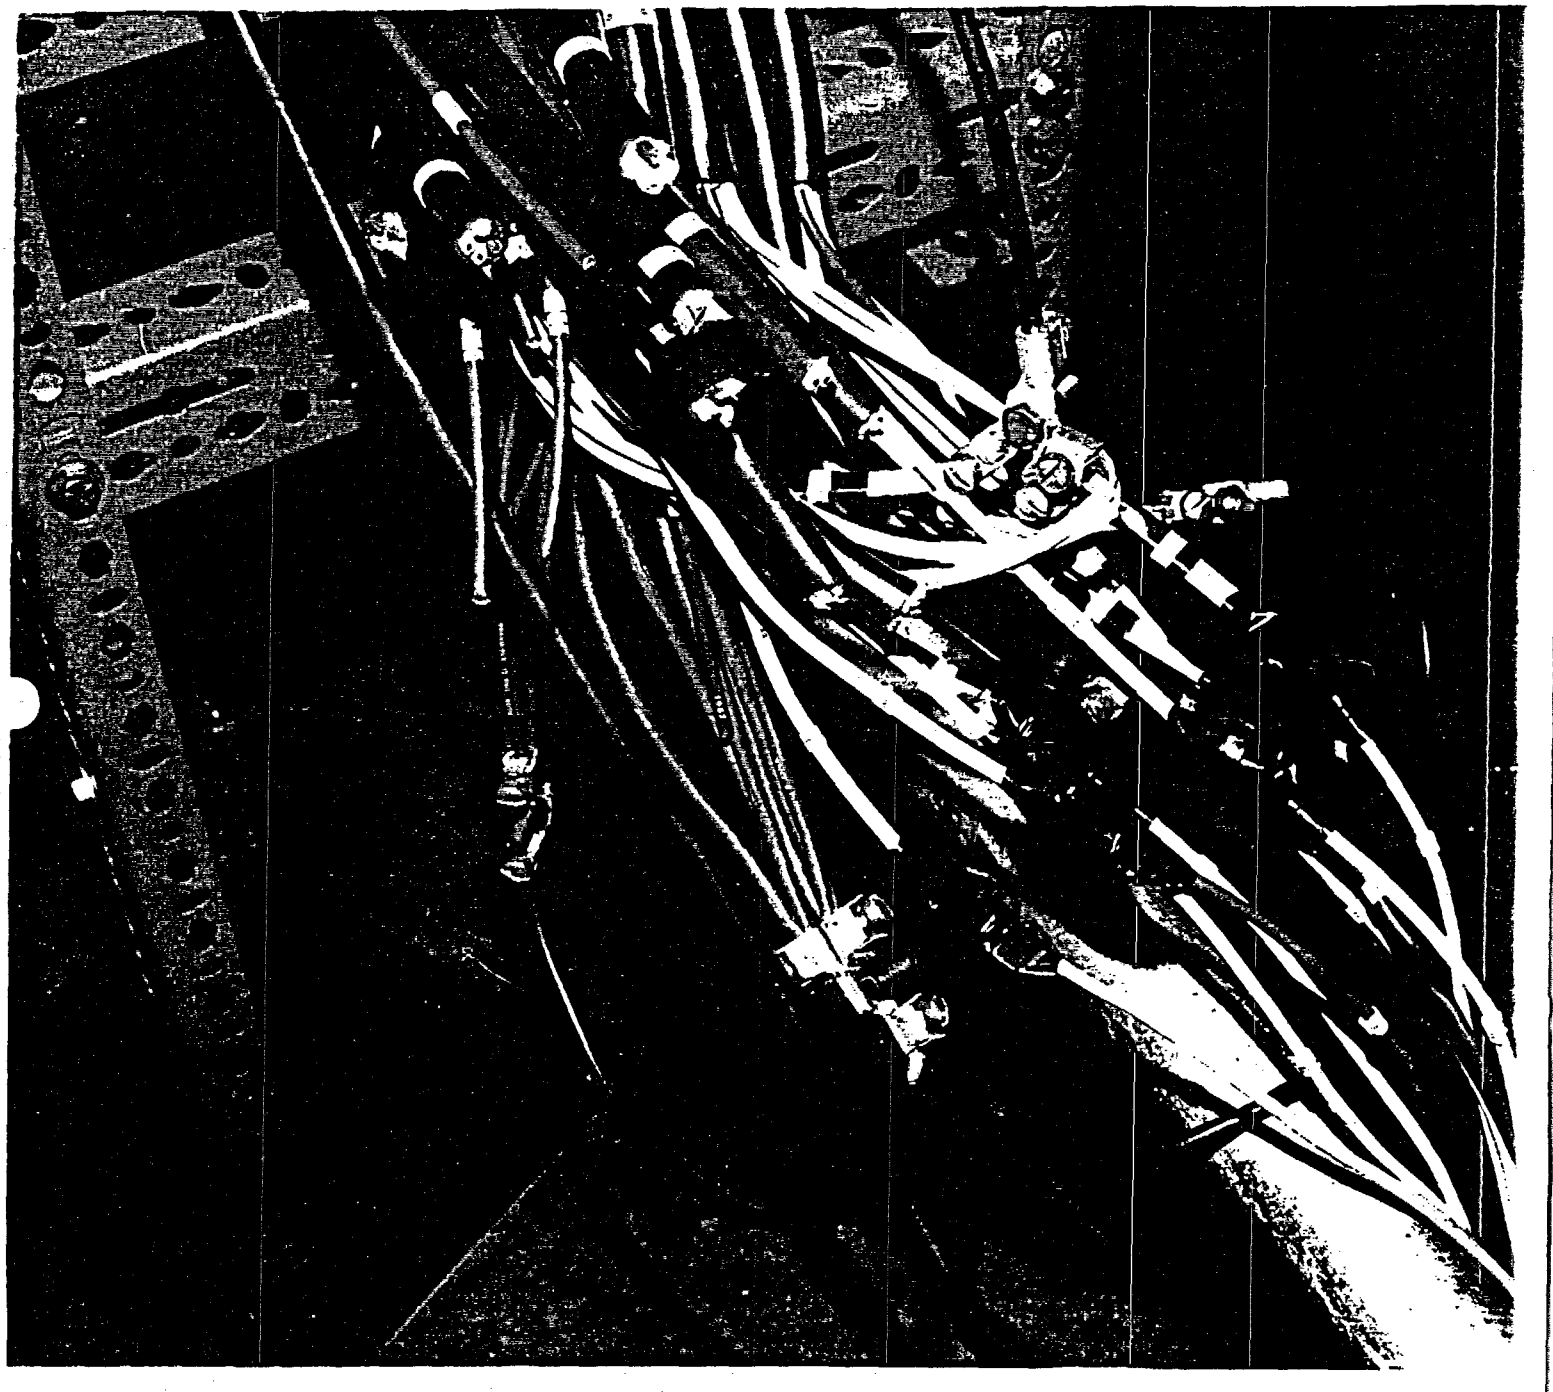
PICTURE NO. 12
Test No. 3
Electrical Cable Connections
At Cable Tray

For test number 3, eight (8) cables were energized with 120 VAC and monitored (4-2 conductor and 4-4 conductor cables). Two (2) of the conductors of the 4 conductor cable were tied together and connected to the line side of the power supply. The other two (2) conductors were tied to neutral along with all non-energized cables and the cable tray. One (1) conductor of the 2-conductor cable was tied to line and the other to neutral, as shown in Figure 10 and Picture 12.

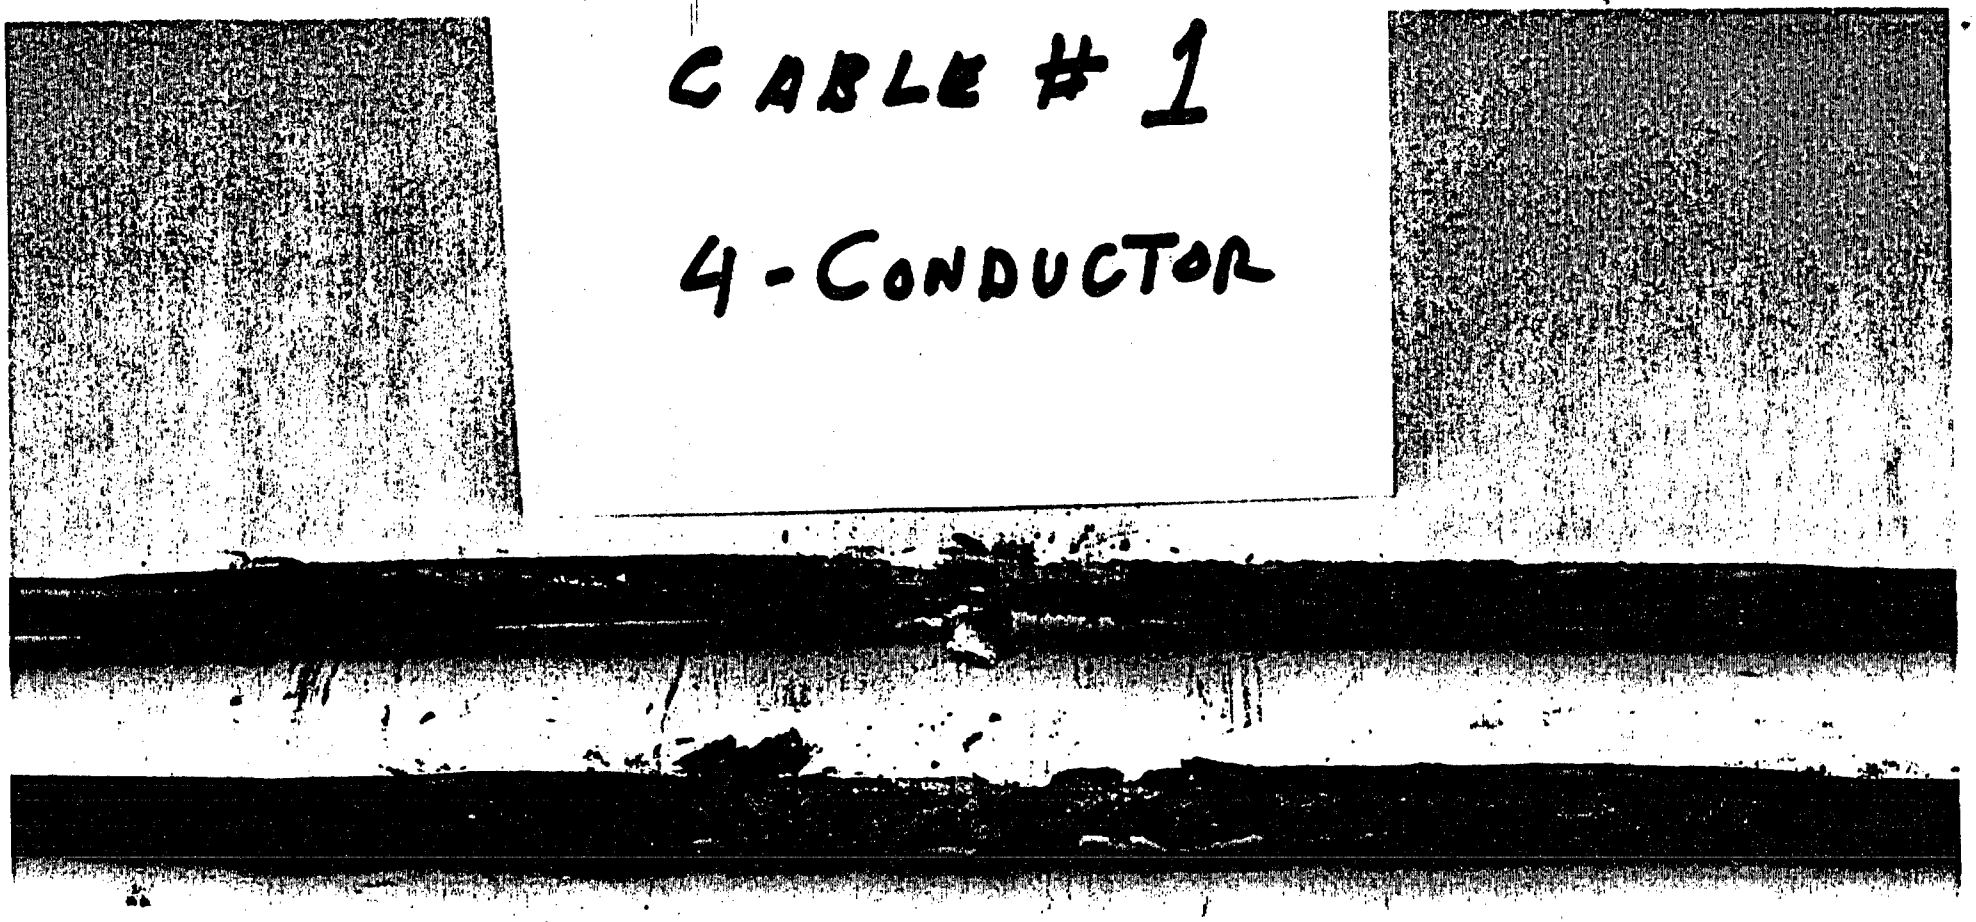
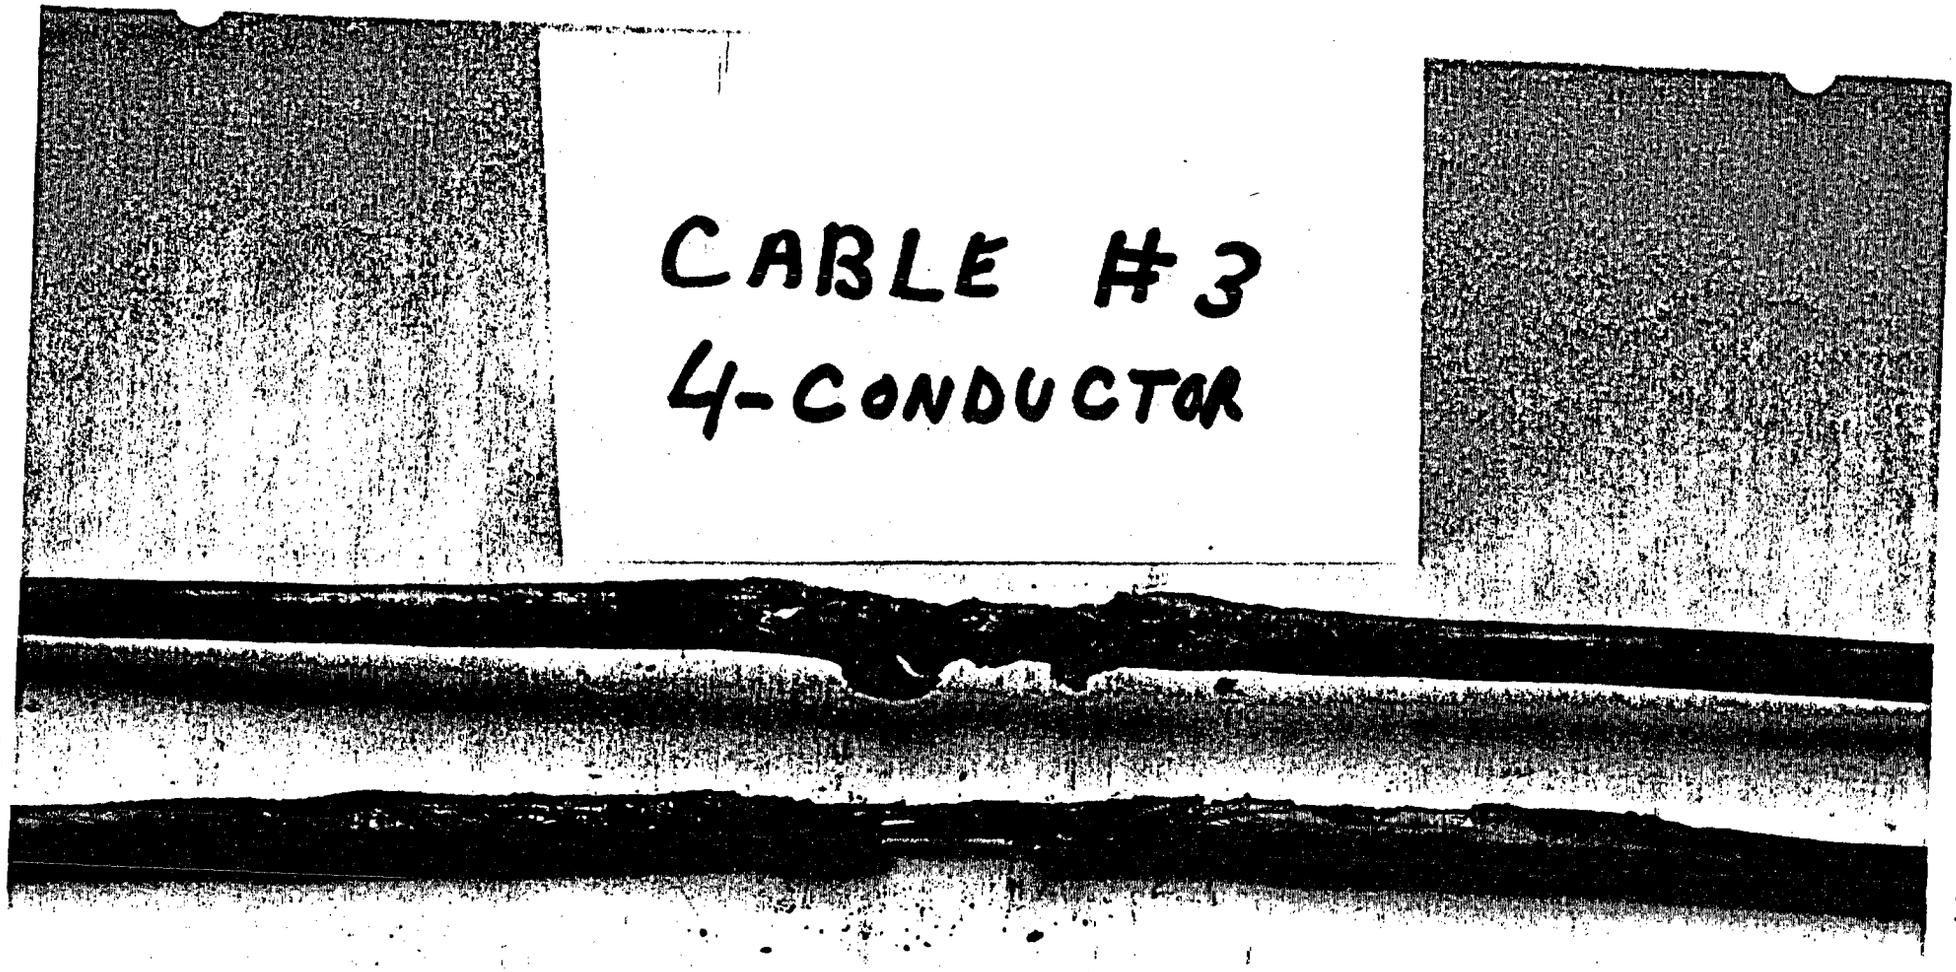
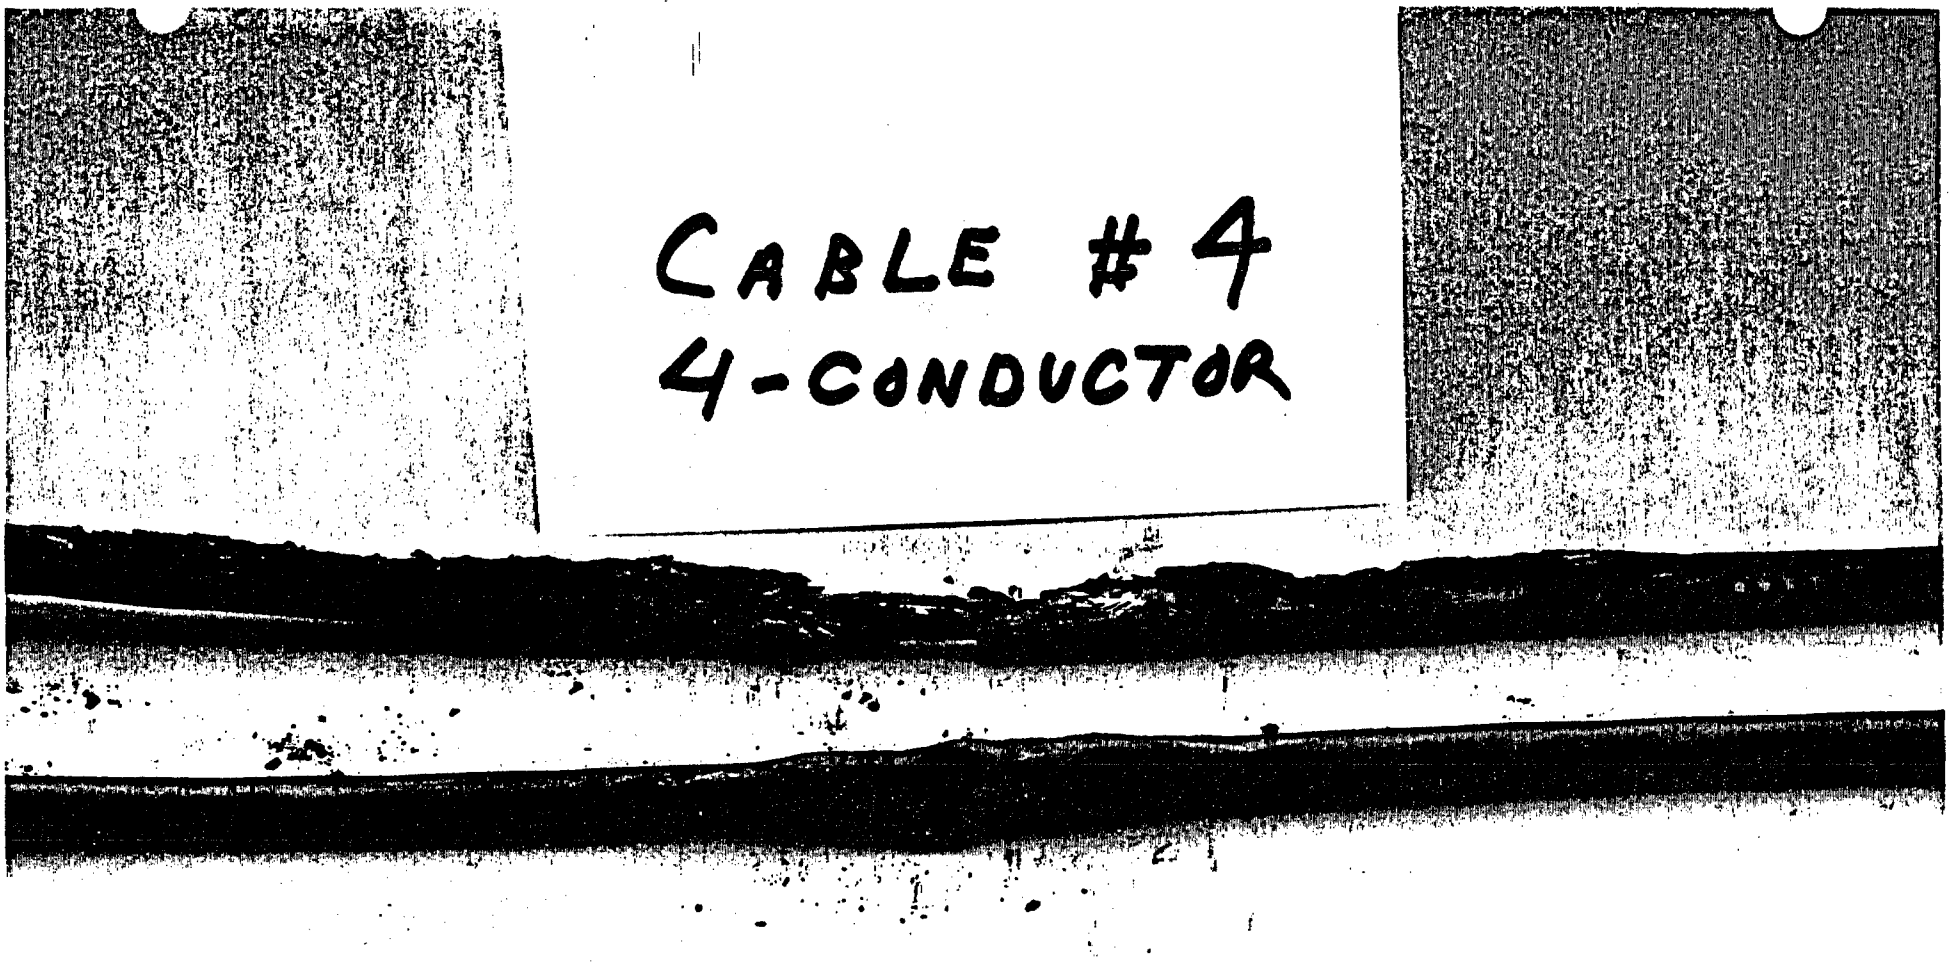
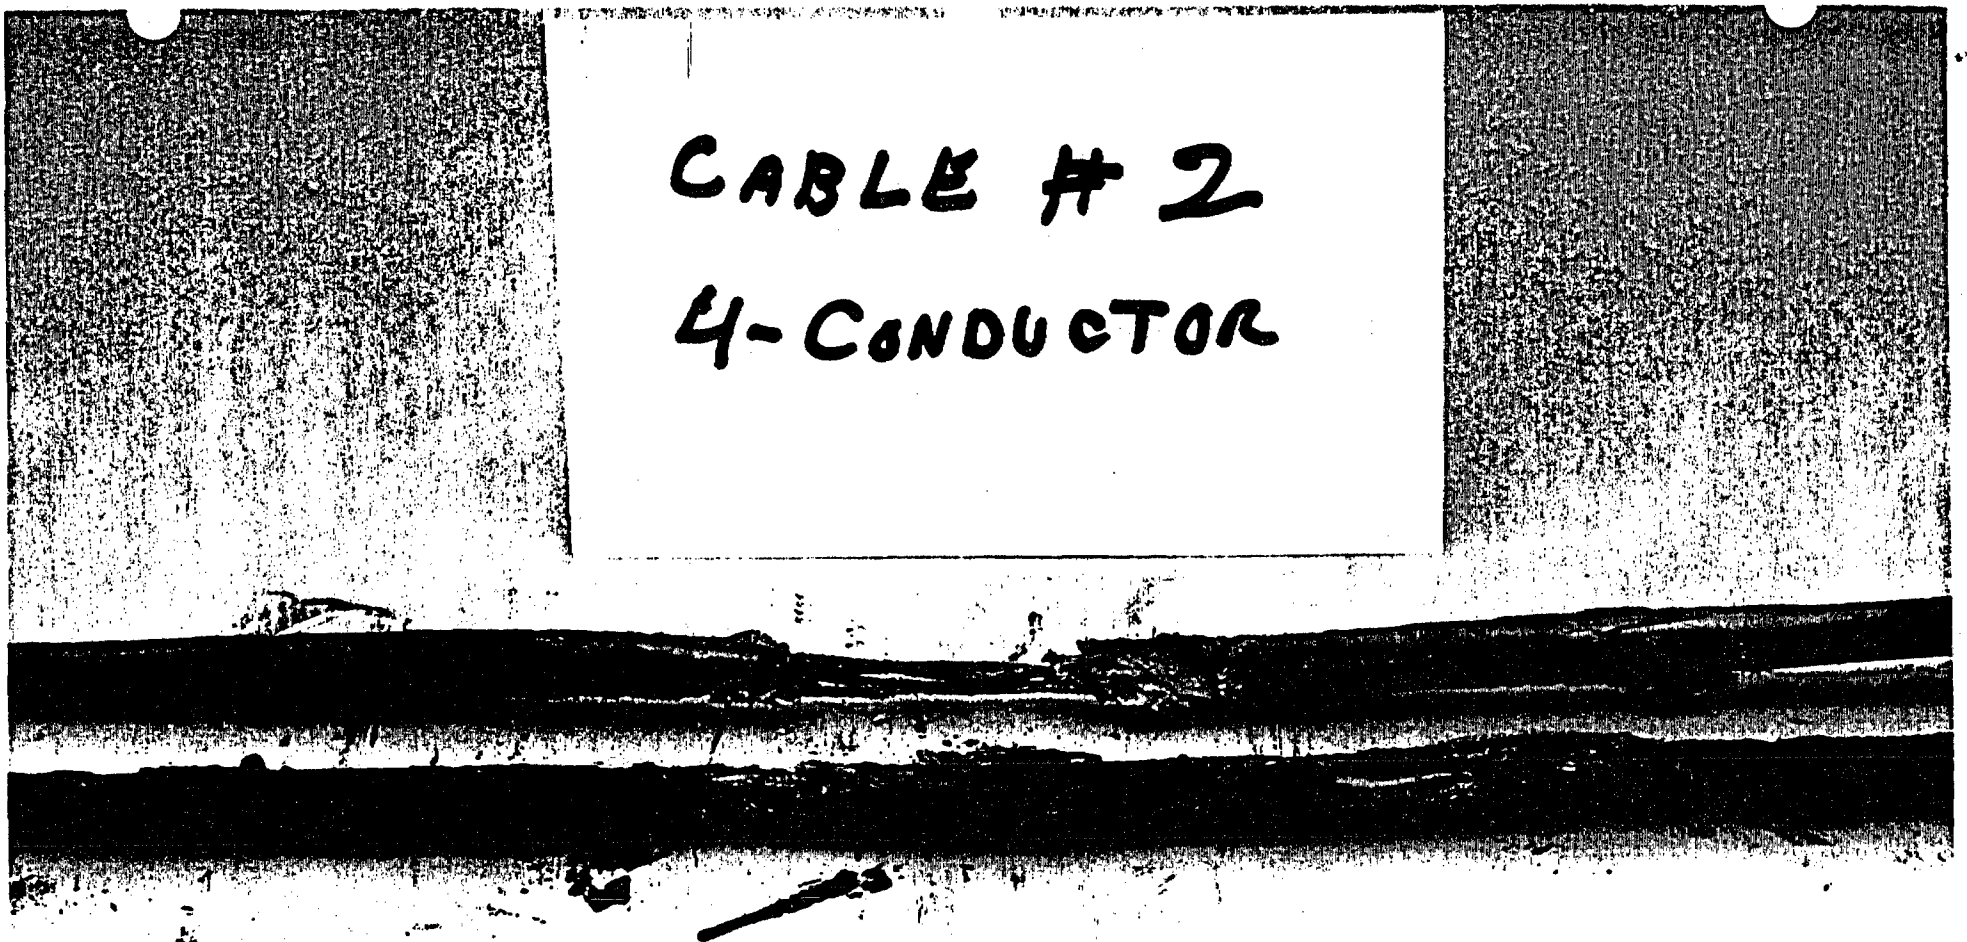
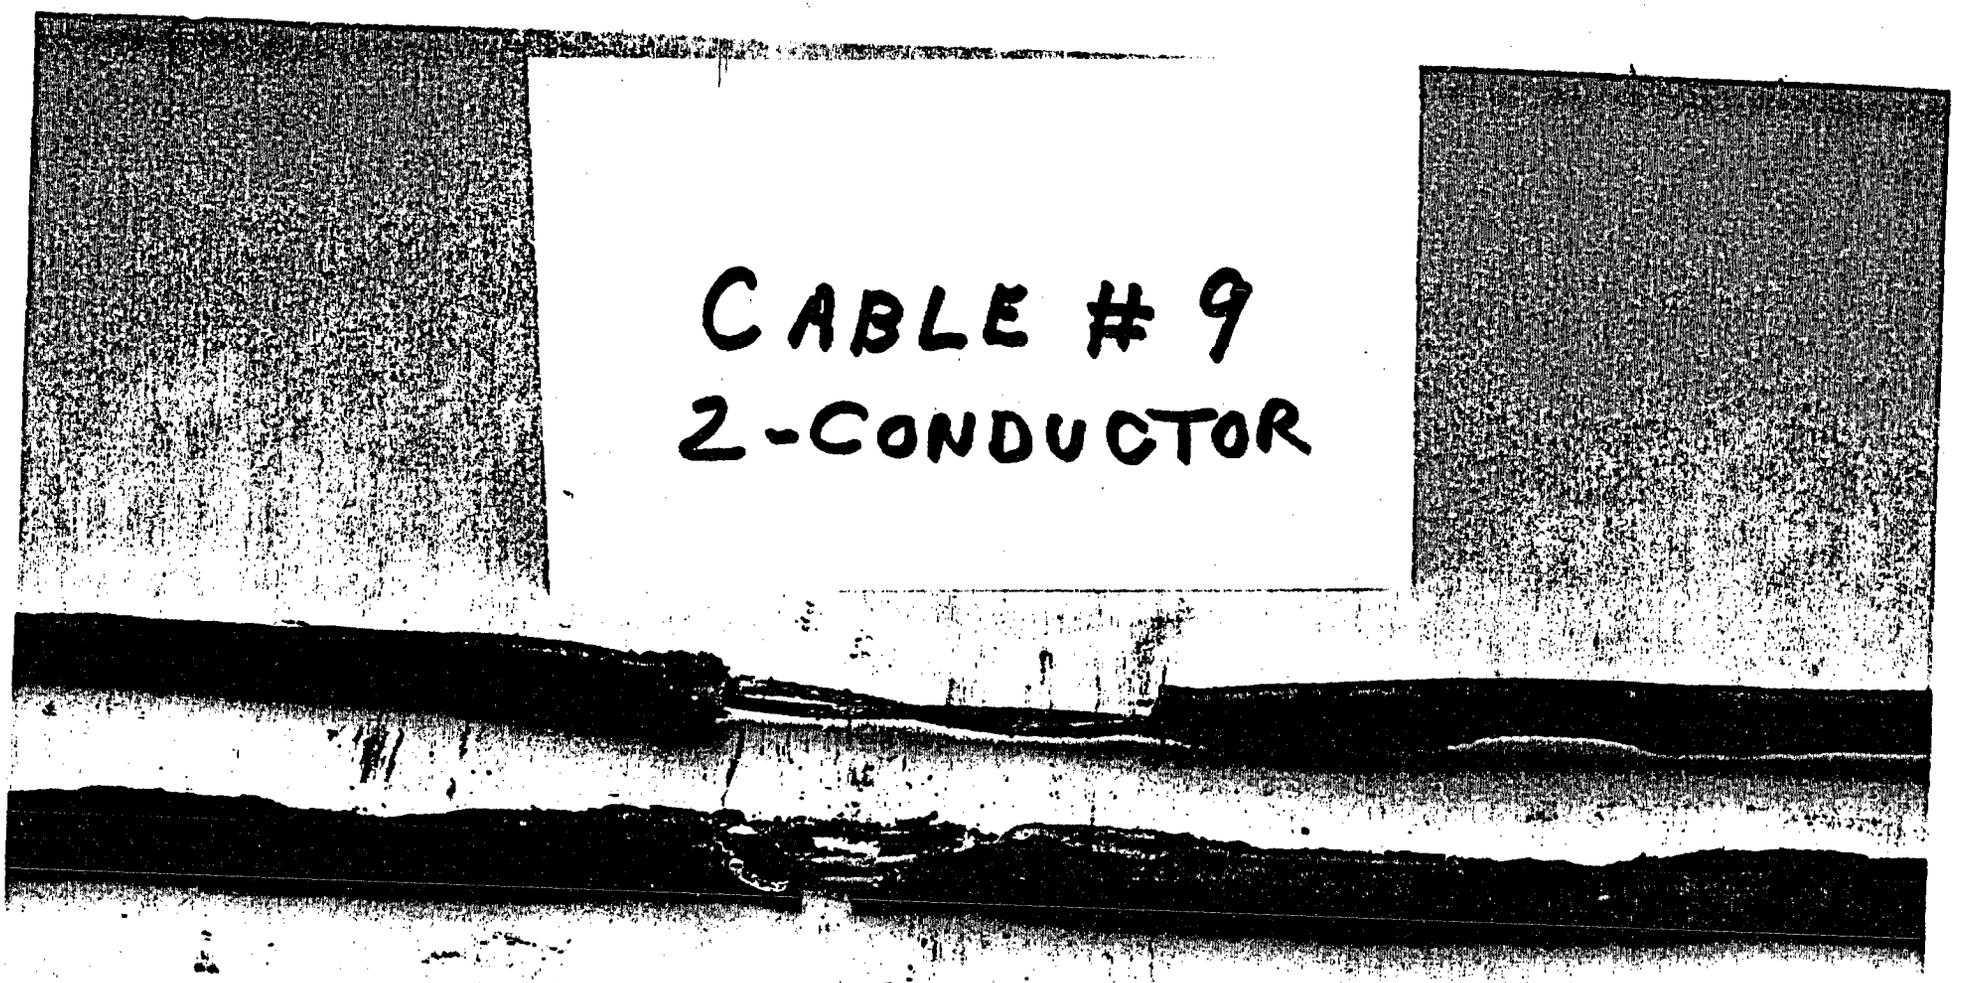
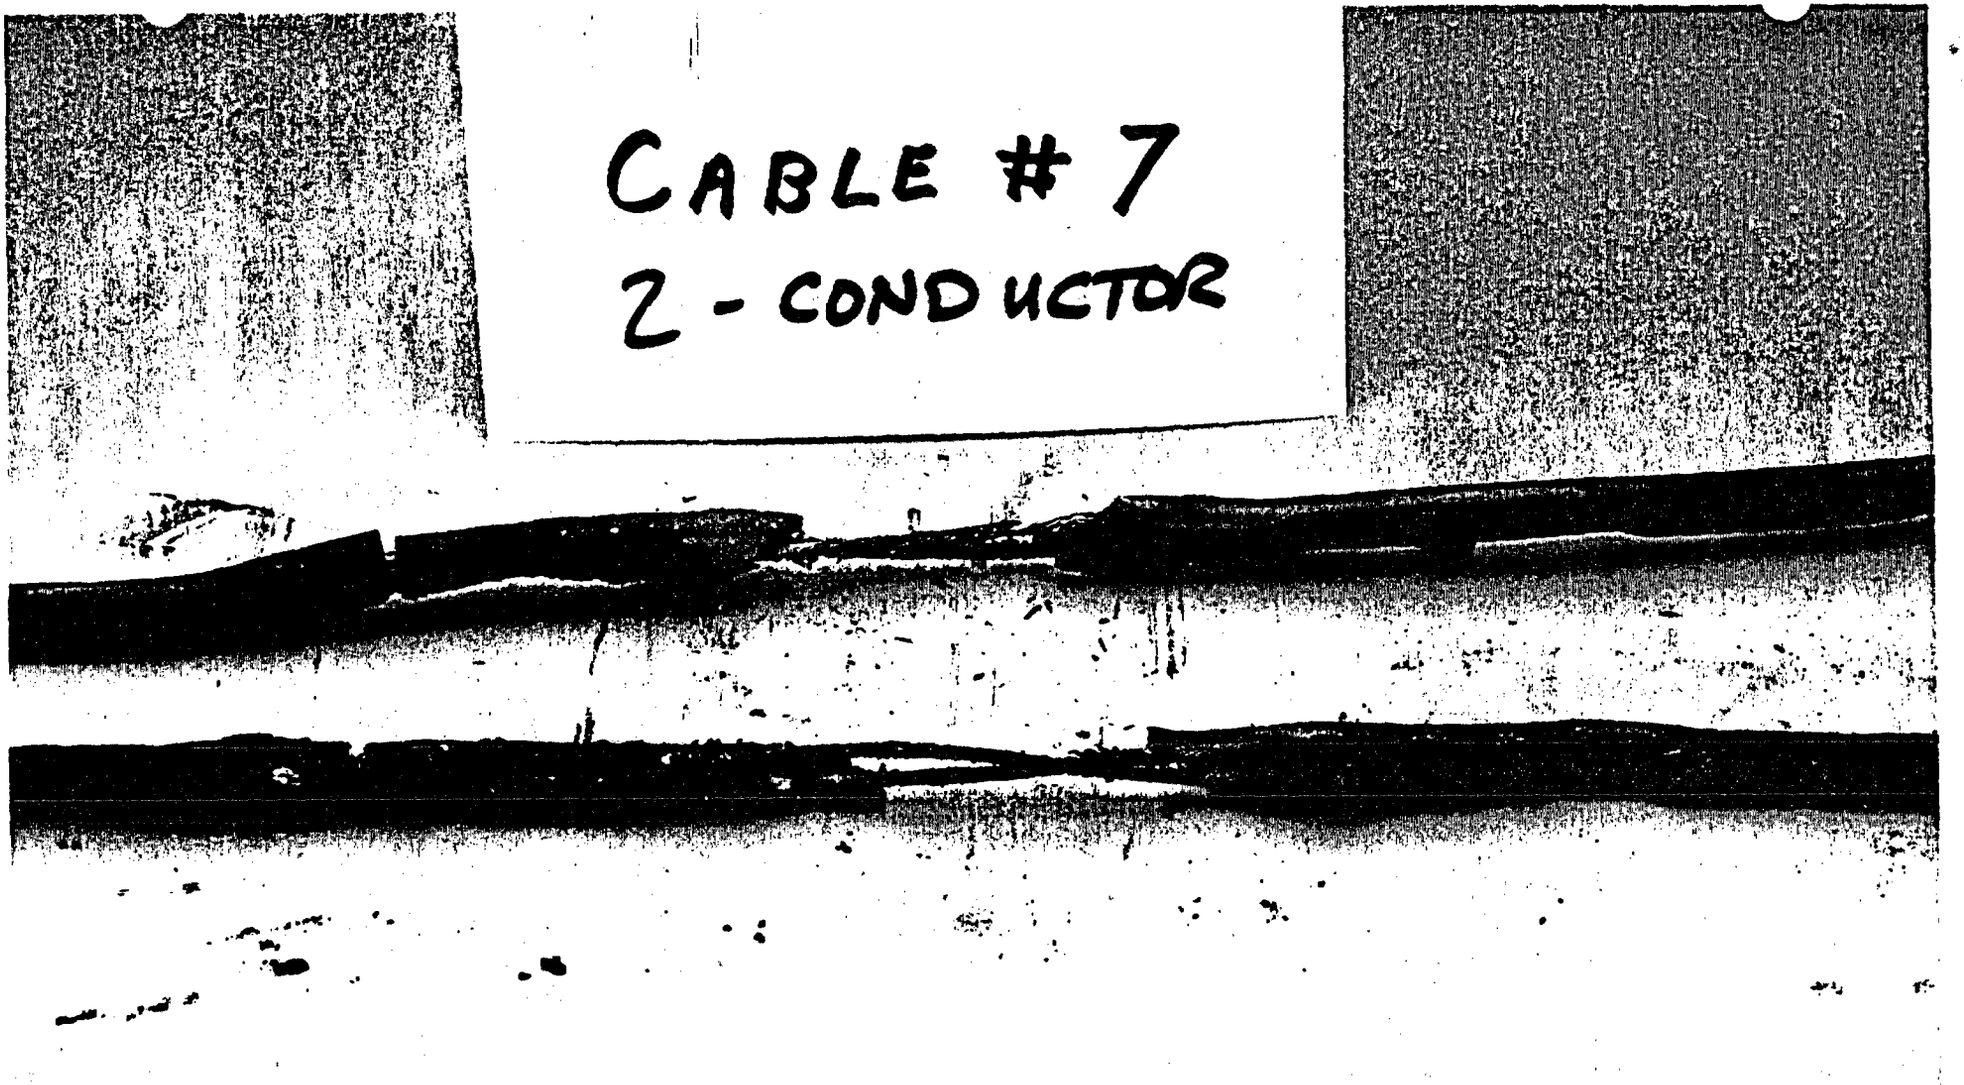
Fuses associated with cables on Channel 13 and 18 did not fail. Figure 14 shows that these cables were located in the top most part of the tray. The cable damage to these circuits is shown in Pictures No. 25 and 26. All energized cables located in the bottom and middle sections of the tray blew their fuses and sustained major cable flame damage as can be seen in Pictures 19 to 24.
