71-9187

RE: TAC No. L23952, Supplemental Information for Current Amendment USA/9187/B(U)-96 for the Model 865 Transport Package

Figure 1.2a: Model 865 Radiographic Exposure Device

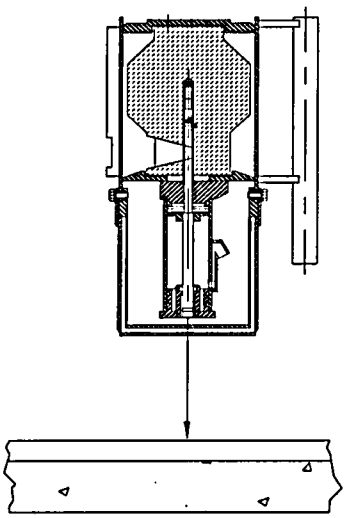
Figure 2.6a - Model 865 (TP84(A)) 1.2 m Drop Test Orientation Top Down Drop

Damage to TP84(A) was limited to impact witness marking on the top cover. As damage was minimal, this unit was used for further testing under the hypothetical accident conditions prior to package profiling. There was no significant change in the radiation profile of the test specimen after all testing including the 1.2 m (4 ft) drop test (See Section 5).

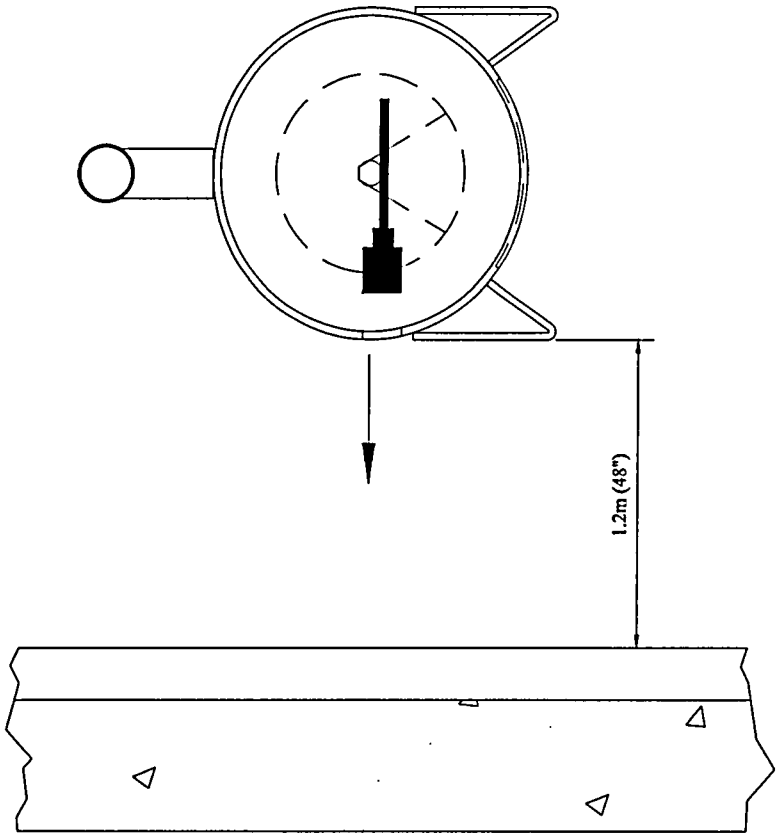
Figure 2.6b - Model 865 (TP84(B)) 1.2 m Drop Test Orientation Side Drop

Damage to TP84(B) was limited to a slight flattening of the cover at the point of impact. As damage was minimal, this unit was used for further testing under the hypothetical accident conditions prior to package profiling. There was no significant change in the radiation profile of the test specimen after all testing including the 1.2 m (4 ft) drop test (See Section 5).

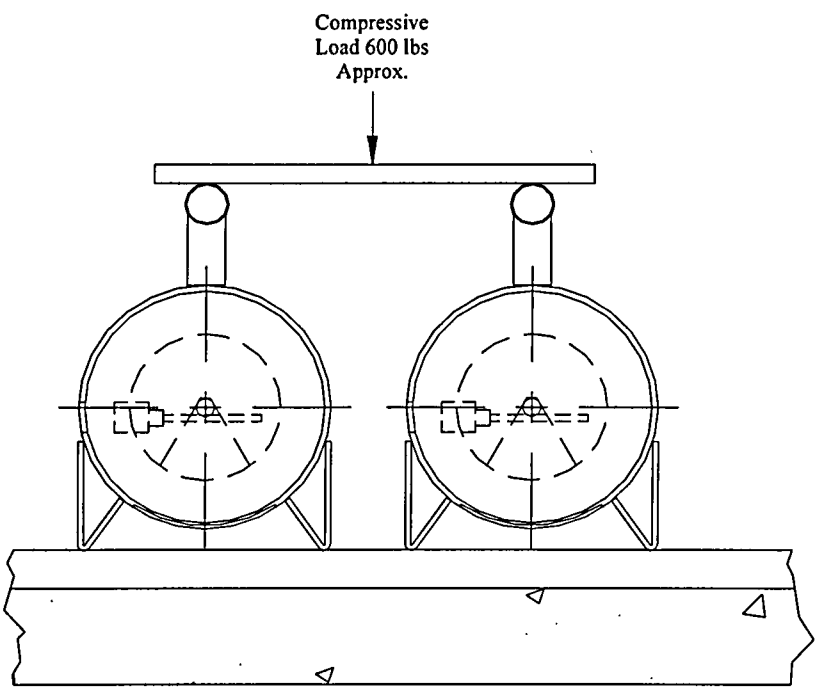
Figure 2.6c - Model 865 Compression Test Orientation

Test Plan 84 Report (Section 2.12.2) documents that the two test specimens (TP84(A) and TP84(B)) were subjected to a combined compressive load of 649 lbs (294 kg) for a period of 24 hours (See Figure 2.6c). This load exceeded five times the maximum transport package weight of 60 lbs (27 kg). This load was also greater than 13 kPa (2 lb/in^2) multiplied by the vertically projected area of the transport package.

Following the test, no damage to the specimens was observed. Radiation profiles performed at the conclusion of the all testing showed no significant increase in radiation levels. The Model 865 package maintained its structural integrity and shielding effectiveness and demonstrated that the packages comply with the requirements of this section.

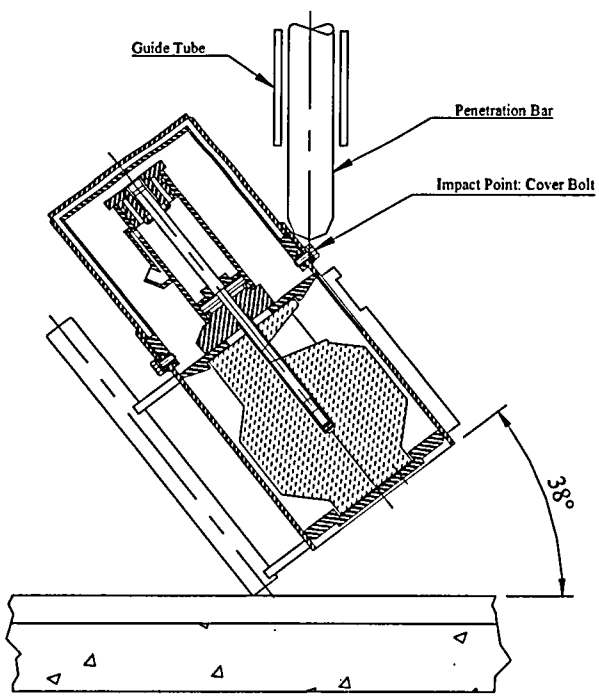
Figure 2.6d - Model 865 TP84(A) Penetration Test Orientation

The penetration bar impacted the specimen twice to achieve the intended impact point. Damage to the package was limited to a small witness mark on the bolt. No significant damage occurred to the specimen.

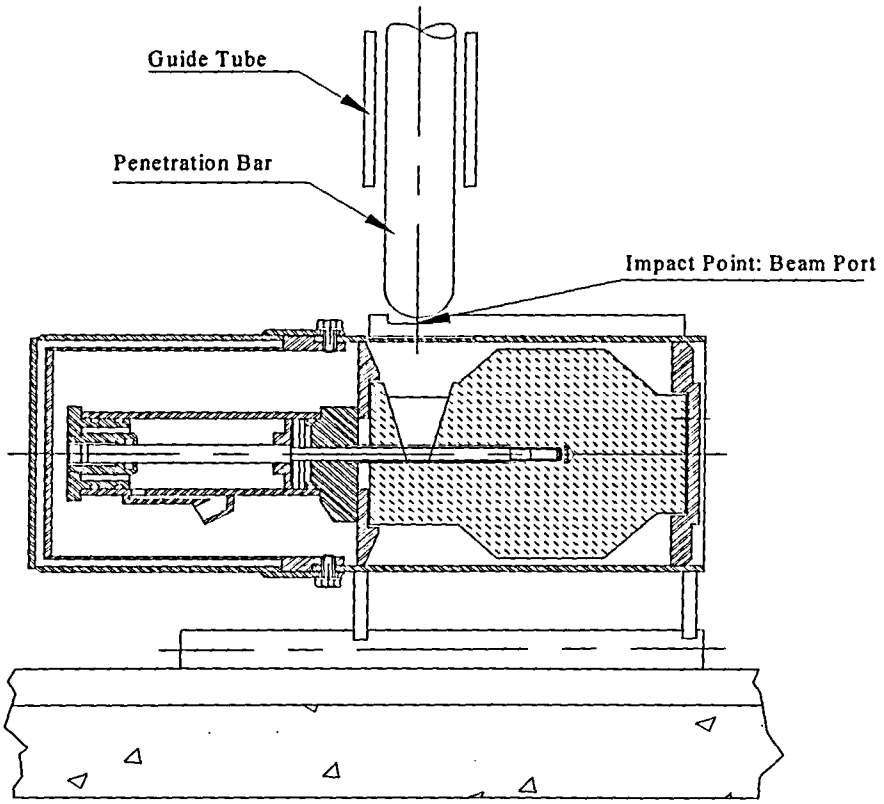
Figure 2.6e - Model 865 TP84(B) Penetration Test Orientation

The penetration bar impacted the specimen as intended leaving an indentation at the point of impact. No significant damage occurred to the specimen.

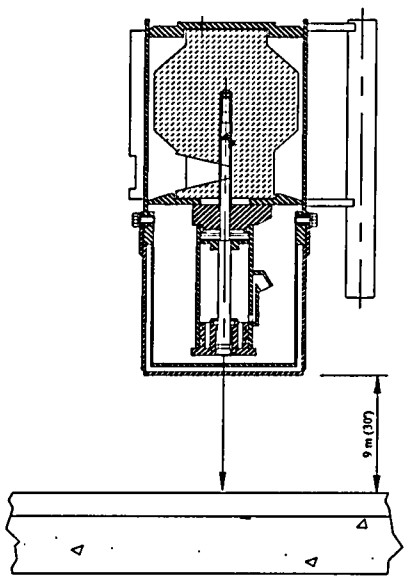
Figure 2.7a - Model 865 (TP84(A)) 9 m Drop Test Orientation – End Drop

This unit was dropped twice from a distance of 9 m (30 ft) and it was determined that the combined damage to the unit in the two 9 m (30 ft) drops was more extensive than would occur in a single flat end drop. The cumulative damage caused a local buckling of the shipping cover and slight deformation of two of the cover bolts. There was no other significant damage to the test specimen.

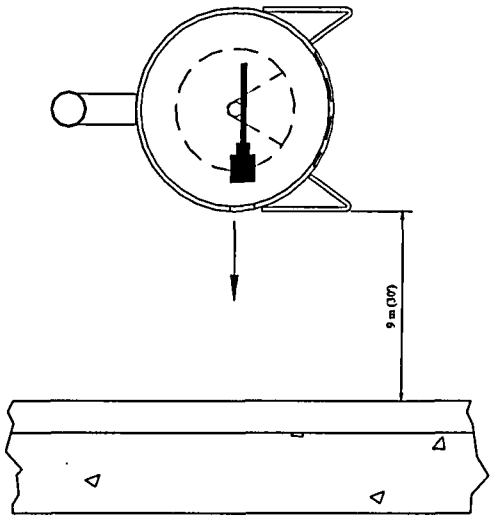
Figure 2.7b - Model 865 (TP84(B)) 9 m Drop Test Orientation – Side Drop

There was no other signs of damage to the specimen.

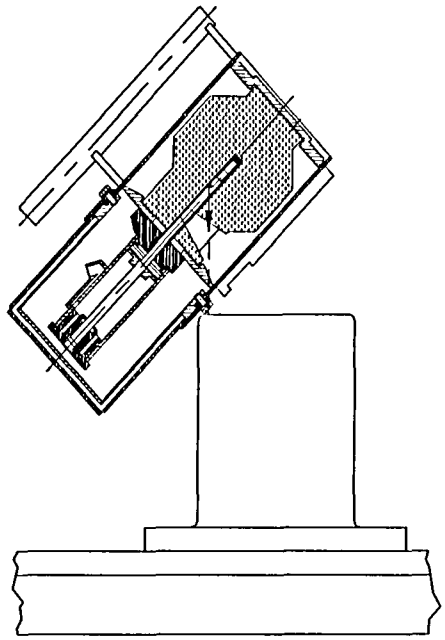
Figure 2.7c - Model 865 (TP84(A)) Puncture Test Orientation Cover Bolts of the Package

Test Specimen TP84(A) impacted the puncture bar to continue the damage inflicted on the specimen by the 9m (30 foot) drop test and to continue to challenge the cover bolts (see Figure 2.7c). The unit hit as intended hitting the cover bolt and causing a secondary impact on the shell and leg of the package. This caused some deformation of the leg, but the unit was fully intact after the impact with no broken or missing parts event externally.

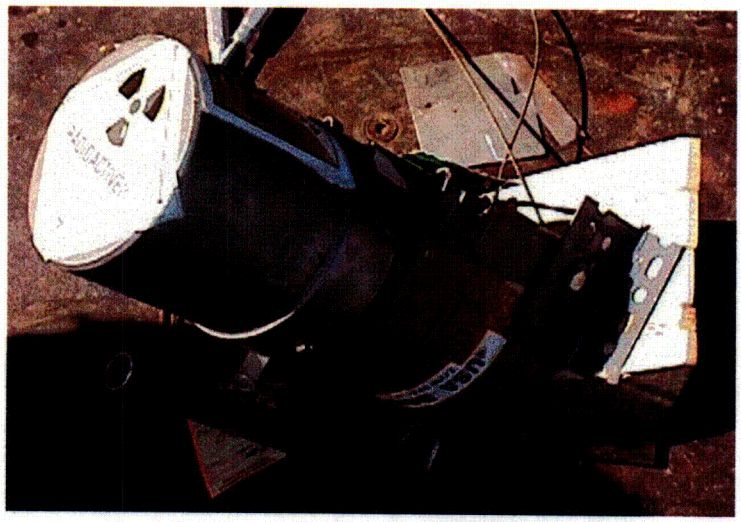
Figure 2:Test specimen TP84(A) penetration test set-up

Test units TP84(A) and TP84(B) were subjected to the penetration tests (bar dropped from 40") per Section 8.6 of Test Plan 84. Test data and results were recorded on checklist 3 together with one data sheet for each test specimen. It was reported on the data sheet relating to test specimen TP84(A) that the first test had to be repeated because the penetration bar struck the package foot instead of the target cover bolt. Subsequent tests were performed successfully with a guide tube. The penetration test set-up and results required by Test Plan 84 are shown in the figures below.

Test specimen TP84(A) was securely fixed to a block mounted to the test figure such that the penetration bar was able to strike the cover bolt and exert the maximum stress in the bolt. The bolt head was struck on the second attempt causing a witness mark as shown in figure 3 below.

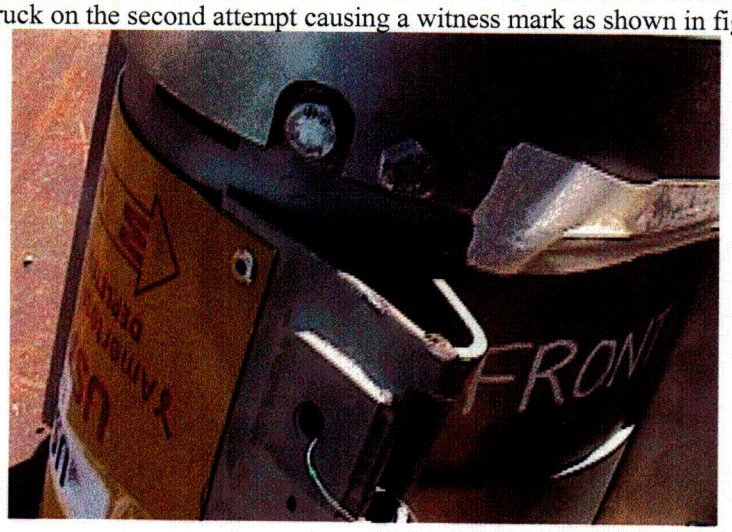
Figure 3:Penetration damage to cover bolt on TP84(A)

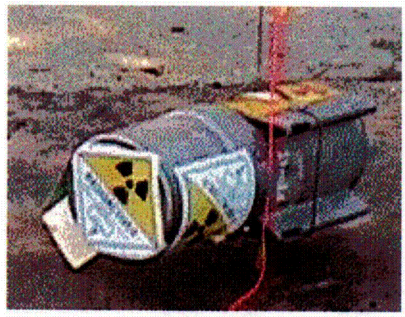
Figure 12:Test specimen TP84(B) 30 foot drop set-up

The test unit impacted as intended and struck the drop surface flat on the left side causing slight flattening of the unit along the line of impact. The planned test sequence for TP84(B) was continued.

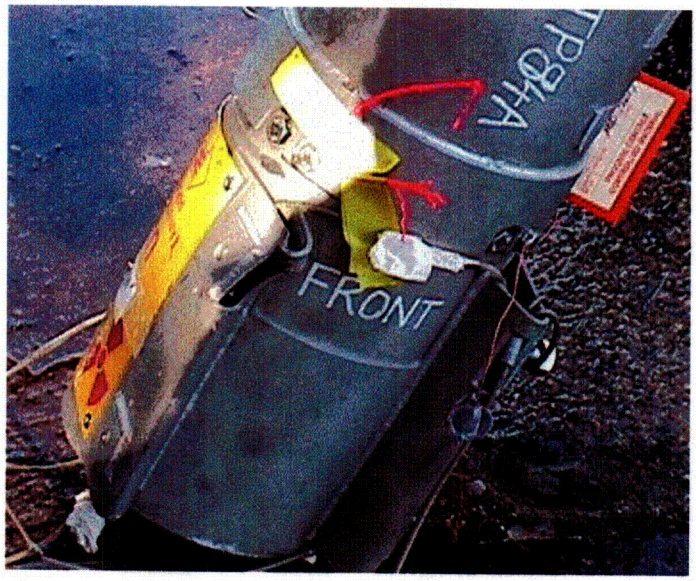
The target for this test (TP84(A)) was a cover bolt. The bolt head was hit during the primary impact. There were secondary impacts on the shell and leg of the unit. There was some deformation of the leg as shown in figure 14.

Figure 14:Puncture test damage to TP84(A)

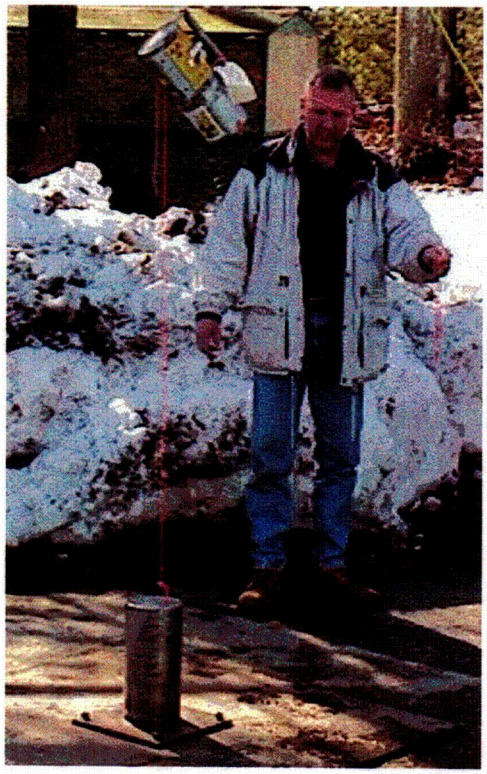
Figure 15:Puncture test set-up for TP84(B) drop 1

The test data sheet describes how in the primary impact the test unit rotated after hitting the legs such that the target beam port did not strike the puncture billet. The test was repeated successfully. The damage to TP84(B) is shown in figure 16.

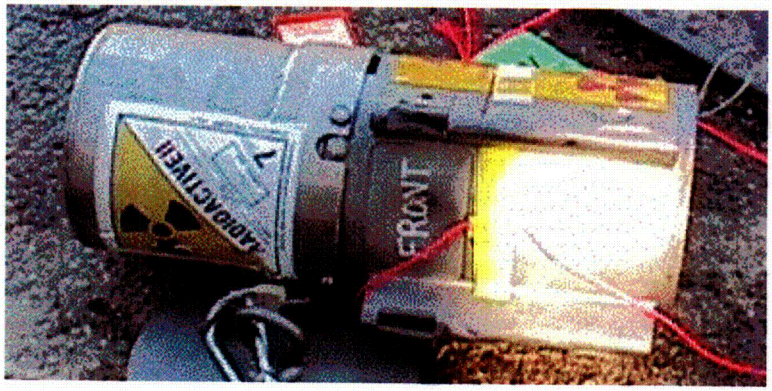
Figure 16:Puncture test damage to TP84(B) following drop 1

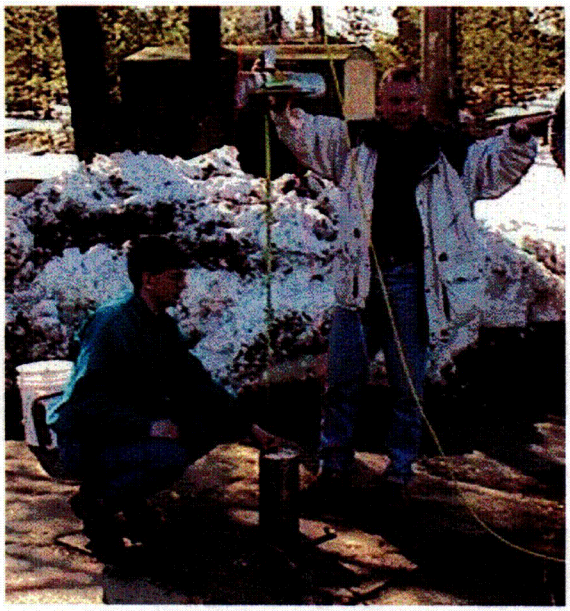
Figure 17:Puncture test set-up for TP84(B) drop 2

TP84(B) was deemed fit to continue with the testing sequence following puncture drop 1. The test set up for puncture drop 2 is shown in figure 17.

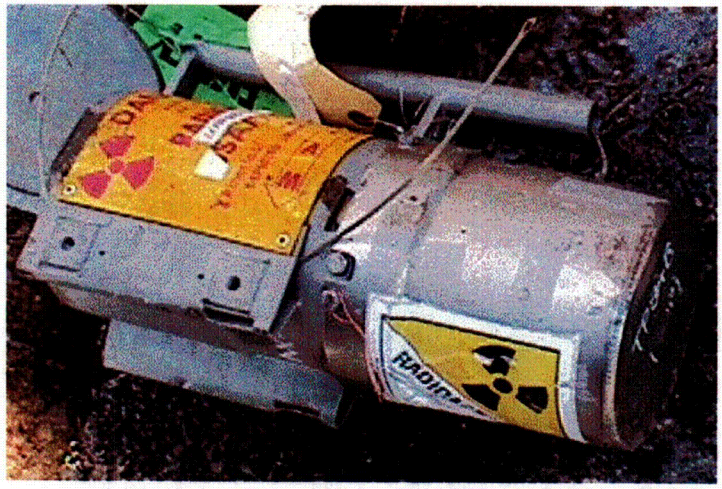
The target for drop 2 was again the lock assembly. The test data sheet indicates that the unit hit the specified point and that no further damage was caused to the device, see figure 18.

Figure 18:Puncture test damage to TP84(B) following drop 2

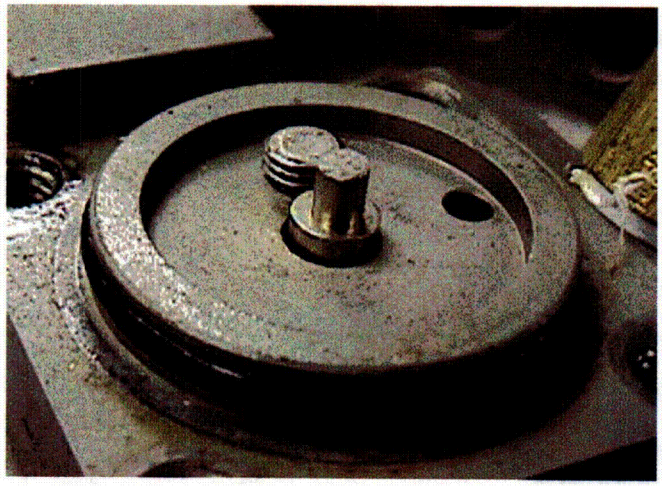
The actuator assembly was removed. The source rod was found to be fractured at the base of the thread which joins the source rod to the actuator assembly, see figure 20. The source rod remained secure in the locked position indicating no movement of the source throughout the test sequence. The lock assembly was not damaged and was operational.

Figure 20:Brittle failure of TP84(A) source rod

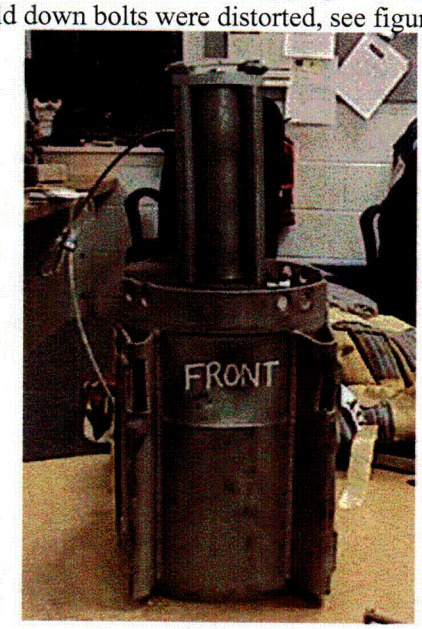
The test data sheet describes the post-test examination performed on TP84(B). This unit was subjected to three puncture tests suffering compounded damage. Both the shipping and actuator covers were removed. Some of the fixing bolts and their corresponding location holes in the cover showed indications of strain. After removal of the shipping and actuator covers it was evident that the actuator assembly and hold down bolts were distorted, see figure 21.

Figure 21:Damage to TP84(B) actuator assembly

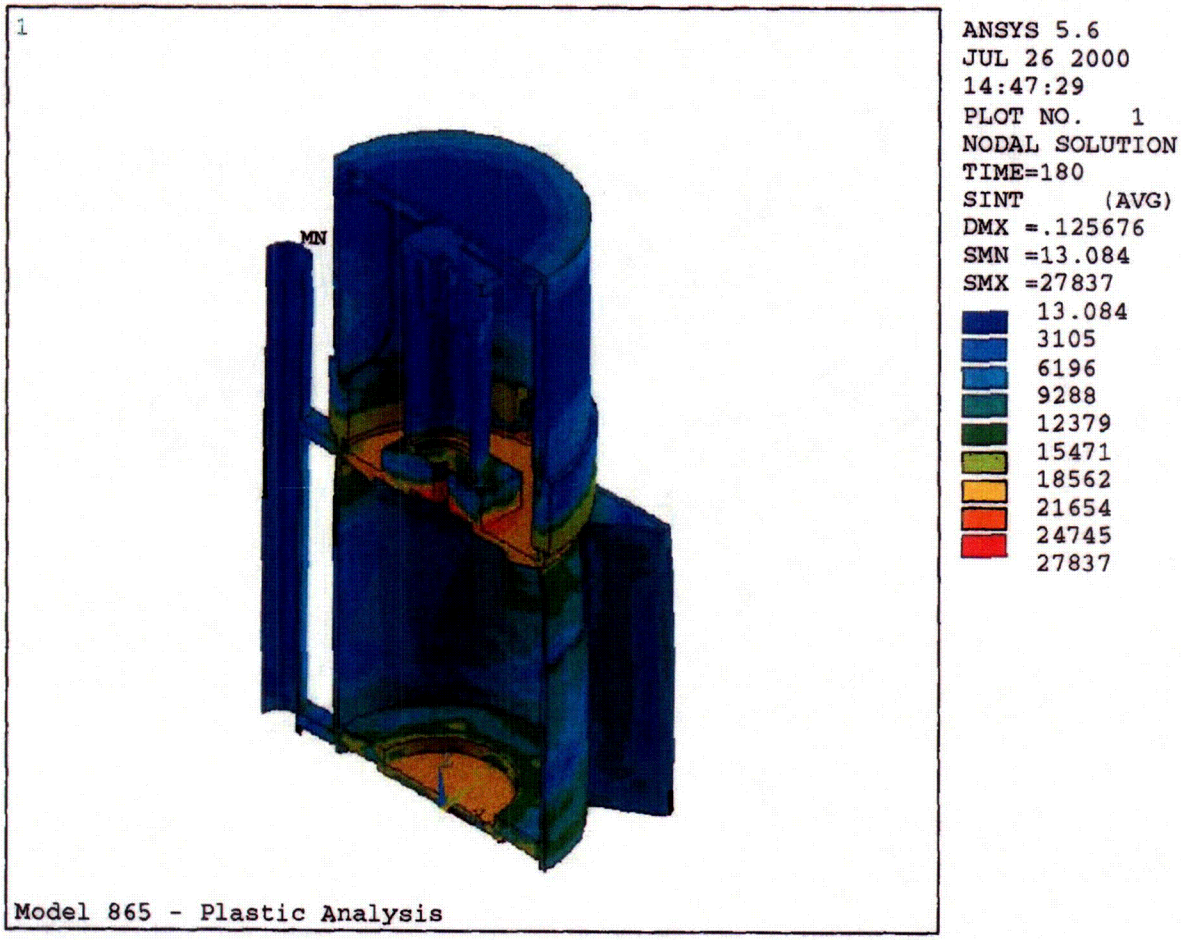
Figure 3
Model 865 Stress Intensity Profile at 3 Minutes

Figure 3 shows contours of the stress intensity profile in the projector at 3 minutes, the time of maximum stress during the transient. The maximum stress intensity is 28 ksi. Figure 4 shows contours of total strain at 3 minutes. The maximum strain is less than 3%. This strain is considerably less than the strain at failure (40 to 50%) for stainless steel at a temperature of 1475°F.

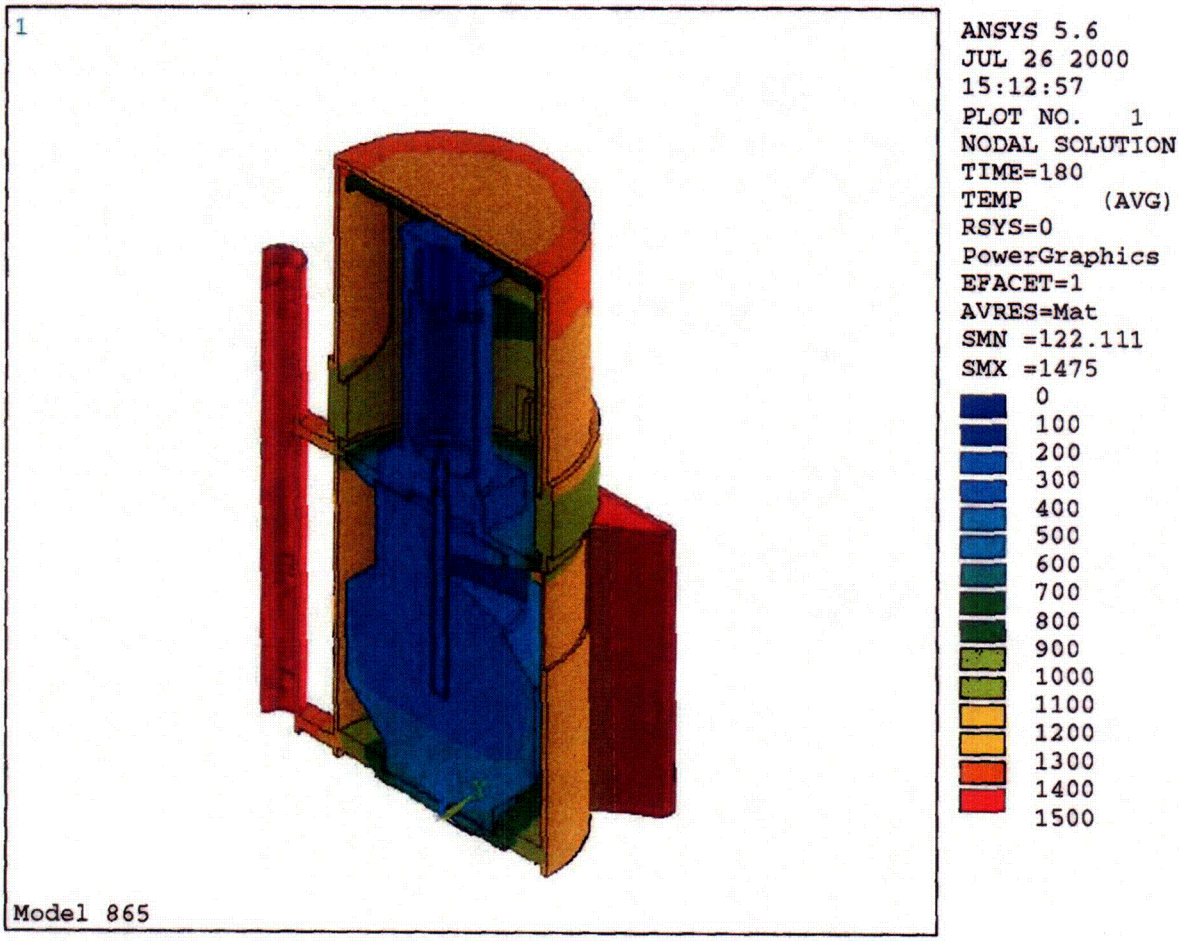
Figure 13
Temperature Profile at 3 Minutes

Figures 12 through 16 show temperature profiles in the projector at selected times during the temperature transient. At three minutes into the transient (Figure 13) the exterior surfaces of the shipping cover and the housing have heated up to nearly 1300°F. The handle and the housing support have heated up to nearly 1475°F. However, the inside of the projector is still relatively cool. By 30 minutes, the projector has nearly reached an equilibrium temperature of 1475°F.

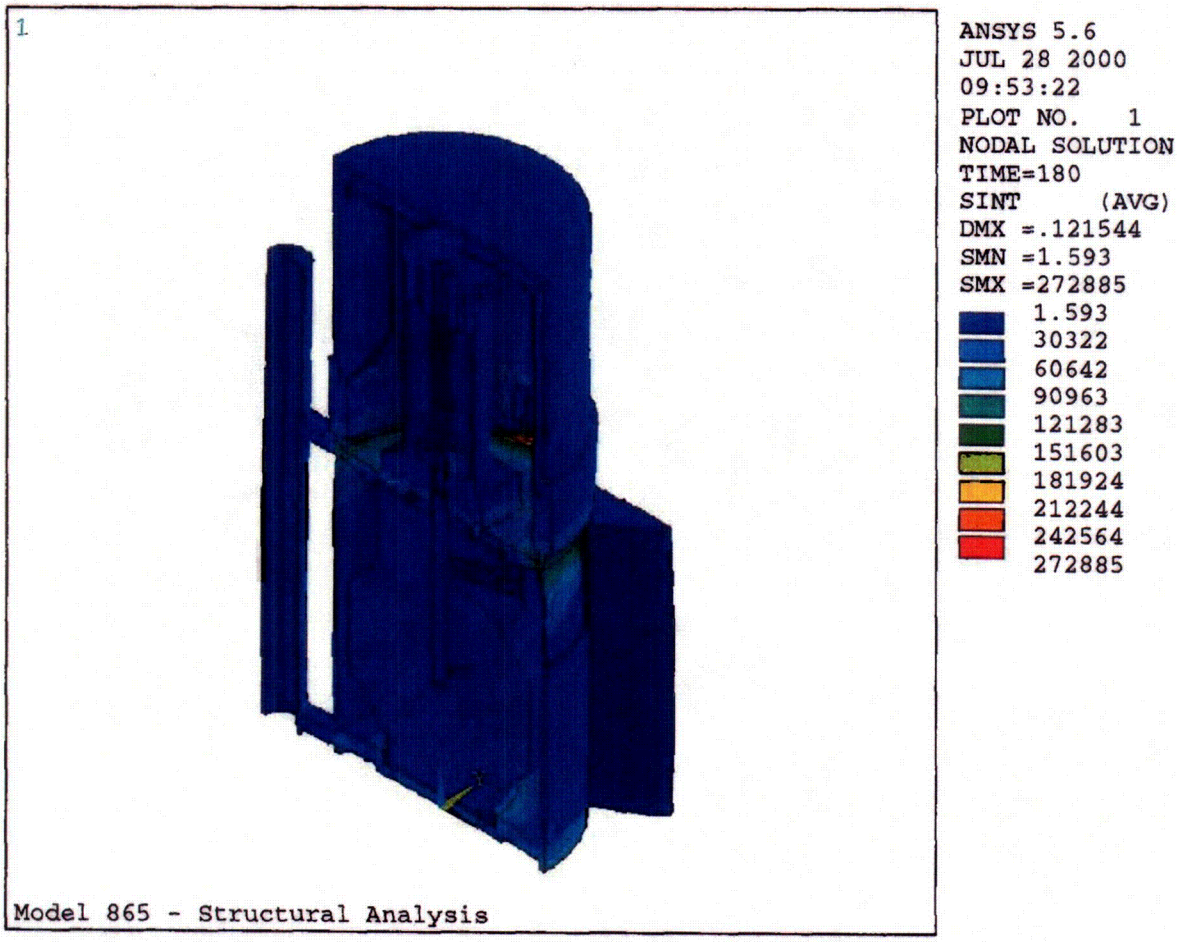
Figure 19
Stress Intensity Profile at 3 Minutes

As shown in Figure 19, high stresses occur at the connection between the projector weldment shell and the upper shield collar. This is due to the expansion of the projector weldment shell which is restrained by the cooler upper shield collar. The maximum calculated elastic stress of 273 ksi occurs at the sharp corner of the lock cut-out due to stress concentration effects. This maximum stress would not occur in the projector weldment subjected to the specified thermal conditions because the stainless steel shell material would yield and relieve the stress. These thermal expansion stresses are secondary and the maximum stress intensity does not occur in the material that forms the containment boundary around the depleted uranium shield.
