Vermont Yankee
Visual Examination Report Form for General Visual (IWE)

Component ID: Torus Penetration X206 A + D System: Containment

Component ID: X-5A Thru 5H System: Drywell

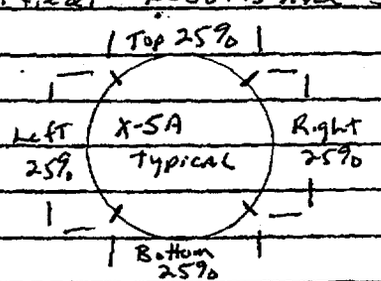
Due to location and proximity of these penetrations to the Torus they can not be safely accessed by Ladder. Examined these penetrations from existing vantage point from top of Torus. Approximately 67% of each penetration can be Examined. The bottom 25% is unavailable and the last 33% of the Top 25% of these penetrations are unavailable for examination. Examined accessible areas of X-5A, B, C, D, E, F, G + H with no findings identified. Results are satisfactory.
