SUBJECT: STAFF OBSERVATIONS OF TESTING FOR GENERIC SAFETY ISSUE 191 DURING MARCH 8 AND MARCH 9 TRIP TO THE ALION HYDRAULICS LABORATORY

OBSERVATIONS OF TESTING

AT ALION SCIENCE AND TECHNOLOGY HYDRAULICS LABORATORY

MARCH 8 AND 9, 2007

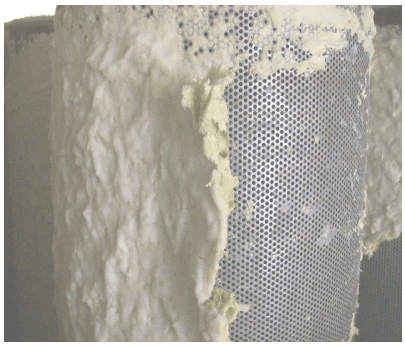
Figure 2-Strainers in Plywood Enclosure

Figures 1 and 2 show the installation of the strainers in the tank. Figure 3 shows a closeup of the perforated strainer surface. All three figures are post-test and show some debris on the strainers' surfaces. Some debris has apparently fallen off of the strainers following the test and subsequent drain down of the tank. Figure 4 shows the bypass eliminator that has been removed from the strainer internals following the test. Figure 5 shows the top surface of a strainer with some debris settled on it.

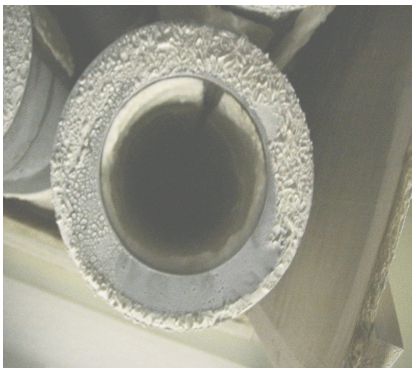
Figure 4-Bypass Eliminators

The strainers contained a fiber bypass prevention material which consisted of layers of metallic mesh. This is a feature currently employed on Enercon strainers to reduce the amount of fiber bypassing the strainer and is termed a “bypass eliminator.” The bypass eliminator was previously reported as being somewhat effective in removing debris that had bypassed the perforated plate in an NRC Alion Laboratory trip report dated June 27, 2006, (ML061720514). Figure 4 (in the test results section) shows some of the mesh removed from the strainers that were used in the test that is the subject of this report. There is some debris apparent on the mesh.
