Byron Station Unit 2
Facility Operating License No. NPF-66
NRC Docket No. STN 50-455

Subject: Byron Station, Unit 2, 60-Day Response to First Revised NRC Order EA-03-009, "Issuance of First Revised NRC Order (EA-03-009) Establishing Interim Inspection Requirements for Reactor Pressure Vessel Heads at Pressurized Water Reactors"

"Byron Generating Station Outage – B2R13 Reactor Vessel Head Penetration Examination"

WDI-PJF-1303451-FSR-001

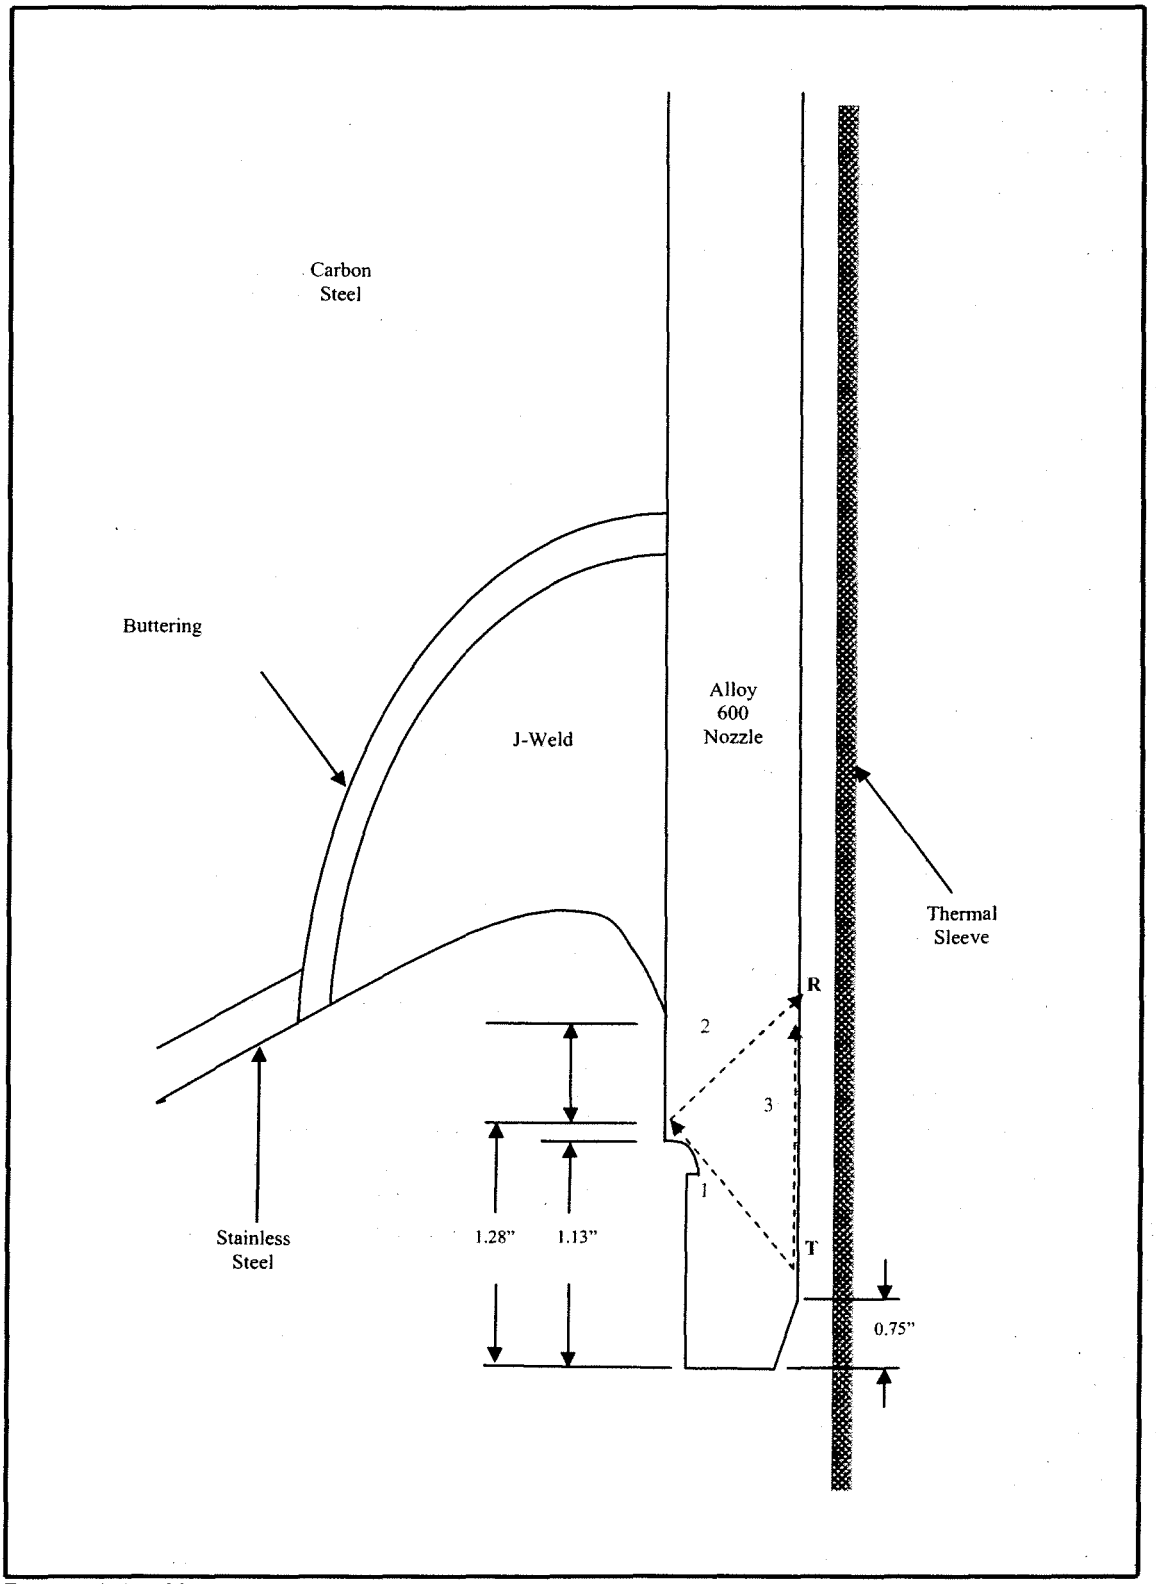
Figure 4.1 – Not to scale

The ID surfaces of the penetration tubes are chamfered at a 20° angle from the bottom of the tube to an elevation of 0.756". The threads on the tube OD surfaces and chamfer on the ID surfaces represent geometric conditions which limit examination coverage near the bottoms of the tubes.

For OD and ID examinations of all twenty three open penetration tubes, the TOFD PCS24 transducer coverage extended from approximately 0.75" from the bottom of the tube, to elevations at least 2.0" above the welds. The extent of coverage was verified for each examination of each penetration by confirmation that 1) loss of lateral wave of TOFD ultrasonic signals from the chamfer and 2) scan coverage elevations were in excess of 2.0" above the uppermost elevation of each weld.

The measured coverage below and above the weld per penetration is presented in table 3.1.1 and 3.2.1.
