Palisades Nuclear Plant
Docket 50-255
License No. DPR-20

Request for Relief from ASME Section XI Code Requirements for Repair of Service Water System Pipe

REQUEST FOR RELIEF FROM ASME SECTION XI CODE REQUIREMENTS
FOR REPAIR OF SERVICE WATER SYSTEM PIPE

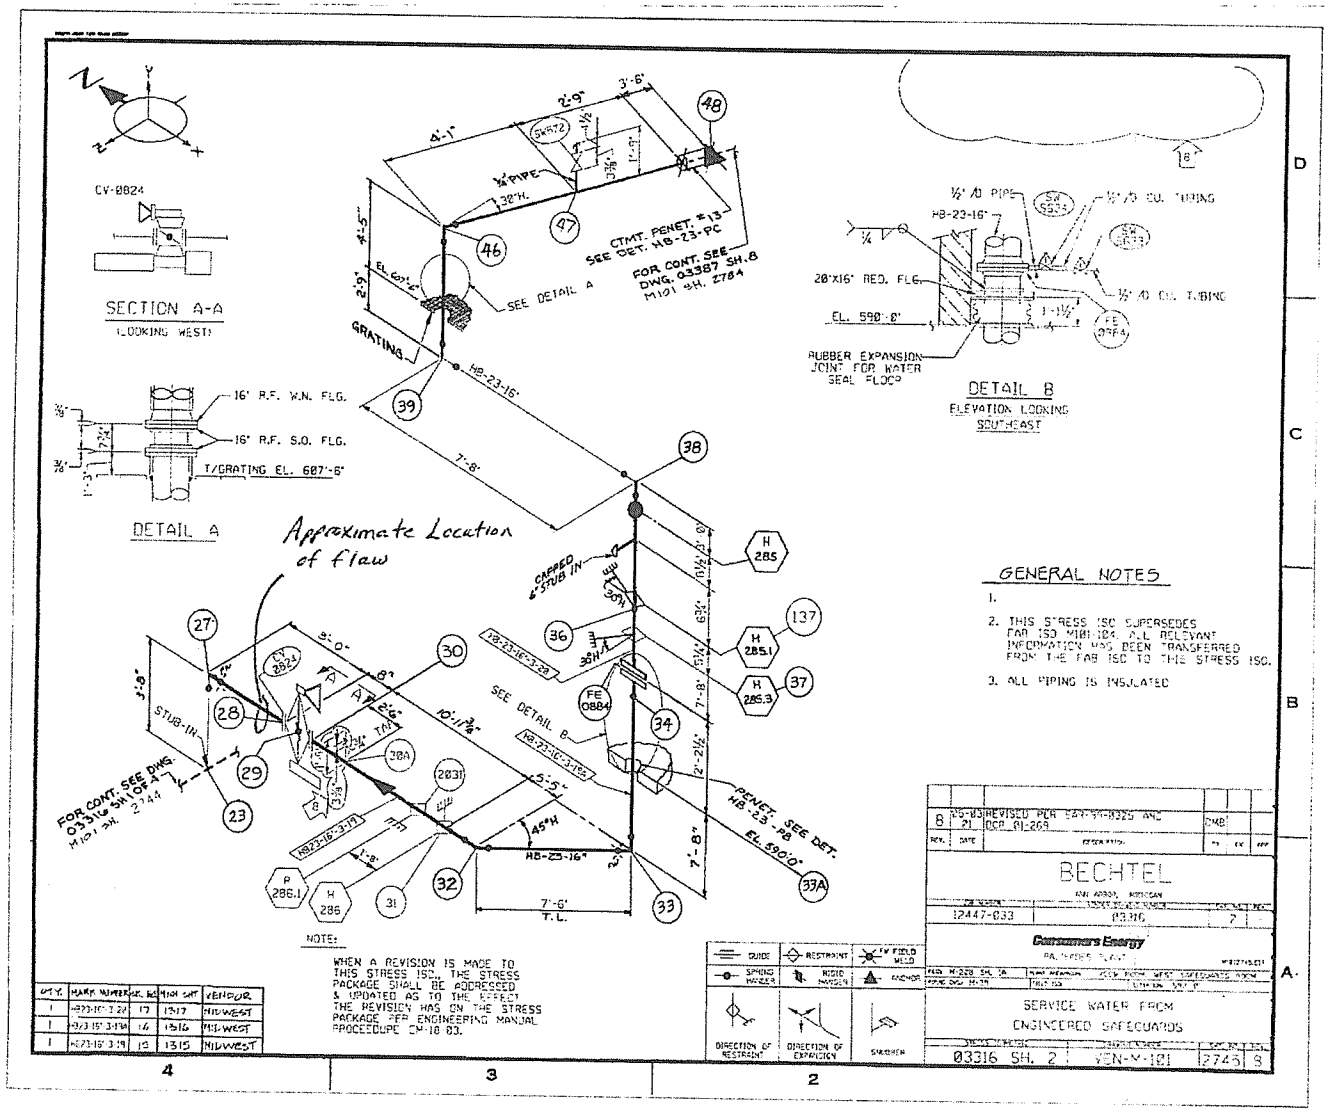
FIGURE 1

boundary of an ASME Class 3 system and affects the operability of the engineered safeguards system due to potential flooding and the SWS heat removal capability. Figure 1 provides an isometric drawing of piping section containing the flaw.

SECTION A-A
LOOKING WEST
DETAIL A
DETAIL B
ELEVATION LOOKING SOUTHEAST
Approximate Location of flaw
GENERAL NOTES
1.
2. THIS STRESS ISO SUPERSEDES FAB ISO M101-104. ALL RELEVANT INFORMATION HAS BEEN TRANSFERRED FROM THE FAB ISO TO THIS STRESS ISO.
3. ALL PIPING IS INSULATED
NOTE:
WHEN A REVISION IS MADE TO THIS STRESS ISO, THE STRESS PACKAGE SHALL BE ADDRESSED & UPDATED AS TO THE EFFECT THE REVISION HAS ON THE STRESS PACKAGE PER ENGINEERING MANUAL PROCEDURE CM-18 03.
BECHTEL
Consumers Energy
SERVICE WATER FROM ENGINEERED SAFEGUARDS
03316 SH. 2
YEN-M-101
2745
8

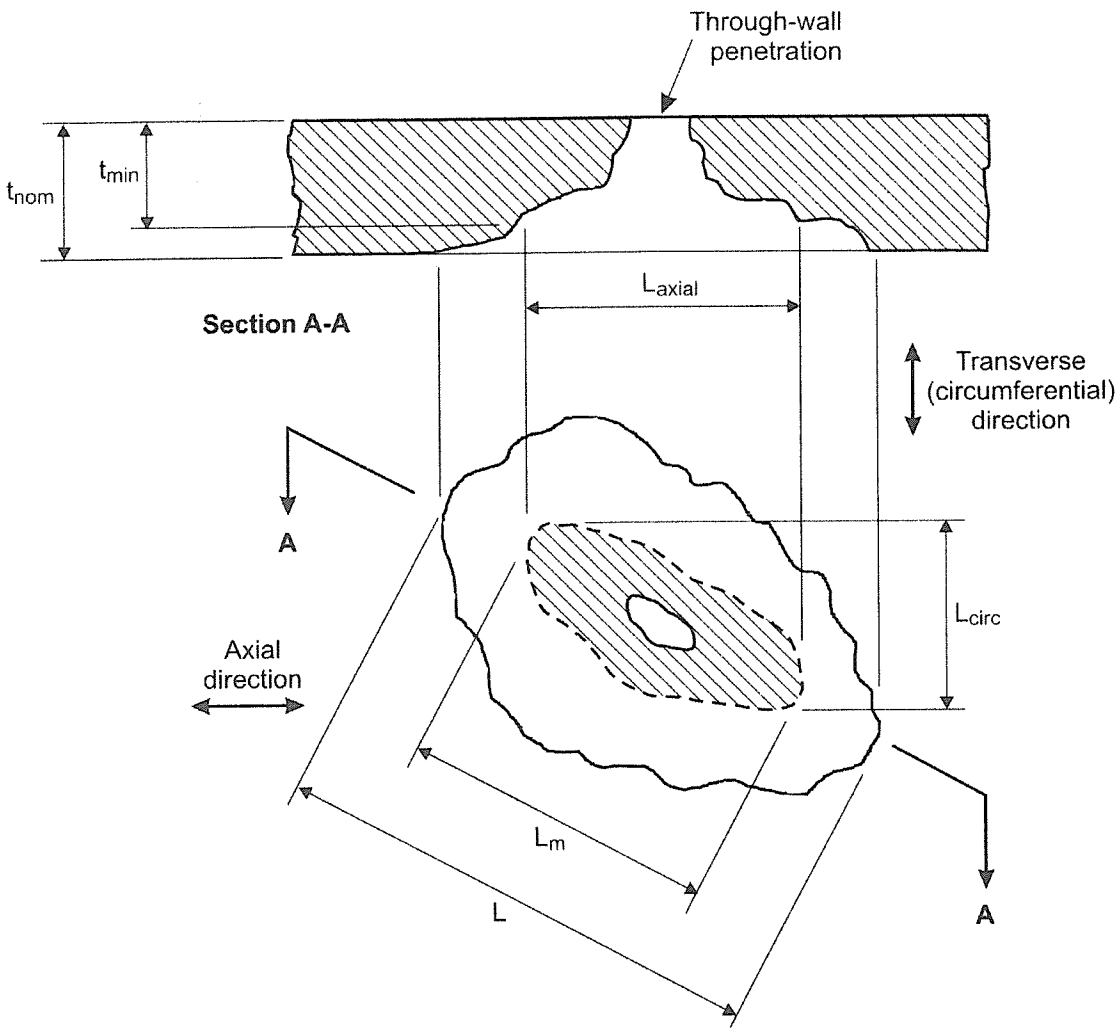
Figure 1. Planar Characterization of Through-wall, Nonplanar Flaw

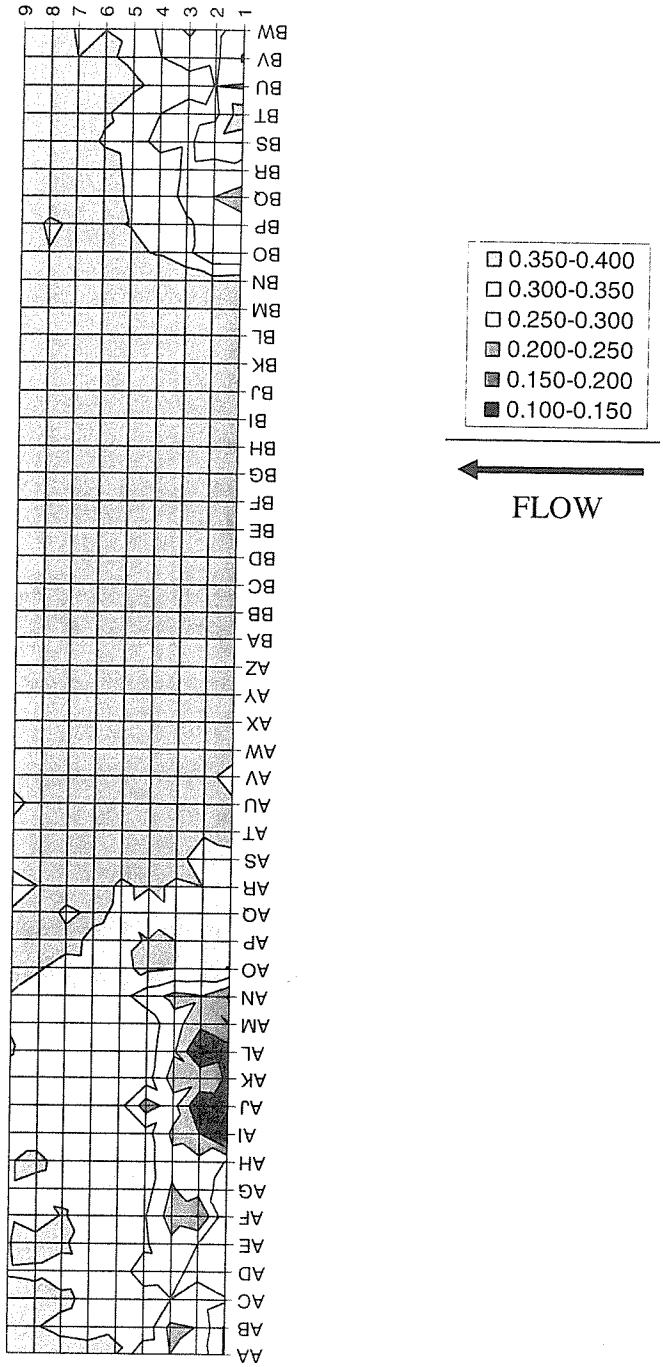
Figure 2. NDE Inspection Data of Effected Pipe Region from 10/27/06

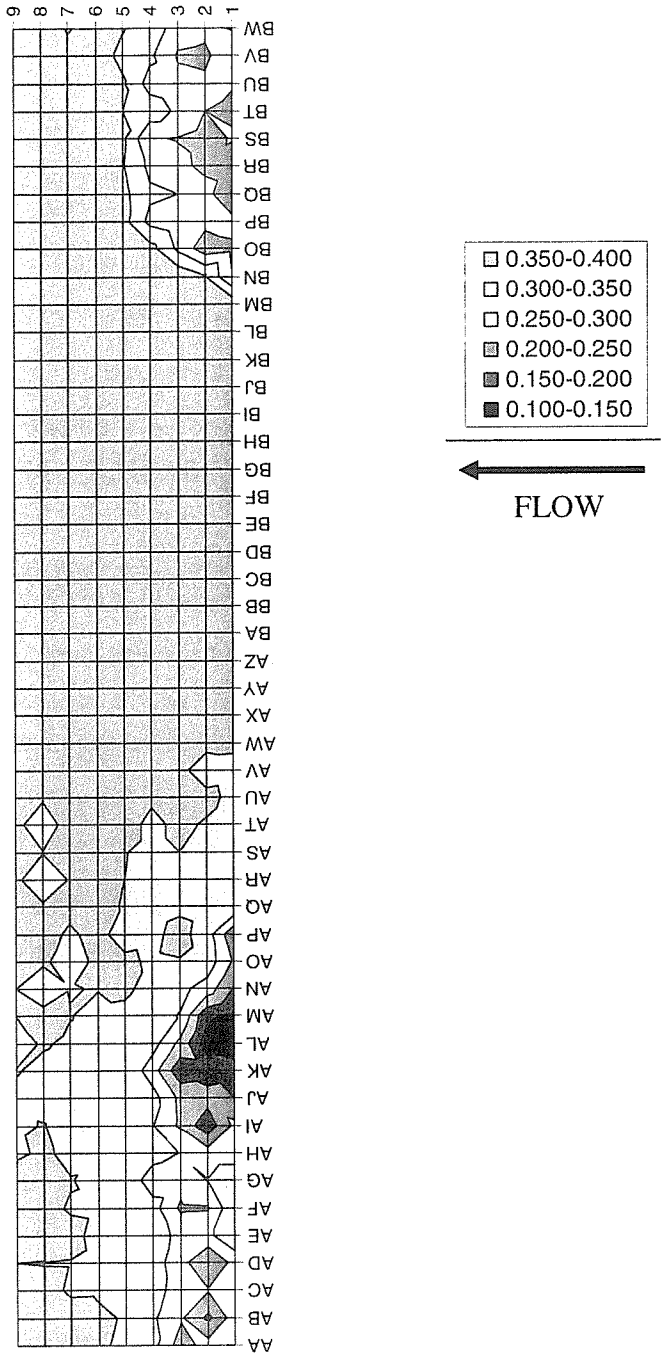
Figure 3. NDE Inspection Data of Effected Pipe Region from 2/14/07

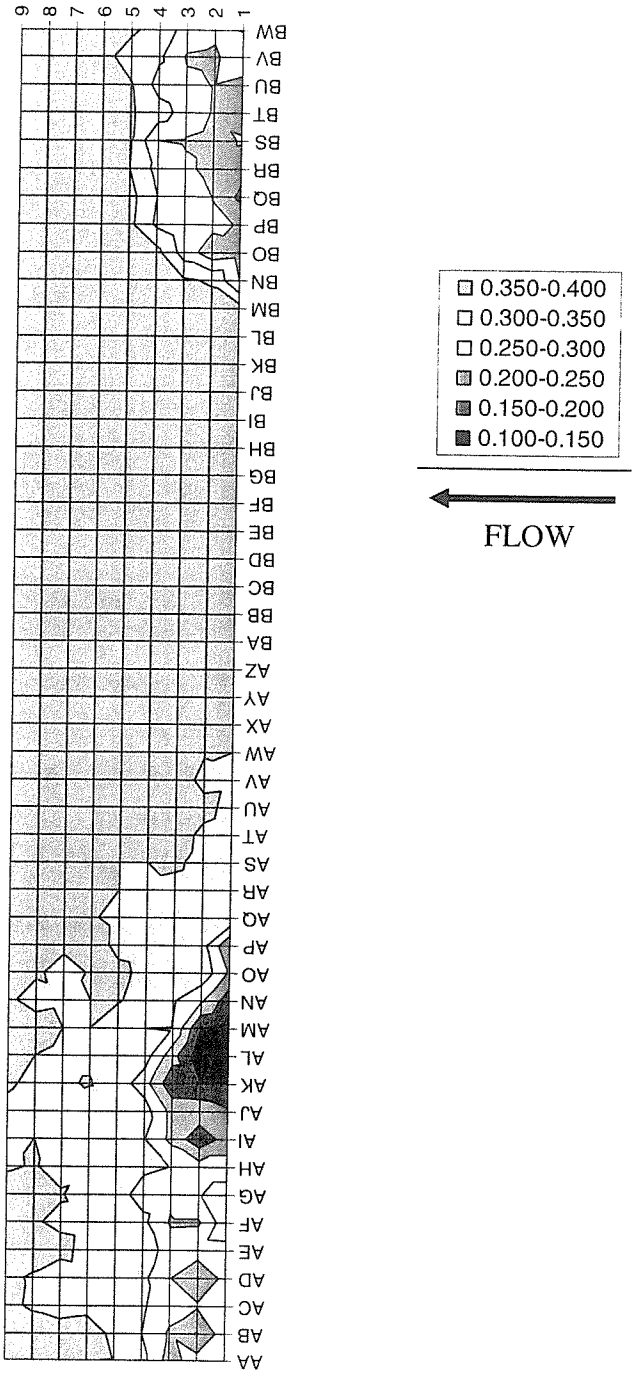
Figure 4. NDE Inspection Data of Effected Pipe Region from 5/09/07

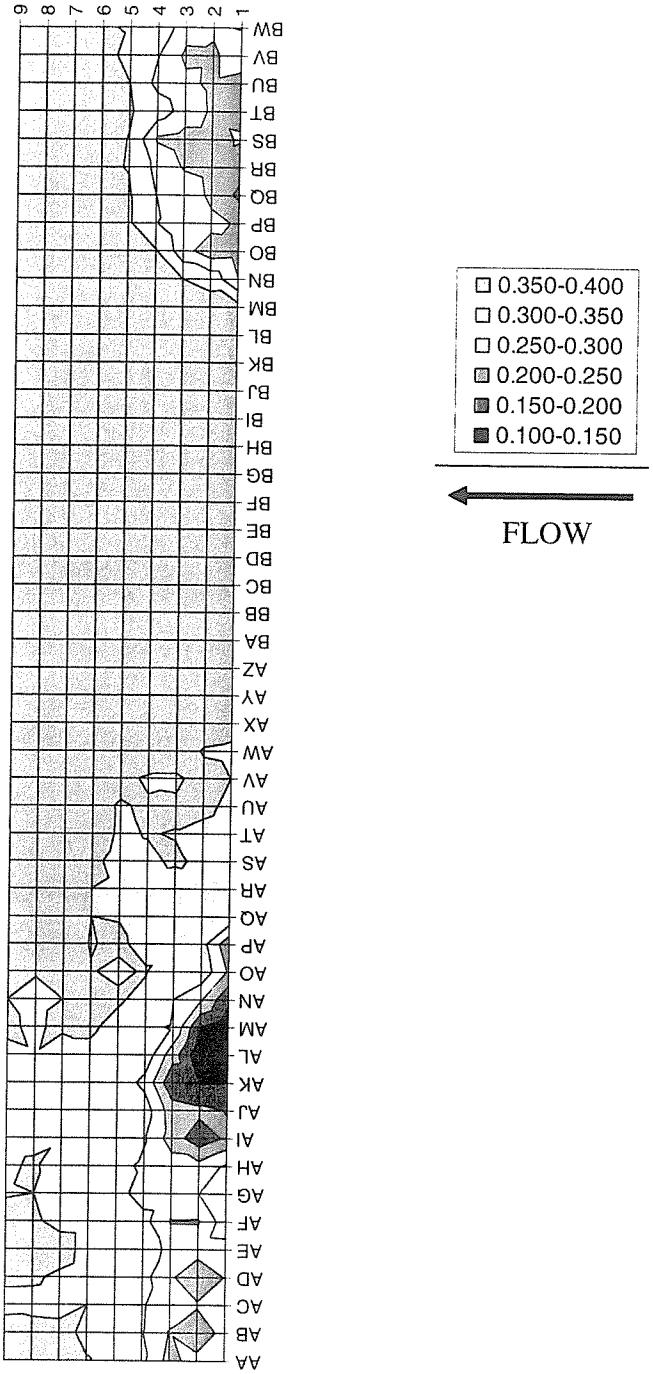
Figure 5. NDE Inspection Data of Effected Pipe Region from 7/02/07

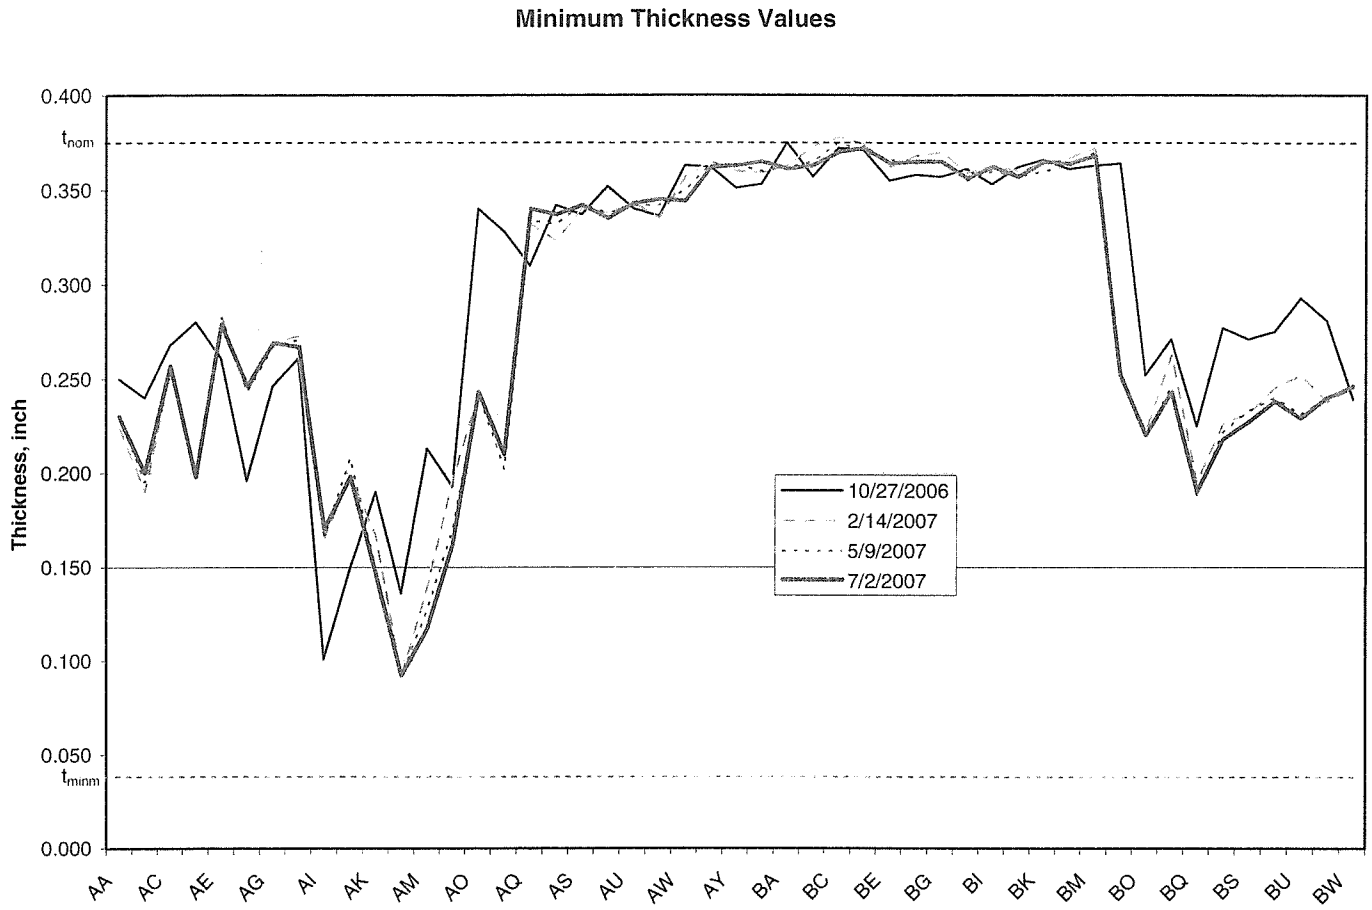
Figure 6. Circumferential Profile – Minimum Values

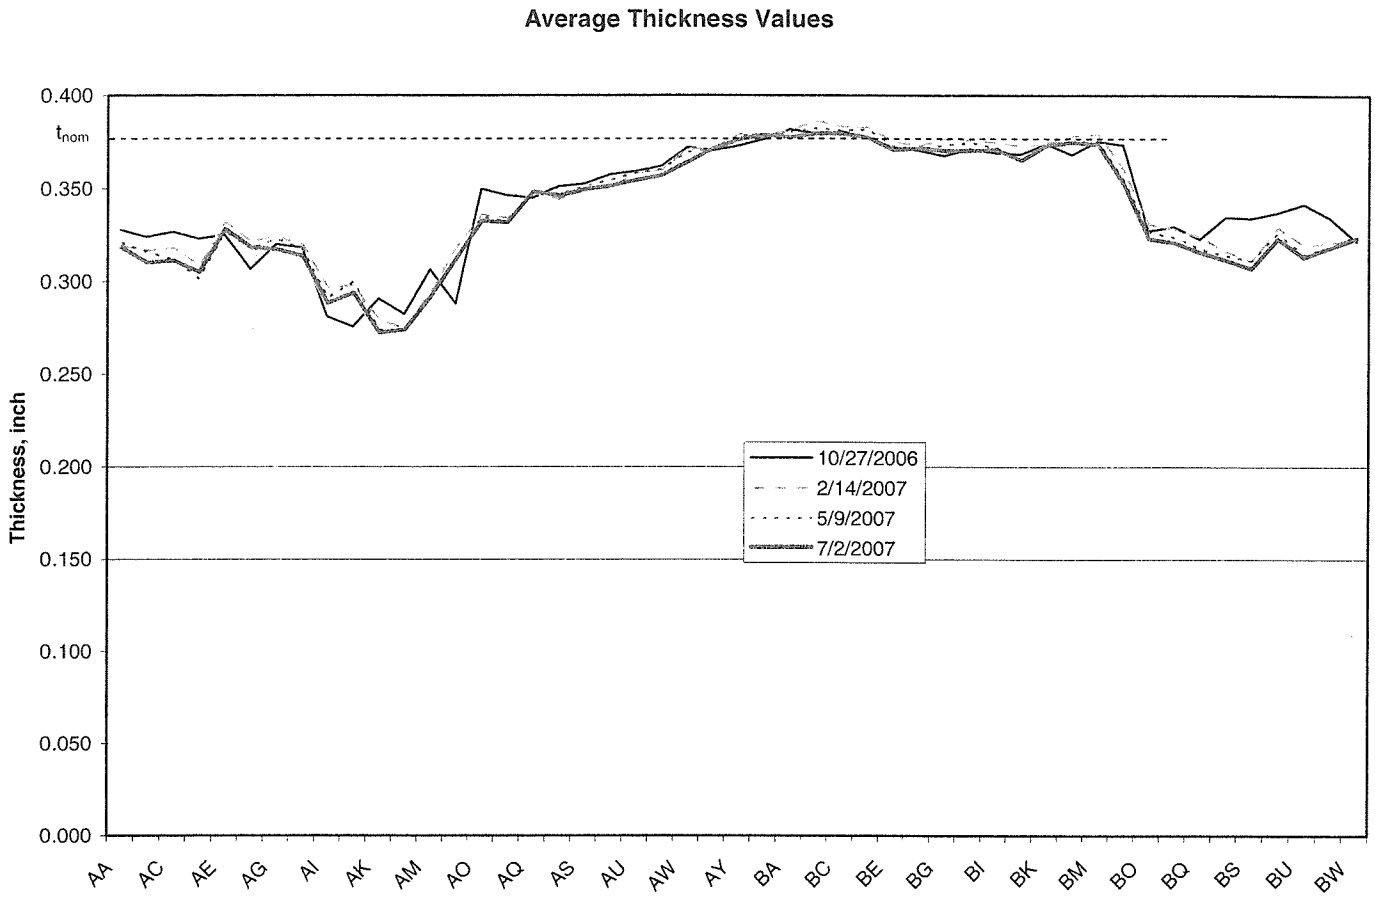
Figure 7. Circumferential Profile – Averages

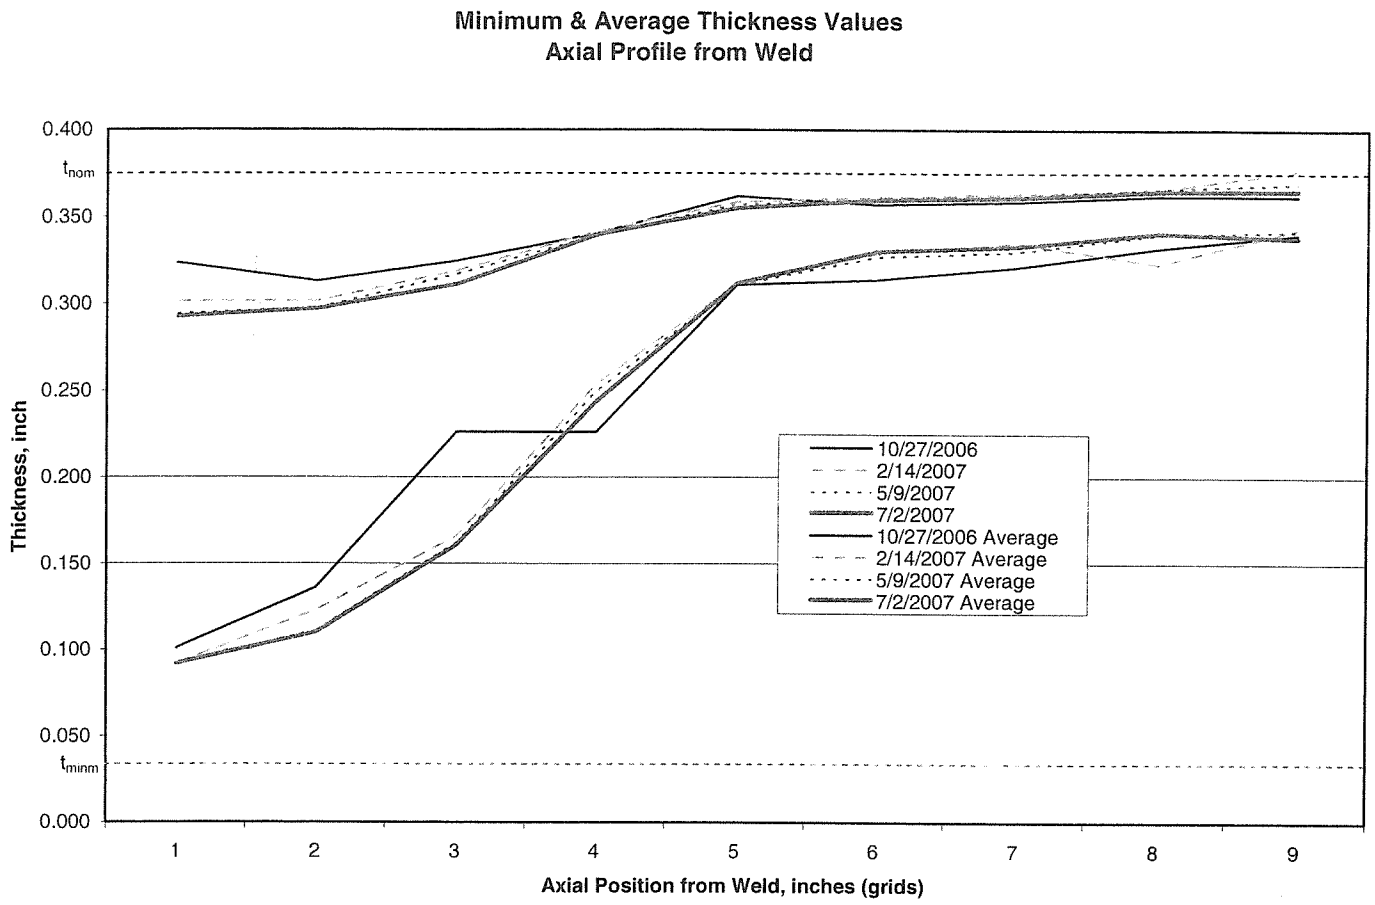
Figure 8. Axial Profiles

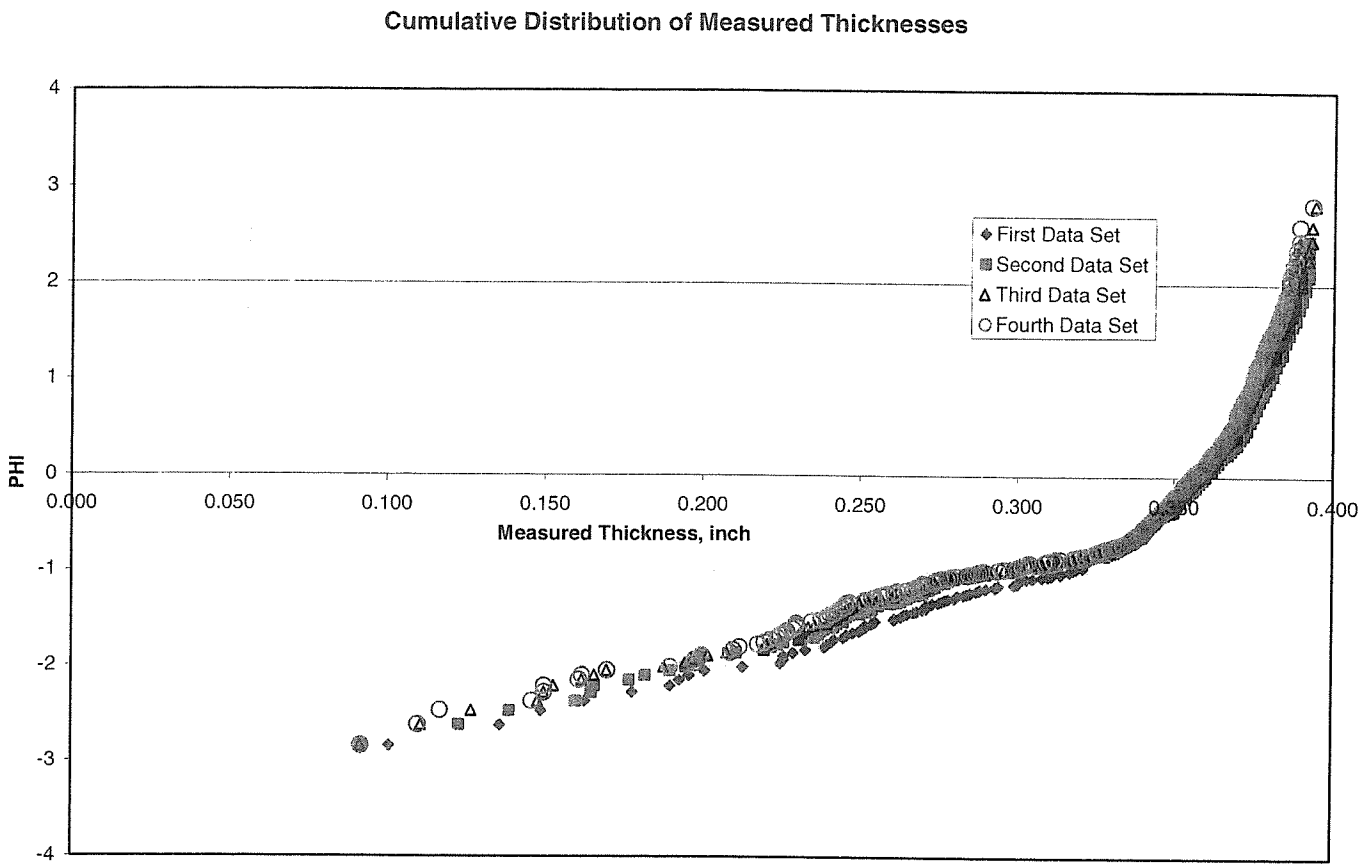
Figure 9. Cumulative Distribution of Measured Thickness

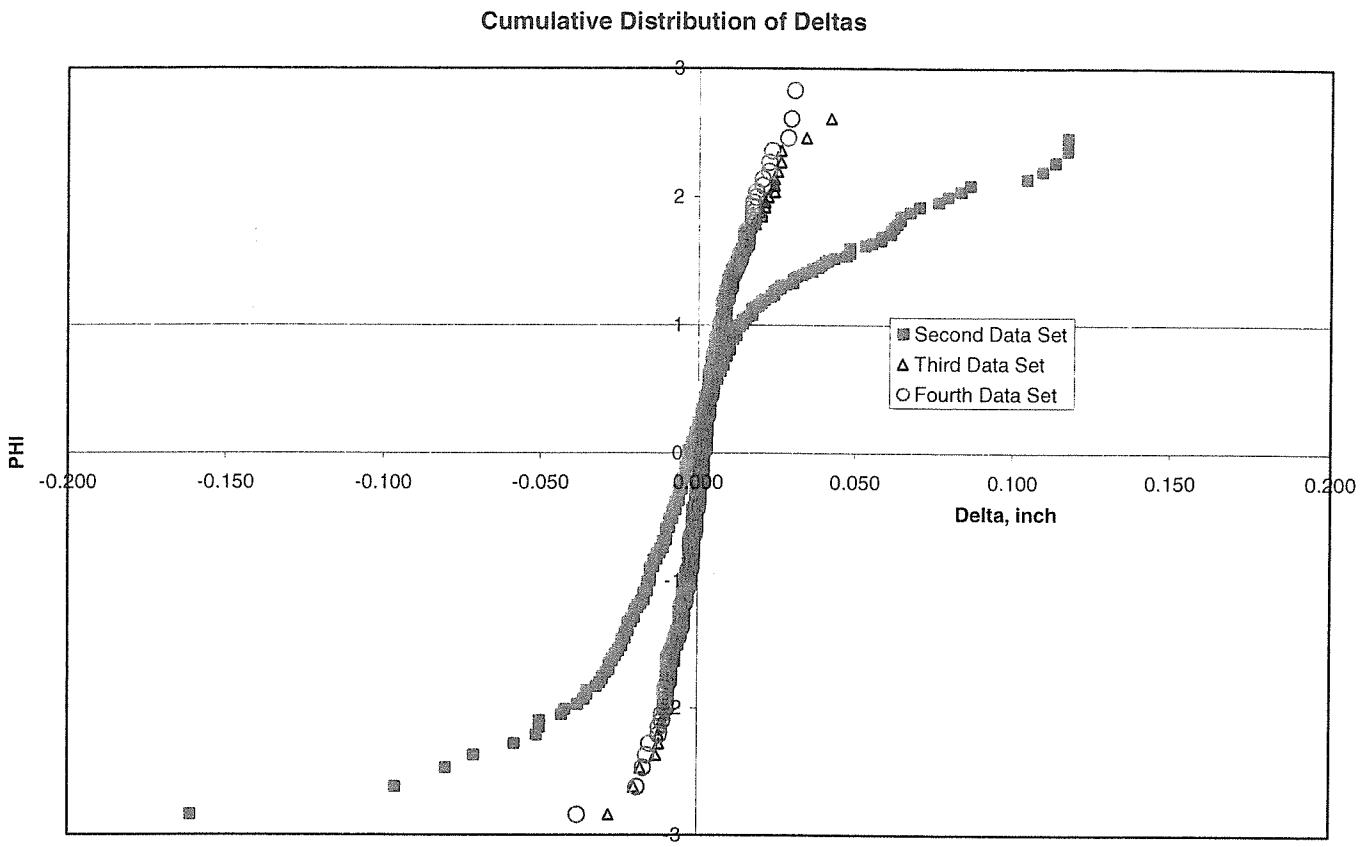
Figure 10 shows the same basic data in a different way. Figure 10 shows the same effect observed from Figures 6-8, but more quantitatively, using the apparent deltas as the measure. The advantage of evaluating delta is that effects show up directly and changes can be observed more readily. The primary disadvantage is that the error in measurements (each thickness measurement will have an error associated with it; typically ±0.010 inch for UT thickness measurements) will be magnified with the differences between subsequent individual measurements are compared. The means of all three data sets (i.e., the value at PHI = 0) are very close to zero, implying that the mean metal loss over the three measurements is very near zero. Figure 10 also shows that the vast majority of the metal loss occurred before the initial inspection in October 2006, with a much smaller amount of metal loss at any point between October 2006 and February 2007. Since February 2007, metal loss

Figure 10. Cumulative Distribution of Deltas (point-to-point thickness differences from one examination to the next)

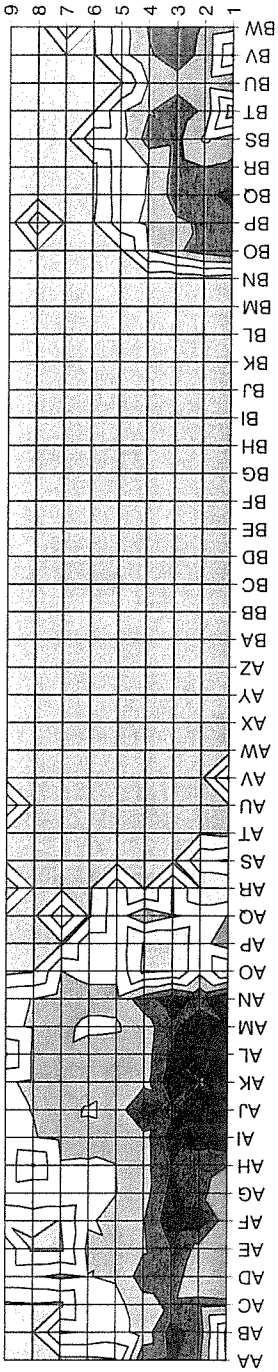
Extrapolating these results to September 2009 indicates the minimum thickness in any grid will be 0 (i.e., a leak is definitely predicted) and the minimum thickness of any circumferential band where thinning is occurring (actually half of a circumference) will be of the order of 0.150 inch. Using the extreme values that the statistical plots permit predicts that the cumulative distribution of thickness in September 2009 will look like the plot in Figure 11. If it is assumed that all thinning occurs in the one inch grid closest to the weld, the band averages for that one inch grid will decrease from 0.292 inch (July 2007) to 0.260 inch.

Figure 11. Predicted UT Thickness Map, September 2009
