What happened in 2006?

What Happened?

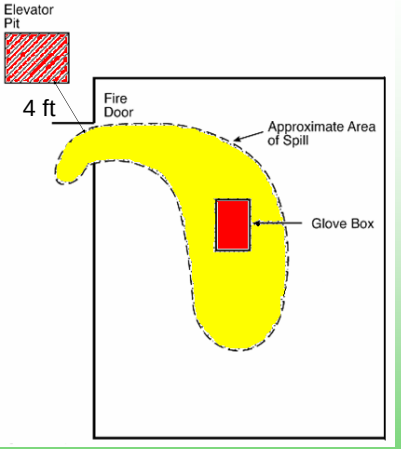
Layout of Spill

- On March 6, 2006, a spill involving 9 gallons (35 liters) of highly enriched uranium solution occurred.
- The solution spread out on the floor in a puddle both around the equipment and out an interior door.
- The solution was discovered by an NFS employee and management was contacted.
- NRC resident inspectors were called to the scene.
- NFS stopped all work in the immediate area and the solution was safely cleaned up.
- Within days, technical experts from the NRC Headquarters and Region II offices reviewed the event.
- The building was shut down for six months while the incident was reviewed and changes to the plant and procedures were made.

The uranium solution spilled from the glove box (pictured above) and dripped onto the floor.

The uranium solution created a puddle on the plant floor which extended beyond the process room into the plant hallway. A distance of six feet was between the solution puddle and the elevator pit.
