Chapter 5: Reactor Coolant System
Table of Contents

NORTH ANNA POWER STATION
UNITS 1 AND 2

STEAM GENERATOR LOWER SUPPORTS - REPAIR PROGRAM REQUIREMENTS

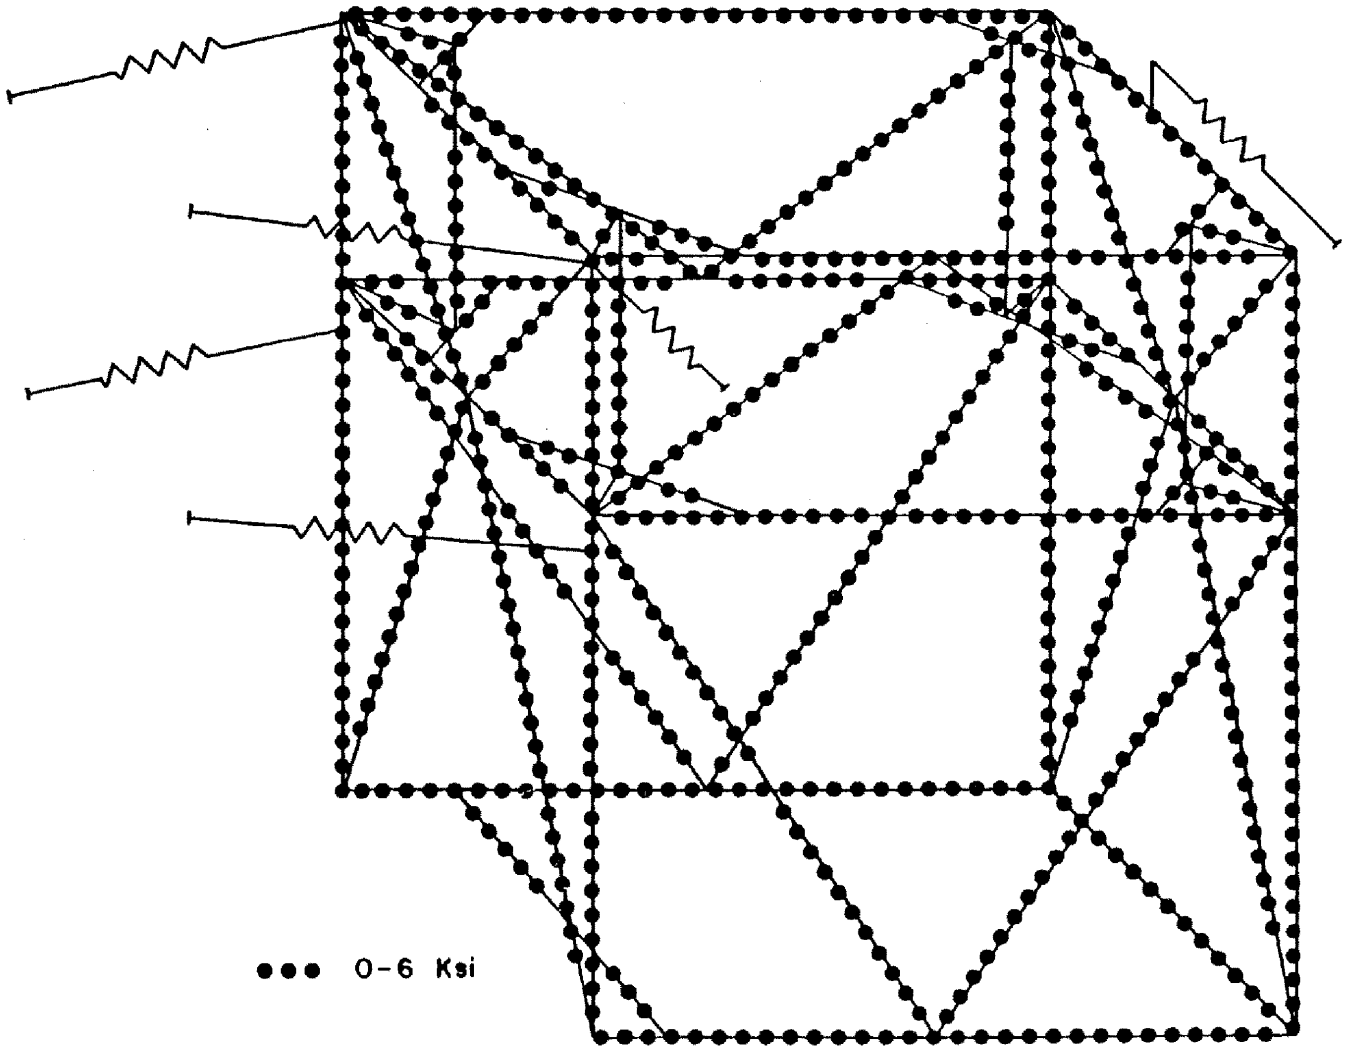
INTEGRAL FRAME
DEAD WEIGHT

load we have prepared the following slides which, in your handout, show the full overlay, but for purposes of presentation we will present them in a phased manner. For the integral frame the deadweight stresses (Fig. 8) show that all of the stresses in the frame for deadweight are less than 6 ksi. This is the condition for which the frame exists for 90, 99 percent of its life, less than 6 ksi.

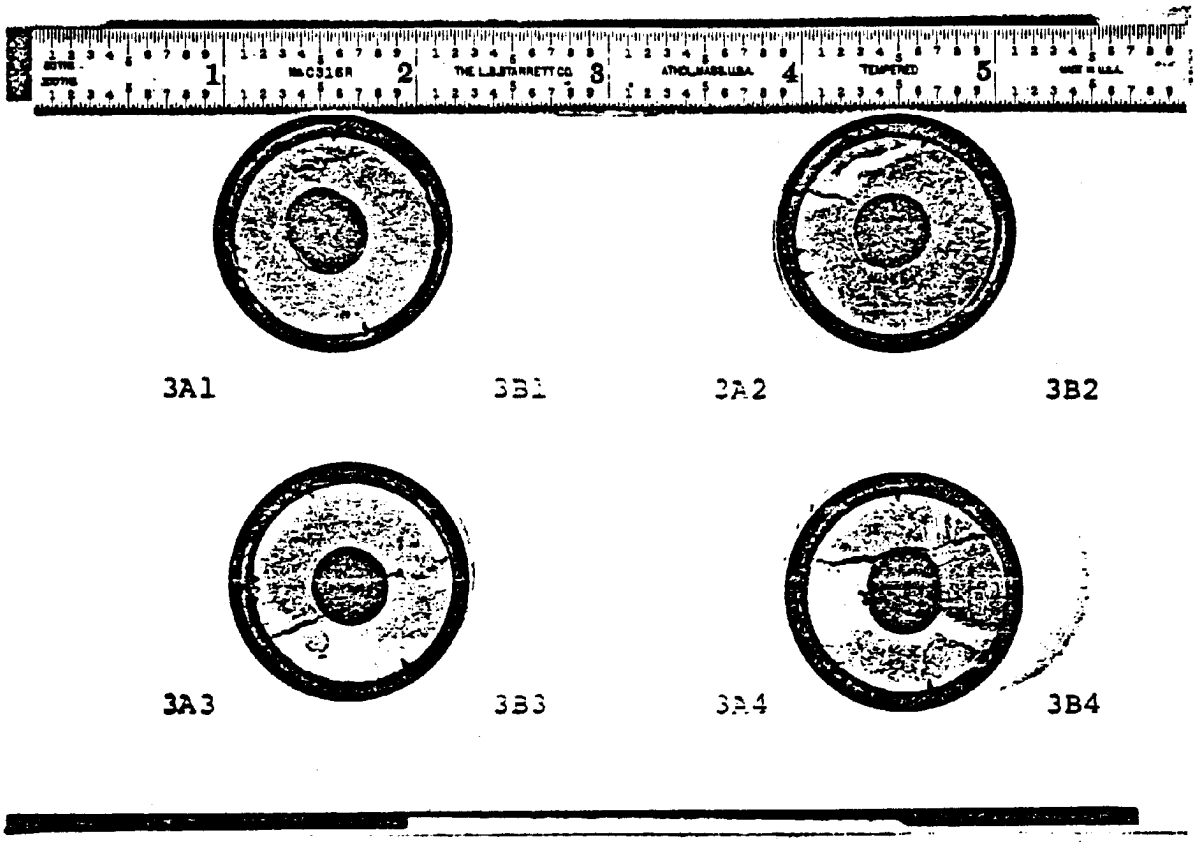
photo #1

1X photograph of samples 3AB-1, 3AB-2, 3AB-3 and 3AB-4, showing weld defect continuous with Lamellar tear (see page 4)

Core sample #3 (Metallographic samples 3AB-1, 3AB-2, 3AB-3 and 3AB-4)
From Unit #2, Cubicle B
From Weld #TZ5W - 207

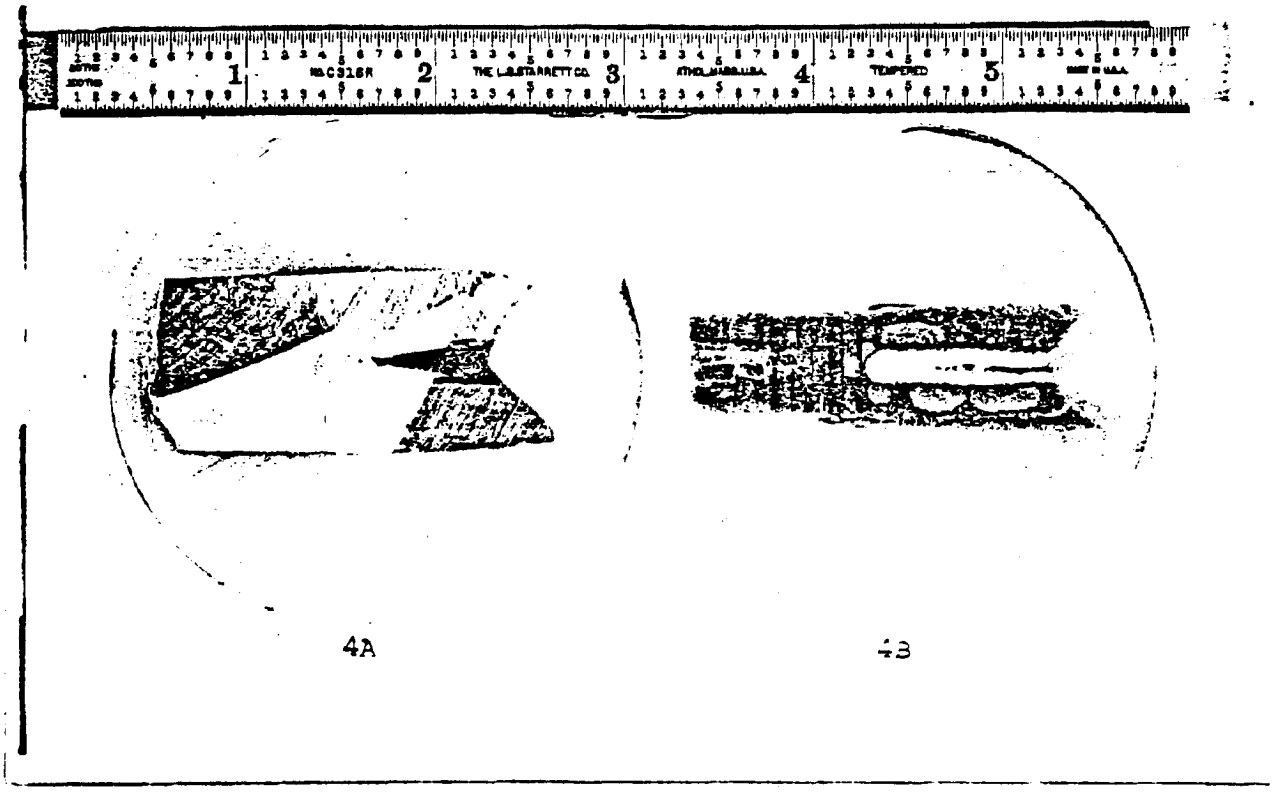
Photo #21

1X photograph of samples 4A and 4B. This sample has a weld metal defect

Core Sample #4 (Metallographic samples 4A and 4B)
From Unit #2, Cubicle B
From Weld #BZ2W-86

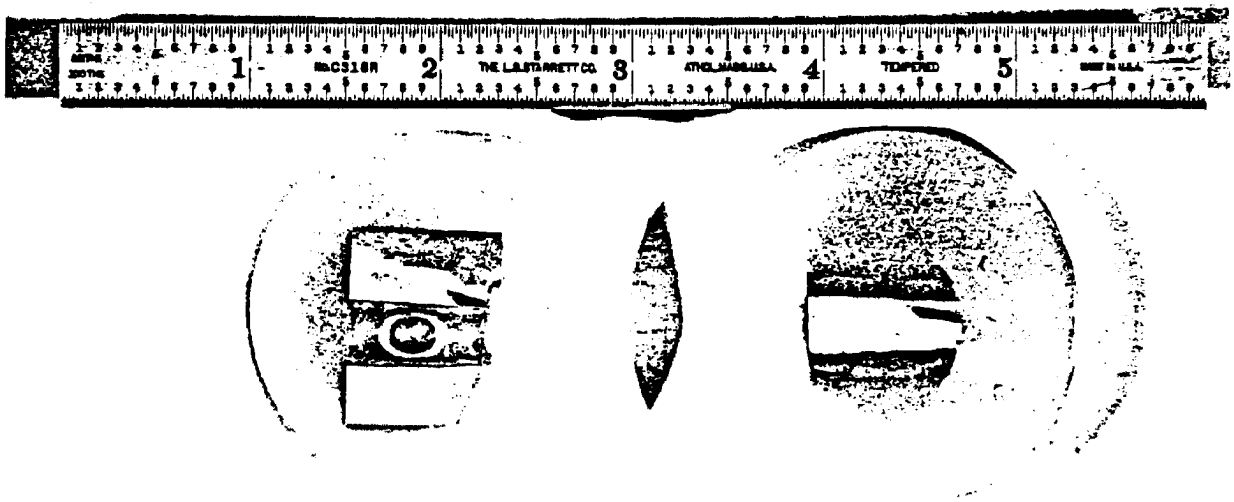
photo #39

1X photograph of samples 5A and 5B , showing weld defect and small sub critical size lamellar tear in 5A (see pages 9 and 10)

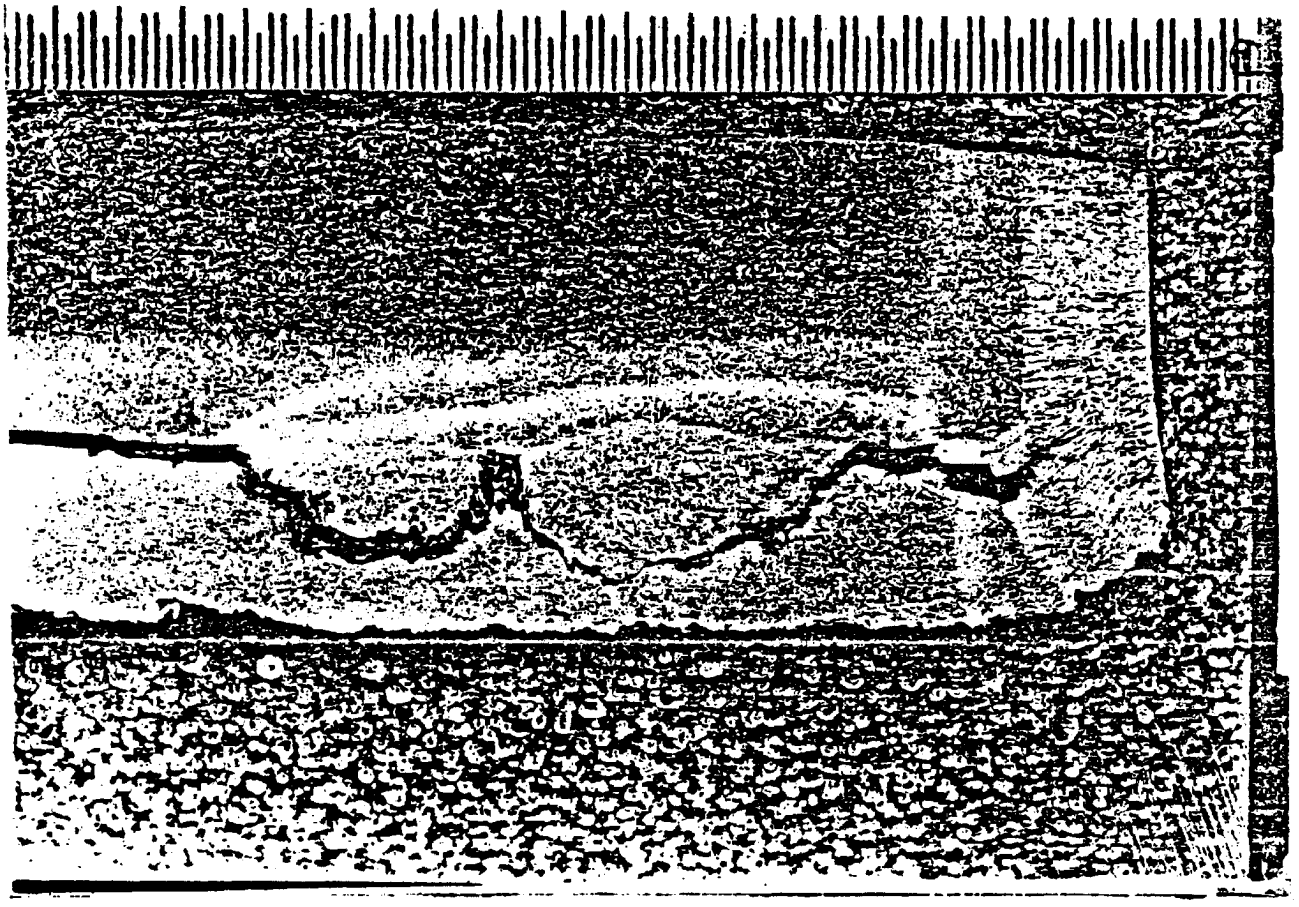
photo #29

6X photograph of sample 7A , showing weld metal tear or crack. Total length is 1.2 inches (see pages 13,14, and 15)

Core sample #7 (Metallographic samples 7A and 7B).

weld status: area of core sample and any associated defects repaired

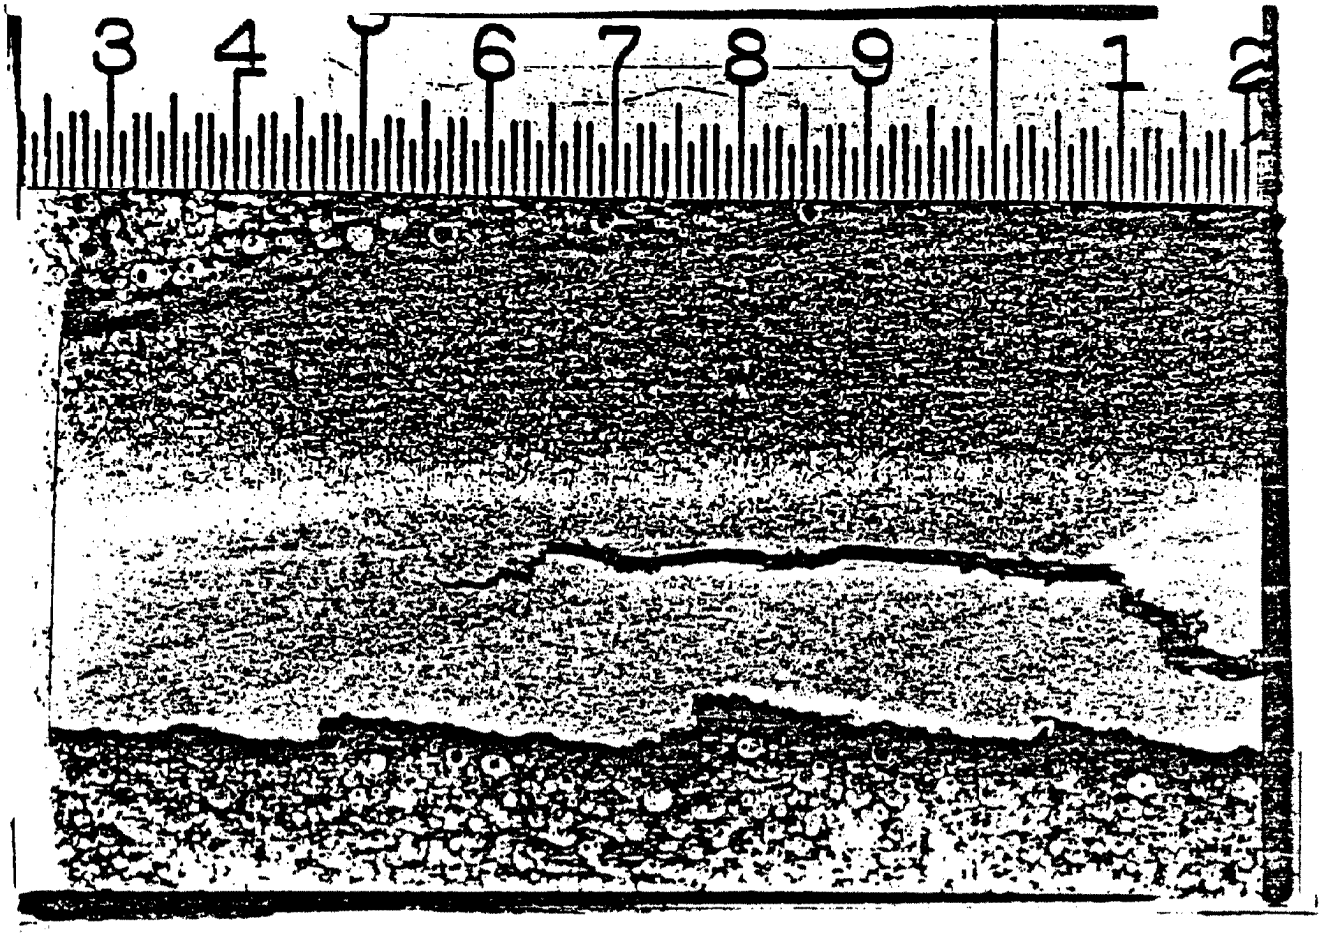
photo #78

6X photograph of sample 7A , continuation of defect on page 12

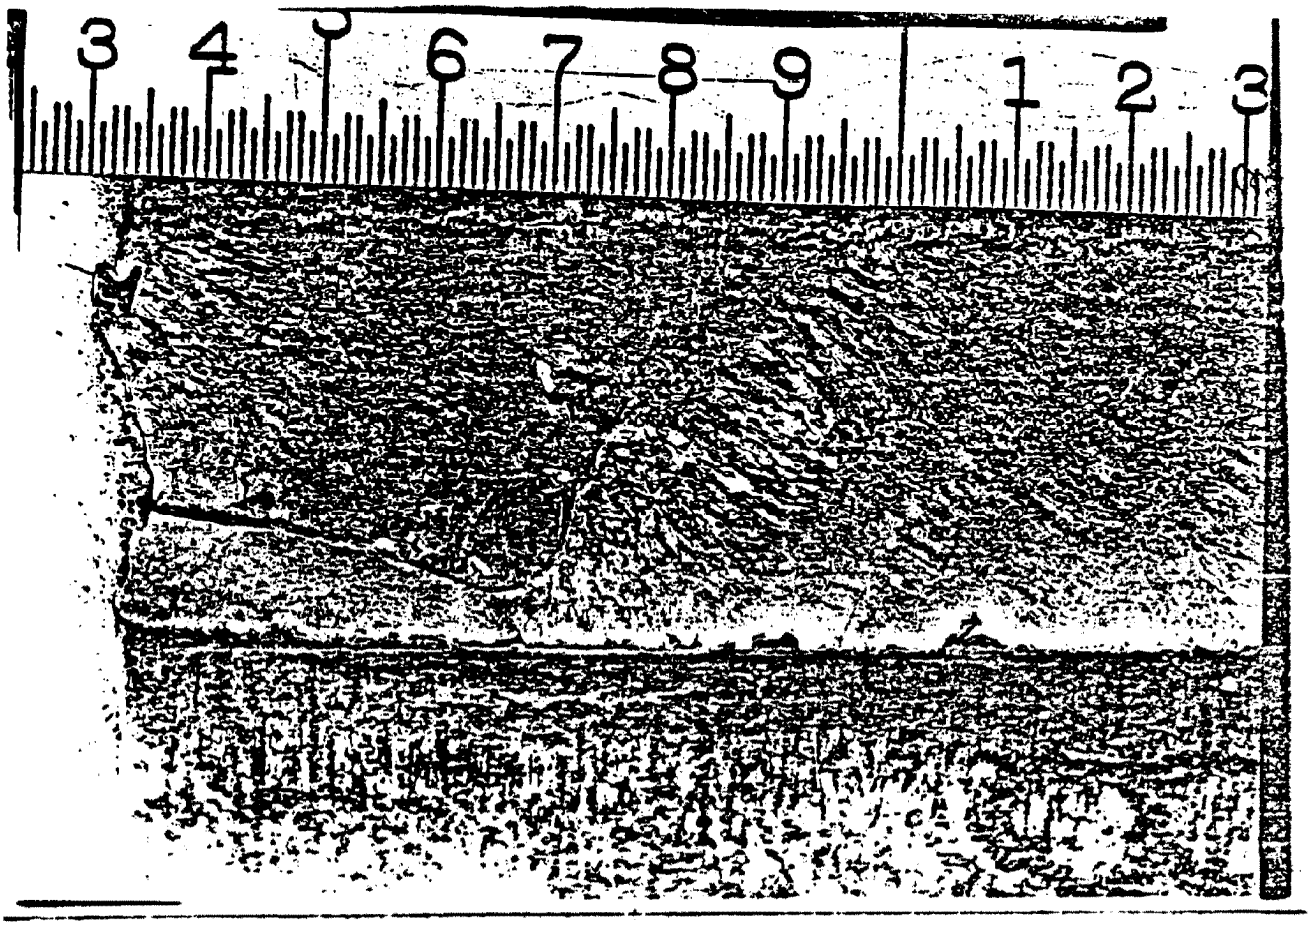
photo #94

6X photograph of sample 8A , showing flaw entirely in the weld metal. Primary defect type is slag entrapment.

Core Sample #8 (Metallographic samples 8A and 8C)

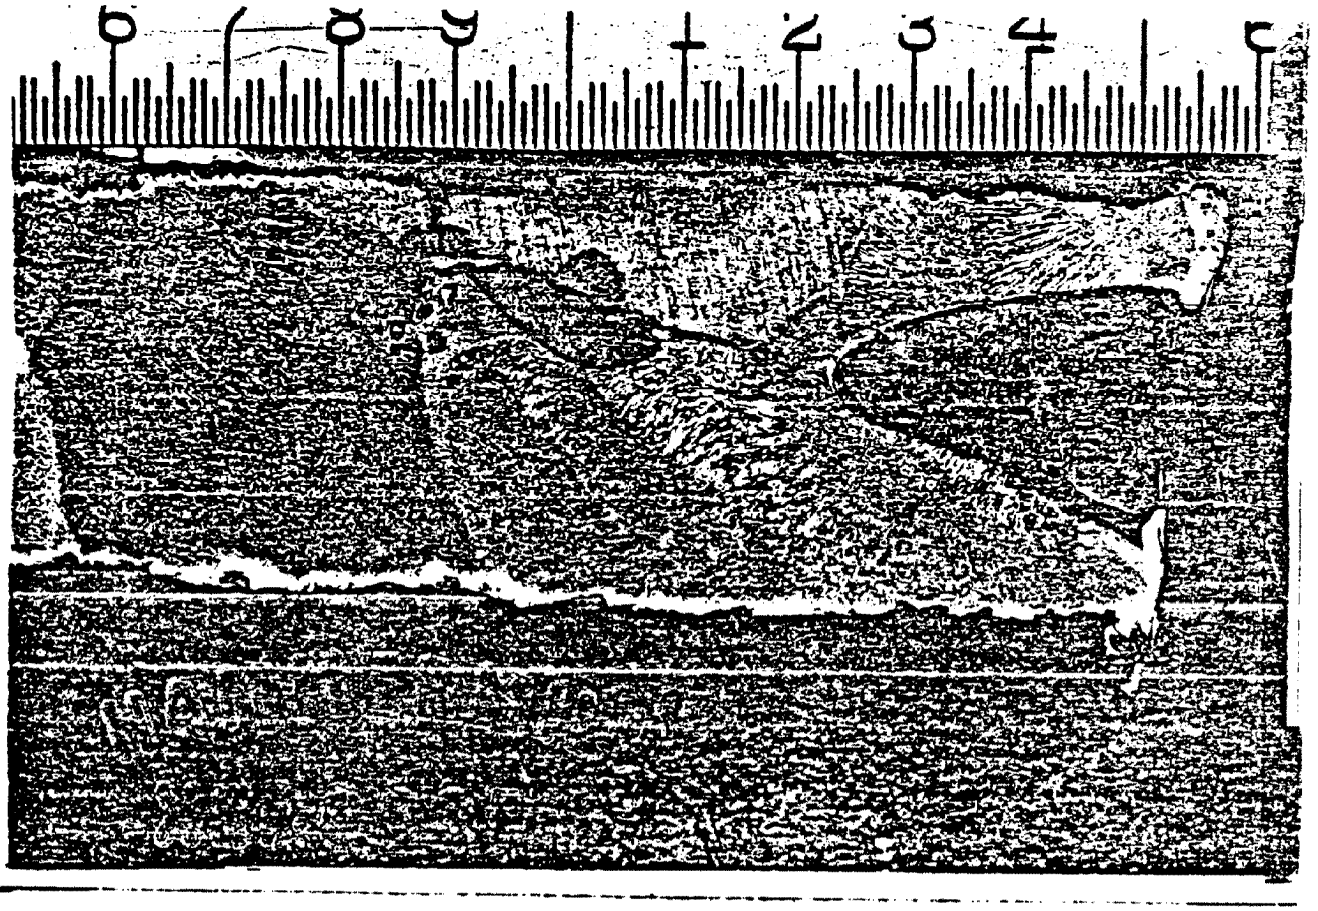
photo #96

6X photograph of area of sample 10, showing slag entrapment and porosity

Core Sample #10 (Metallographic sample 10)

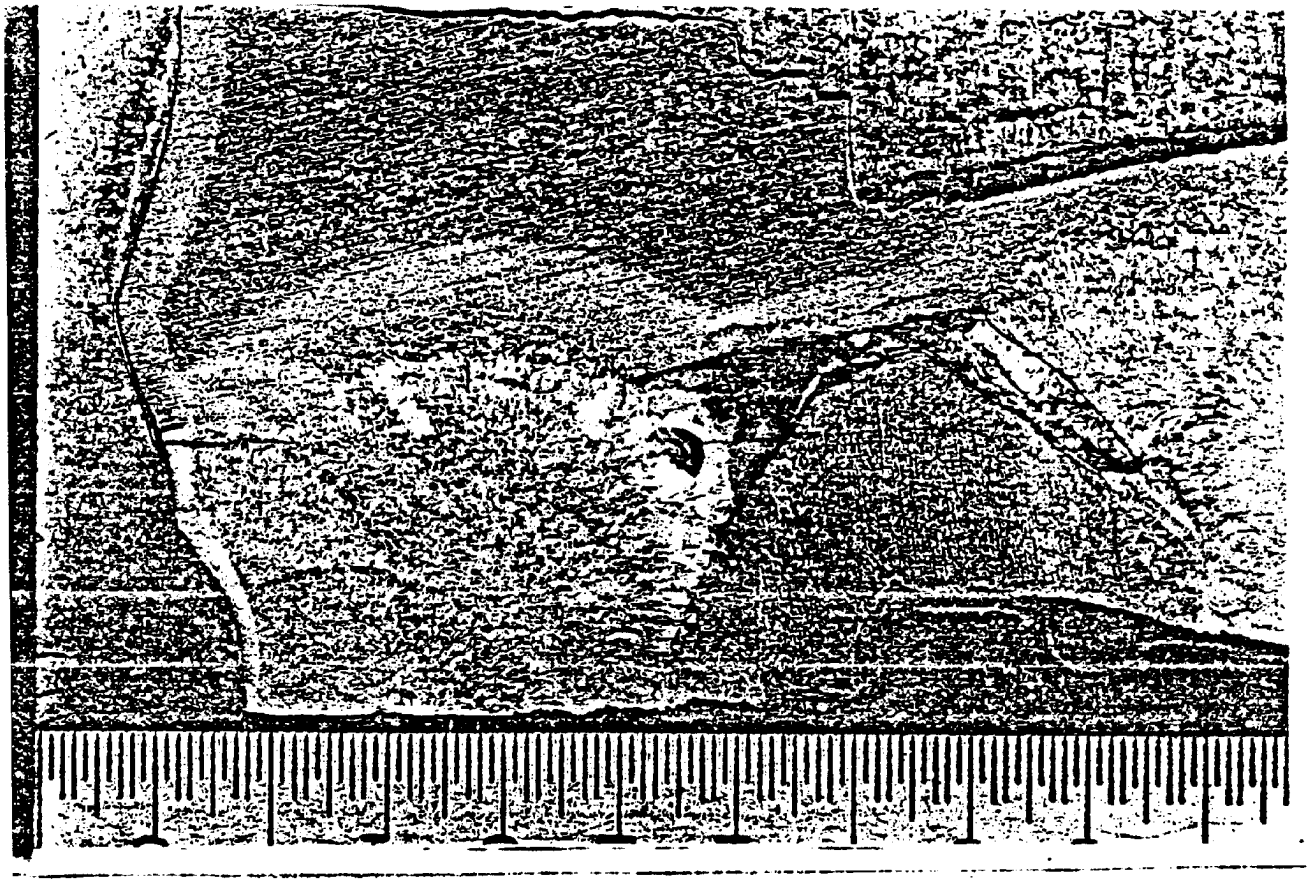
photo #131

6X photograph of area of sample 11A showing lack of penetration at weld root. Defective area is about 1/2" in width.

Core Sample #11 (Metallographic sample 11A)

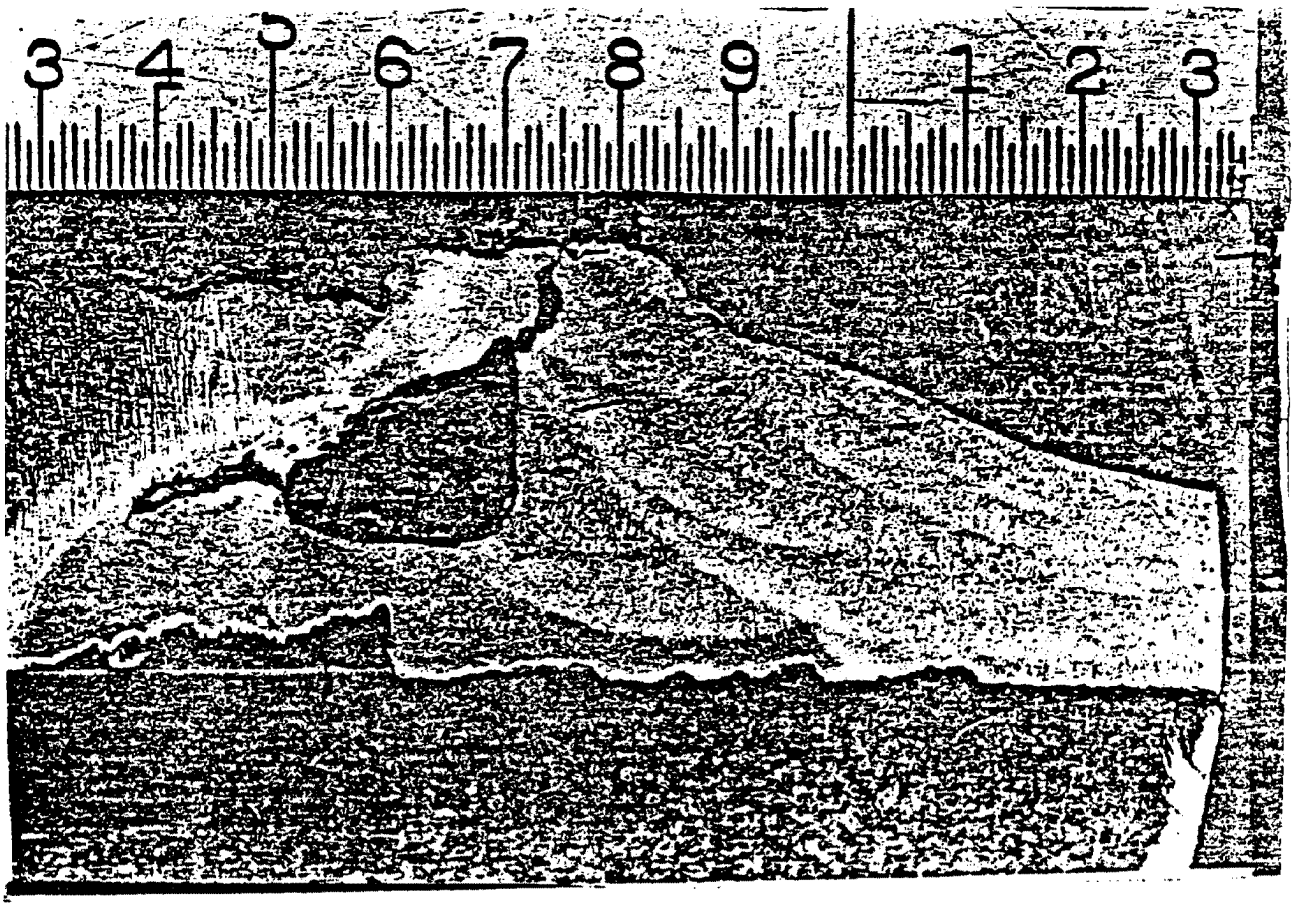
photo #117

6X photograph of area of sample 12A, showing a large slag entrapment associated with some tearing. Also a 1/16" isolated weld tear is visible.

Core Sample #12

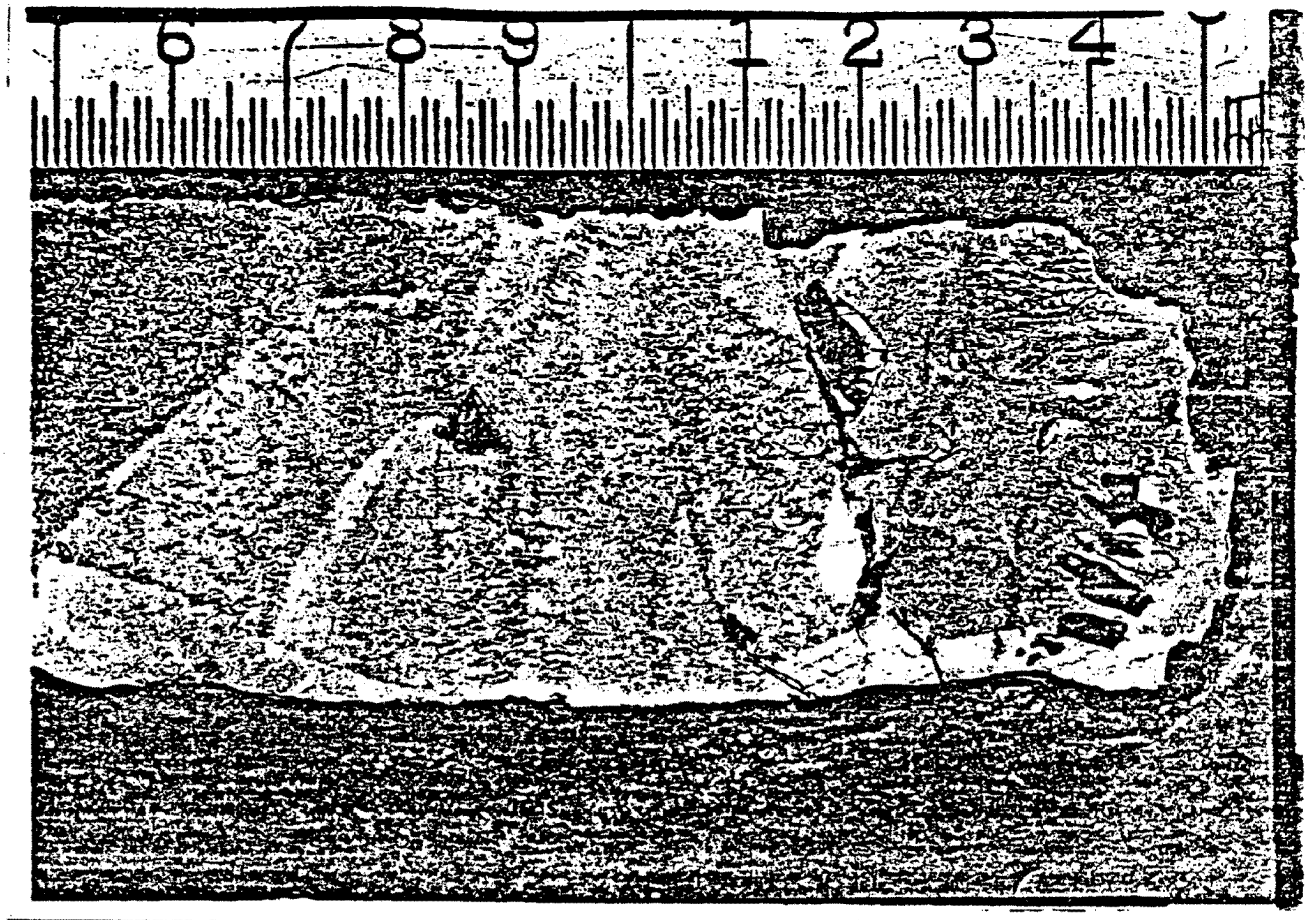
photo #128

6X photograph of sample 13, showing slag entrapment and lack of fusion in weld metal.

Core Sample #13 (Metallographic sample 13)

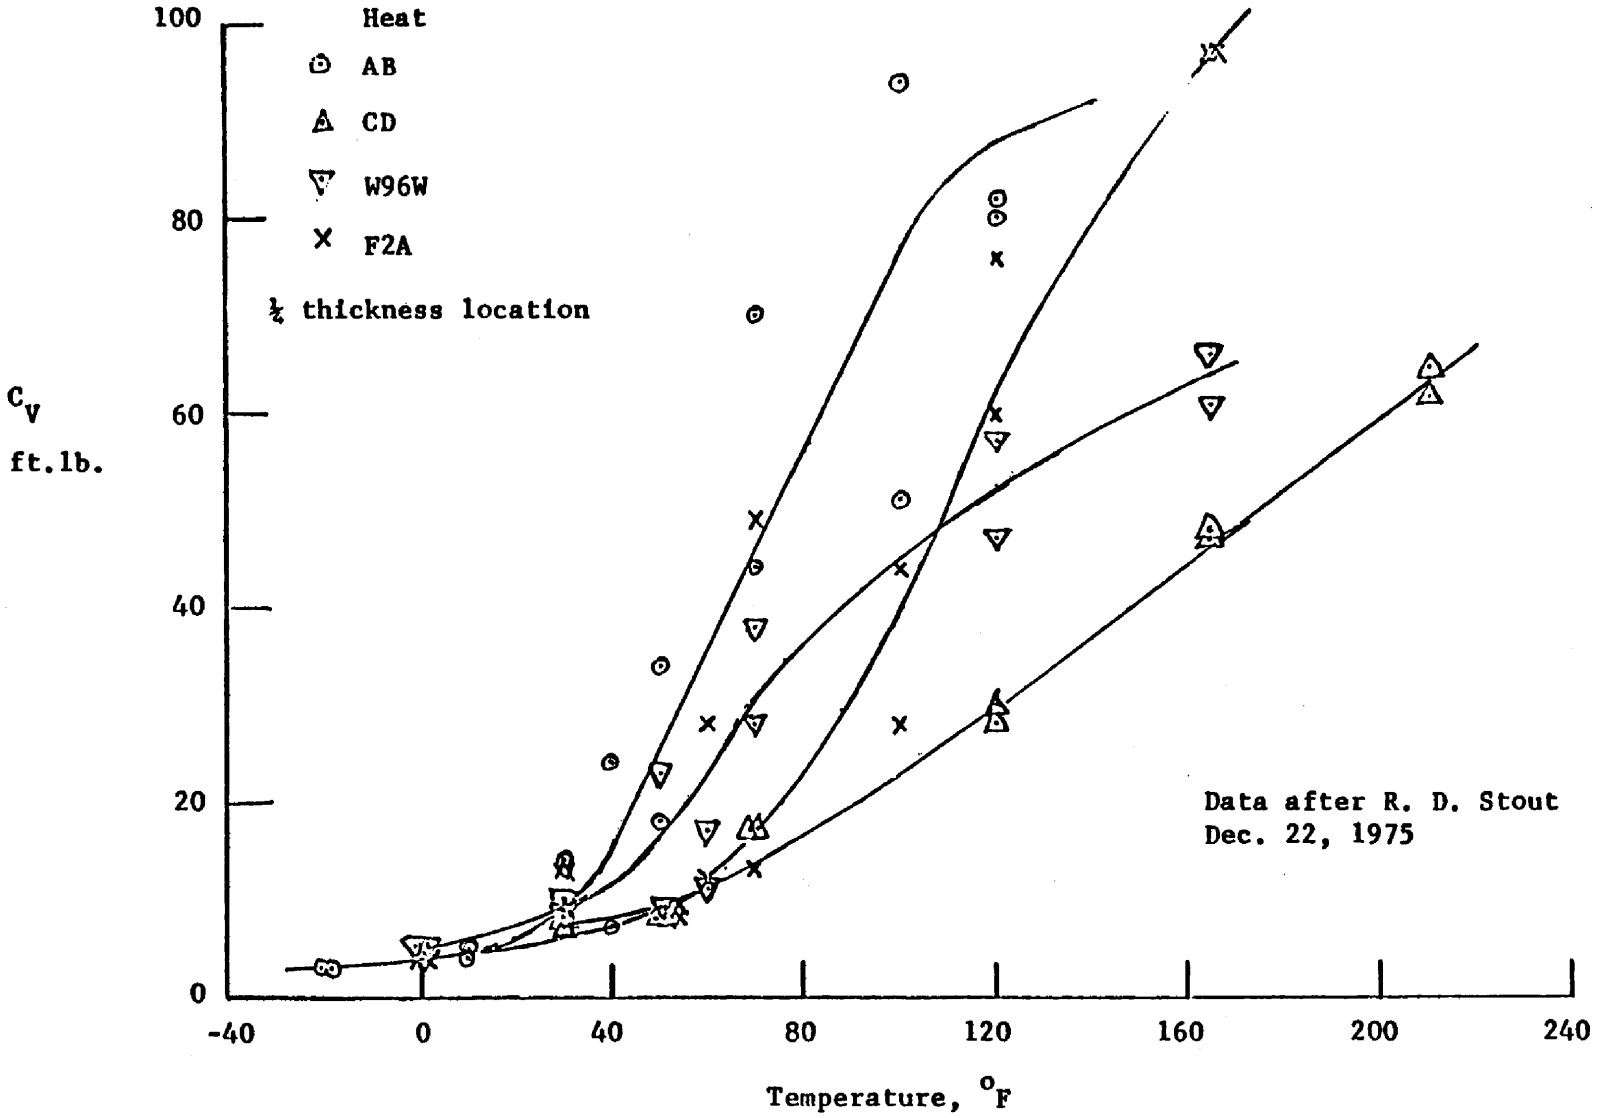
Fig. 1. A-36 Steel from Generator Support Cubicles - North Anna Station

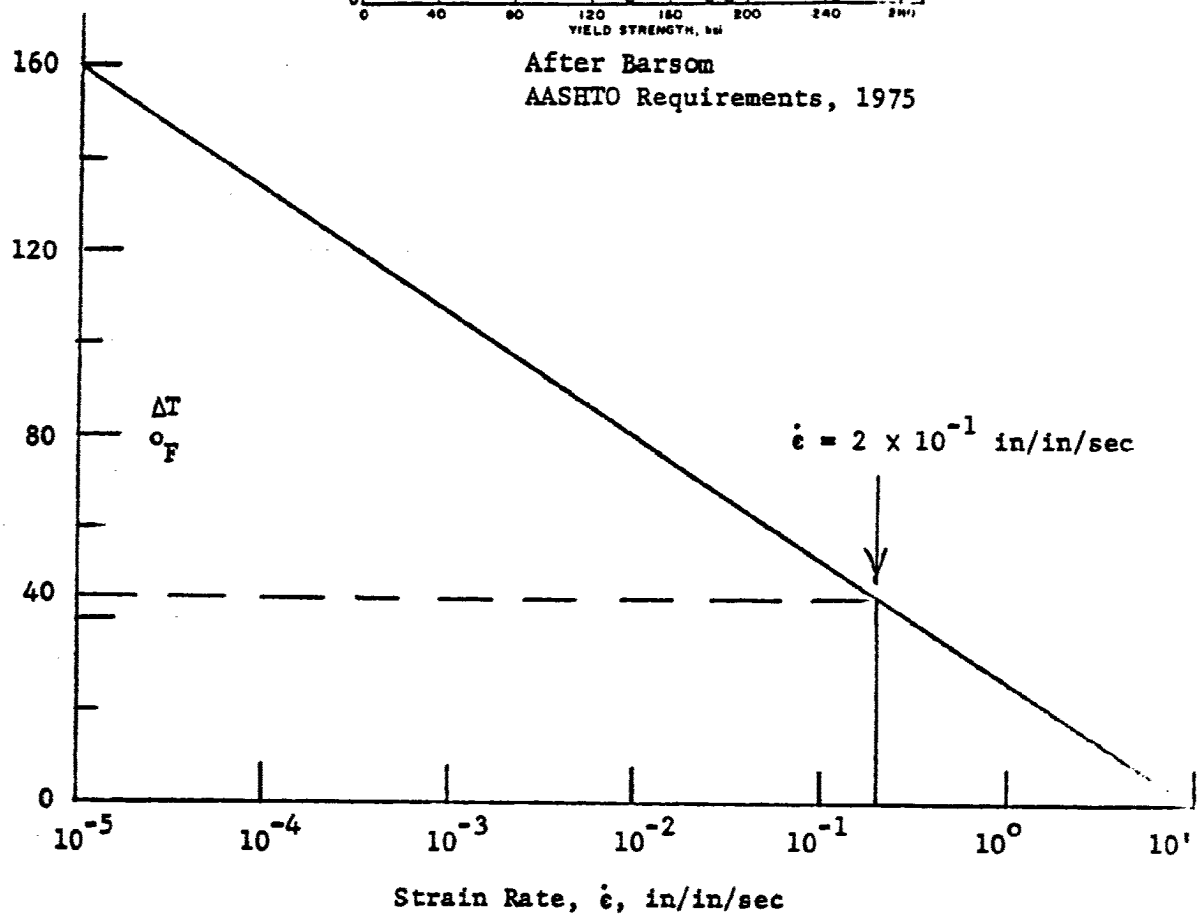
For $\dot{\epsilon} = 2 \times 10^{-1}$ in/in/sec, a $+45^{\circ}F$ temperature shift is estimated. See Fig. 2a and 2b.

Fig. 2a Temperature Shift for Strain Rates Between Slow (10^{-5}) and Dynamic (10')

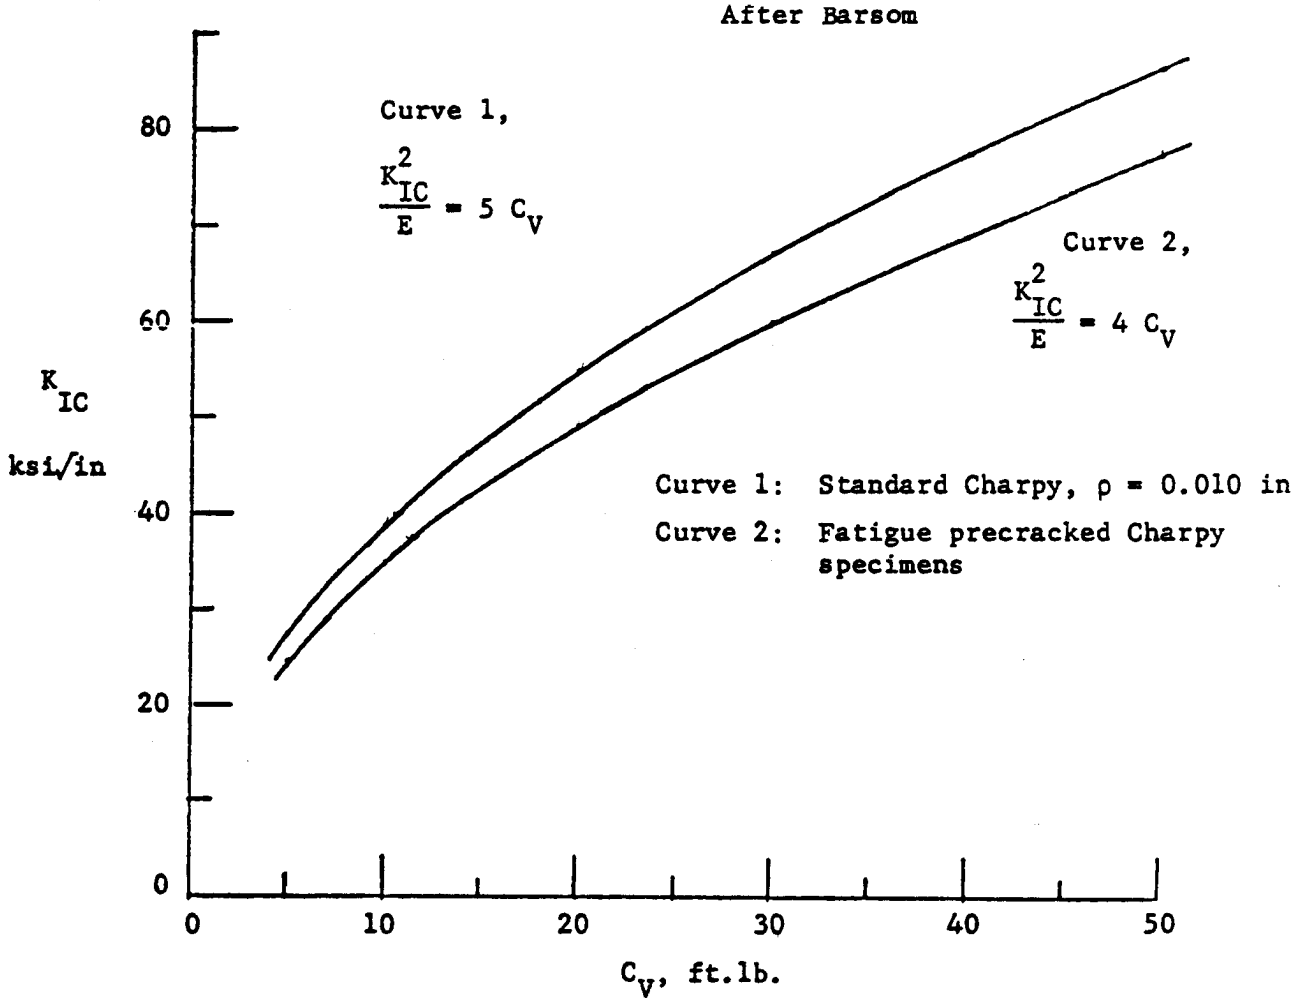
4. Charpy Energy values are used to estimate fracture toughness K_{IC}, using Barsom's recommended AASHTO formula: (see Fig. 3)

Fig. 3 Relation Between Energy in a Charpy Type Test and K_{IC}. Same time to fracture in both tests.
