SUBJECT: CONFIRMATORY SURVEY REPORT FOR PORTIONS OF THE AUXILIARY BUILDING STRUCTURAL SURFACES AND TURBINE BUILDING EMBEDDED PIPING, RANCHO SECO NUCLEAR GENERATING STATION, HERALD, CALIFORNIA DCN 1695-SR-01-0 (DOCKET NO. 50-312, RFTA NO. 06-003)

CONFIRMATORY SURVEY REPORT FOR PORTIONS OF THE AUXILIARY BUILDING STRUCTURAL SURFACES AND TURBINE BUILDING EMBEDDED PIPING

RANCHO SECO NUCLEAR GENERATING STATION, HERALD, CALIFORNIA

DECEMBER 2007

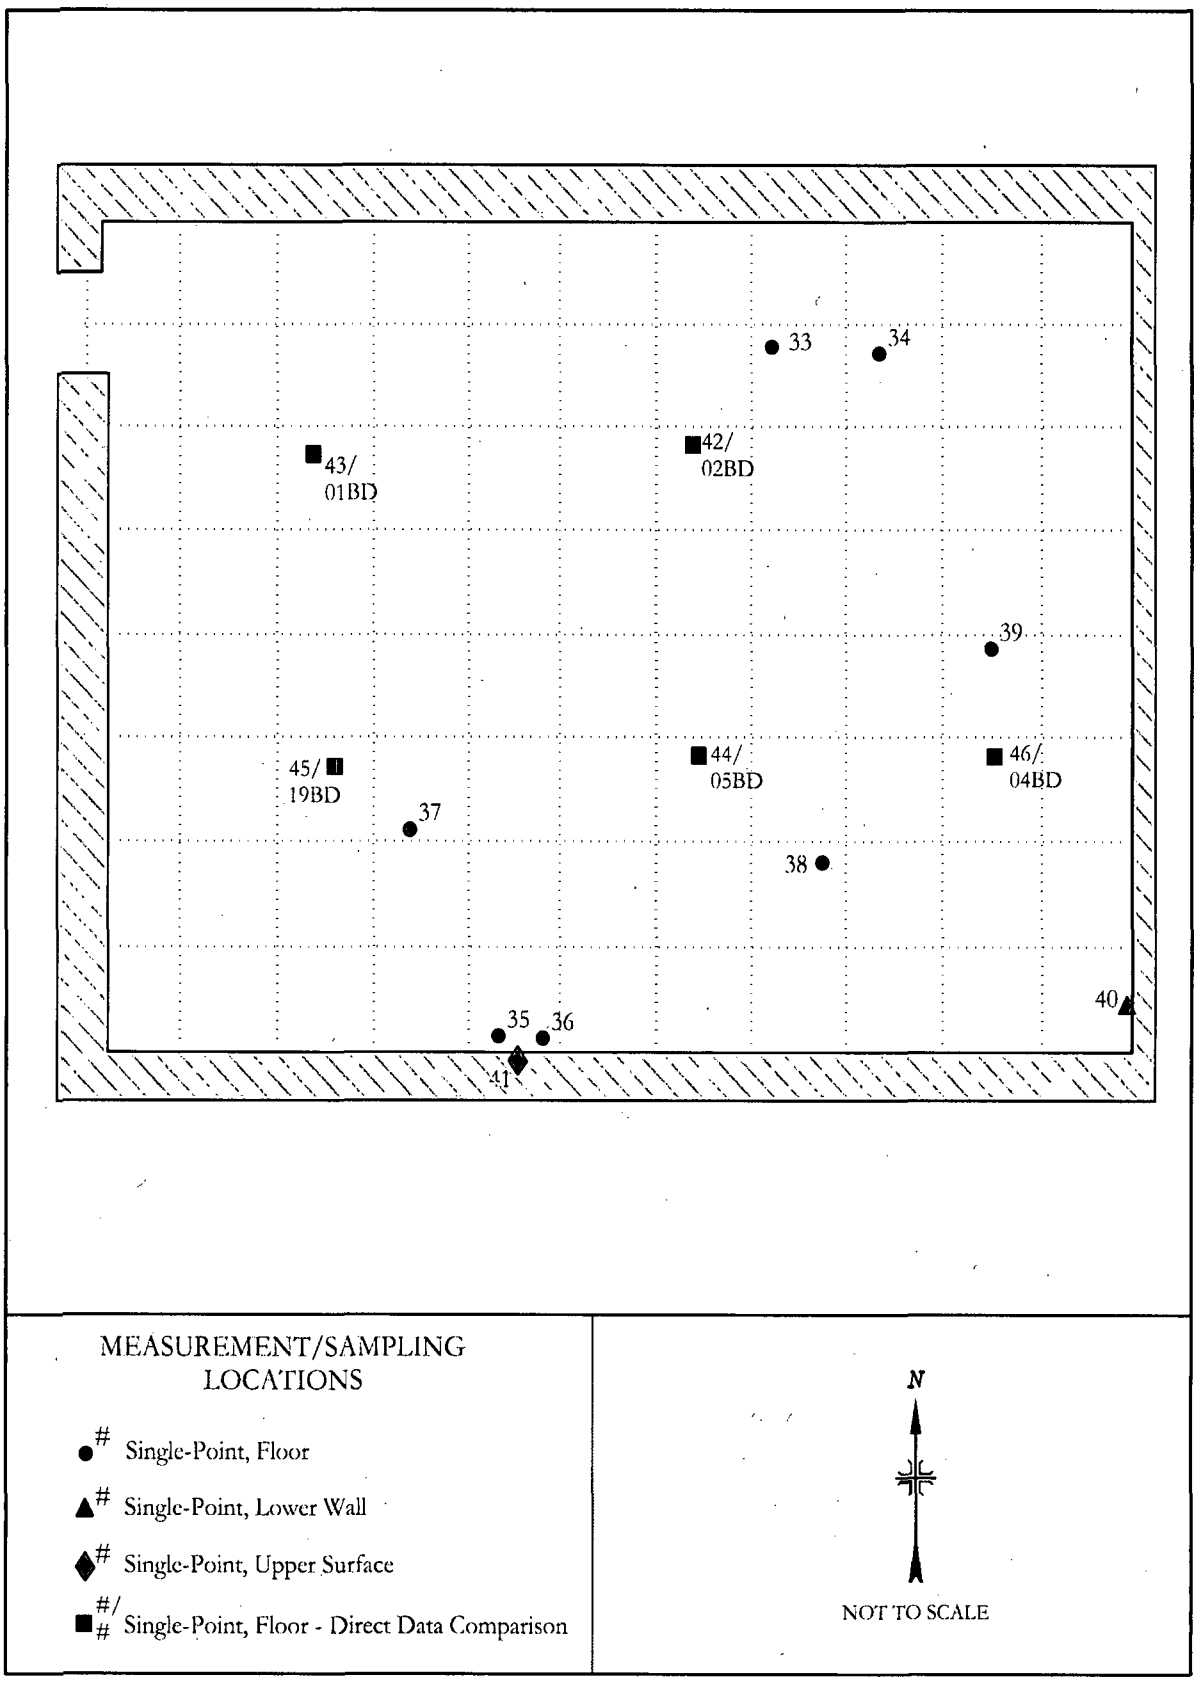
FIGURE 5: Auxiliary Building, Room 25 - Direct Measurement Locations

ORISE performed direct beta measurements at five SMUD direct measurement locations in Room 25 for direct measurement data comparison (Figure 5).

ORISE surface activity levels for the comparison data set ranged from 2,000 to 5,000 dpm/100 cm^2; and the SMUD surface activity levels ranged from 2,500 to 4,300 dpm/100 cm^2. The data indicate that ORISE and SMUD surface activity levels collected from approximately the same locations are within 25% of the respective FSS and confirmatory survey values. The surface activity data comparison results are presented in Table 3.

ORISE performed survey data comparisons on five RSNGS direct measurement locations within Auxiliary Building Room 25; the results indicated that SMUD's radiological survey data were consistent and in agreement with ORISE's direct measurement results.

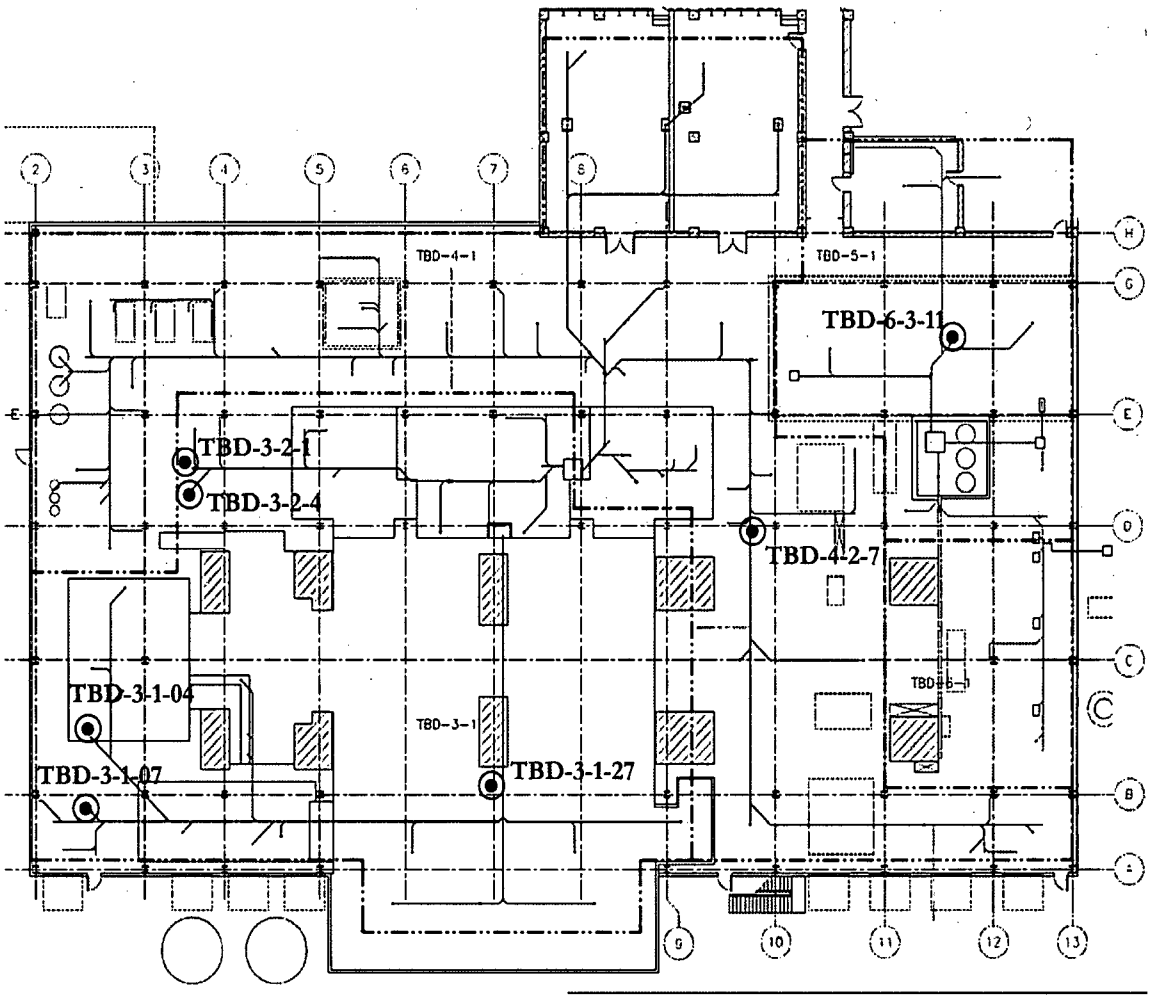
FIGURE 13: Turbine Building; Ground Level Elevation - Embedded Piping Measurement Locations

Direct measurements for beta-gamma activity were performed at 14 locations at approximately 1 meter (3.3 feet) intervals within TBD 3-1-27. The ORISE-designed pipe monitor array was equipped with three GM detectors spaced at 120° intervals and coupled individually to portable ratemeter-scalers. Measurement data were collected for each individual detector as well as totaled for the array. The location of TBD 3-1-27 is indicated on Figure 13.

Beta-gamma scans of TBD 3-1-27 did not detect beta-gamma radiation levels in excess of the embedded piping derived concentration guideline levels (DCGLs).

Gross surface activity levels for TBD 3-1-27 are summarized in Table 4. The gross surface activity levels for each measurement location over the assessed area (168 cm^2) for the pipe monitor array ranged from 4,500 to 6,700 dpm/100 cm^2. ORISE did not subtract background activity from the gross surface activity due in part to the total activity levels within the pipe being well below the guideline levels.

Confirmatory survey data for the TBD 3-1-27 were compared with the site-specific DCGL for embedded piping. The results indicated that gross surface activity levels (i.e., assuming all detected activity attributed to ROCs) within the pipe were well below the DCGL. Gamma scans of the other evaluated Turbine Building drains did not detect gamma radiation levels in excess of the detector background.

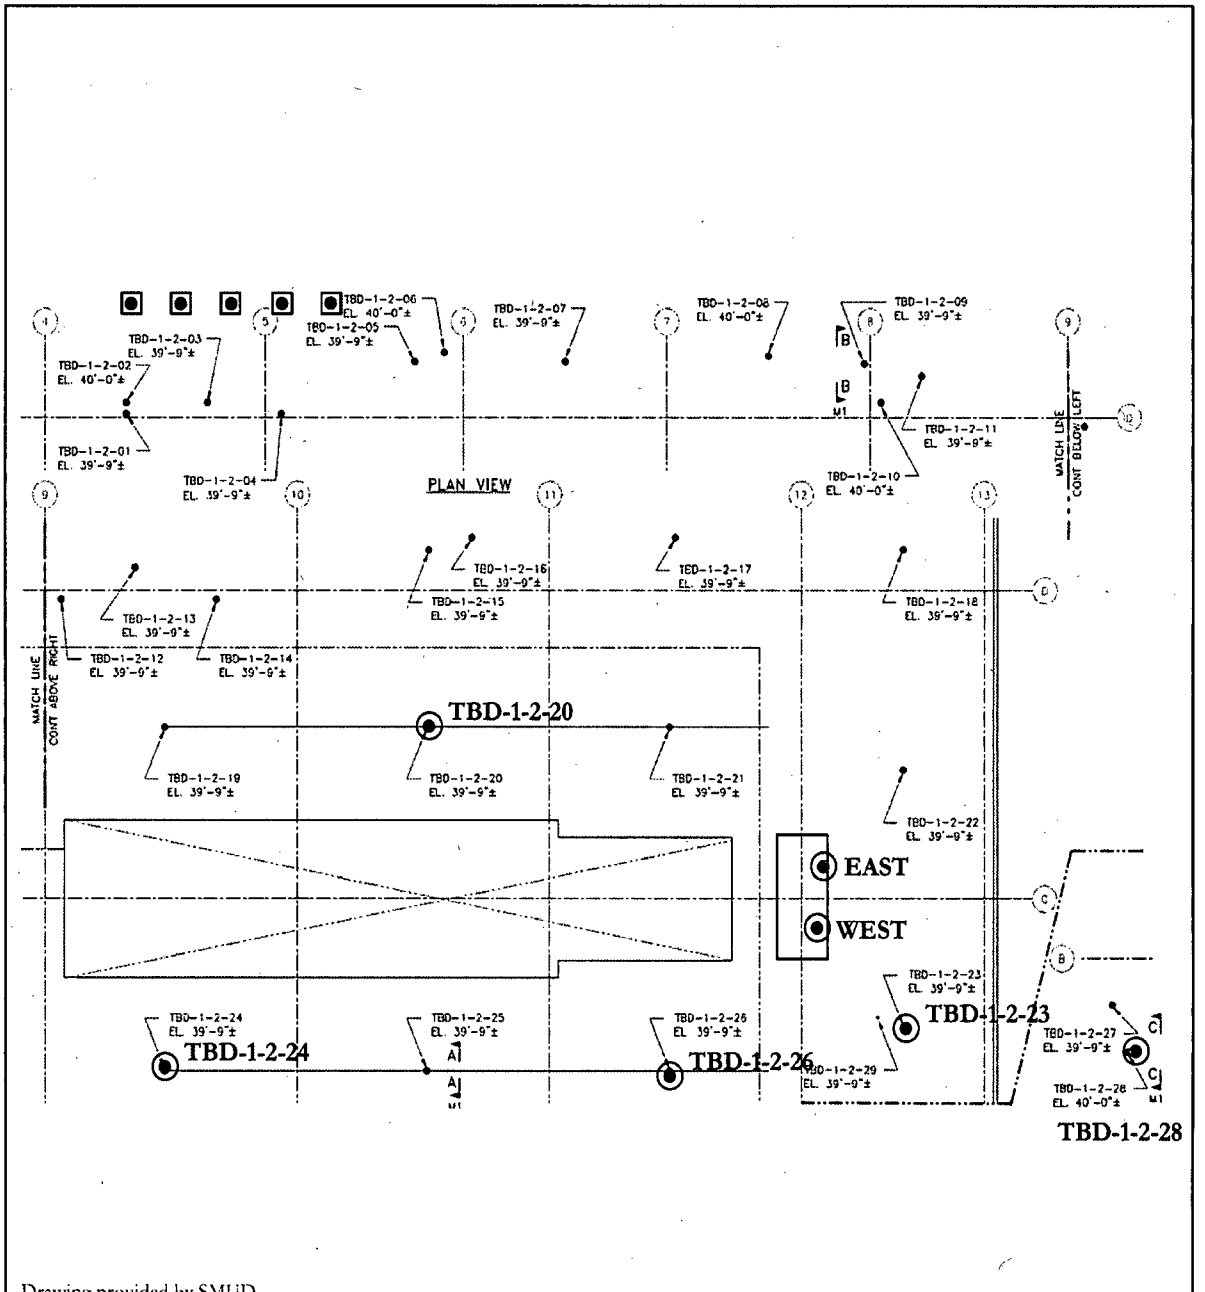
FIGURE 14: Turbine Building; 40 Foot Elevation - Embedded Piping Measurement Locations

Gamma scans of the drop down 4" embedded pipes on the ground level and +40 level elevations did not detect gamma radiation levels in excess of the detector background as determined in the Turbine Building +40 level elevation east side conduits and Exciter conduits.

Gamma scans of the drop down 4" embedded pipes did not detect significant gamma radiation levels in excess of the detector background as determined in Turbine Building conduits. For comparison, the CsI(Tl) detector background range for the conduits along the east side of the +40 level elevation was 200 to 800 cpm and the gamma radiation levels observed within the Turbine Building drains ranged from 200 to 1,600 cpm. The confirmatory gamma scan ranges are provided in Table 5.
