Survey Unit Release Record				
Design #	EP-FH-111	**Revision #**	Original	**Page 1 of 3**
Survey Unit #(s)	FH-111			
Description	1) Embedded Pipe (EP) Survey Unit FH-111 meets the definition of embedded pipe for Plum Brook Reactor Facility (PBRF). 2) EP FH-111 is a Class 1, Group 3.1 survey unit as per the PBRF Final Status Survey Plan (FSSP) and Technical Basis Document (TBD)-06-004. 3) Surveys in EP FH-111 were performed using a scintillation detector optimized to measure gamma energies representative of Cs-137. Sample #EP 3-5 from Survey Request (SR)-13 was referenced for this decision. 4) Survey Instructions for this survey unit are incorporated into and performed in accordance with (IAW) the Babcock Services Incorporated (BSI)/LVS-002, Work Execution Package (WEP) 05-006. Survey instructions described in this document constitute "Special Methods" and the survey design used in the acquisition of survey measurements. 5) Instrument efficiency determinations are developed in accordance with the BSI/LVS-002, WEP 05-006, these determinations are appropriate for the types of radiation involved and the media being surveyed.

BSI EP/BP SURVEY REPORT

Pipe Interior Radiological Survey F

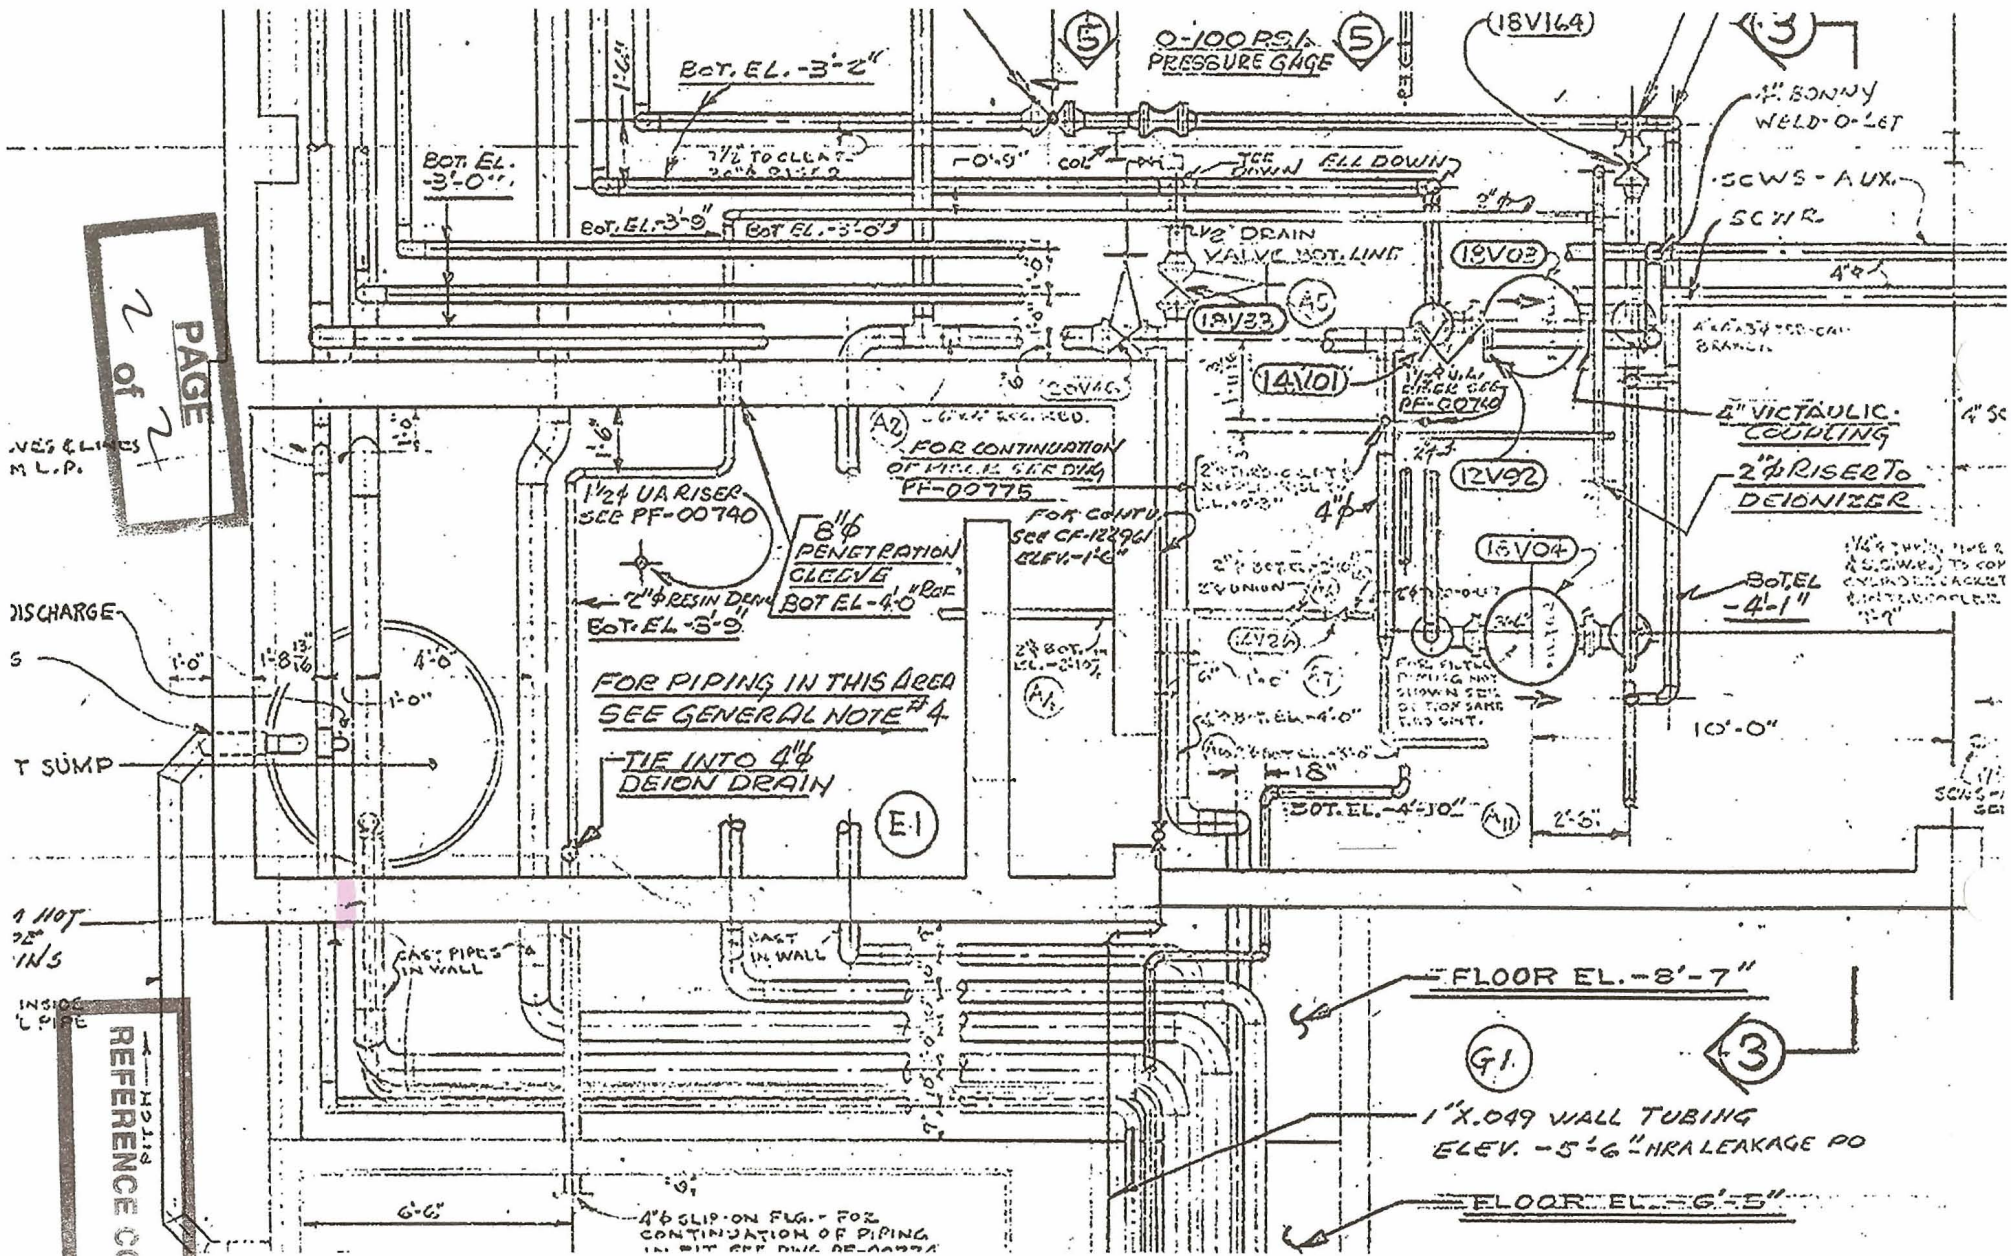
Pipe ID#: FH-111 ~~63~~ Pipe Diameter: 2.0" Access Point Area: Rm 7

Building: FAN House Elevation: -11' System: _____

Comments: ENTIRE, EP3-3 COMPLETE
