Survey Unit Release Record				
Design #	EP-1.51A-3	**Revision #**	Original	**Page 1 of 3**
Survey Unit #(s)	1.51A-3			
Description	1) Embedded Pipe (EP) Survey Unit 1.51A-3 meets the definition of embedded pipe for Plum Brook Reactor Facility (PBRF). 2) EP 1.51A-3 is a Class 1, Group 1 survey unit as per the PBRF Final Status Survey Plan (FSSP) and Technical Basis Document (TBD)-06-004. 3) Surveys in EP 1.51A-3 were performed using a scintillation detector optimized to measure gamma energies representative of Co-60. Sample #EP 3-9 from Survey Request (SR)-13 was referenced for this decision. 4) Survey Instructions for this survey unit are incorporated into and performed in accordance with (IAW) the Babcock Services Incorporated (BSI)/LVS-002, Work Execution Package (WEP) 05-006. Survey instructions described in this document constitute "Special Methods" and the survey design used in the acquisition of survey measurements. 5) Instrument efficiency determinations are developed in accordance with the BSI/LVS-002, WEP 05-006, these determinations are appropriate for the types of radiation involved and the media being surveyed.

BSI EP/BP SURVEY REPORT

Pipe Interior Radiological Survey

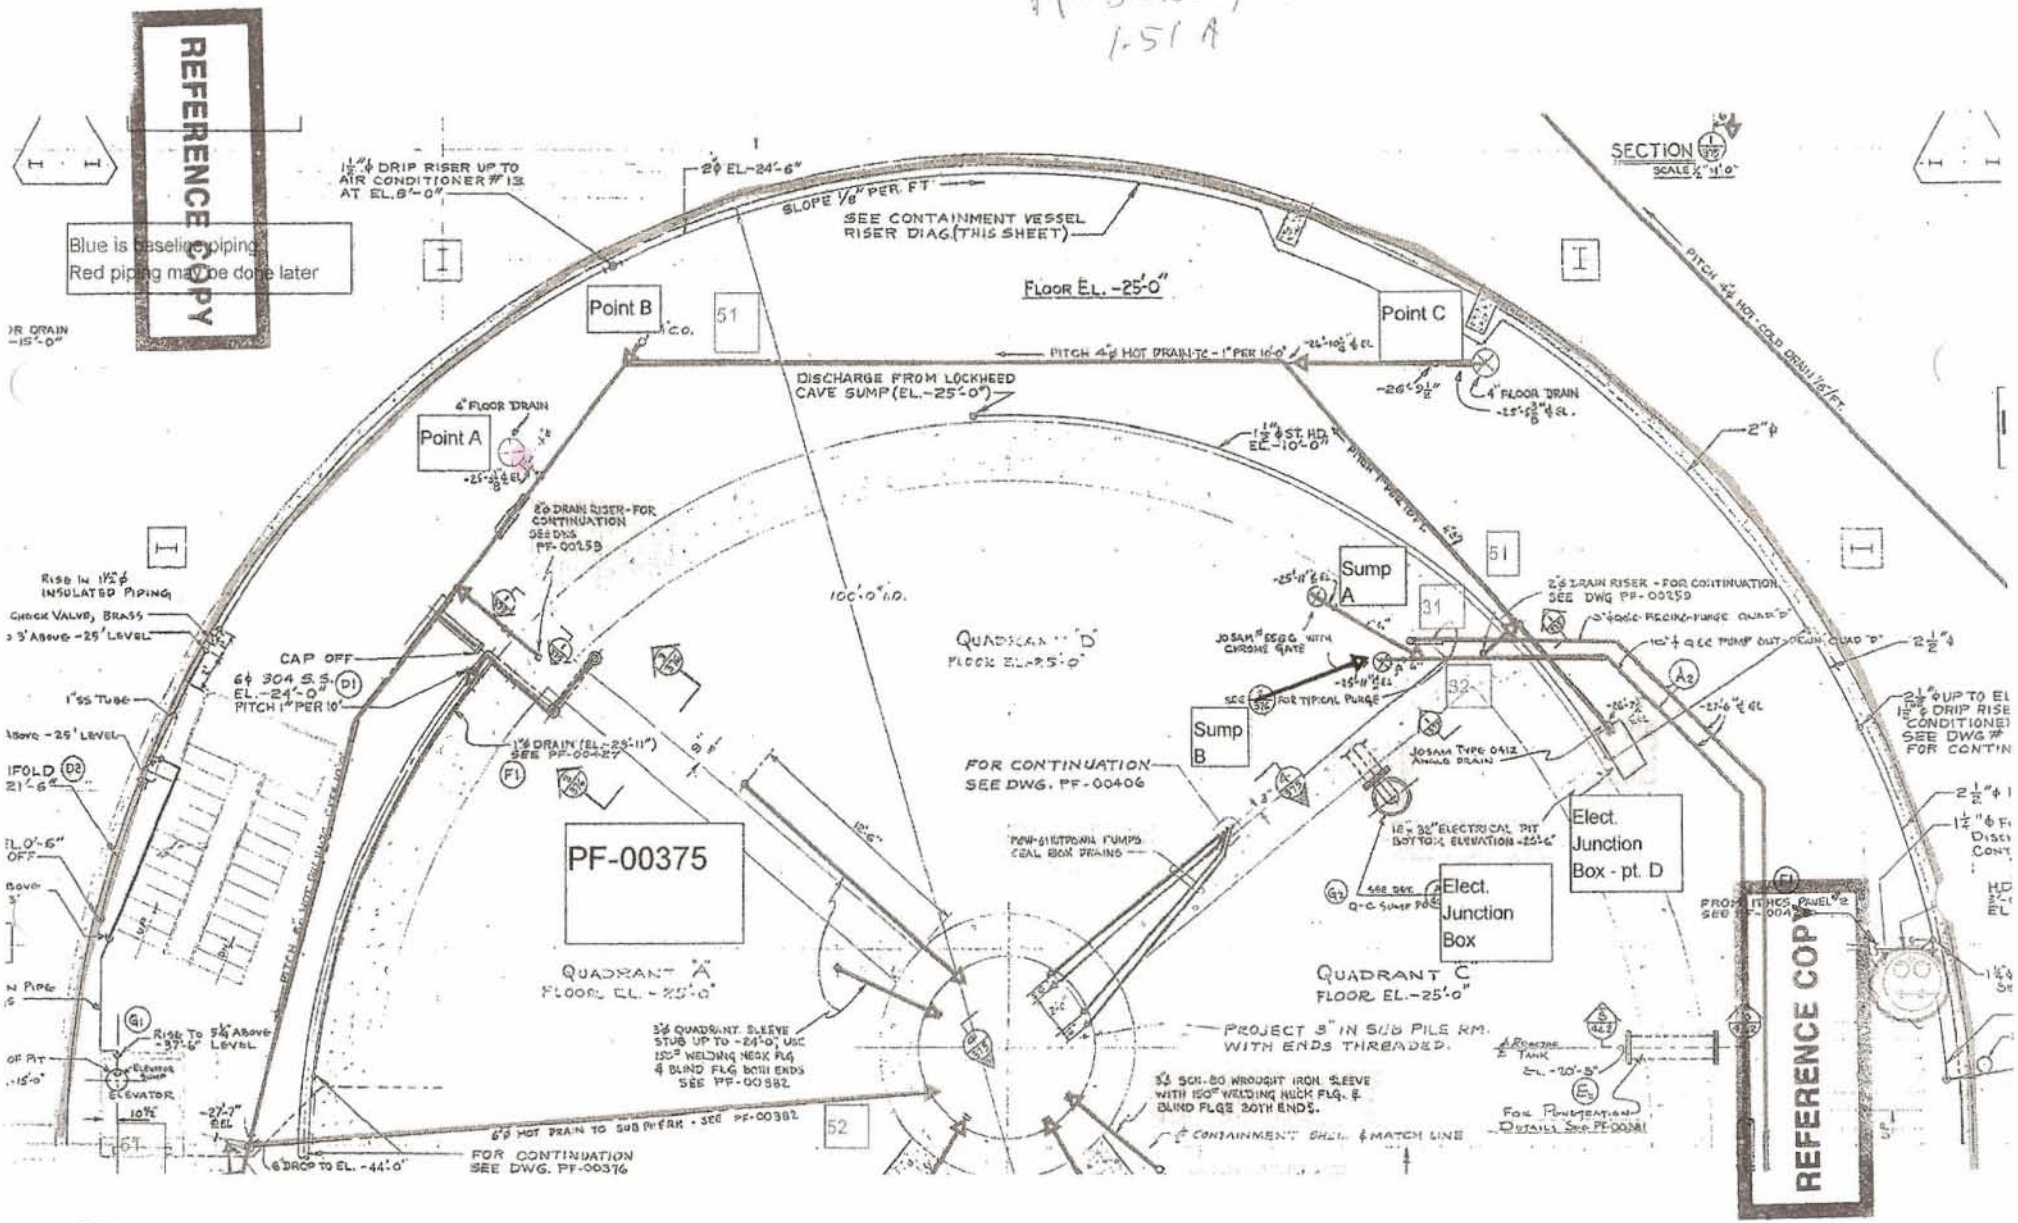
= pipe surveyed
1.51 A

Date: 2-16-06 Time: 1305 DRAIN STEM

Pipe ID#: 1.51A Pipe Diameter: 3" Access Point Area: ANNULUS
