Key Conclusions of Exponent's December 15, 2006 Report:

"Review & Analysis of the Davis-Besse March 2002 Reactor Pressure Vessel Head Wastage Event"

Exponent *Failure Analysis Associates*

March 22, 2007

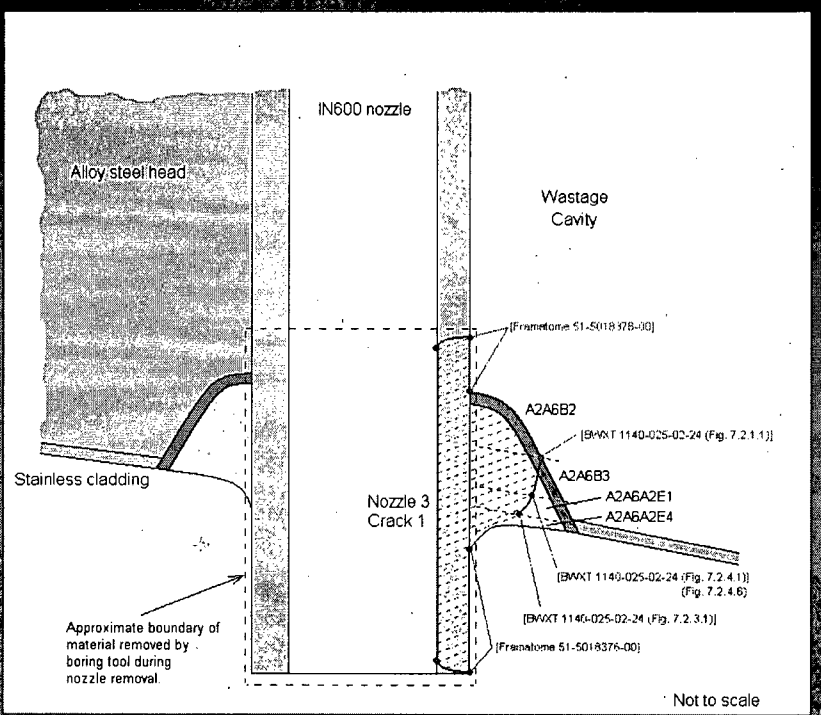
CRDM Nozzle 3 and Weld Cracking

- **May/October 2001:**
  - Nozzle 3 axial crack has grown to about 1.1 inches above the weld by October 2001
  - The leak rate from this crack is estimated at 0.02 gpm
  - The upward growing axial nozzle crack and downward growing wastage cavity have intersected
  - Mechanical erosion at the bottom of the wastage cavity increases due to the change in crack jet direction and high velocity jet impingement
  - Moisture penetrates further into the bottom of the wastage cavity due to the higher leak rate
  - Metal temperatures still remain high enough to result in phase transformation of boric acid to metaboric acid and melting
  - Combined action of wetted molten metaboric acid corrosion and mechanical action rapidly removes the 1 inch of remaining low alloy steel covering the weld
  - Undercutting of the wastage cavity likely begins

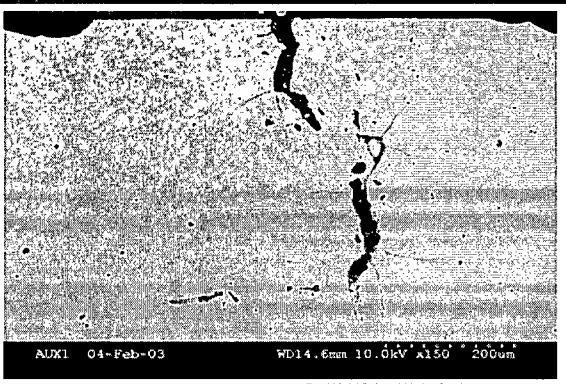
- Scanning electron micrograph of CRDM Nozzle 3 crack at 180° location showing typical width of PWSCC nozzle cracks. Maximum crack width is about 20 microns (0.0008 inches)

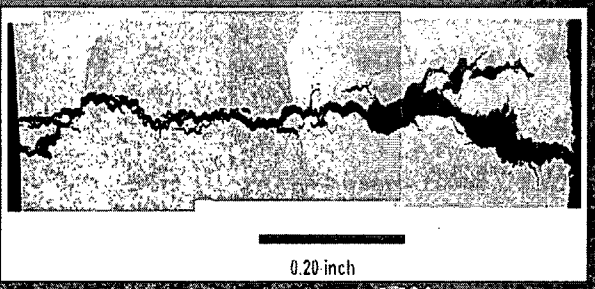
- Optical micrograph of J-groove weld crack in CRDM Nozzle 3 at 10° location. Nominal crack width is about 400 microns (0.016 inches), about 20 times larger than the PWSCC crack in the same nozzle

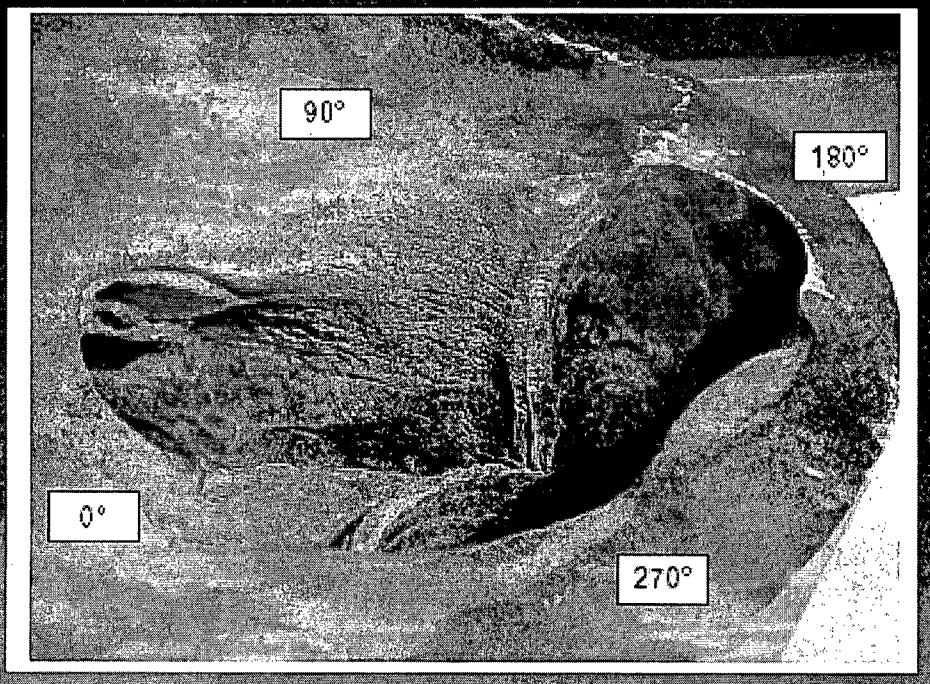
Final Wastage Cavity at CRDM Nozzle 3

- **October/November 2001:**
  - Large pre-existing weld crack is uncovered by the rapidly downward growing wastage cavity
  - Leak rate increases to around 0.16 gpm
  - Cavity metal wall temperatures remain higher than phase transformation to and melting temperature of metaboric acid
  - High velocity high flow jet impingement and wetted molten metaboric acid corrosion cause rapid wastage cavity growth, undercutting, and large cavity by February 2002
  - Significant moisture penetrates to the RPV head underneath the existing boric acid deposit from CRDM leakage
  - Head surface metal temperature remains high enough to form molten metaboric acid and presence of moisture from higher leak rate results in top-down wastage of RPV alloy steel evident in final wastage cavity morphology

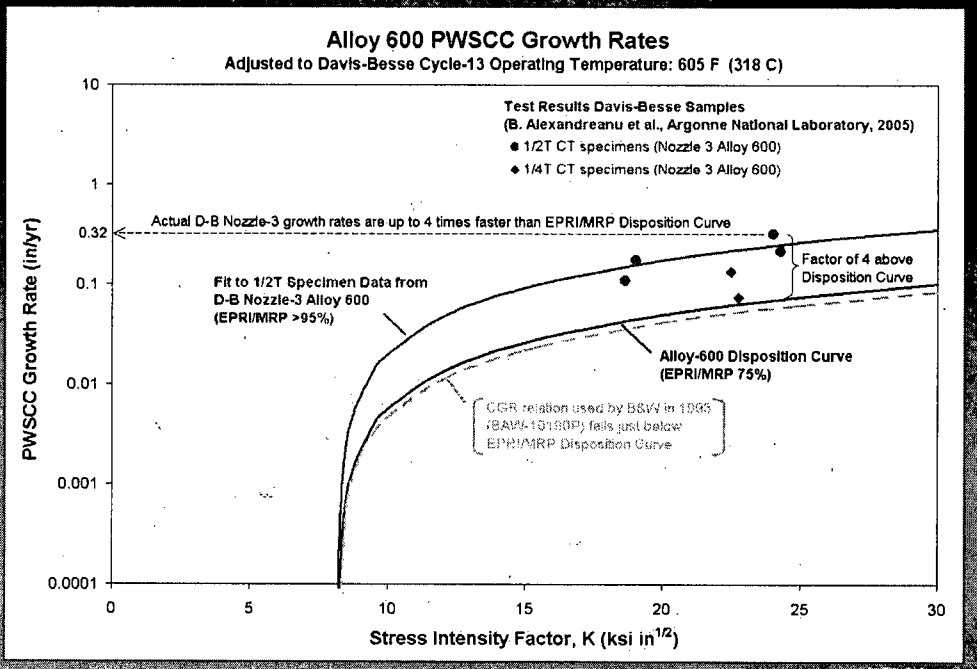
CRDM Nozzle 3 Cracking Behavior (cont'd)

- Actual Nozzle 3 Alloy 600 material exhibited very high crack growth rates in NRC/ANL work reported in 2006
- Crack growth rates for Nozzle 3 Alloy 600 material were 3 to 4 times industry expected rates, at 95th percentile of data
- Explains why the Nozzle 3 axial crack grew to 1.23 inches above the weld and 4.08 inches in total length
- Led to conclusion that cracking timeline for CRDM Nozzle 3 was much shorter than previously thought
