Waterford Unit 3 GSI-191 Generic Letter 2004-02
Corrective Actions Audit Report

ENCLOSURE

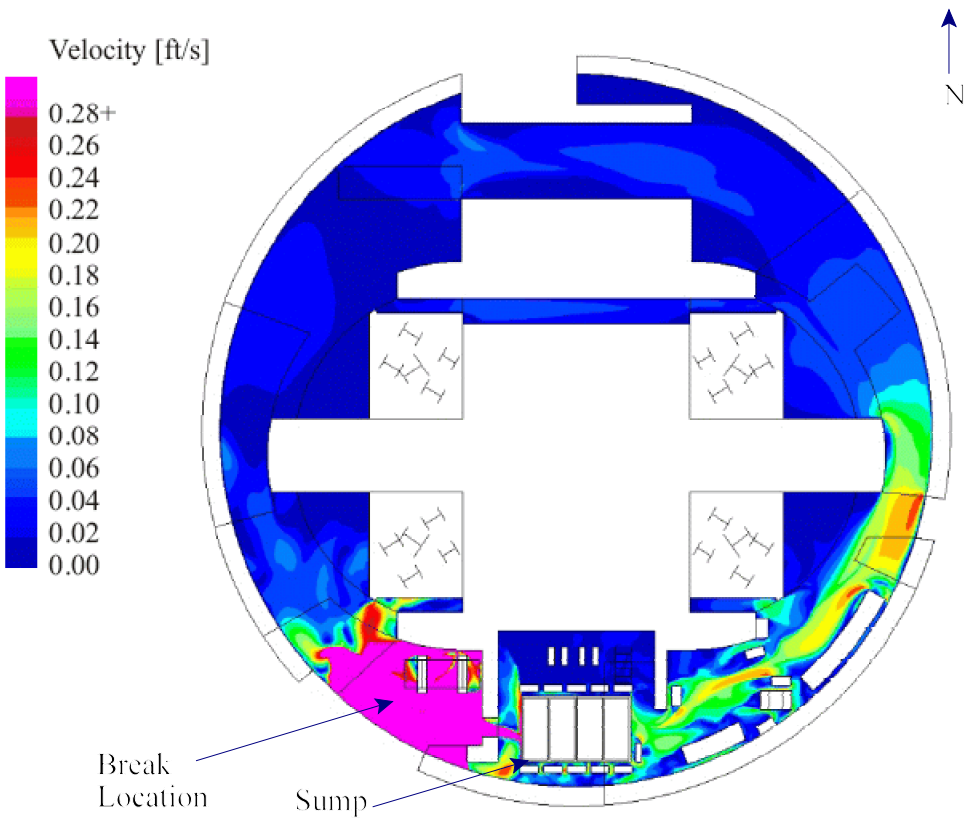
Figure 1: Waterford 3 Containment Pool Flow Velocity for Break S7

The first concern is that the staff concluded that there is inadequate technical basis for the licensee to assume that the percentage of debris transporting along the east and west sides of containment is equal to the percentage of flow approaching the sump from the east and west side of containment. Although there are limited conditions under which the licensee's assumption may be reasonable, the staff expects that the location of the break would generally have a significant impact on which side of containment debris will transport, regardless of the flow split between the east and west sides of containment. The staff's expectation is borne out by most of the plots of pathlines from the breaks to the containment sump that are included in the debris transport calculation for the CFD simulations performed by the licensee [16]. These plots suggest that debris transport would be generally biased toward the side of containment on which the break occurred and, in many cases, overwhelmingly so. Furthermore, as noted in the

debris transport calculation, the flow in the Waterford Unit 3 containment pool was found to be highly three-dimensional [16]. This observation further suggests that the use of the total flow to the sump from the east and west sides of containment (i.e., a summation over the vertical flow distribution across the entire 5.05-foot depth of the containment pool) may not be a reasonable predictor of the direction of travel for pieces of Nukon and RMI debris transporting predominately only several inches above the containment floor. The lack of technical validity of the licensee's assumption is significant because the use of the assumption could result in non-conservatively low debris transport fractions under some conditions if sufficient countervailing conservatisms are not incorporated into the analysis.

The second concern is that the licensee's debris transport calculation did not clearly define the point at which the transport paths from the east and west sides of containment to the sump strainers were assumed to begin. Although the results of the licensee's transport calculation were consistent with the interpretation that the transport path on the side of containment with the pipe rupture begins at the point where this break water enters the containment pool, the licensee could not explain where the transport path on the opposite side of containment was assumed to begin.
