Byron Station, Unit 2
Facility Operating License No. NPF-66
NRC Docket No. STN 50-455

Subject: Submittal of Analytical Evaluation of Pressurizer Seismic Restraint Lug Indications

Byron Unit 2 Flaw Evaluation at the Pressurizer Seismic Lug (PSL-1) Region

LTR-PAFM-05-78

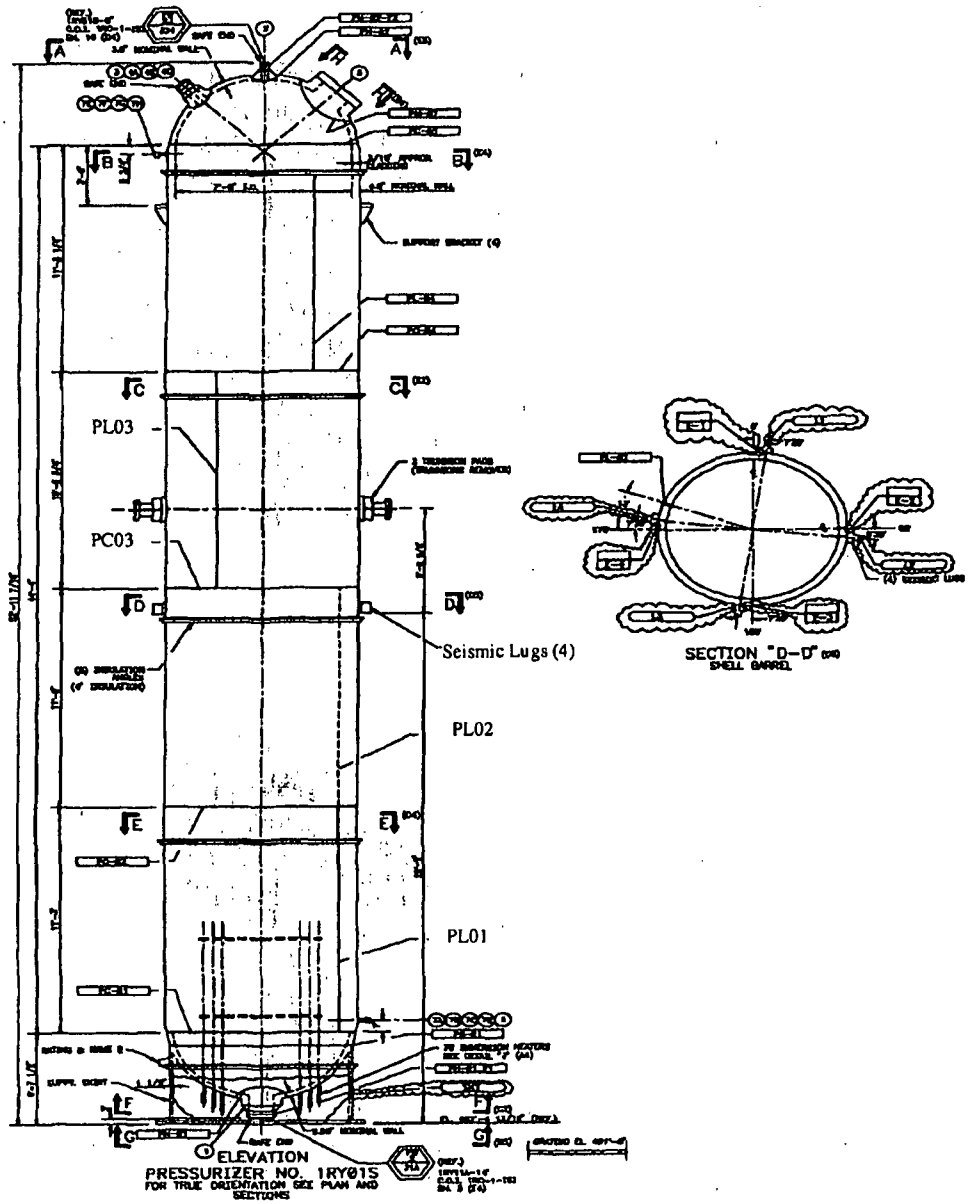
Figure 1-1

Geometry of the Byron Unit 2 Pressurizer

The axial stress distribution along the upper middle shell to lower middle shell weld (PC03) [10] and those due to the seismic lug [4] were used for determining the circumferential critical flaw depths since the seismic lug (PSL-1) was at about the same elevation as the PC03 weld. As for the hoop stress distribution, those from the longitudinal weld seam (PL02) [11] and those due to the seismic lug [4] were used for determining the axial critical flaw depths since the seismic lug (PSL-1) was at about the same elevation as the top of the PL02 weld, as shown in Figure 1-1.

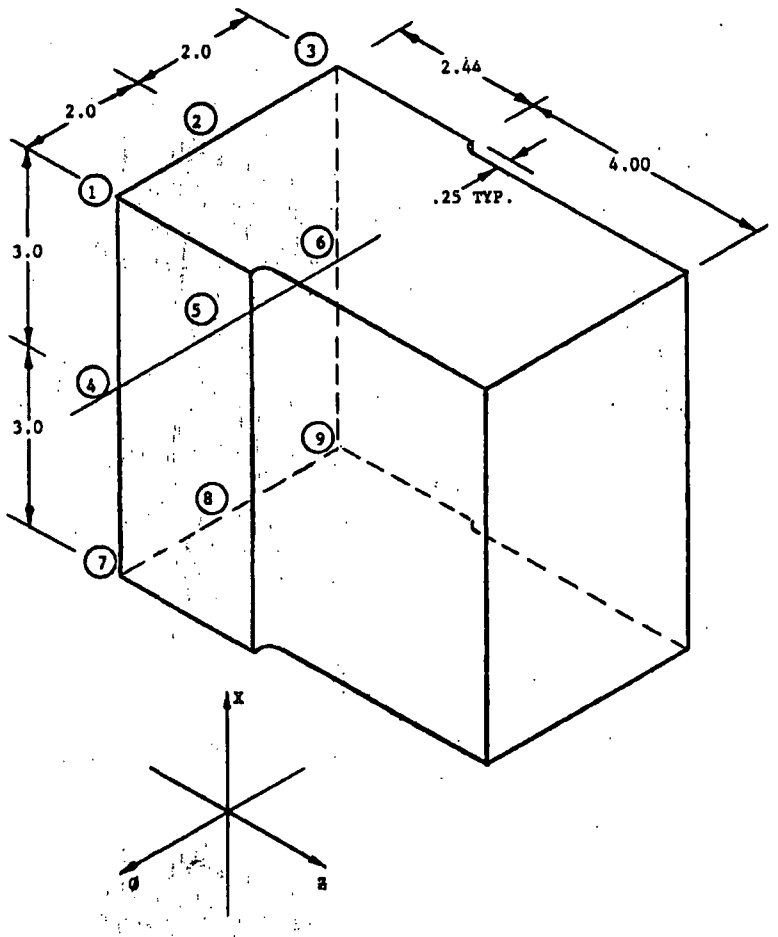
Figure 1-2

During the B2R12 refueling outage, the Byron Unit 2 ISI program scheduled the inspection of the Pressurizer Integrally welded attachment seismic lugs PSL-1 through PSL-4. The geometry of the pressurizer and the seismic lugs are shown in Figures 1-1 and 1-2 respectively.

Geometry of the Pressurizer Welded Attachment Seismic Lug

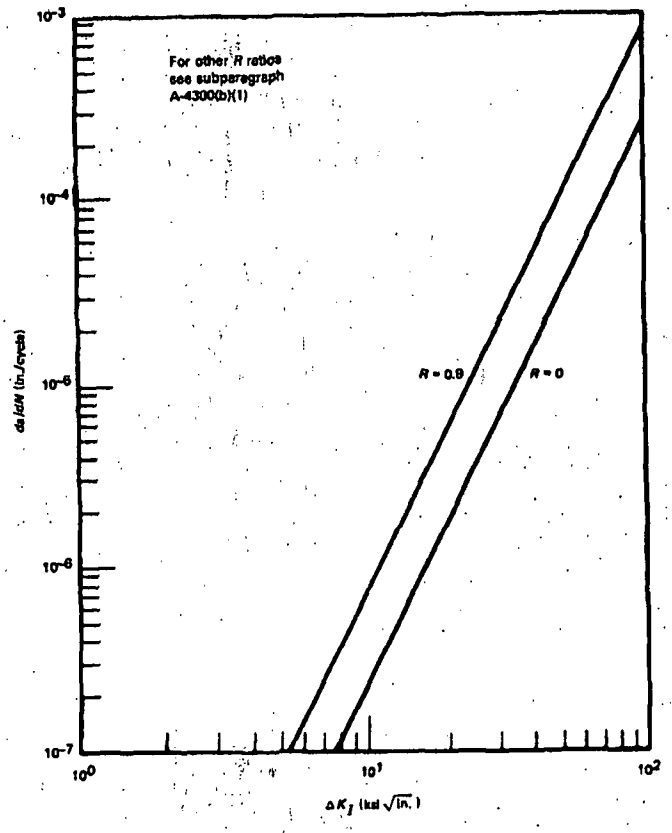
Figure 5-1

The air environment crack growth rate curve used in the analyses was taken directly from Appendix A in 1990 Addenda of the ASME Code 1989 Edition. This curve is similar to the curve in the 1989 Edition [2] but included the effect of Stress Ratio (R) and appears also in later editions of the ASME Code. The use of this curve represents a more up-to-date treatment of the crack growth rate. Air environment curve was used for the outside surface flaws because they are not exposed to the primary water environment. The crack growth rate reference curve for air environment is a function of applied stress intensity factor range (ΔK_I) and stress ratio (R). This reference curve is also shown in Figure 5-1.

FIG. A-4300-1 REFERENCE FATIGUE CRACK GROWTH CURVES FOR CARBON AND LOW ALLOY FERRITIC STEELS EXPOSED TO AIR ENVIRONMENTS (SUBSURFACE FLAWS)

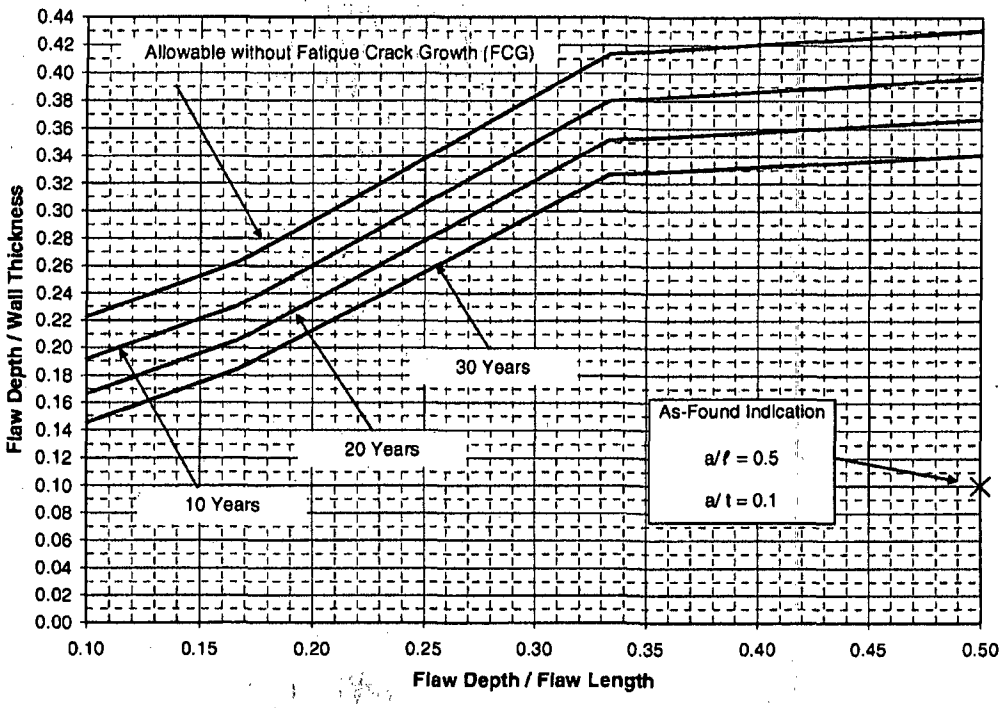
These flaw parameters are plotted in Figures 6-1 and 6-2. It is evident that ample margin exists and that the as-found indications are acceptable without repair for at least 30 years of service life.

Assuming a circumferential flaw depth of 0.4 inch, that is a/t = 0.1, the maximum allowable aspect ratio as shown in Figure 6-1 is at least 10:1 (length:depth) . Therefore for a circumferential flaw with a flaw depth of 0.4 inch, the maximum allowable length of the flaw can be at least 4 inches for an operational period of at least 30 years.

Circumferential Flaw Evaluation Chart – Pressurizer Welded Attachment Seismic Lug (PSL-1) Region

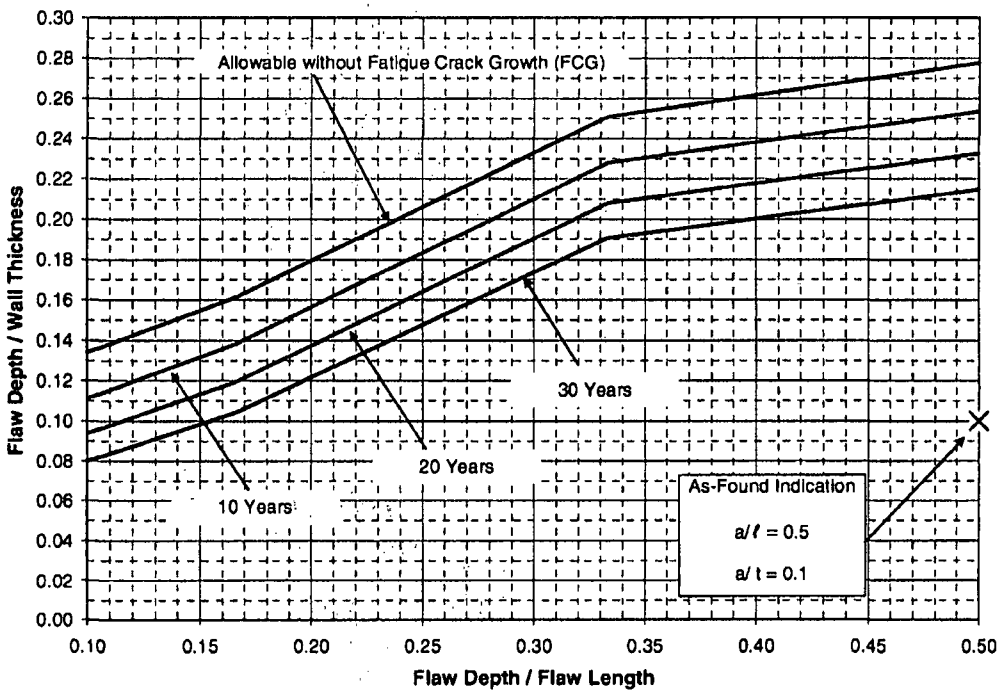
For an axial flaw with a flaw depth parameter a/t = 0.1, the maximum allowable aspect ratio as shown in Figure 6-2 for an operational period of 30 years is about 6.5:1. Therefore for an axial flaw with a flaw depth of 0.4 inch, the maximum allowable length of an axial flaw is 2.6 inches for an operational period of 30 years. Using the same approach, the maximum allowable length is at least 4 inches for an operational period of 10 years.

Axial Flaw Evaluation Chart – Pressurizer Welded Attachment Seismic Lug (PSL-1) Region

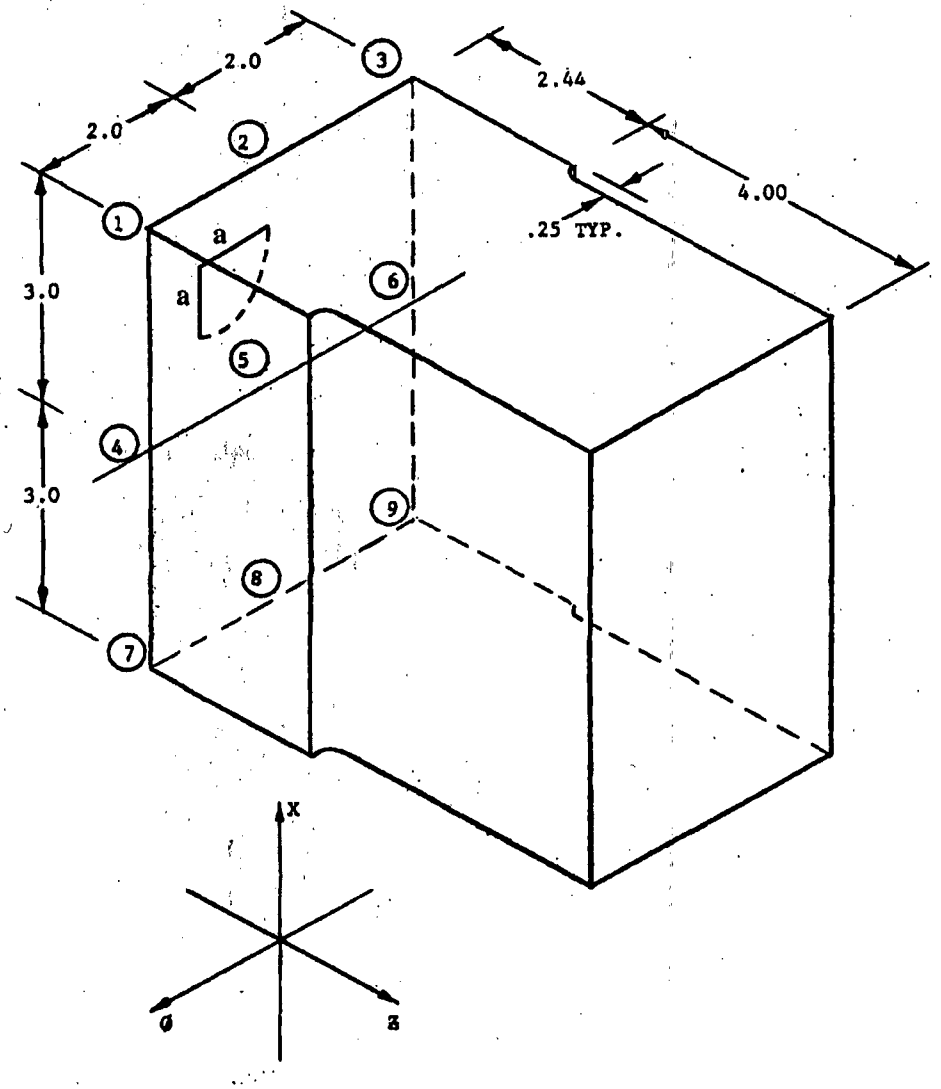
Figure 7-1

A linear quarter-circular flaw is postulated along the top of the seismic lug (PSL-1) as shown in Figure 7-1. The stress intensity factor expression for a plane quarter-circular flaw at the edge of a square bar was used as discussed in Section 4.2. The use of this stress intensity factor expression is conservative with respect to the detected flaw configuration because the indication is assumed to be an edge crack and that the depth of the flaw is assumed to be the same as the length of the detected indication. This quarter-circular edge flaw model is also a conservative model for a semi-circular flaw near the top center of the seismic lug weld. Therefore the flaw evaluation results obtained can be conservatively applied to the actual indication detected.

Postulated Crack Along the Top of Pressurizer Seismic Lug

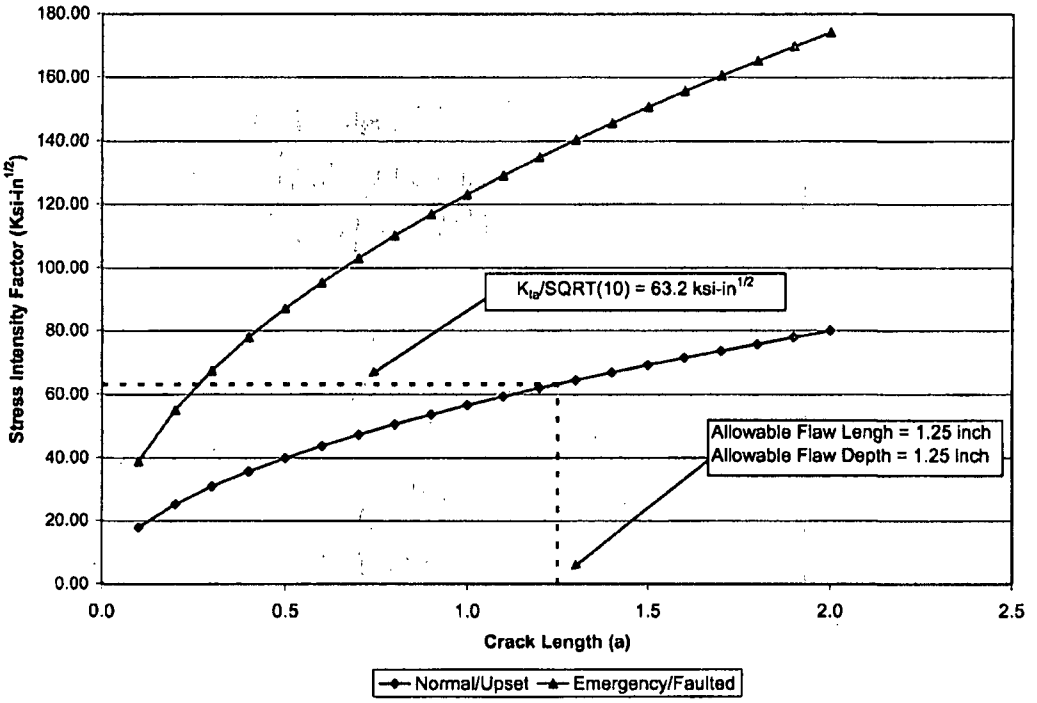
Figure 7-2

The critical flaw depth for such quarter-circular flaw was determined as discussed in Section 4.0 and based on the acceptance criteria discussed in Section 2.0. The resulting allowable flaw depth at the end-of-evaluation period, defined as a_f, is shown in Figure 7-2.

Based on the results tabulated in Table 7-1, a quarter-circular flaw ($a = \ell = 1.23$ inch) postulated along the top of the seismic lug is acceptable for 30 years without repair. As

can be seen in Table 7-1, the fatigue crack growth due to seismic loading experienced by the lug is negligible. Since the flaw shape of the as-found indication is being encompassed by the maximum allowable flaw shape, it can be concluded that the as-found indication along the top of the seismic lug is acceptable for 30 years without repair.

Allowable Flaw Size Determination for Pressurizer Seismic Lug Without Including Fatigue Crack Growth
