Annual Review Report – 2007
Groundwater Corrective Action
Church Rock Site, Church Rock, New Mexico

January 2008

N.A. Water Systems

PREPARED BY:
MARK D. JANCIN, P.G.

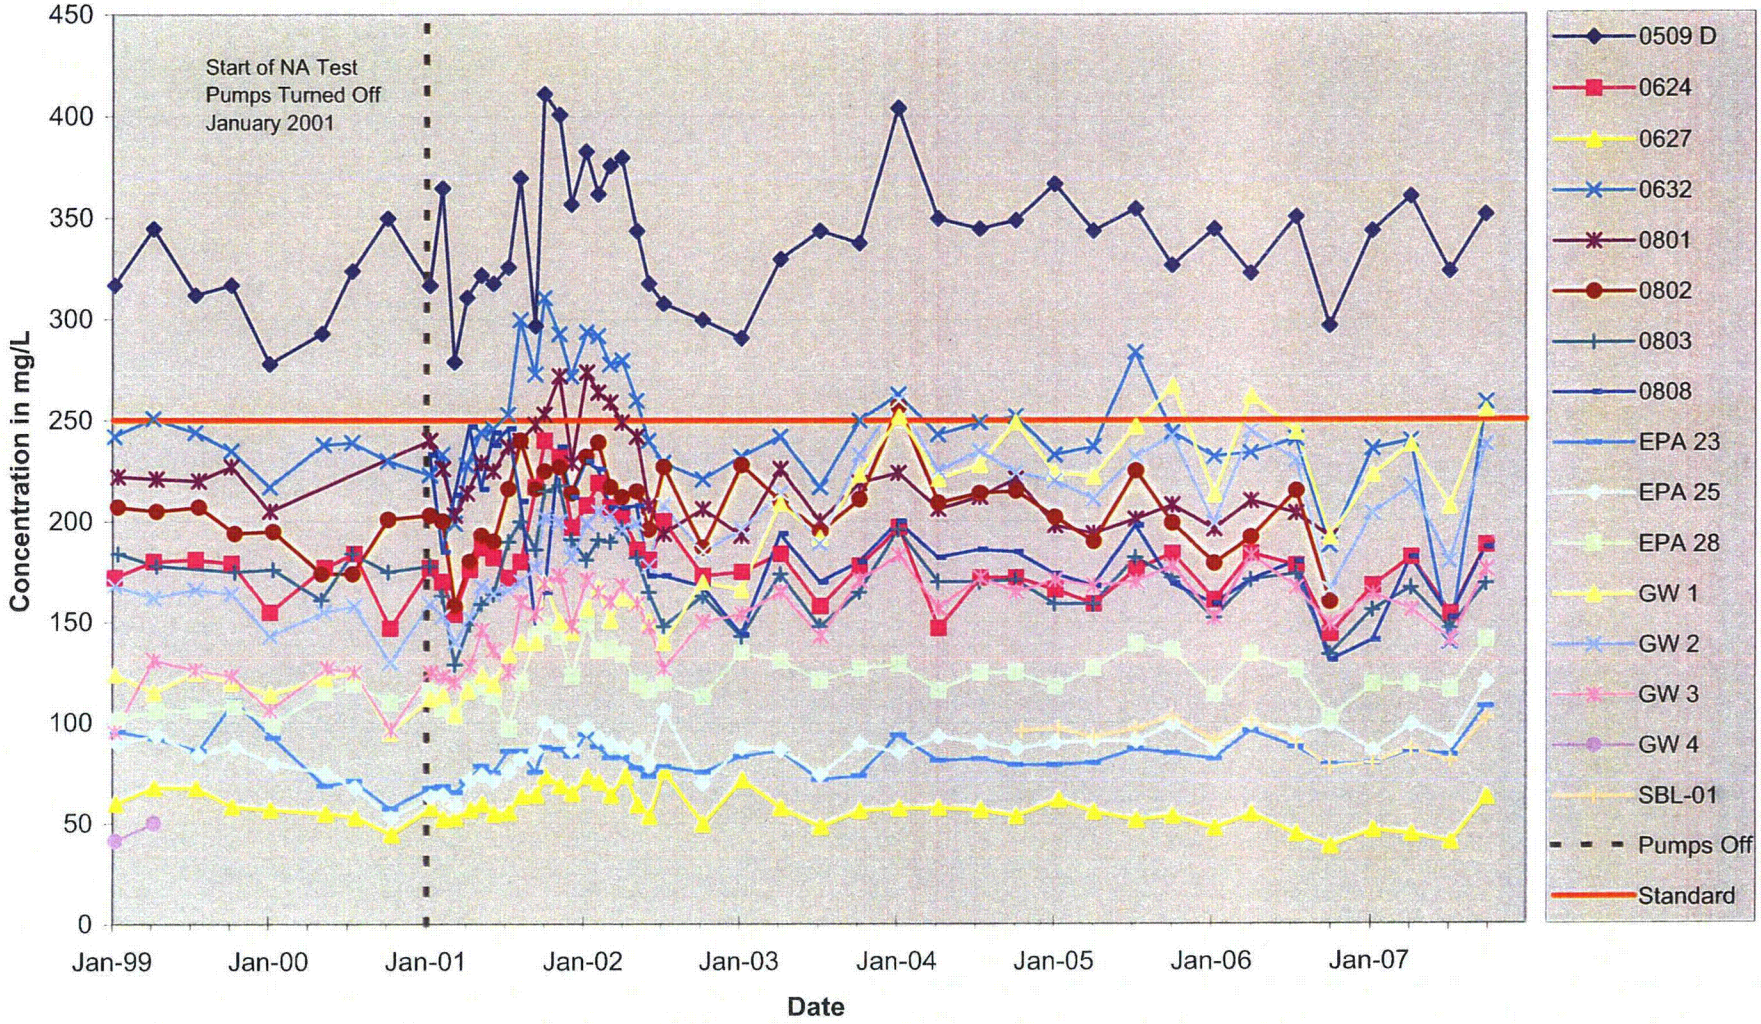
FIGURE 10

- Chloride – Chloride is a non-hazardous constituent. Chloride concentrations exceed the Site standard (250 mg/L) at Well 509 D. This well has exhibited

Southwest Alluvium Chloride Concentrations From 1999 Through October 2007
United Nuclear Corporation, Church Rock Site, Church Rock, New Mexico

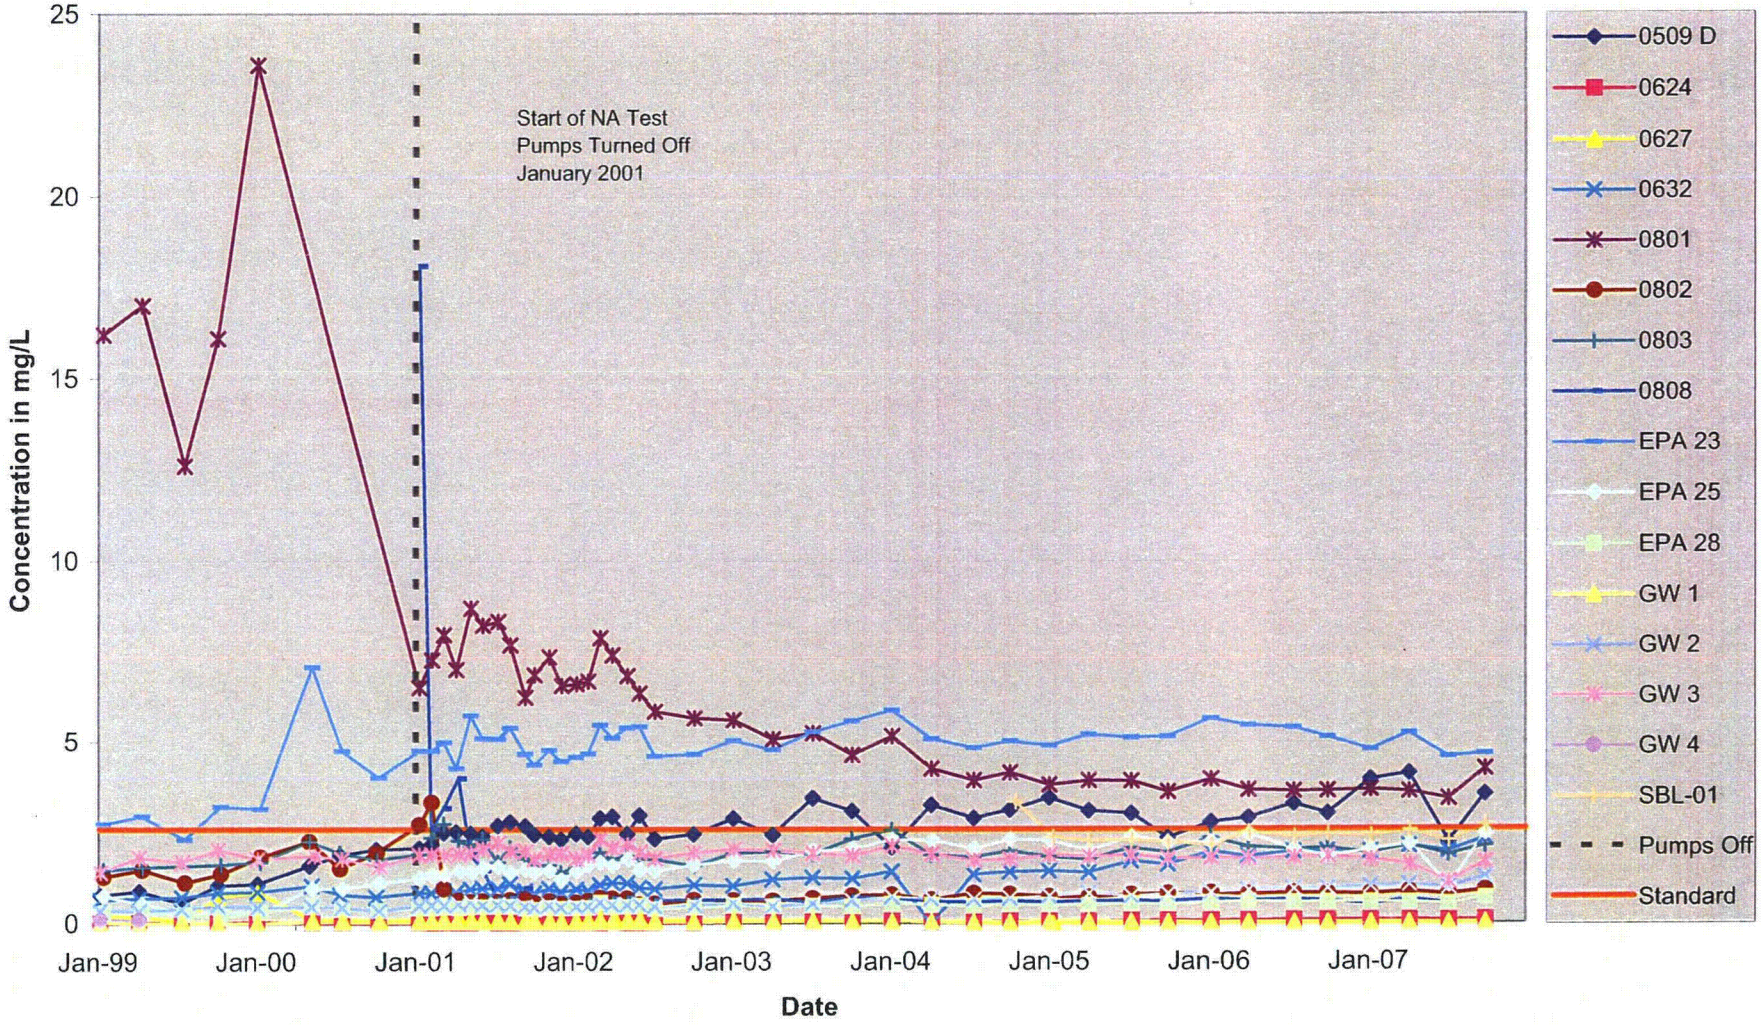
FIGURE 11

There was a minor exceedance of the manganese standard at background Well SBL 1 in October 2007 (2.7 mg/L; Table 2 and Figure 11). Well SBL 1 has also had an exceedance of nickel and has shown relatively high concentrations of magnesium (Table 2; Figure 9; Appendix A). These characteristics do not reflect the presence of seepage-impacted water at this location. Rather, as explained earlier in Section 2.3.2, the geochemistry of groundwater at SBL 1 reflects background conditions that are very likely related to the dissolution of soluble alluvium minerals associated with the initial discharge of mine waters.

Southwest Alluvium Manganese Concentrations From 1999 Through October 2007

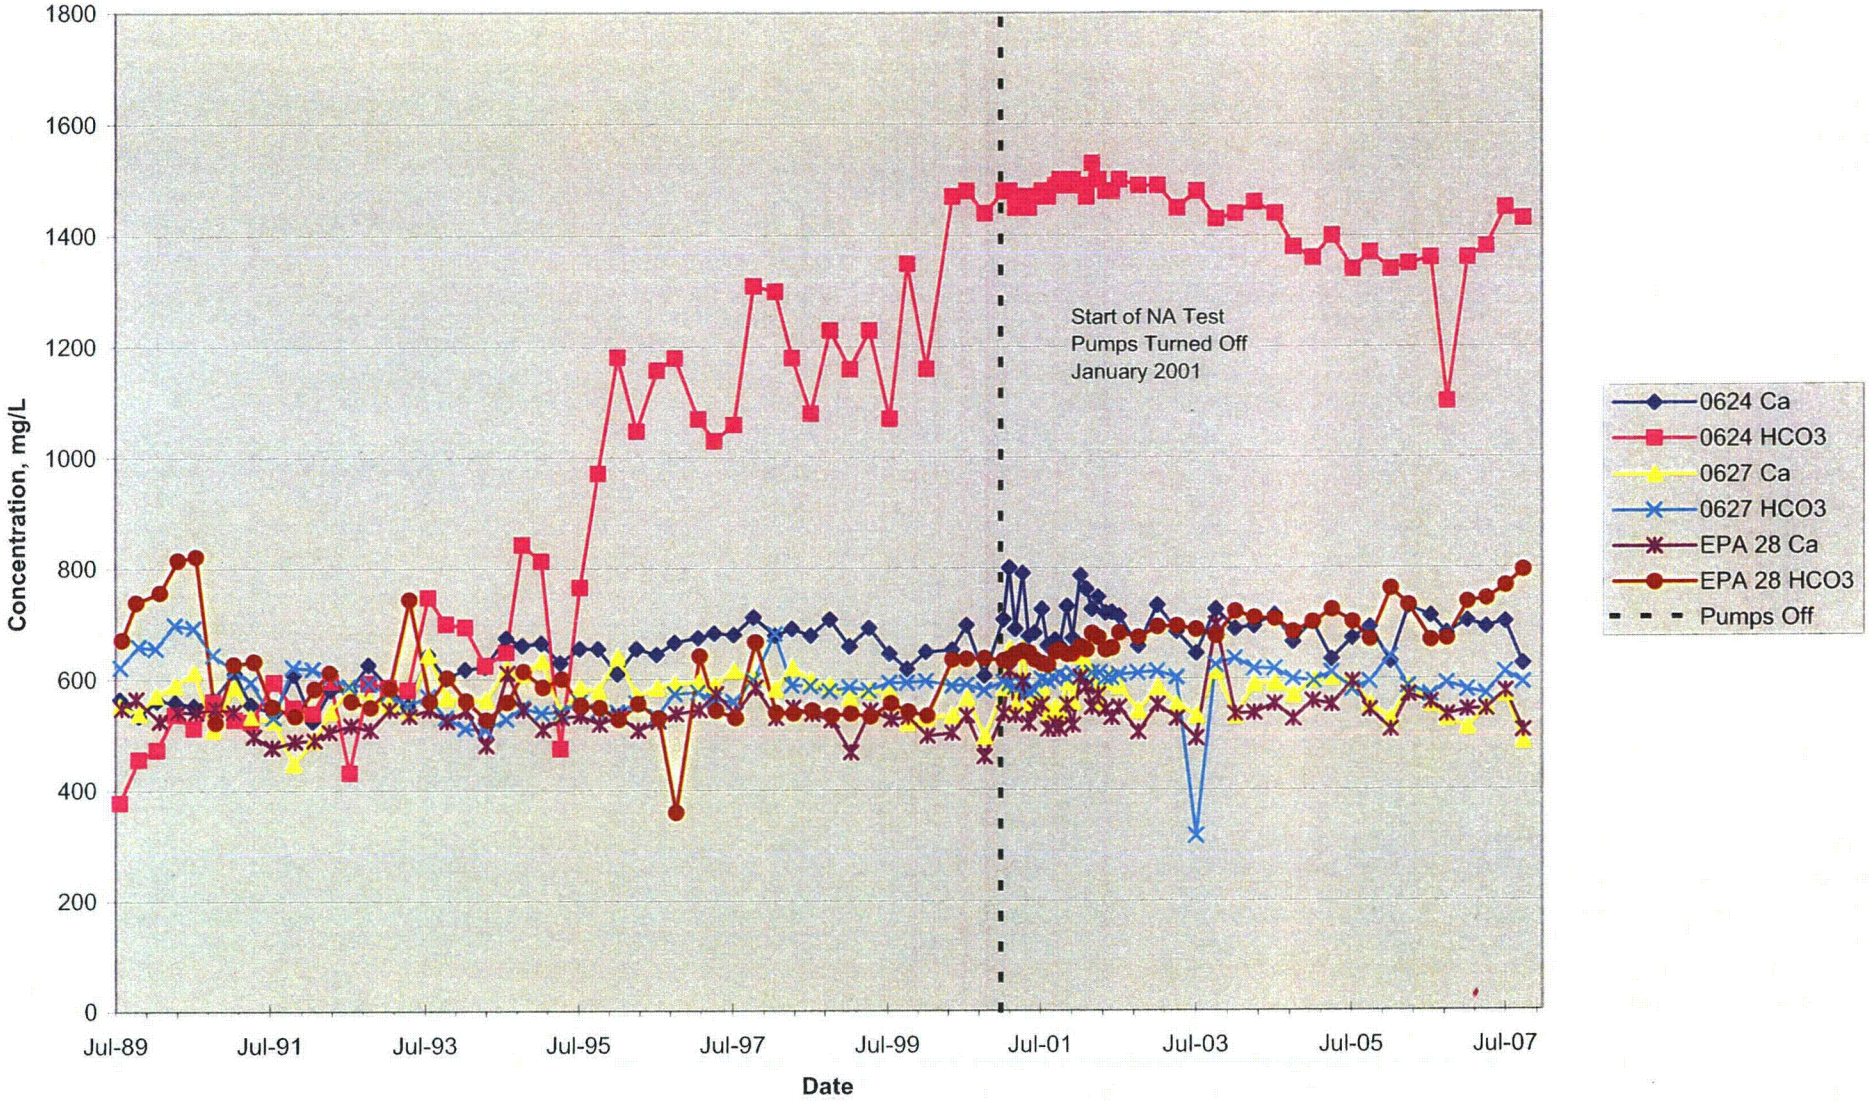
FIGURE 13

Calcium and bicarbonate are non-hazardous constituents. Figure 13 illustrates the long-term stability of calcium and bicarbonate concentrations at Wells 627 and EPA 28, which are examples of background wells that have not been impacted by tailings seepage. Calcium concentrations in Wells 627 and EPA 28 have been essentially the same through time. Figure 13 shows that during the onset of seepage impact in Well 624 (indicated by the increasing bicarbonate), the calcium concentration increased by approximately 100 mg/L and then re-equilibrated at a concentration of 650 to 700 mg/L. Under changed groundwater quality flux, calcium concentrations remain fixed in the presence of calcite and gypsum by the Phase Rule; the long-term consistency of calcium concentrations in the Southwest Alluvium attests to the established equilibrium between the groundwater and these minerals. In general, calcium concentrations do not vary appreciably anywhere in the groundwater flow system (see Figures 9 and 14).

Calcium and Bicarbonate Concentrations in Selected Backgound and Seepage-Impacted Wells
United Nuclear Corporation Church Rock site, Church Rock, New Mexico

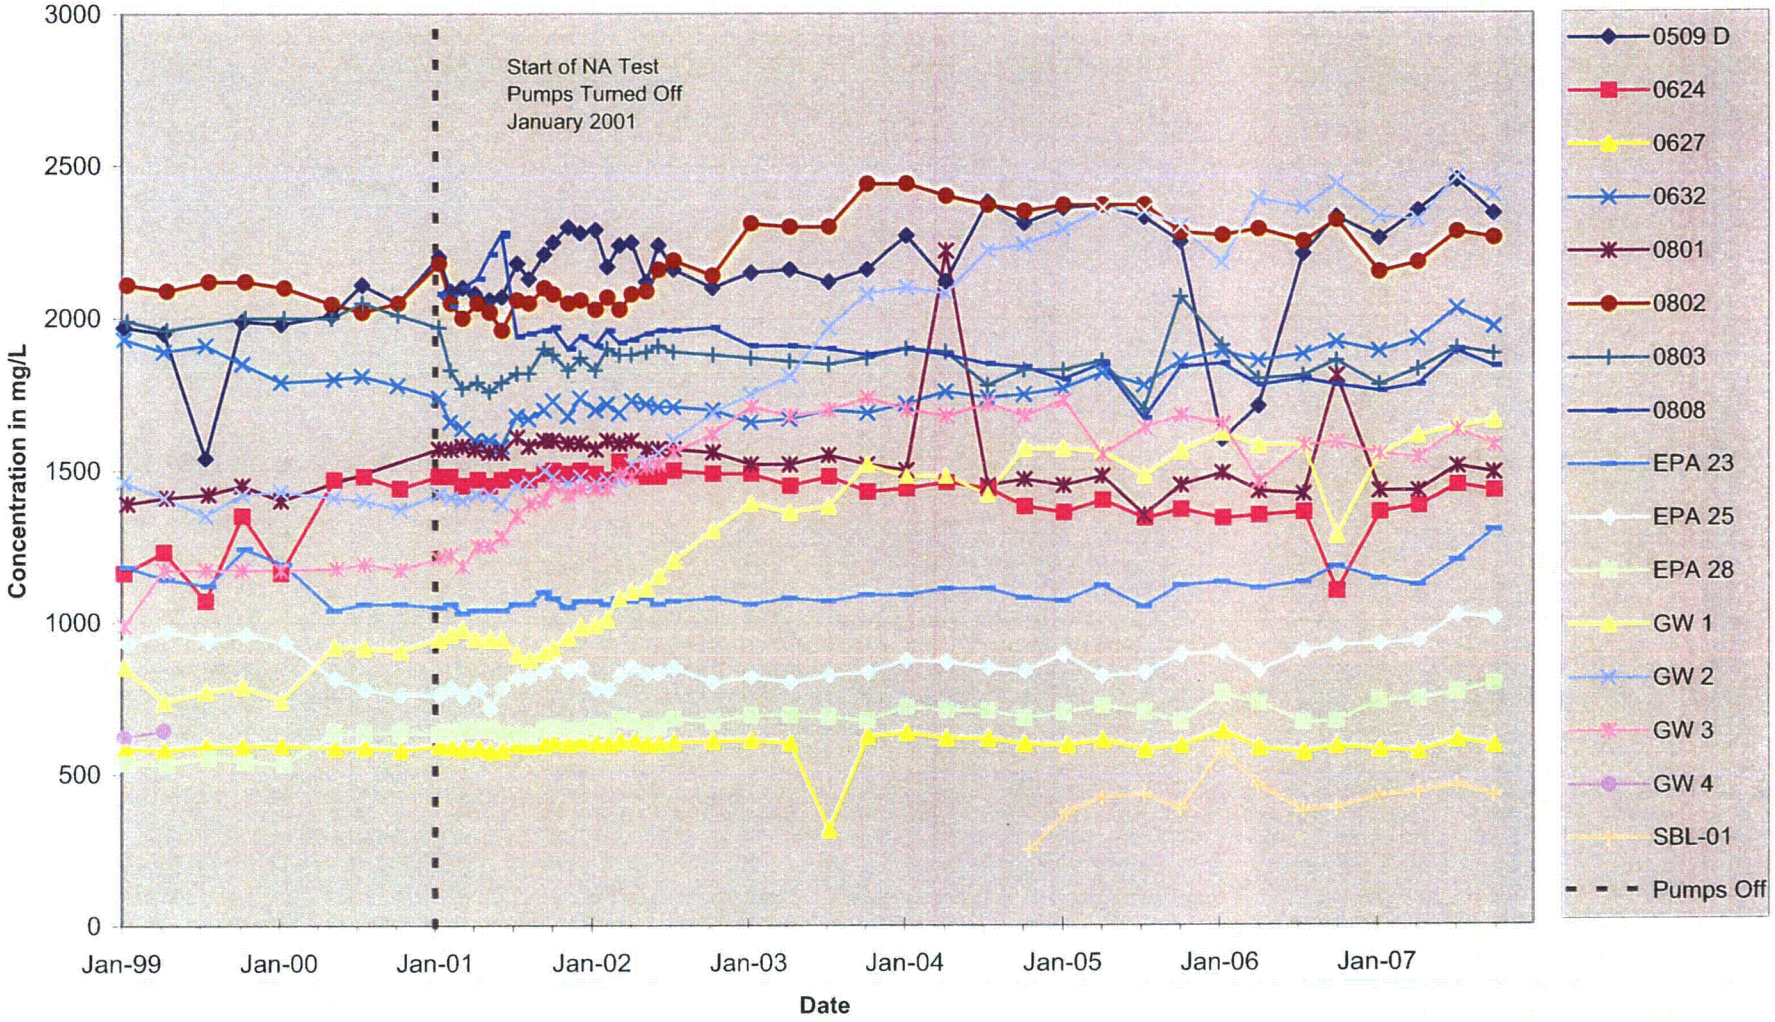
FIGURE 15

Figure 15 shows the bicarbonate concentrations over the same period. Bicarbonate is a non-hazardous constituent that serves as the primary

Southwest Alluvium Bicarbonate Concentrations From 1999 Through October 2007
United Nuclear Corporation, Church Rock Site, Church Rock, New Mexico
