Figure 1. Location of Indian Point Energy Center site, Buchanan, New York.

LONG TERM MONITORING PLAN

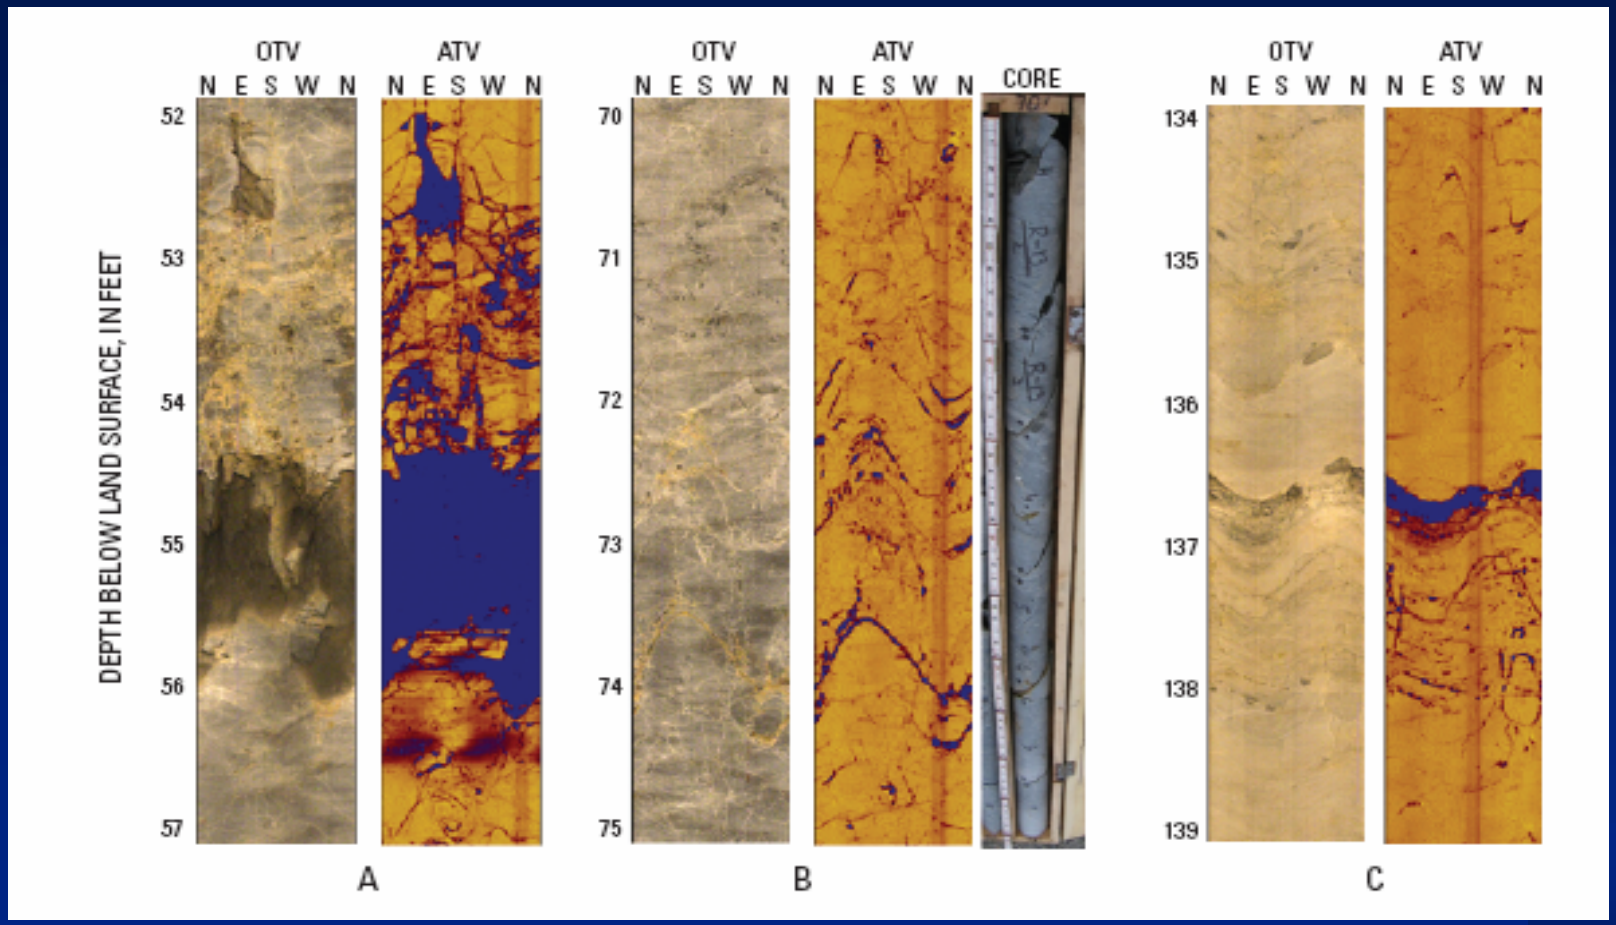
Fig. 4

Composites of Geophysical Logs, Transmissivity and Hydraulic-Head Difference Estimates and Measurements, And Tracer-Test Results for Test Wells (Williams, 2008)
