AMAG ROOT CAUSE - FINAL

Root Cause Report

1. Title: Inaccuracies in Feedwater Ultrasonic Flow Measurements Caused by Low Frequency Velocity Signals Result in Exceeding Licensed Maximum Power Level at Byron and Braidwood Stations

2. Unit(s): Byron Station Units 1 and 2
Braidwood Station Unit 2

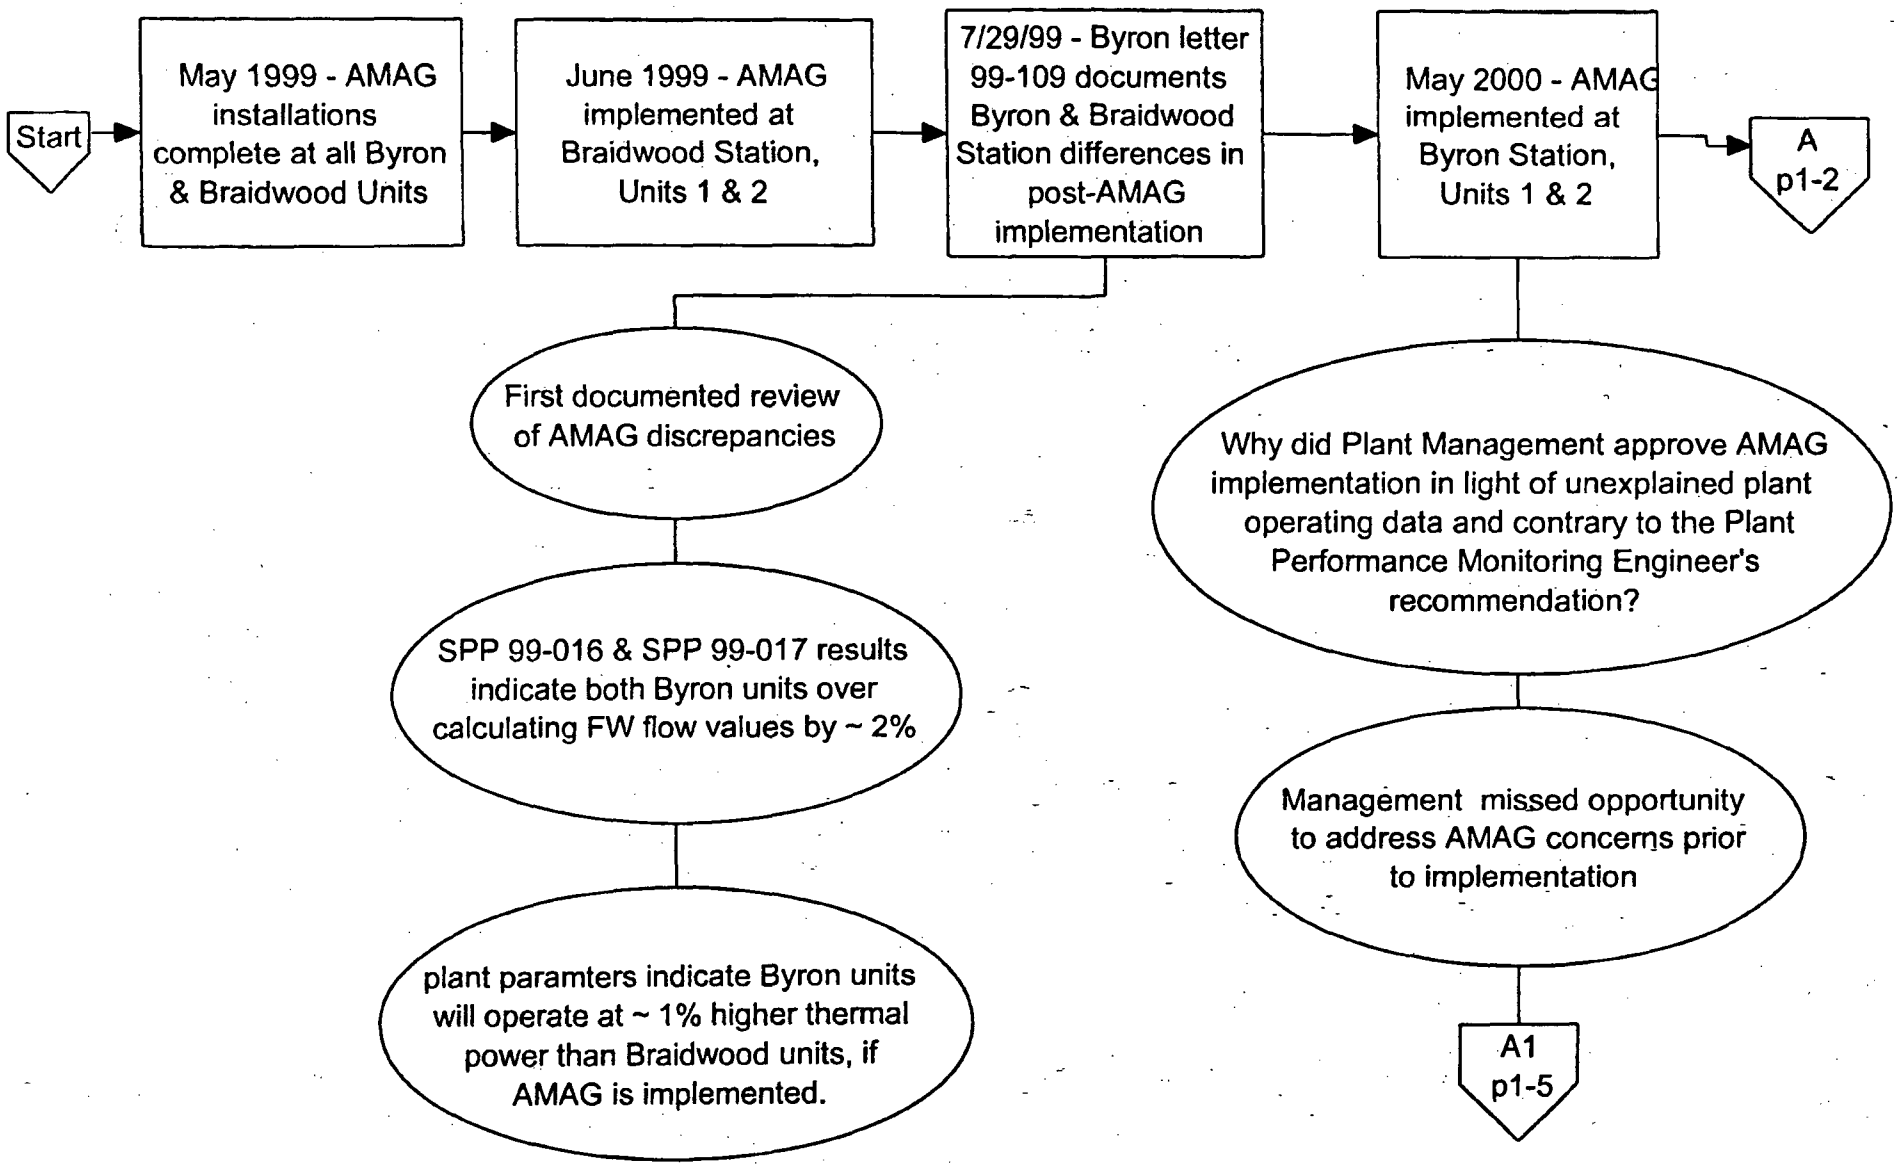
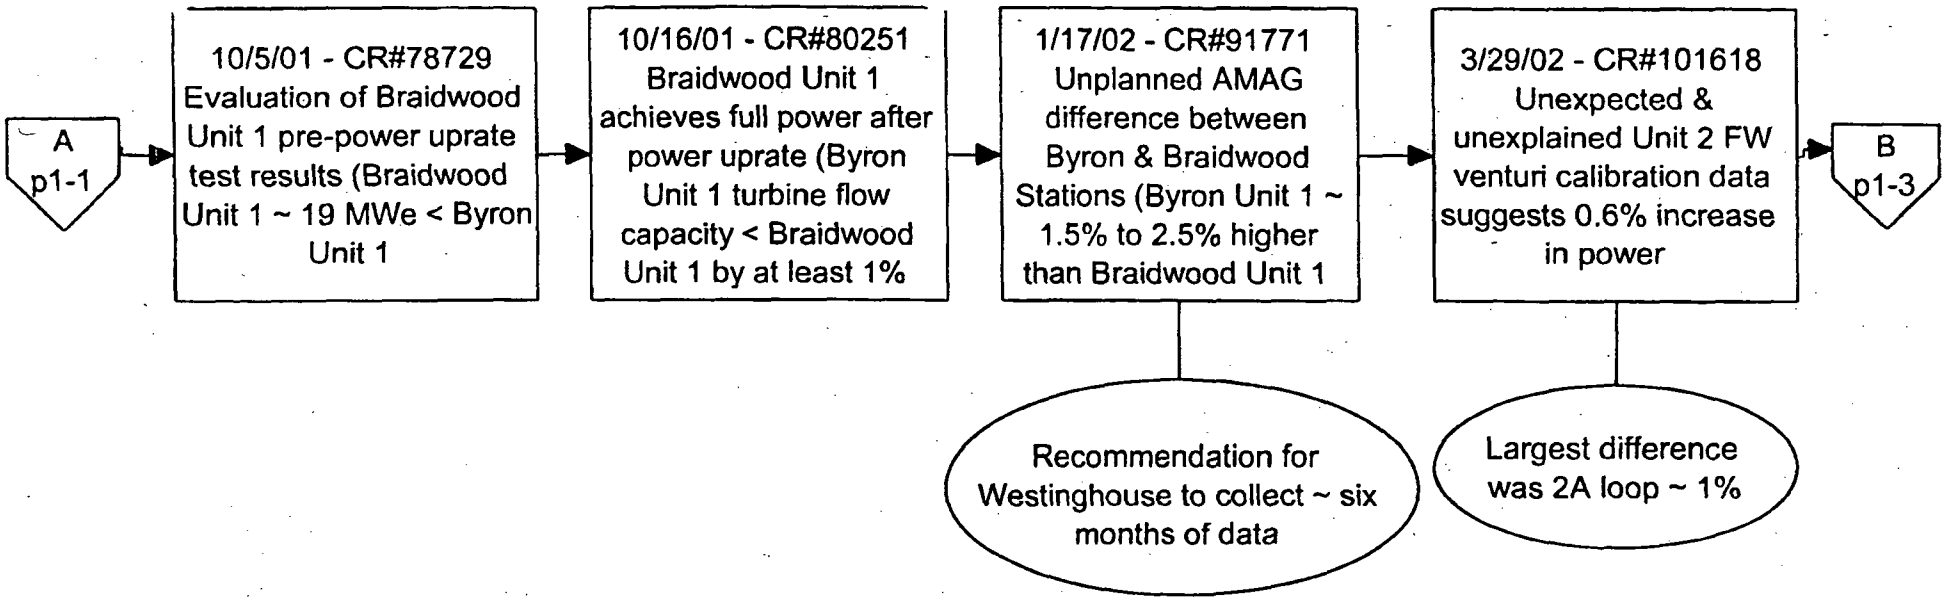
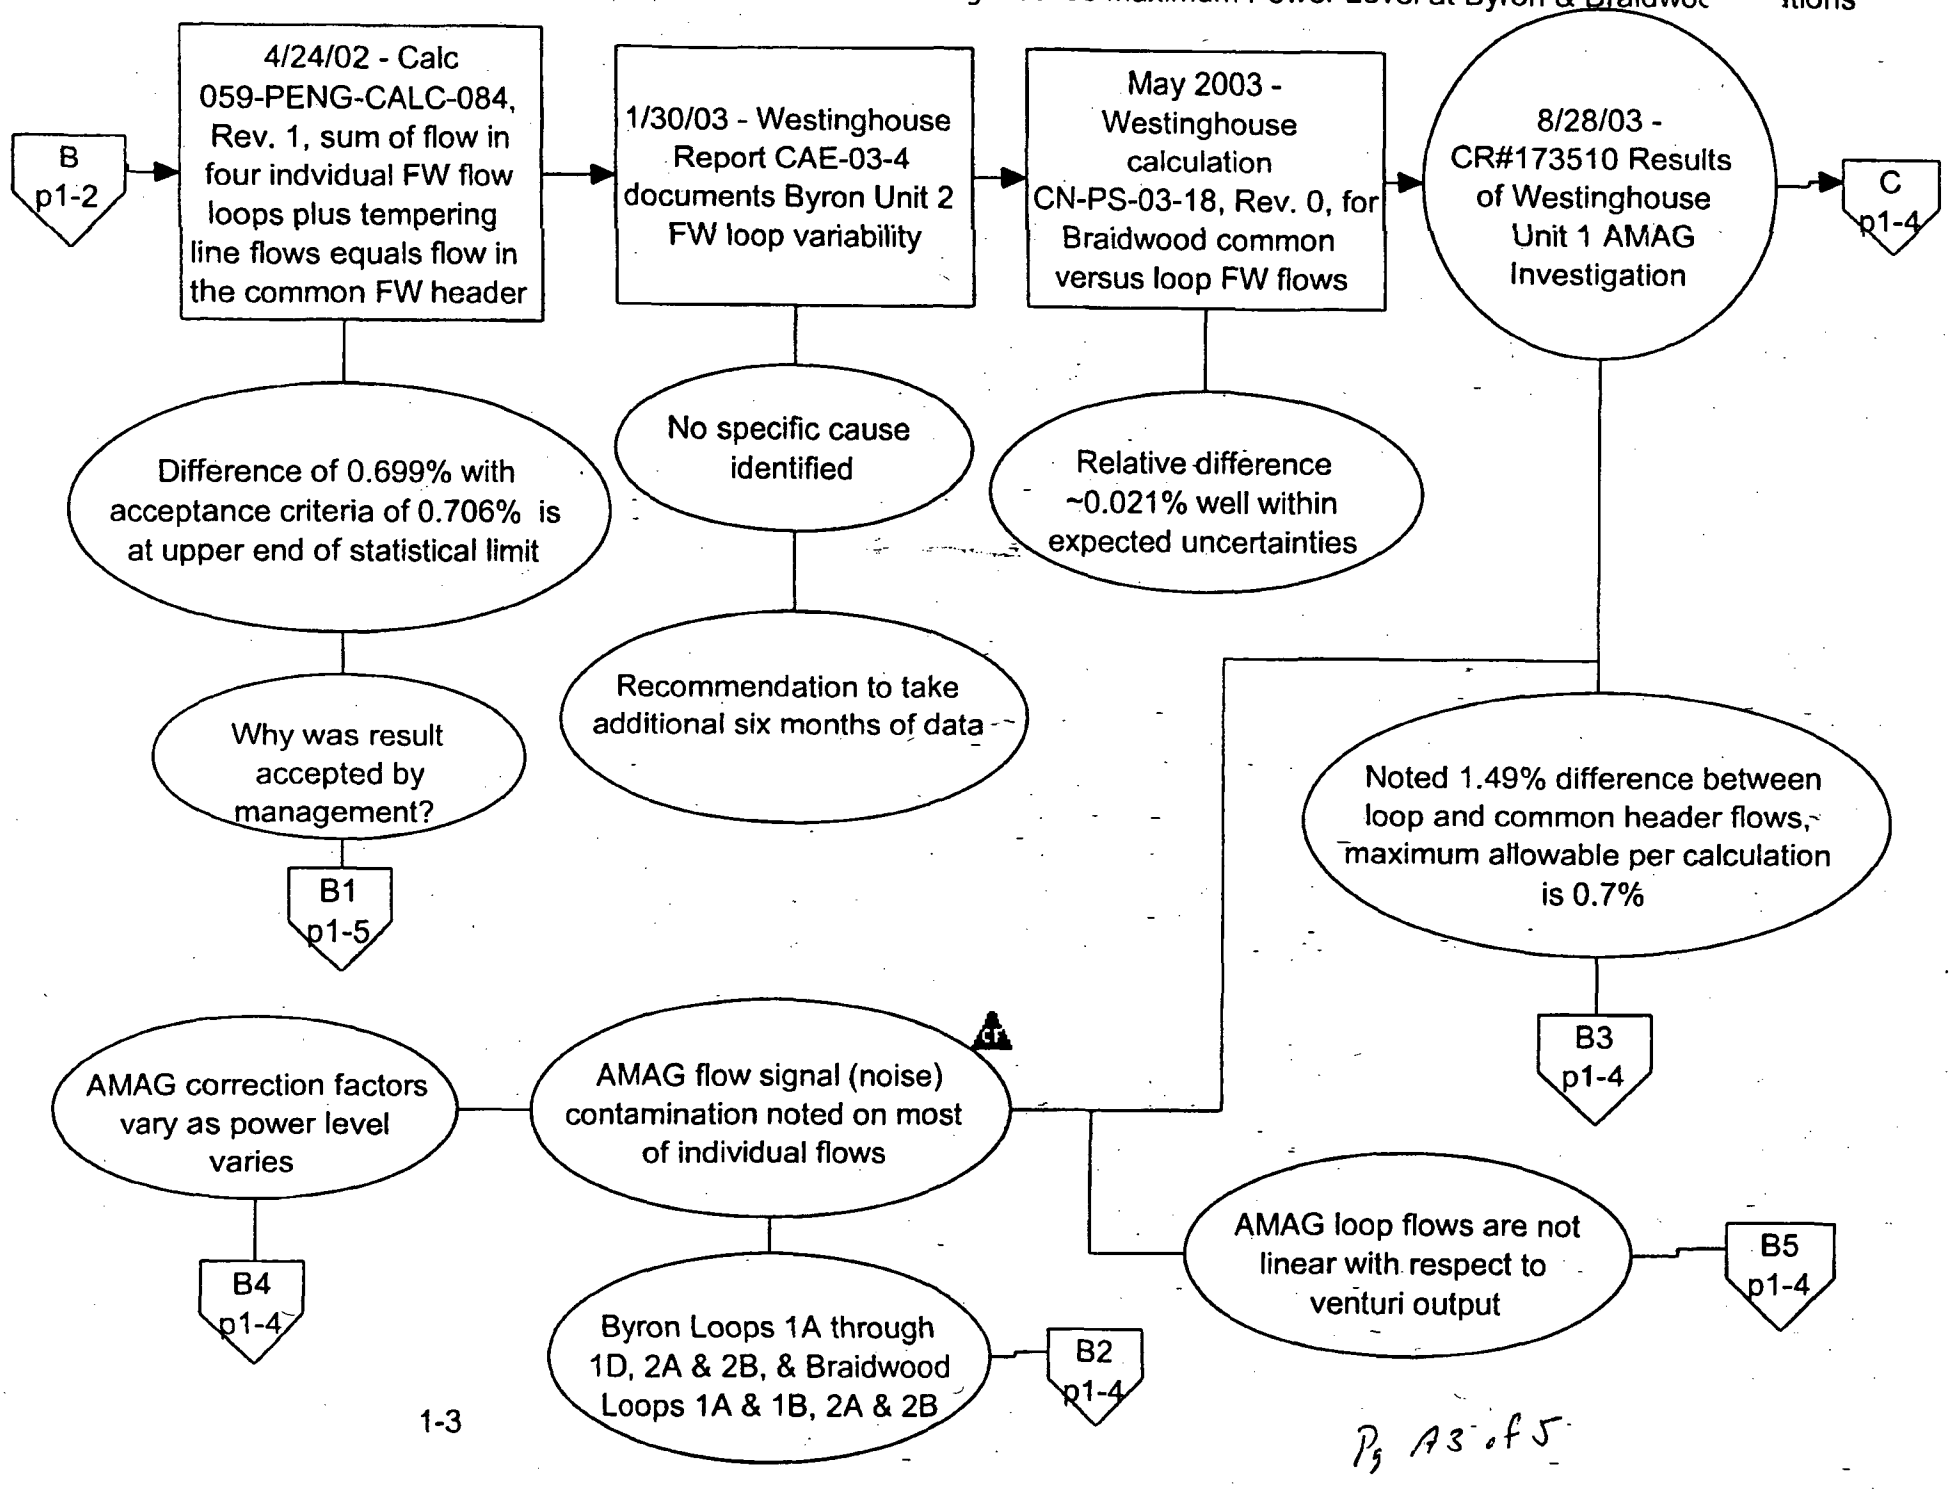
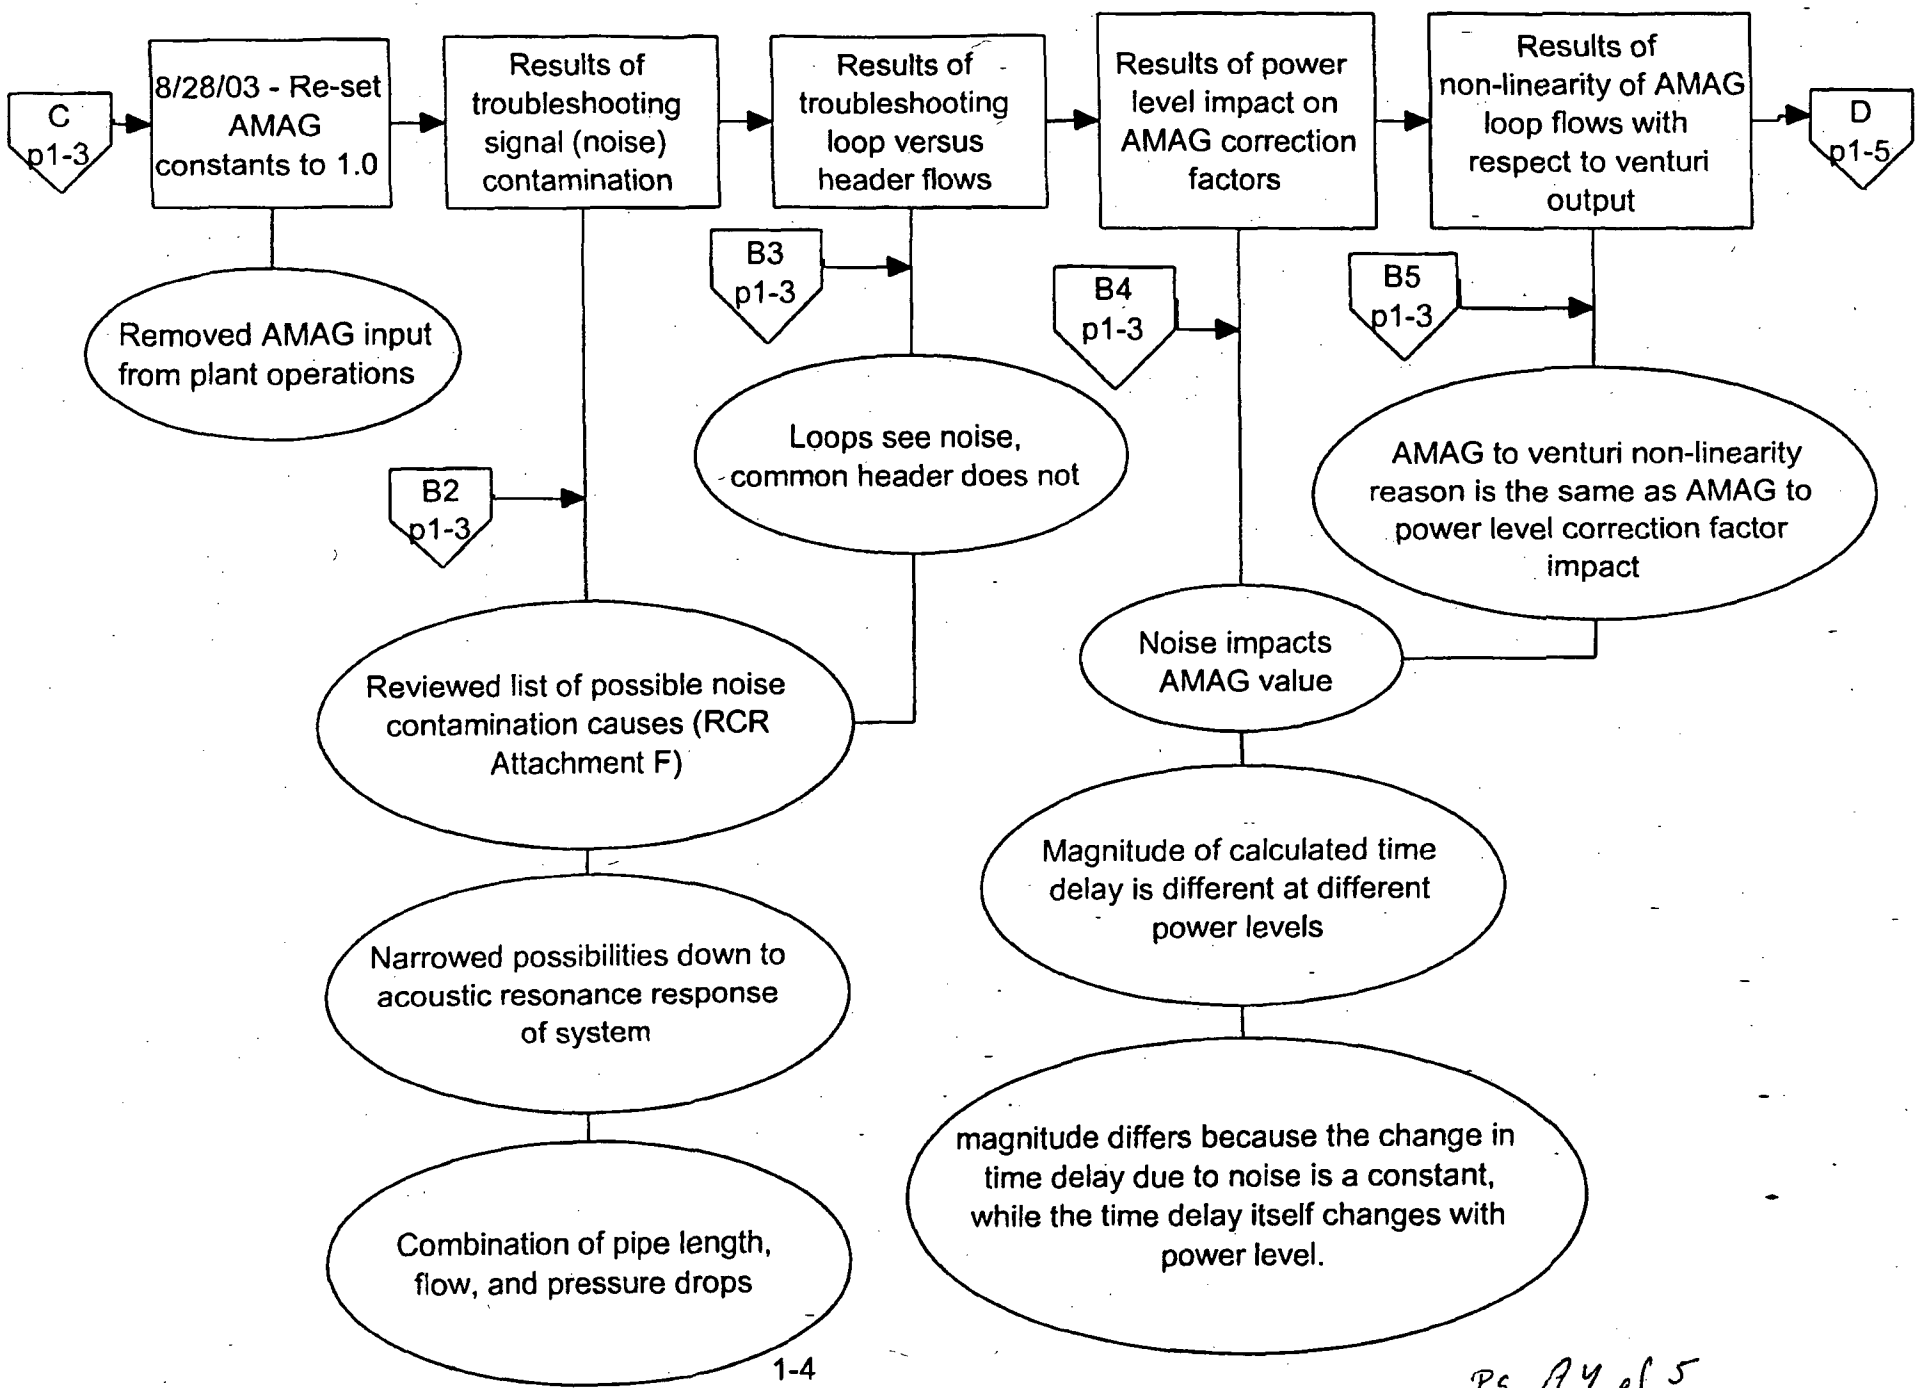
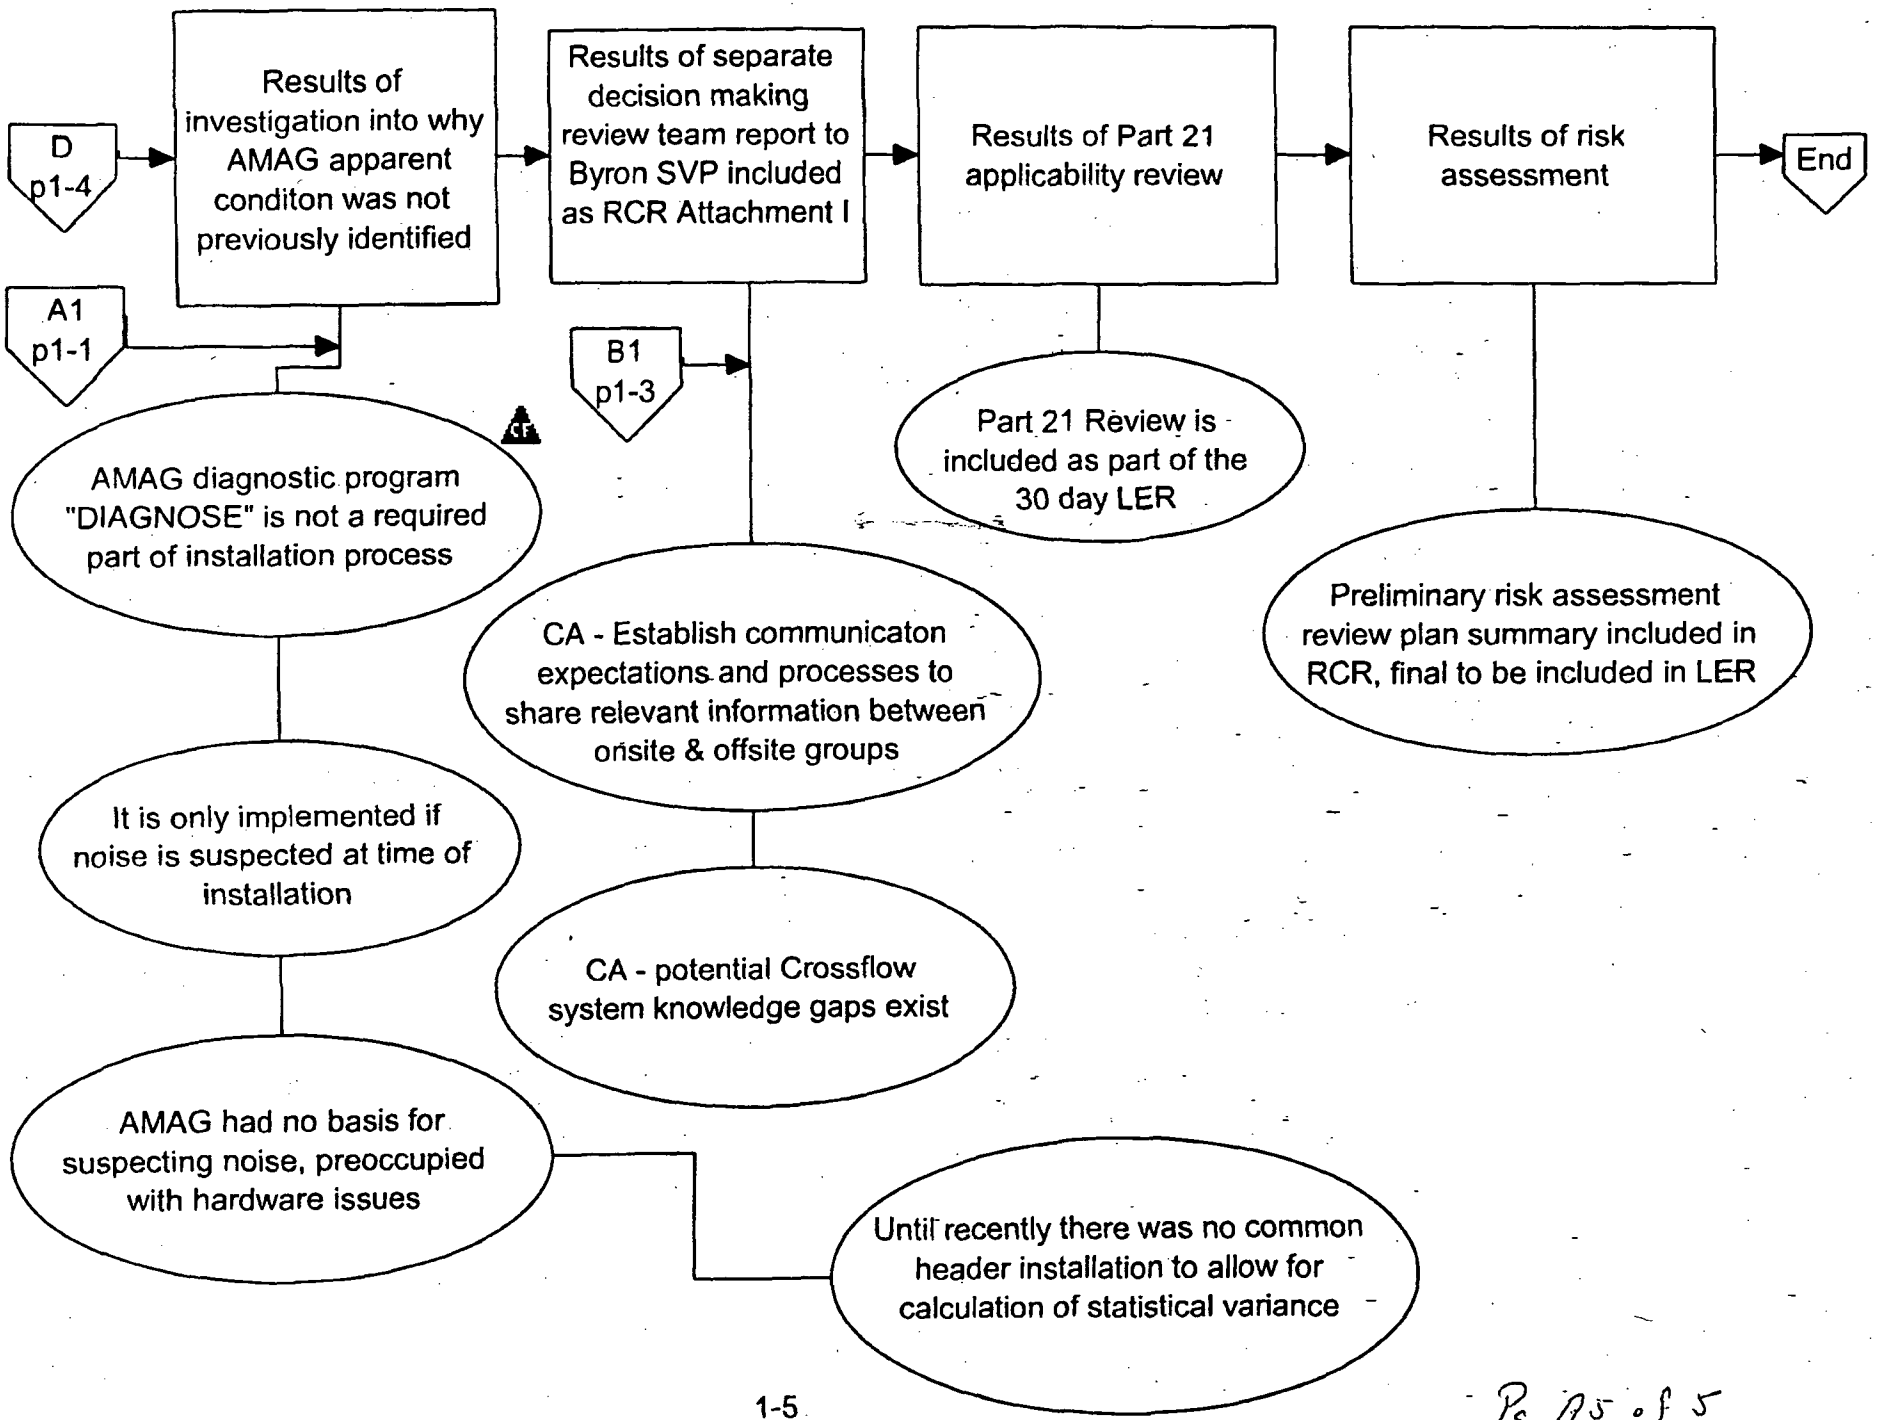
Attachment A - Event and Casual Factor Chart

Start
May 1999 - AMAG installations complete at all Byron & Braidwood Units
June 1999 - AMAG implemented at Braidwood Station, Units 1 & 2
7/29/99 - Byron letter 99-109 documents Byron & Braidwood Station differences in post-AMAG implementation
May 2000 - AMAG implemented at Byron Station, Units 1 & 2
A p1-2
First documented review of AMAG discrepancies
SPP 99-016 & SPP 99-017 results indicate both Byron units over calculating FW flow values by ~ 2%
plant paramters indicate Byron units will operate at ~ 1% higher thermal power than Braidwood units, if AMAG is implemented.
Why did Plant Management approve AMAG implementation in light of unexplained plant operating data and contrary to the Plant Performance Monitoring Engineer's recommendation?
Management missed opportunity to address AMAG concerns prior to implementation
A1 p1-5

A
p1-1
10/5/01 - CR#78729 Evaluation of Braidwood Unit 1 pre-power uprate test results (Braidwood Unit 1 ~ 19 MWe < Byron Unit 1
10/16/01 - CR#80251 Braidwood Unit 1 achieves full power after power uprate (Byron Unit 1 turbine flow capacity < Braidwood Unit 1 by at least 1%
1/17/02 - CR#91771 Unplanned AMAG difference between Byron & Braidwood Stations (Byron Unit 1 ~ 1.5% to 2.5% higher than Braidwood Unit 1
3/29/02 - CR#101618 Unexpected & unexplained Unit 2 FW venturi calibration data suggests 0.6% increase in power
B
p1-3
Recommendation for Westinghouse to collect ~ six months of data
Largest difference was 2A loop ~ 1%

B
p1-2
4/24/02 - Calc 059-PENG-CALC-084, Rev. 1, sum of flow in four indvidual FW flow loops plus tempering line flows equals flow in the common FW header
1/30/03 - Westinghouse Report CAE-03-4 documents Byron Unit 2 FW loop variability
May 2003 - Westinghouse calculation CN-PS-03-18, Rev. 0, for Braidwood common versus loop FW flows
8/28/03 - CR#173510 Results of Westinghouse Unit 1 AMAG Investigation
C
p1-4
Difference of 0.699% with acceptance criteria of 0.706% is at upper end of statistical limit
No specific cause identified
Relative difference ~0.021% well within expected uncertainties
Why was result accepted by management?
Recommendation to take additional six months of data
B1
p1-5
Noted 1.49% difference between loop and common header flows, maximum allowable per calculation is 0.7%
B3
p1-4
AMAG correction factors vary as power level varies
AMAG flow signal (noise) contamination noted on most of individual flows

AMAG loop flows are not linear with respect to venturi output
B5
p1-4
B4
p1-4
Byron Loops 1A through 1D, 2A & 2B, & Braidwood Loops 1A & 1B, 2A & 2B
B2
p1-4

C
p1-3
8/28/03 - Re-set AMAG constants to 1.0
Results of troubleshooting signal (noise) contamination
Results of troubleshooting loop versus header flows
Results of power level impact on AMAG correction factors
Results of non-linearity of AMAG loop flows with respect to venturi output
D
p1-5
Removed AMAG input from plant operations
B3
p1-3
B4
p1-3
B5
p1-3
Loops see noise, common header does not
AMAG to venturi non-linearity reason is the same as AMAG to power level correction factor impact
B2
p1-3
Reviewed list of possible noise contamination causes (RCR Attachment F)
Noise impacts AMAG value
Magnitude of calculated time delay is different at different power levels
Narrowed possibilities down to acoustic resonance response of system
magnitude differs because the change in time delay due to noise is a constant, while the time delay itself changes with power level.
Combination of pipe length, flow, and pressure drops

D
p1-4
Results of investigation into why AMAG apparent conditon was not previously identified
Results of separate decision making review team report to Byron SVP included as RCR Attachment I
Results of Part 21 applicability review
Results of risk assessment
End
A1
p1-1
B1
p1-3
AMAG diagnostic program "DIAGNOSE" is not a required part of installation process
Part 21 Review is included as part of the 30 day LER
CA - Establish communicaton expectations and processes to share relevant information between onsite & offsite groups
Preliminary risk assessment review plan summary included in RCR, final to be included in LER
It is only implemented if noise is suspected at time of installation
CA - potential Crossflow system knowledge gaps exist
AMAG had no basis for suspecting noise, preoccupied with hardware issues
Until recently there was no common header installation to allow for calculation of statistical variance

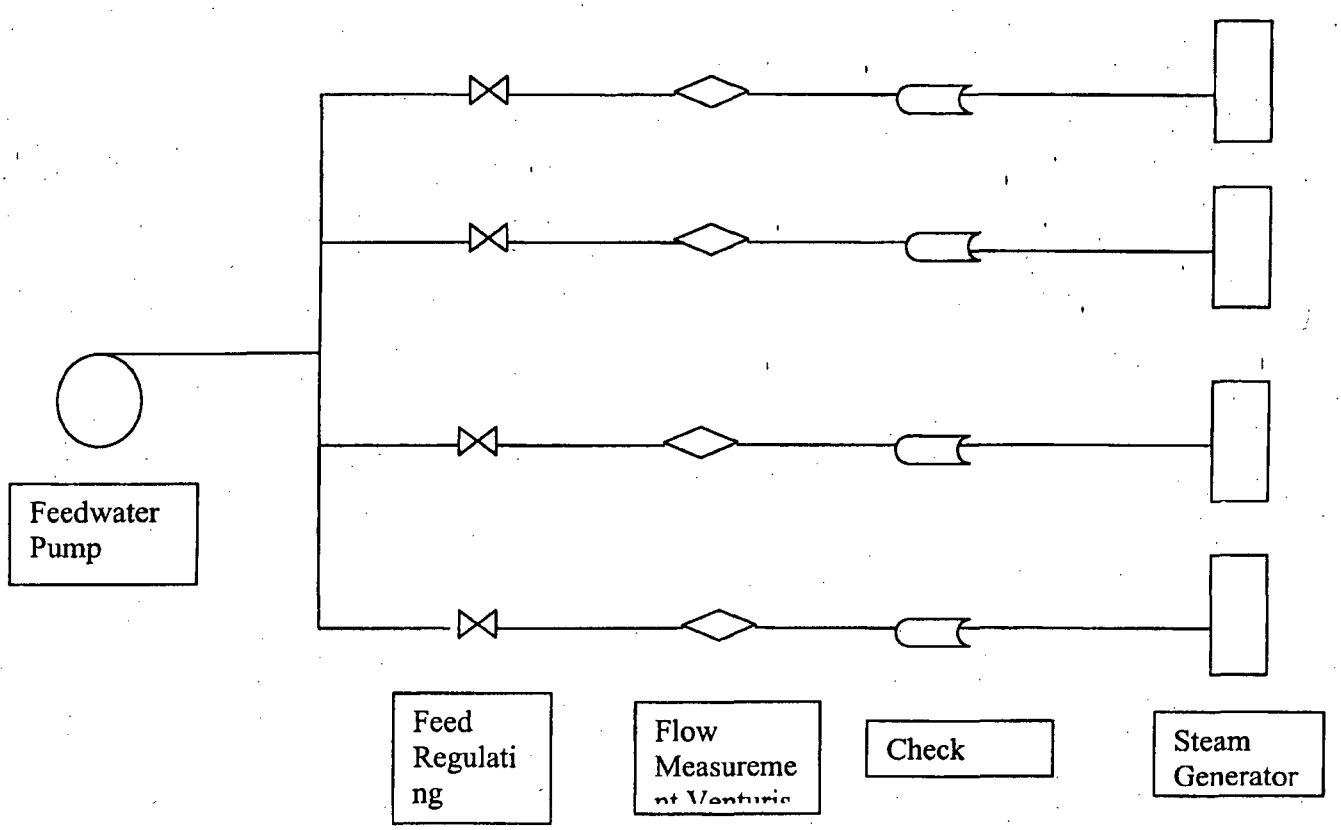
Typical Feedwater Line Schematic

Where
c= sound speed, fps
L= length of pipe
f= frequency
and i=1,2,...n

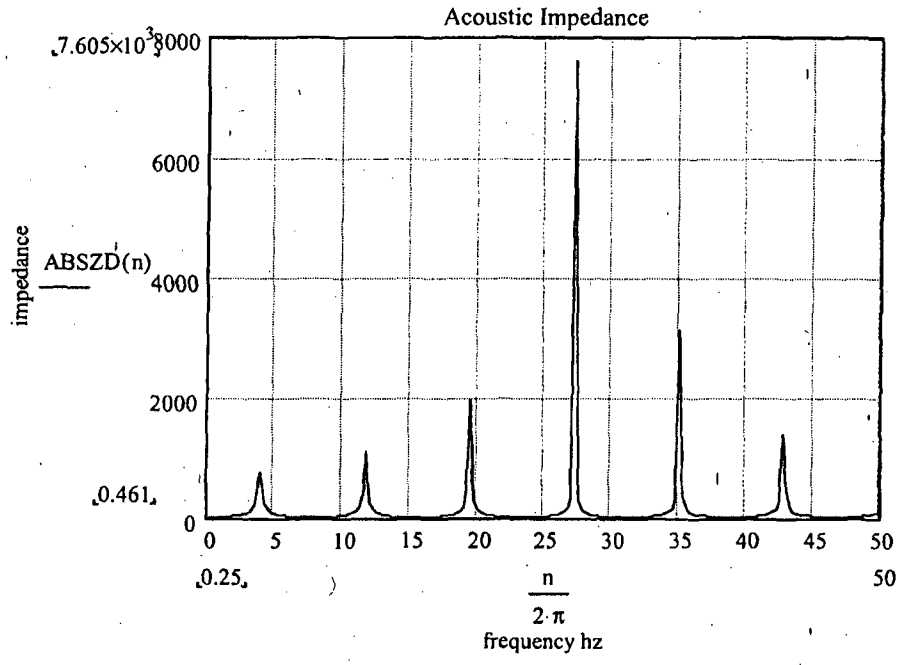
The frequency response can also be characterized using acoustical impedance methods as delineated in Wylie "Fluid Transients in Systems". Employing this approach for the common header yields the impedance as a function of frequency as shown on the next page:

This plot shows agreement with the frequencies predicted using open-closed formulas for the common header, and suggests that the most significant mode for excitation of the common header would be approximately 27 hz at full flow conditions. A similar calculation for the combined pump discharge, bypass line, and common header, treated as a single diameter pipe carrying full flow yields the following results:

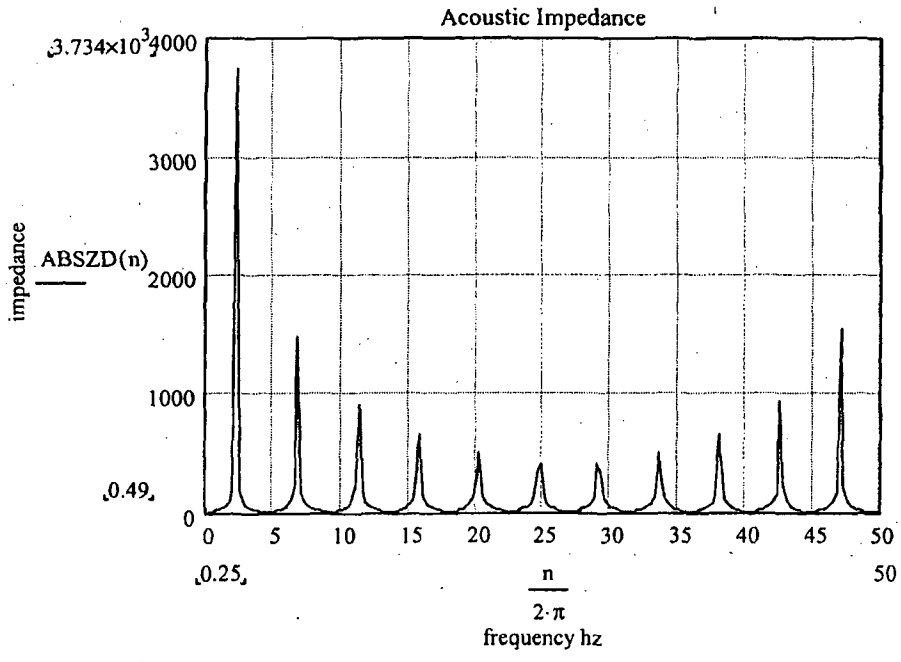
This result also compares favorably with the frequencies predicted by the open-closed formulation generated above. It should be noted that this approach is a simplified one, and that the actual system contains parallel paths carrying significant flows that could be expected to result in similar frequency predictions, but significantly different magnitudes of the impedances at specific frequencies than shown in the above figure.
