SUBJECT: STAFF OBSERVATIONS FROM JANUARY 2008 TRIP TO THE PCI/ALDEN TEST FACILITY TO OBSERVE HEAD LOSS TESTING FOR WOLF CREEK AND CALLAWAY PLANTS

OBSERVATIONS OF TESTING AT ALDEN RESEARCH LABORATORY
JANUARY 16 TO JANUARY 18, 2008

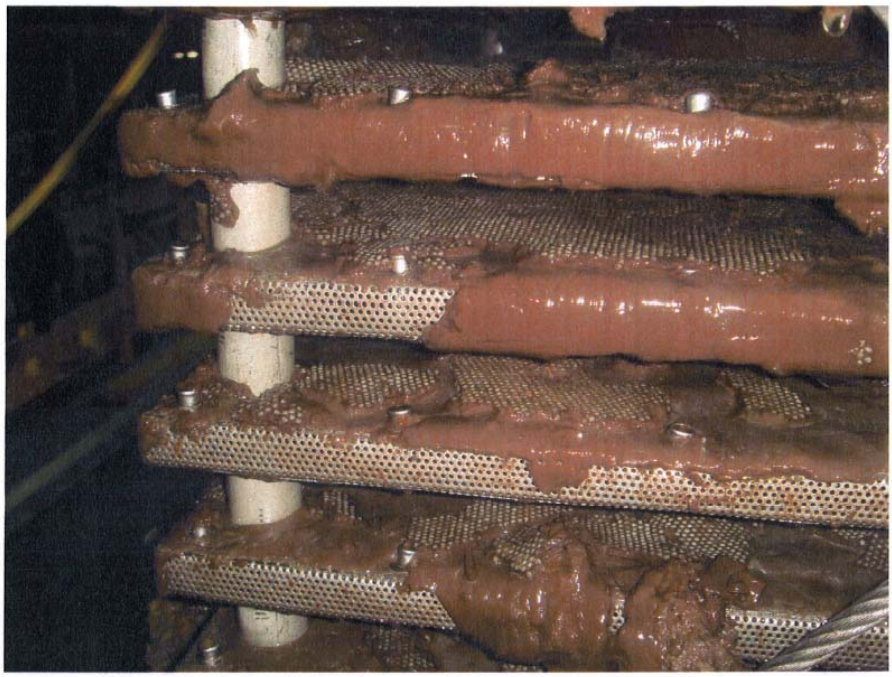
Figure 1 shows evidence that a thin bed accumulation formed. In this photo, small sections of accumulation at the edges of the disks look like a classic thin bed formation. At others location, such as on the bottom disk in the photo, globs of scooped up thin bed debris can be seen. It is unrealistic to assume a thin bed can form at selected locations, such as at disk edges, and have no debris accumulate on other screen surfaces. The reasonable conclusion was that a thin bed formed on all strainer surfaces but was subsequently highly disrupted at test termination which effectively cleared substantial screen surface of debris. A head loss calculation using the NUREG/CR-6224 correlation demonstrates that a thin bed consisting of the walnut flour and the chemical precipitates could cause the observed head losses. In this calculation, the full load of walnut flour and the chemical precipitates was assumed to accumulate in the debris bed and that the specific surface area of the chemical precipitates was on par with that of calcium silicate. The correlation indicated that the walnut flour alone could not cause such a high head loss.

Figure 1. Evidence of Thin-Bed Debris Accumulation
