Moab Site Project Completion Report

Appendix Package Off-Pile Remediation

July 2008

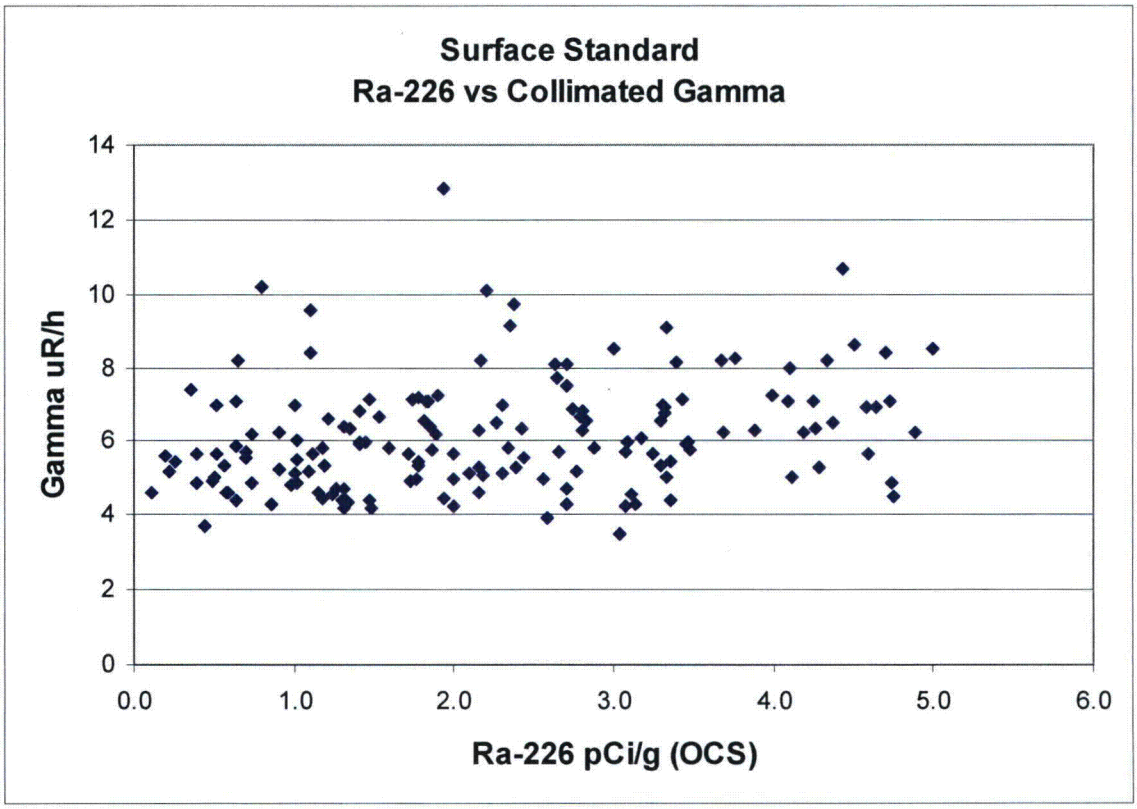
Figure 2. Collimated Data for Areas Verified to the Surface Standard

To determine the background ranges for the excavated area, the GS/GPS data were used to calculate the average gamma for verification blocks where soil sampling showed the block met the cleanup standard. Each gamma value represents the average of approximately 30 GS/GPS measurements within that block. A summary of the block averages is shown in Table 3. The paired average gamma and Ra-226 soil results for the gamma data are shown in Table 4 and graphically presented in Figure 2. The block locations are shown in Plates 1 and 2.

For areas verified to the surface standard, the maximum concentration of Ra-226 was 5.0 pCi/g, which is below the cleanup standard of 5.8 pCi/g (Table 6). The mean concentration was 2.2 pCi/g. The projected upper limit of the mean concentration, calculated at the 95 percent confidence level, was 2.35 pCi/g. These results indicate that the radionuclide concentrations do not exceed the Authorized Limits; therefore, all cleanup criteria have been met for the areas verified to the surface standard.
