WATTS BAR NUCLEAR PLANT UNITS 1 AND 2 - FAULTY ANCHOR PLATES AND BOLTS - WBRD-50-390/81-51, WBRD-50-391/81-49 - FIRST INTERIM REPORT

WATTS BAR NUCLEAR PLANT UNITS 1 AND 2
FAULTY ANCHOR PLATES AND BOLTS
WBRD-50-390/81-51, WBRD-50-391/81-49
10 CFR 50.55(e)
FIRST INTERIM REPORT

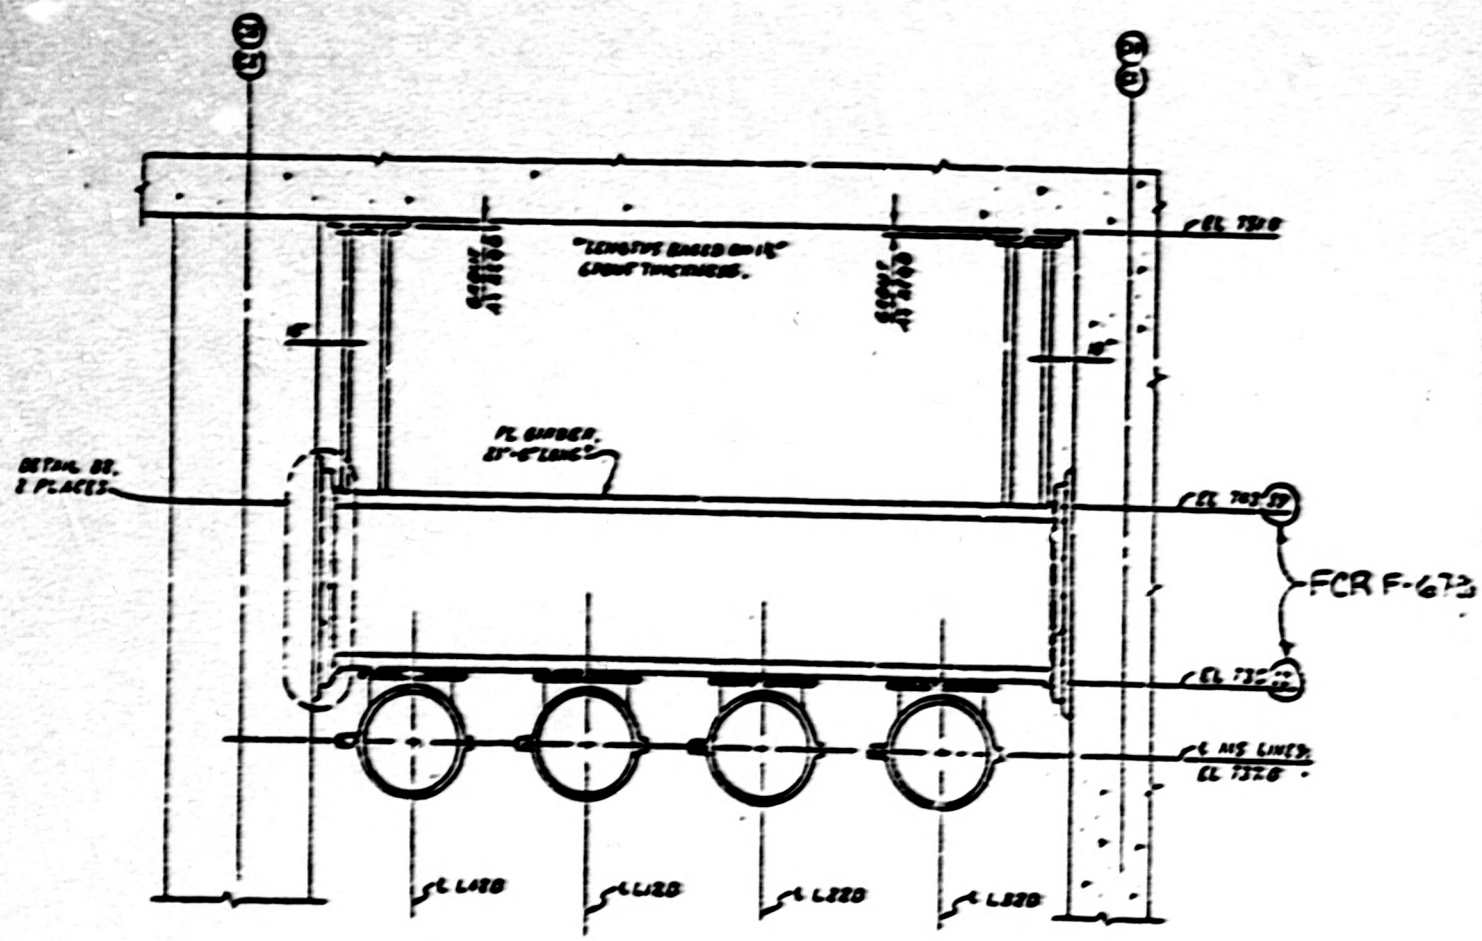
ELEVATION A2-A2
UNIT 1 AS SHOWN
UNIT 2 OPP HAND

The pipe rupture protection structures for main steam lines are shown on the attached drawings. The top part of each wall anchor plate has been bowing away from the walls, and therefore, the top two anchor bolts have been partially pulled out. The exact cause has not been determined, but it probably has to do with the welding sequence during fabrication.
