Subject: Byron Station, Unit 2, 60-Day Response to First Revised NRC Order EA-03-009, "Issuance of First Revised NRC Order (EA-03-009) Establishing Interim Inspection Requirements for Reactor Pressure Vessel Heads at Pressurized Water Reactors"

"Byron Generating Station Outage – B2R14
Reactor Vessel Head Penetration Examination"

Final NDE Report

WDI-PJF-1303982-FSR-001

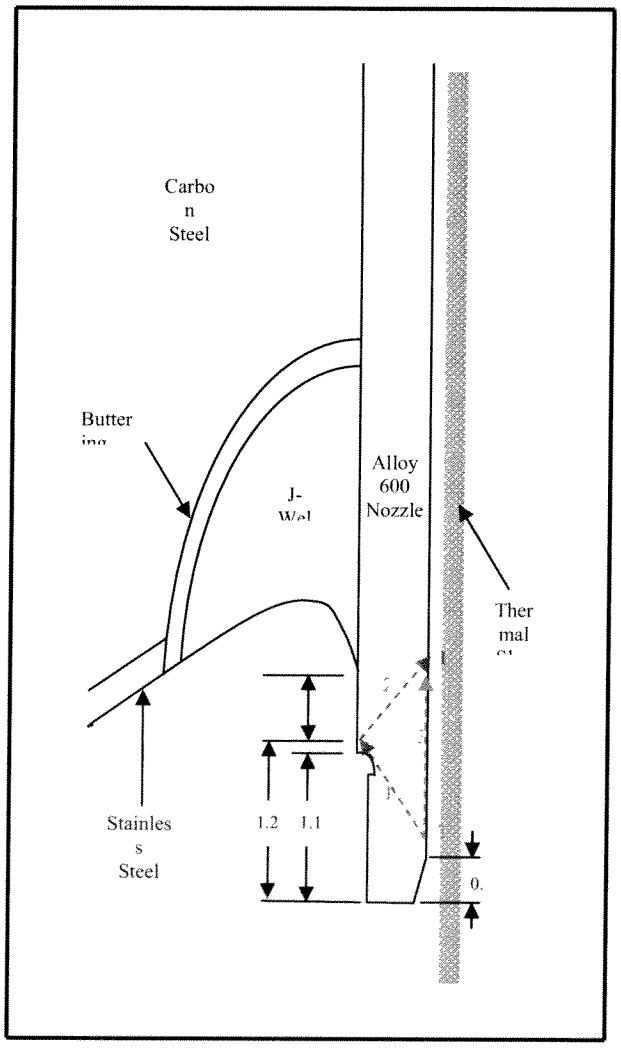
Figure 4.1
Byron Unit 2 Tube End Geometry

The configuration of the Byron Unit 2 CRDM penetration tubes is shown in the figure 4.1 below. This figure represents the tube-to-head geometry on the "downhill" side of the tube (0° location of the penetration). The bottom ends of all seventy-eight penetration tubes are threaded on the OD surface and have a 20° chamfer on the ID surface. The threads on the tube OD surfaces and chamfer on the ID surfaces represent geometric conditions which limit examination coverage near the bottoms of the tubes.

The coverage below the weld that was obtained during the B2R13 outage was measured and documented in WesDyne report PJF-1303451-FSR-001. The coverage below the weld obtained for each tube during the B2R14 outage was the same as the coverage below the weld obtained during the B2R13 outage.
