Subject: 2008 Annual Pond Inspection Report
Source Materials License SUA-1534
Docket Number 40-8943

CROW BUTTE MINE

2008 POND INSPECTION REPORT

By: David V. Coe, PE
Nebraska Registration No. E - 4295

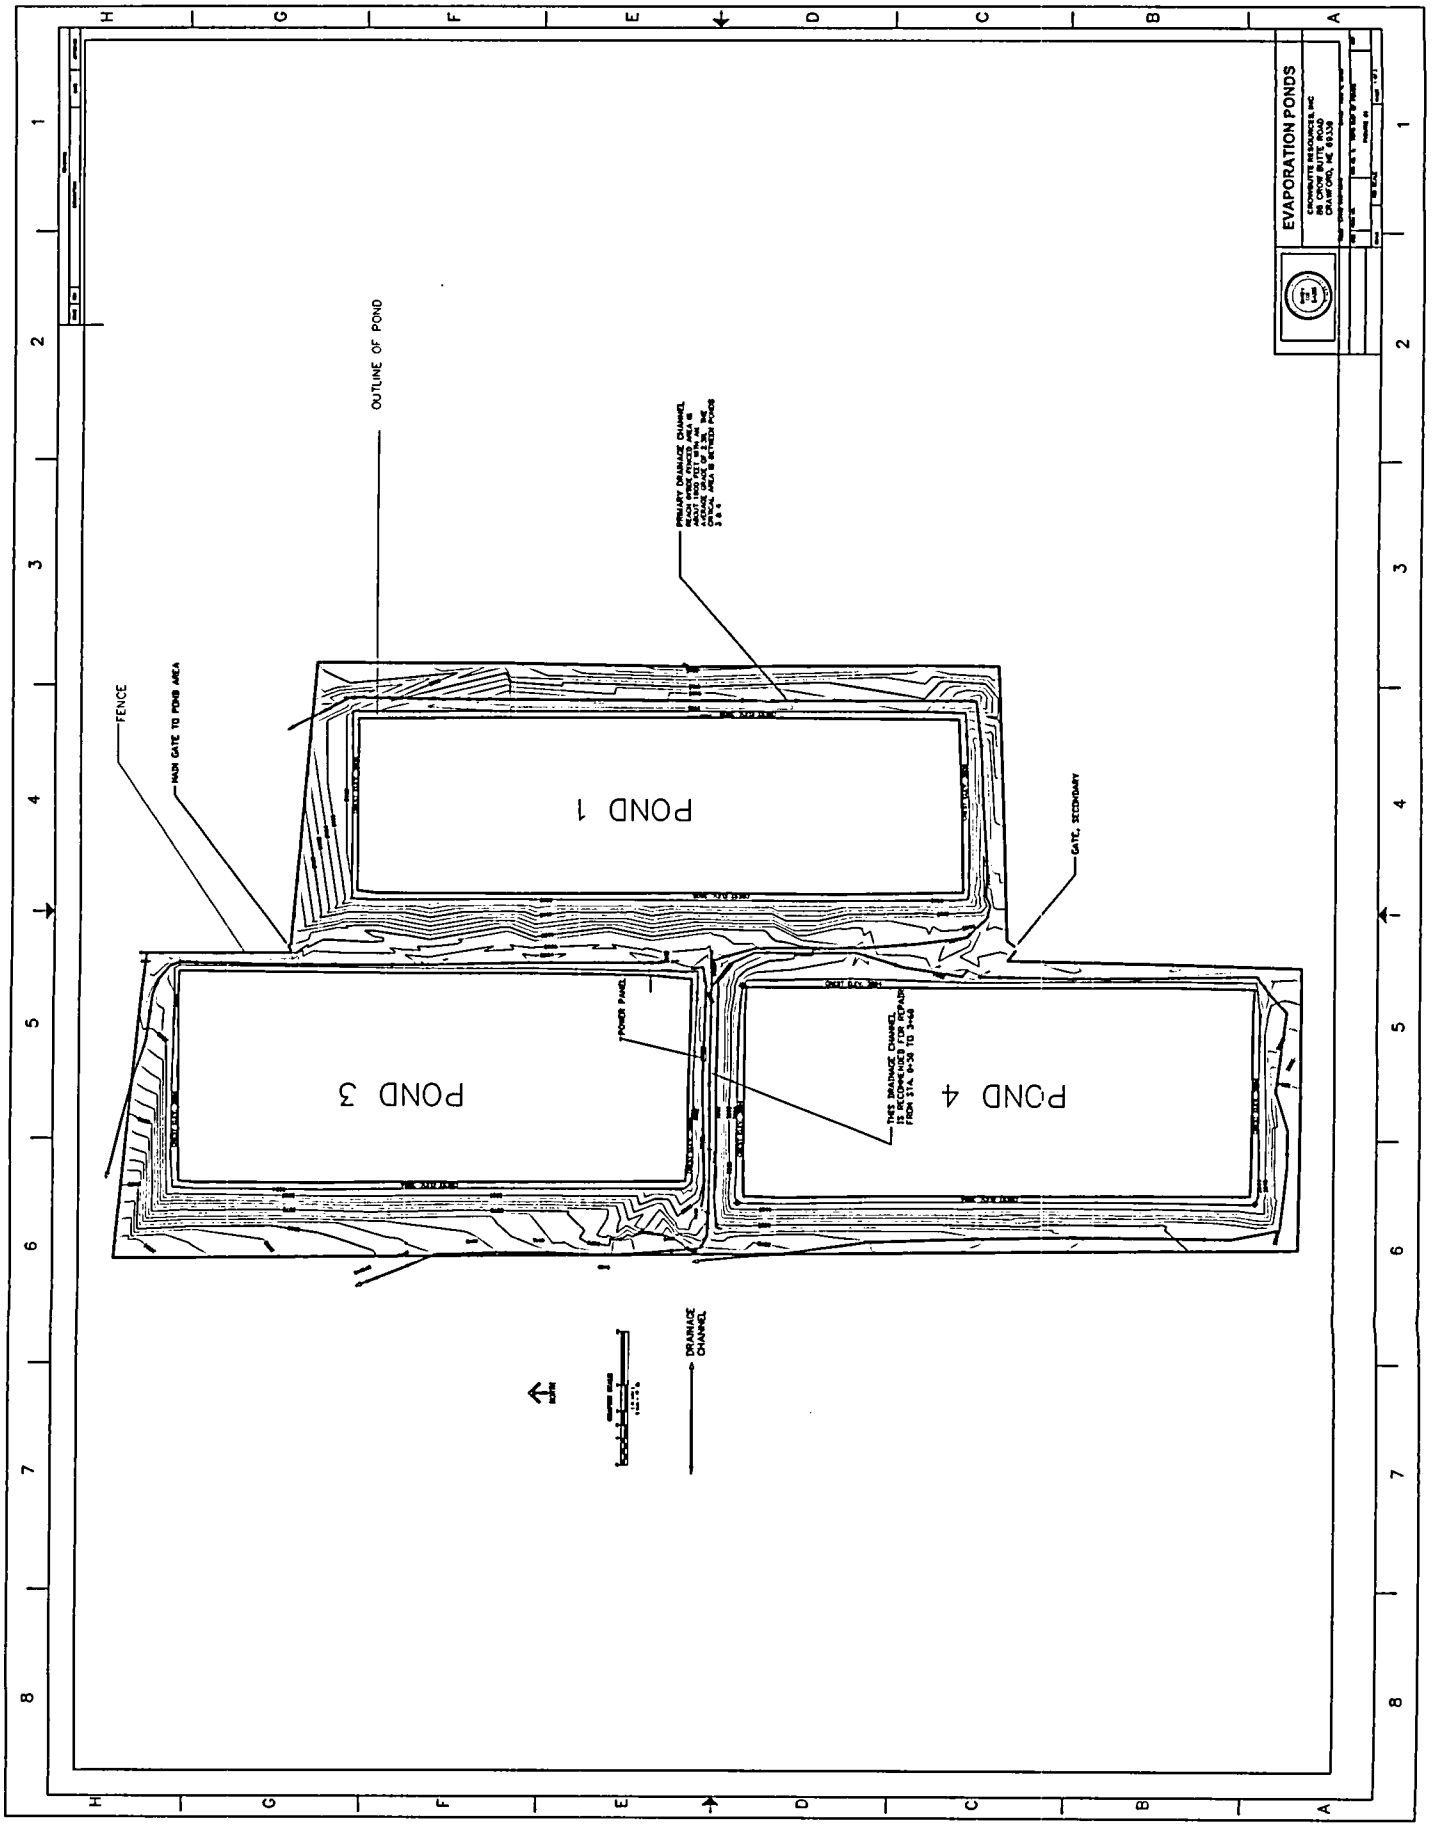
FIGURE - 1

EVAPORATION PONDS
OUTLINE OF POND
FENCE
MAIN GATE TO POND AREA
POND 1
POND 3
POND 4
GATE, SECONDARY
DRAINAGE CHANNEL

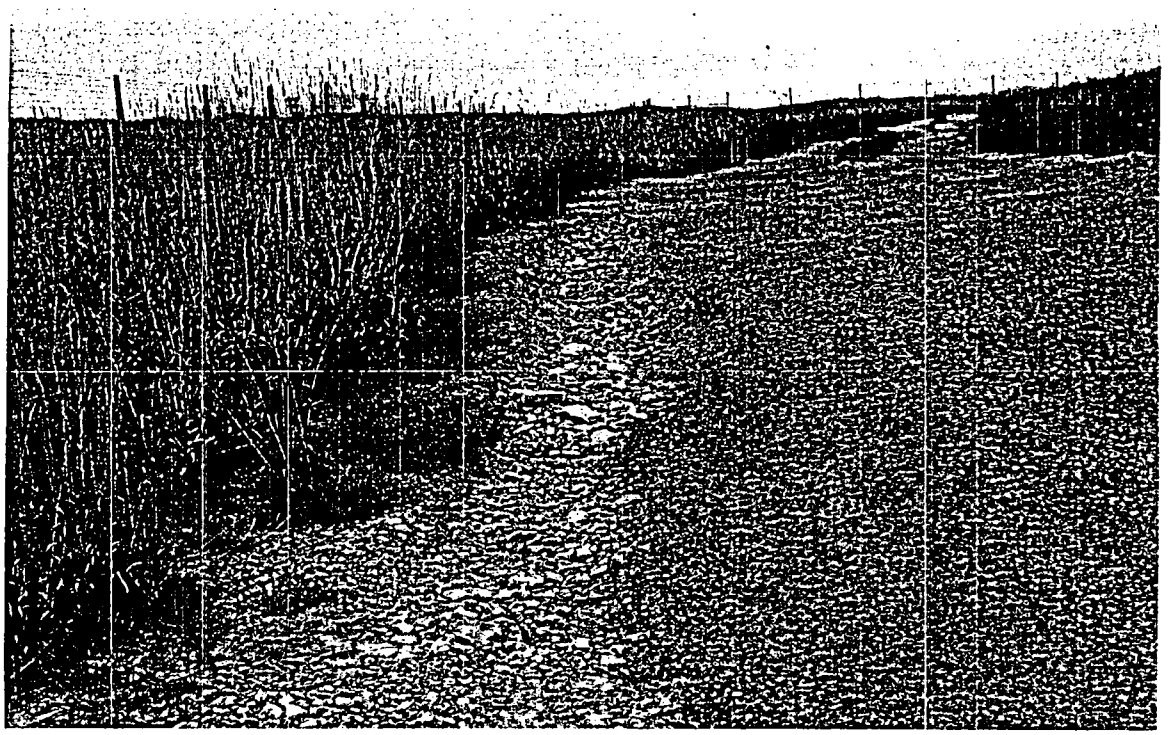
#11 North view of west embankment & berm of pond #1, good protection against erosion of berm & protection of area adjacent to pond liner. 10/20/08
