Con Edison - Indian Point Station
Outside Materials Notebook

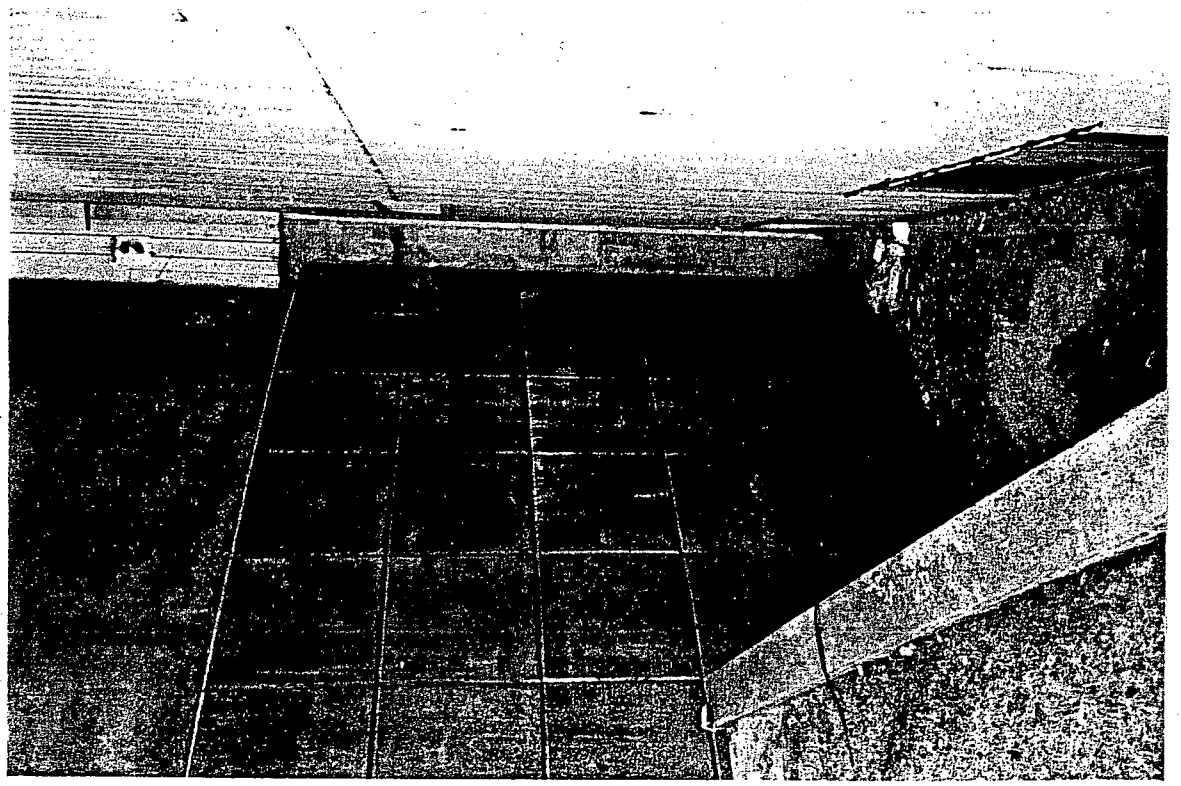
Location: 5. ABFP alleyway 15'

Description of Potential: Overhead line steam blowout in distant past.

Area was cleared for free release in late 80's.
Followup sampling/results: /
low spot: 1.2E-5 uCi/g; general area: 3E-6 uCi/g

THE PITCH OF THIS ALLEYWAY DOES NOT PERMIT FREE DRAINAGE OF RAINWATER. IT'S K. ROPER'S JOB TO FIX THIS SITUATION, AND DON BELIEVES THAT PAVING AFTER A GRADING IS THE LIKELY APPROACH. IT'S LONG BEEN KNOWN THAT THERE'S ACTIVITY IN THE SOILS FROM LONG PAST PLANT OPERATION. AFTER YESTERDAY'S SAMPLING/ANALYSIS, I'D SAY WE HAVE A DISPOSAL PROBLEM AS WELL. ACTIVITY CONCENTRATION IN SHALLOW (2-3 INCH DEEP SAMPLES) AT THE CLAY-LIKE LOW SPOT NEXT TO THE LOUVERS RUNS EQUAL AMOUNTS OF CO-60 AND CS-137, TOTALLING 1.2E-5 UCI/G. ANOTHER SAMPLE (COMPOSITE) FROM NEARBY GENERAL AREAS IS ABOUT 1/4 OF THE LOW SPOT ACTIVITY. UNLESS REMEDIATED NOW, THESE SOILS WILL HAVE TO BE KEPT IN THE DATA FILE FOR DECOMMISSIONING PURPOSES. IN ANY EVENT, I DON'T BELIEVE WE CAN LEAVE THE PRESENT SITUATION ALONE. I HAVE INFORMATION ON OTHER SIMILAR SUBJECT AREAS AS WELL.

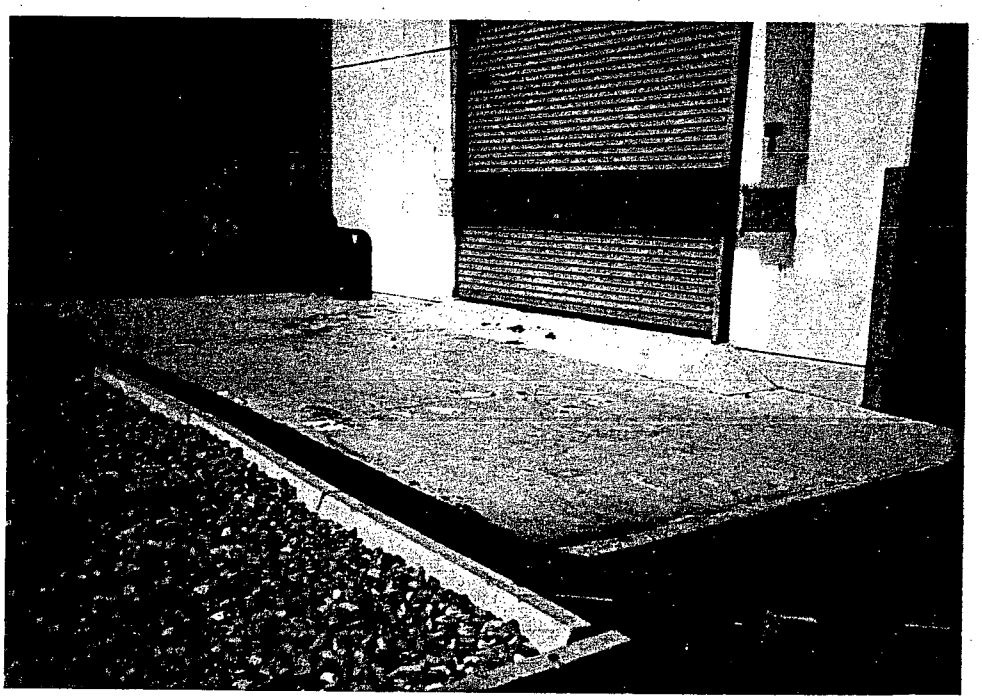
Location: 7. Hittman Shed boom door 70'
(to driveway) at CSB

Description of Potential: Prior operations and possible spills getting to or transported to concrete boundary and blacktop

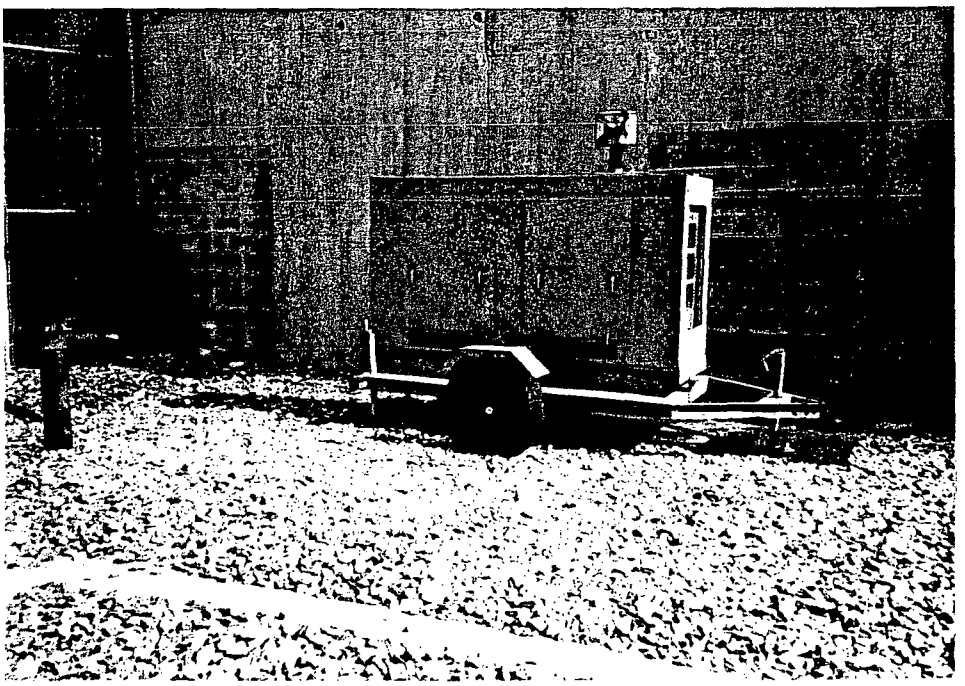
Location: 8. Transformer yard at RHR Wall

Description of Potential: Wall disassembly of RHR cells to remove motors from both pumps

6/23/92 shallow scrape results: 3.2E-6 Co-60 ; 5.6E-6 Cs-137

6/22/94 Composite outside 21 RHR/door : 1.24E-7 Co-60, 2.99E-7 Cs-137

6/22/94 at edge of storm drain, near hydrant : 2.58E-6 uCi/g Co-60
6.57E-7 uCi/g Cs-137

good candidate area for detailed grid survey (DHS, 6/28/94)

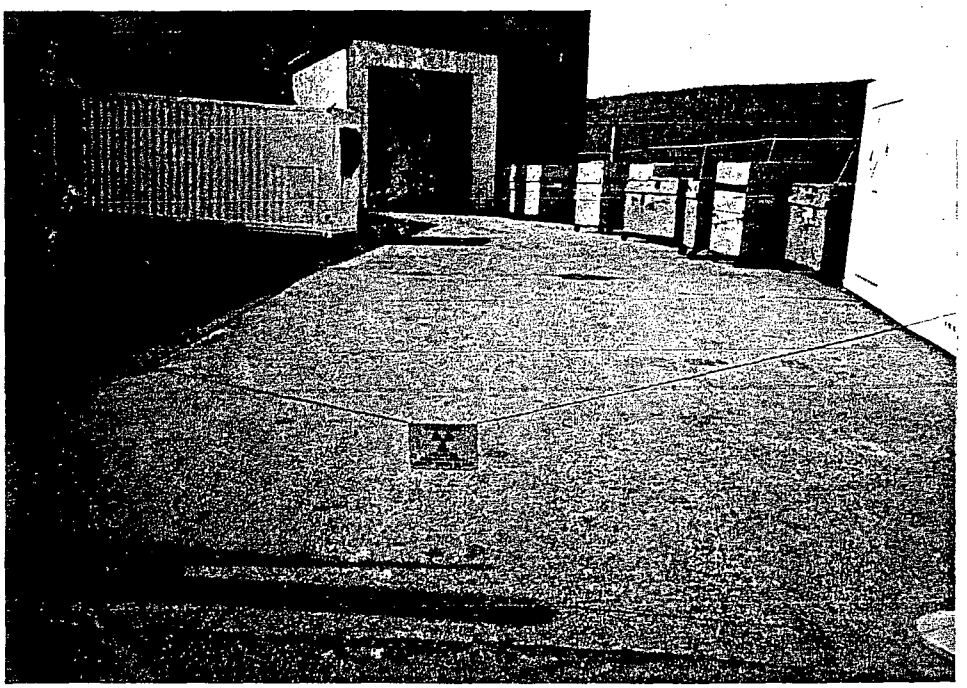
Location: Doghouse and Hill RMSA 95'

Description of Potential: Ongoing storage of RAM, movement of materials on grand scale in/out of VC

11/22/93 shallow samples at points of driveway run off, either side of gate/hope. HP lost samples. Resampled 4/26/94 5 point composite just outside North fence: Second sample at south side of driveway shoulder, at entrance to RMSA; also 4/26/94 5 point composite: 6.55E-7 uCi/g 4.06E-7 uCi/g Co-60; 9.29E-7 uCi/g Cs-137

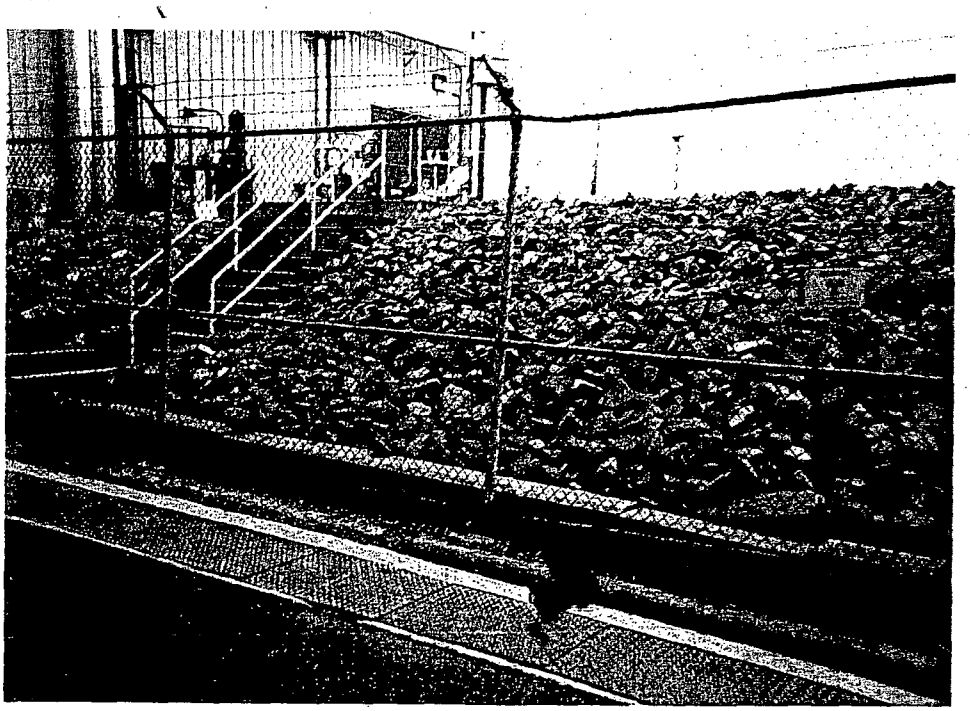
Location: 14 Diesel Generator Rooms & Fill 80'

Description of Potential: Carryover from RWST spills

bottom of fenceline, about 6'-10' from RWST / Diesel
Common fence: 2.7E-7 µCi/g Co-60, 3.2E-6 µCi/g Cs-137

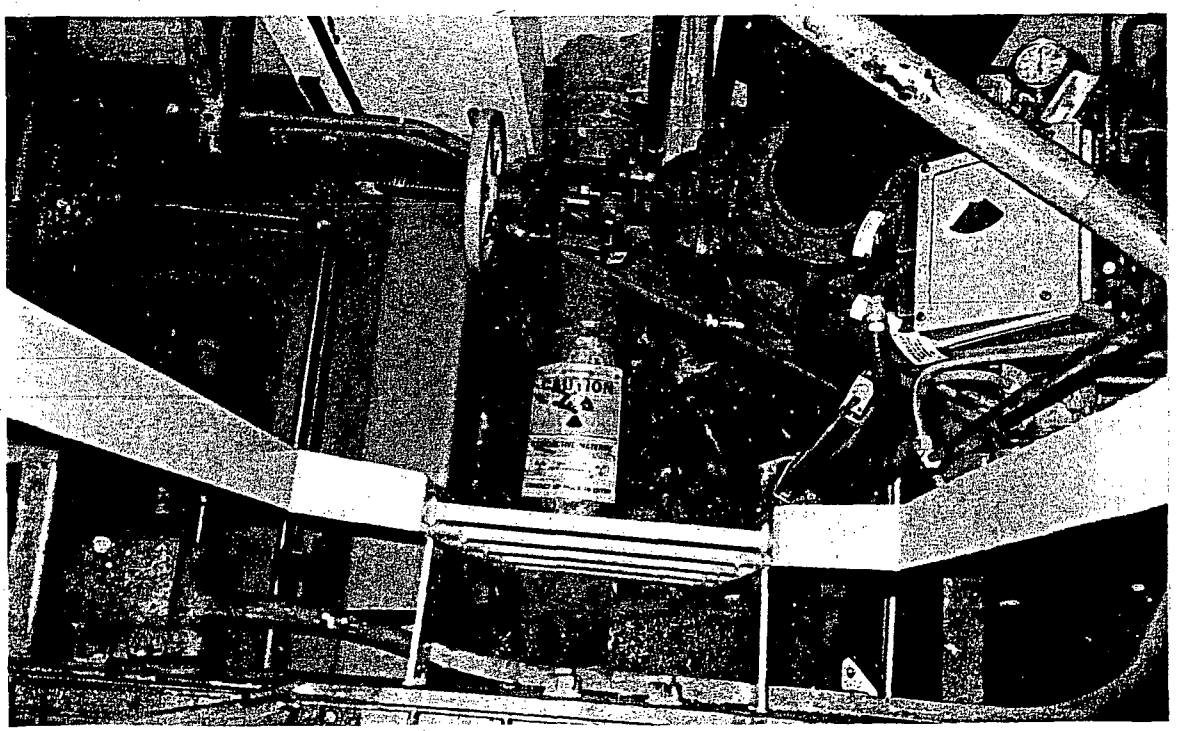
Location: 15. Blowdown line in EDG Bldg 72', and driveway to Unit 1

Description of Potential: Blowdown alternate path to Unit 1 Flash Tank; failed high temperature gasket in EDG building; underground leaks

General: leave alone until decommissioning; retain labeling of line in EDG Bldg.
If maintenance arises in/out of EDG Bldg, examine pipe environs and sample soil. Restore clean fill only.

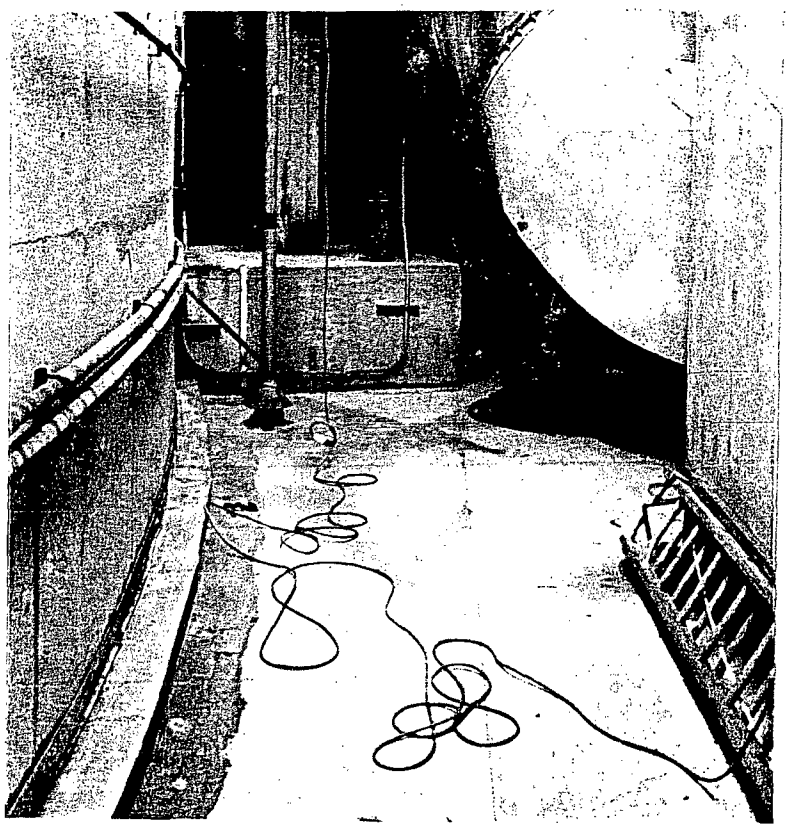
Location: 16. Fanbuilding alleyway 78'

Description of Potential: Plant vent, valves

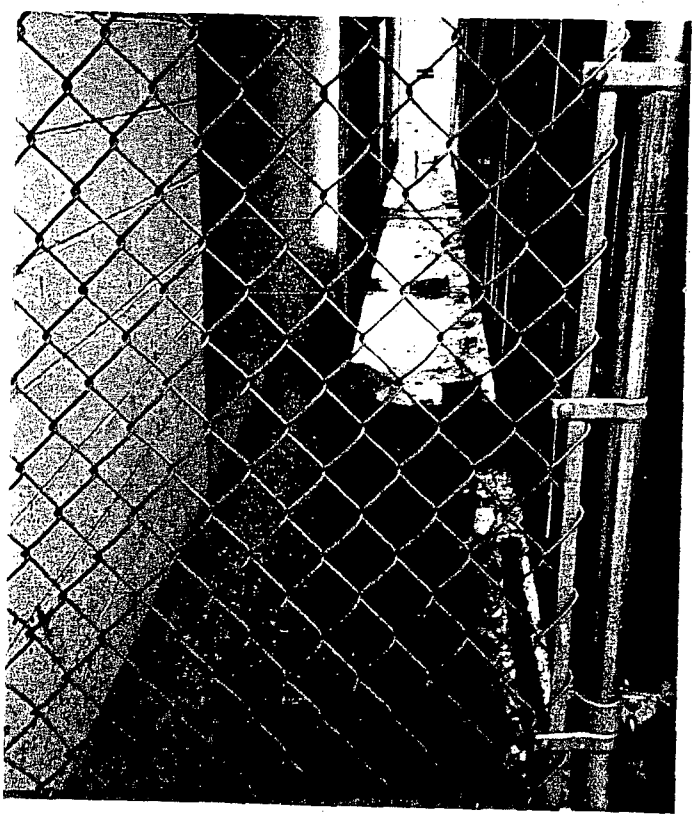
Location: 17. MOB/FSB alleyway

after photo taken, FSB to alleyway leak detected and repaired. Sb primarily in soils completely removed ~100 barrels. No activity above TS environmental soil LLD detected. Area access controlled/locked; anticipating no further operational survey actions

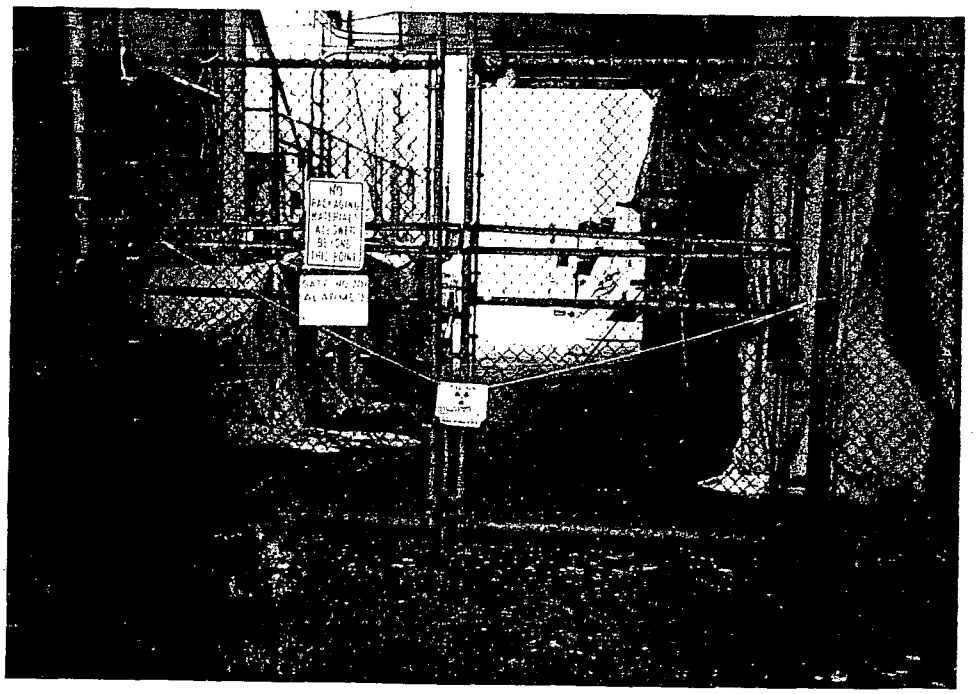
Location: 18. PAB/BAB driveway

Description of Potential: RAM movement and scaffold storage

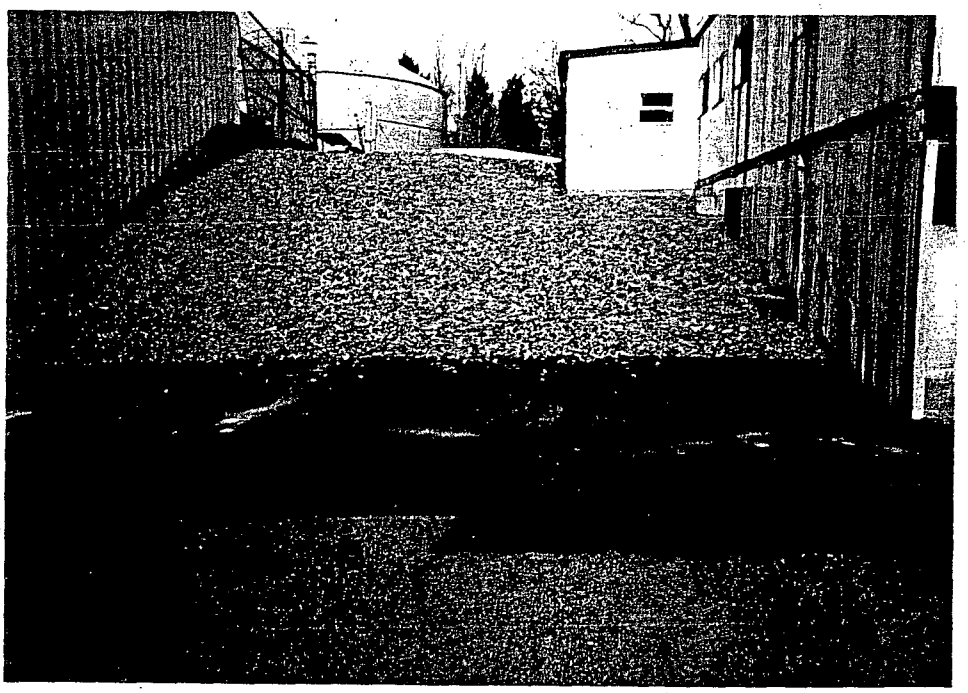
Location: 20. MOB/Construction Hill 90'-95'

Description of Potential: attendant to RAM monements in doghouse / hill area ; RAM storage at east end of doghouse/hill RAMSA.

2 samples composited, halfway up hill; 3/4 of way up hill on MOB side (estimated higher traffic area) 11/22/93 samples lost by HP. Resampled 4/26/94 4 point composite : 9.4E-8 uCi/g (this is less than environmental LLD)

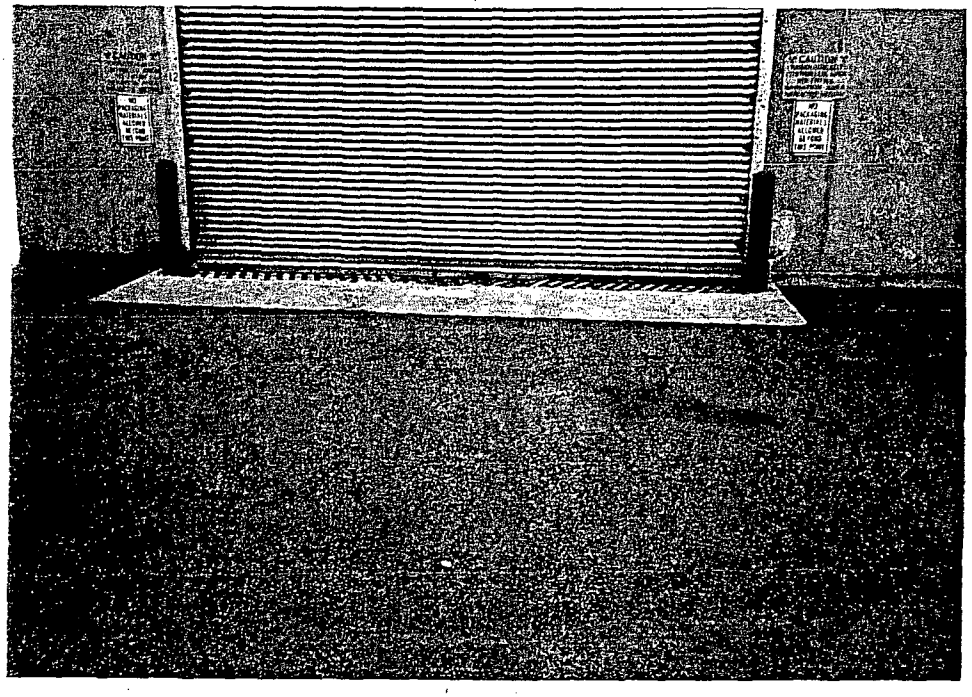
Location: 24. Outside RR door at FHF 70'

Description of Potential: Dam movements

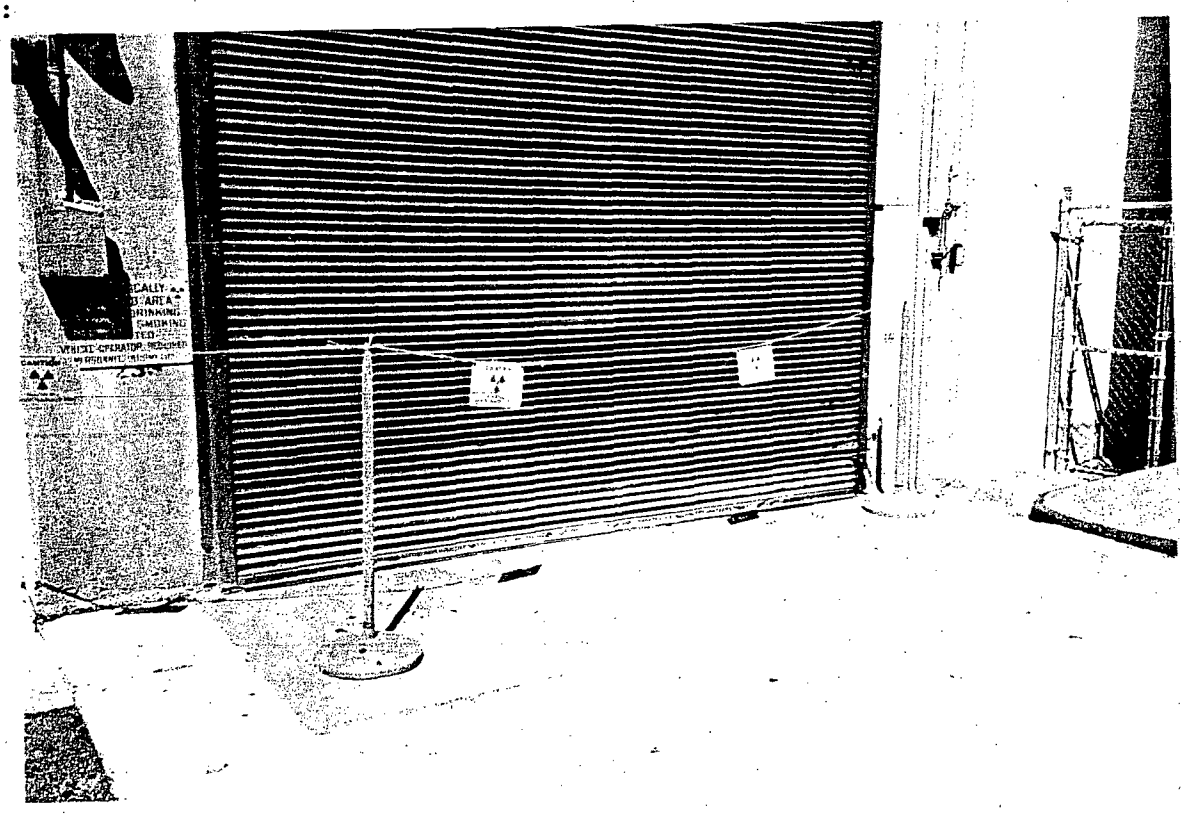
Location: 27. FSB Door 80'

Description of Potential: Lower level FSB activities
