From: STROUD, MICHAEL D [MSTROUD@entergy.com]
Sent: Monday, April 27, 2009 9:22 AM
To: Kimberly Green
Cc: Curry, John J; YOUNG, GARRY G; Caputo, Charles
Subject: FW: Revised comparative pictures
Attachments: Comparative Photo 1a.pdf; Comparative Photo 4a.pdf; Comparative Photo 3a.pdf

See attached comparative photos of containment spalling areas for the call at 1pm today.

I revised the pictures to go back to 2000 also. You can see some cosmetic changes in the 2000 to 2005 pictures but no structural signifigance.

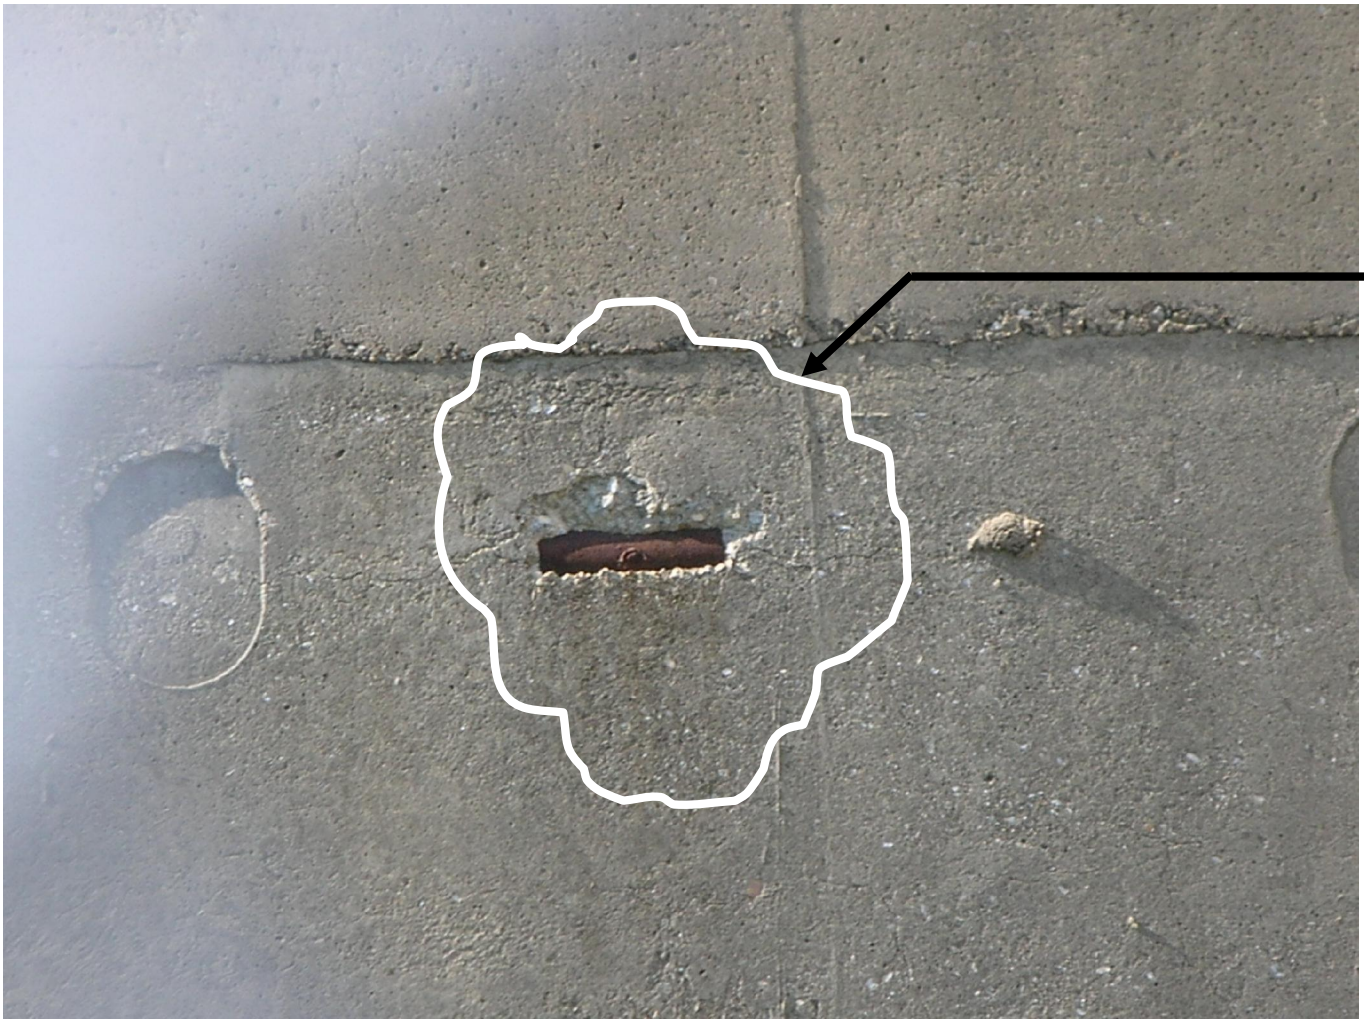
2005 IWL Photo

2” high by approx. 8” long Cadweld On Cylinder portion of U2 containment.

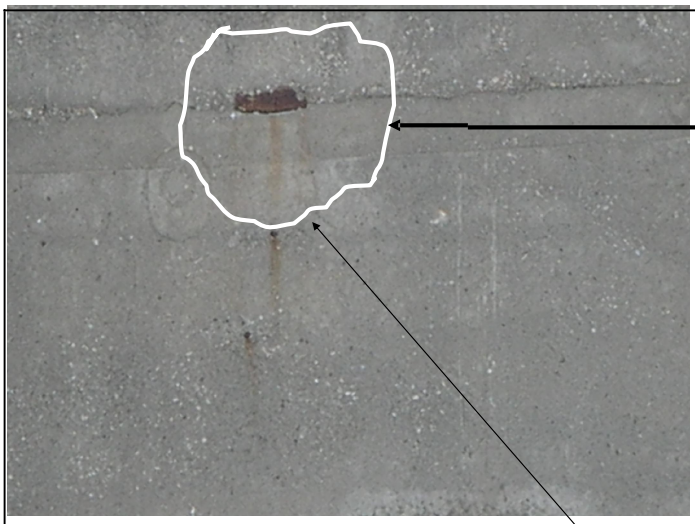
2005 IWL Inspections

~2" x 8" long exposed cadweld.
Note the small concrete patch material fell off between the 2000 and 2005 inspection.
Cosmetic change only

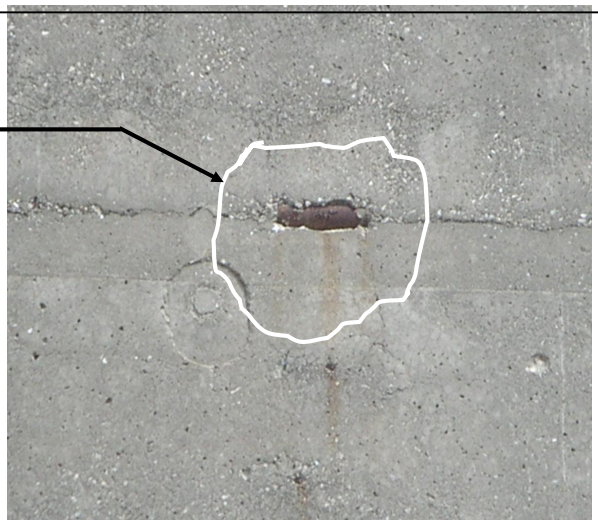
4-15-2009 Photo

8" diameter popout that fell between 2000 and 2005 inspections. Which exposed the embedded metal piece ~1" x 5" .
