SUBJECT: ASSESSMENT OF THE OYSTER CREEK 3-D FINITE ELEMENT ANALYSIS OF THE DRYWELL SHELL

STAFF ASSESSMENT OF THE OYSTER CREEK 3-D FINITE ELEMENT ANALYSIS OF THE DRYWELL SHELL

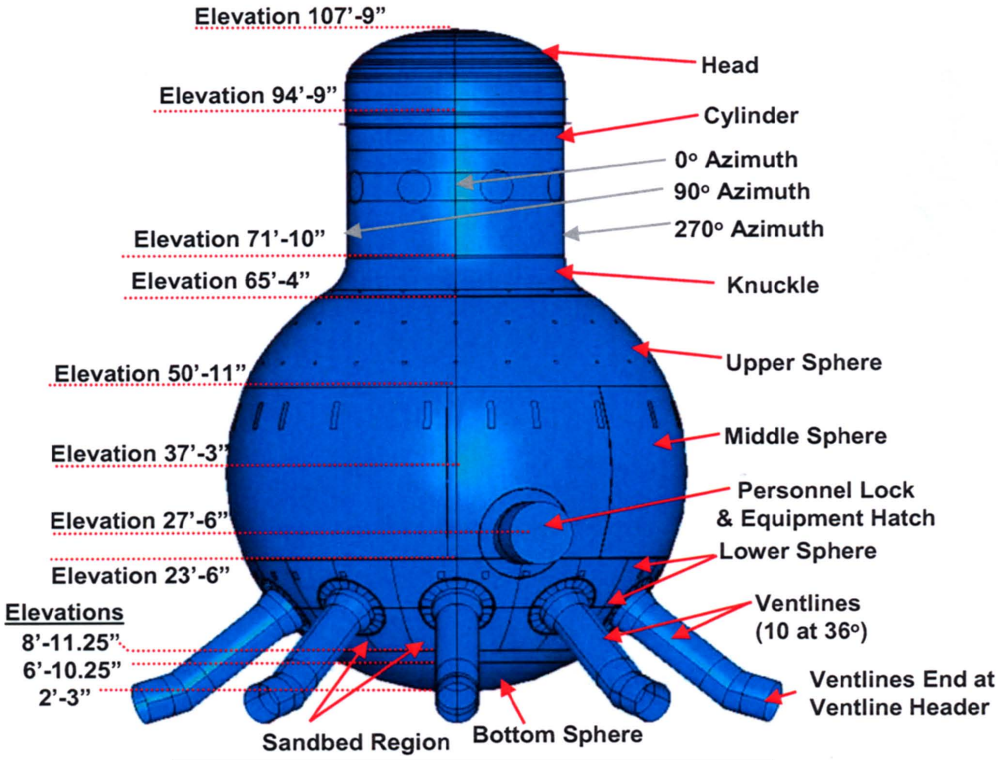
FIGURE 1 Oyster Creek Drywell Shell

As part of the LRA review, the Staff reviewed the aging management program for the drywell shell. The plant contains a drywell shell constructed of carbon steel, which is approximately 100 feet tall and is shaped like an inverted light bulb (Figure 1). It measures approximately 70 feet in diameter at the spherical base. At an elevation of 71 feet 6 inches, it transitions from a spherical shape to a cylindrical shape that is approximately 33 feet in diameter. In the late 1980s, corrosion was discovered in an area in the spherical section of the shell marked in Figure 1 as the sandbed region, which is divided into 10 bays each designated with an odd number from 1 through 19. After removing the sand from this region, it was found that corrosion was unevenly distributed within the ten bays of the drywell shell, with Bays 1, 11, 13, 17, and 19 being the most affected bays. An analysis was performed by General Electric ("GE") during that period, which is the analysis of record and Oyster Creek's current licensing basis, to confirm that the drywell shell had sufficient structural integrity for continued operations. To support that analysis, the applicant evaluated the degradation of the shell, taking approximately 1,000 ultrasonic ("UT") measurements. Based on the UT measurements, areas on the external side of the shell that were considered the most thinned were ground flat for UT monitoring and grids were established for UT monitoring on the inside of the shell. The Staff reviewed the GE analysis and documented its review in the "Evaluation Report on the Structural Integrity of the Oyster Creek Drywell," dated April 24, 1992. The sandbed region was subsequently coated to protect the shell from further corrosion. Since discovery of the corrosion, monitoring of the drywell shell by UT measurements has continued, with the most recent measurements taken in 2008.

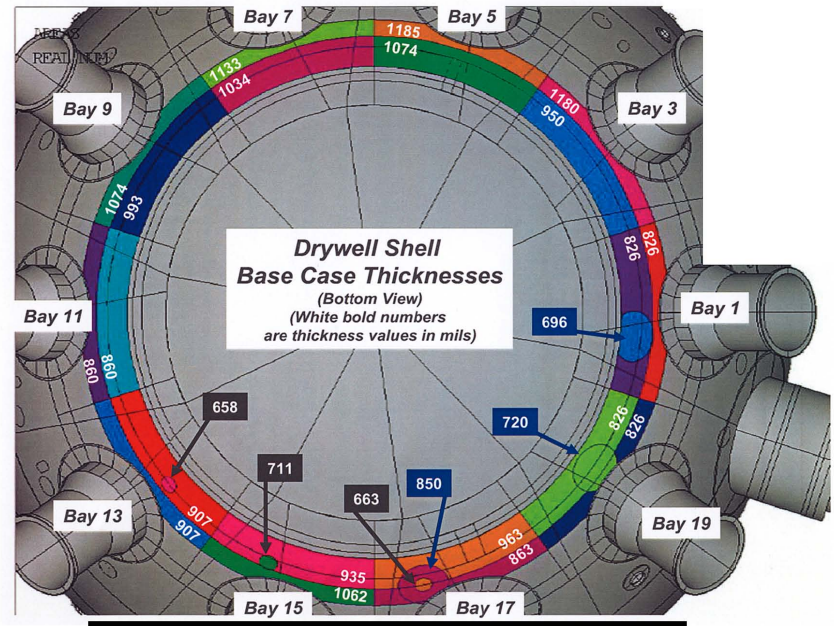
FIGURE 2 Schematic - Sand Bed Area

The assigned thicknesses in all bays in the sandbed area correspond to the UT measurements taken during the 2006 inspection.[8] The applicant confirmed that the thicknesses found during the 2008 inspection are consistent with those found during the 2006 inspection. The staff finds Exelon's modeling of the corroded areas in the sandbed region appropriate for a realistic analysis of the available margin to the ASME code limits.

To capture the potential uncertainties in identifying the location and degradation of the locally thinned areas, the applicant has reduced the thickness of the 51-inch diameter circle (see Figure 2) by 100 mils in Bay 1, the bay most affected by corrosion. As the UT measurements at certain elevations are not available in certain bays, in addition to the approach taken by the applicant in the Baseline analysis, the applicant has reduced the shell thickness by 50 mils in Bay 19 in S2. This will quantify of the effects of thickness reduction in the sandbed region on the buckling safety factors. The staff finds the use of these sensitivity cases conservative and acceptable for considering the effect of the size and thickness of degraded areas on the available margin.
