Spring Industry Dissimilar Metal Weld Examination Update

NRC/PDI Meeting
May, 2009

Carl Latiolais
Senior Program Manager
Appendix VIII Performance Demonstration
EPRI NDE Center

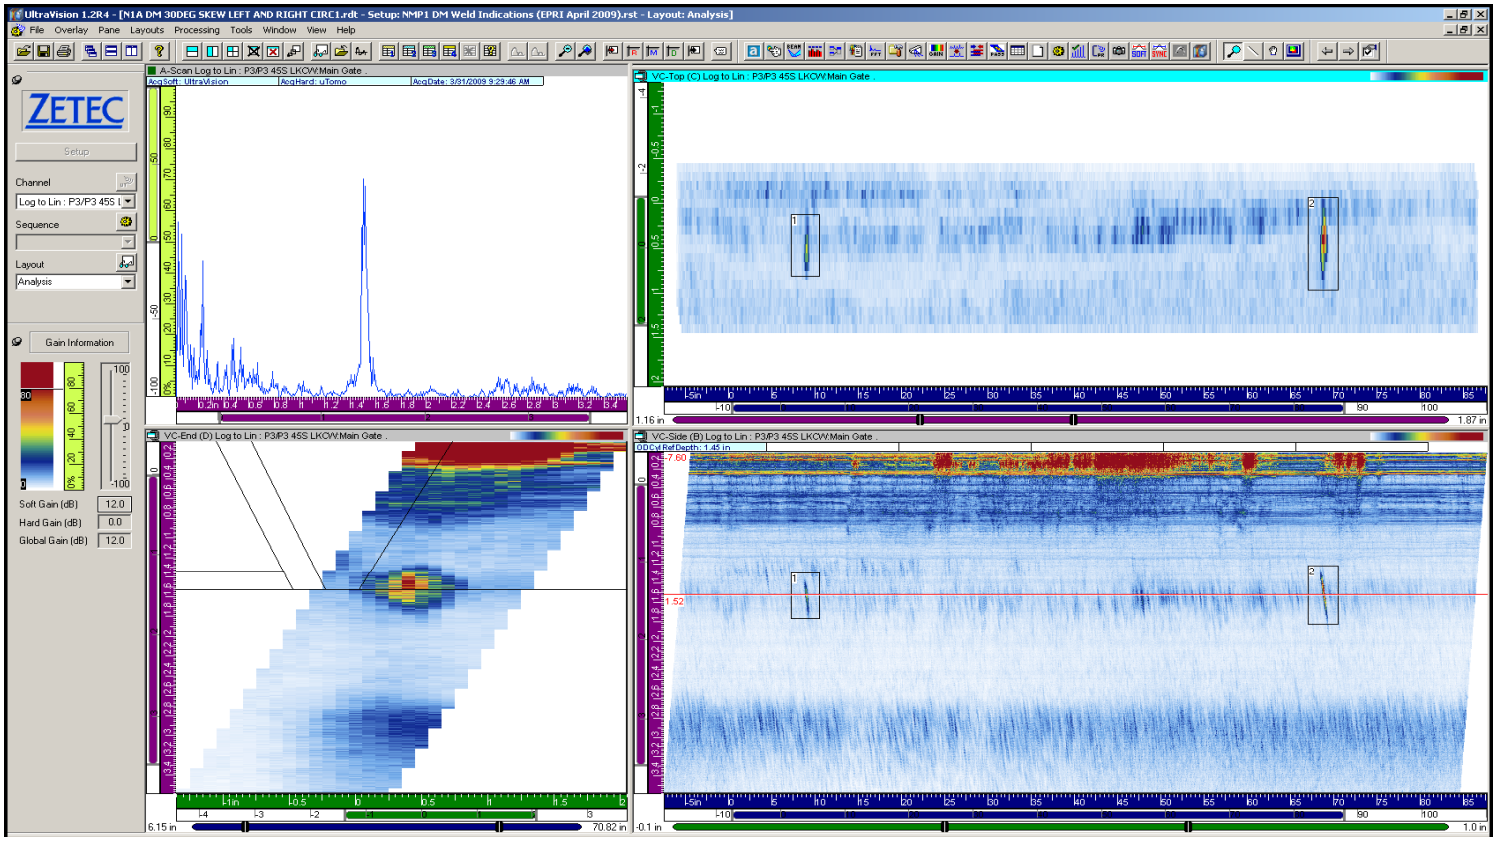
- 2009 Data N1A

- During a regular scheduled examination axial indications were reported in two separate dissimilar metal welds
- Indications were clearly located in 316SS safe-end
  - Not in weld
- Indications did not obtain characteristics indicative of SCC
  - Straight
  - Uniformed
- Review of 1999 data showed the indications were also present
  - Same size
  - Similar characteristics
- Utility conservatively treated them as flaws and evaluated them in accordance with IWB-3500 and they were found to be acceptable

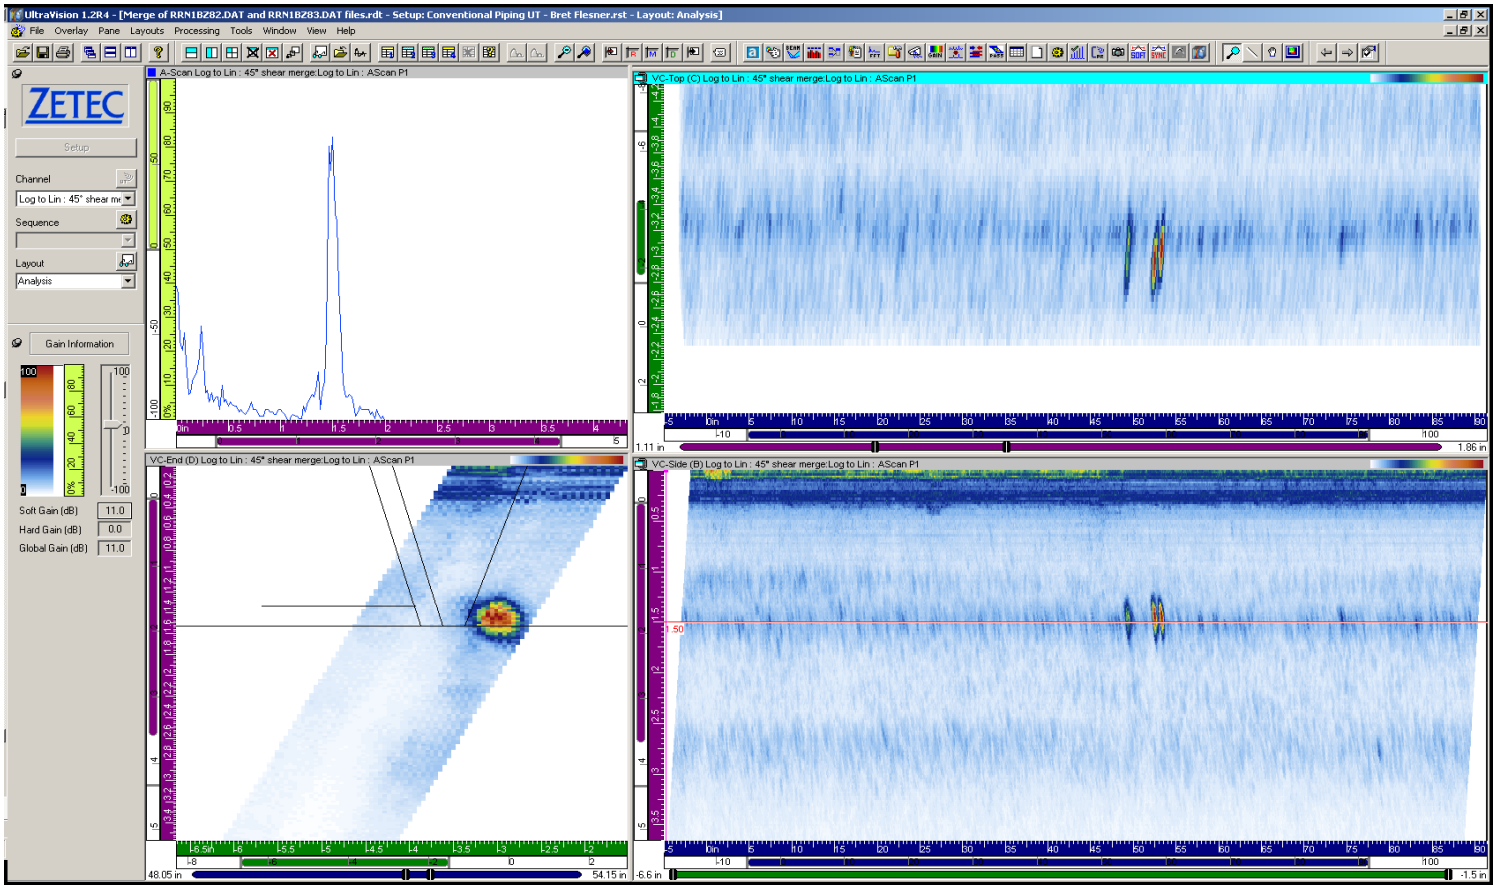
- Same indications in N1B 1999 Data
