Prairie Island Nuclear Generating Plant Units 1 and 2
Dockets 50-282 and 50-306
License Nos. DPR-42 and DPR-60

Response to NRC Request for Additional Information Regarding Application for Renewed Operating Licenses

Enclosure 1
Response to Follow-up RAI B2.1.38

NRC Follow-up RAI B2.1.38

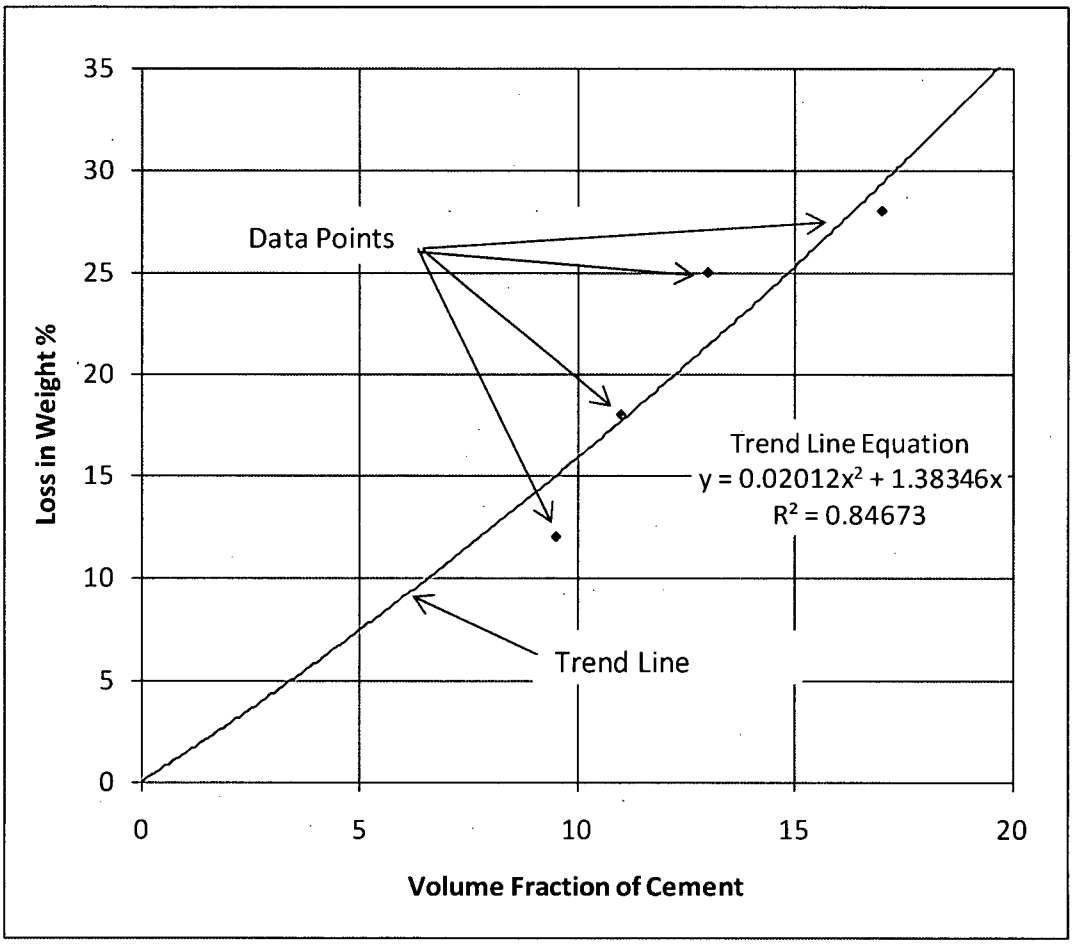
Figure 1 Weight Loss in Acid vs. Volume Fraction of Cement (based on data from Reference 7)

Quantitative data in Reference 7 for weight loss of concrete cubes when exposed to an acid concentration of 3% is shown in Figure 1. A trend line is shown on the figure that provides an equation for quantifying this dissolution behavior. As can be seen, the weight loss increases somewhat more strongly than linearly as the volume fraction of cement, (i.e., of soluble material), increases.

A footnote on page 10 of Reference 4 indicates that concrete normally contains 10 to 15% of cement, or an average of about 12.5%. As noted on page 2-2 of Reference 1, the amount of carbonaceous aggregate in the concrete used at Prairie Island was about 5%. Adding this 5% to the average 12.5% cement results in a total of 17.5% soluble material in the concrete at Prairie Island as compared to the 12.5% in a concrete with all igneous (no carbonate) based aggregate such as was used at the cited plants. (Section 8.1.3 of Reference 8) Using the trend line equation shown in Figure 1, increasing the fraction of soluble material (cement in the figure, cement plus soluble aggregate in this case) from 12.5% to 17.5% increases the weight loss by a factor of 1.49. This indicates that the assumed factor of 2.0 increase in severity of acid attack to account for the presence of 5% carbonate-based aggregate is conservative by a significant margin (2 vs. 1.49).

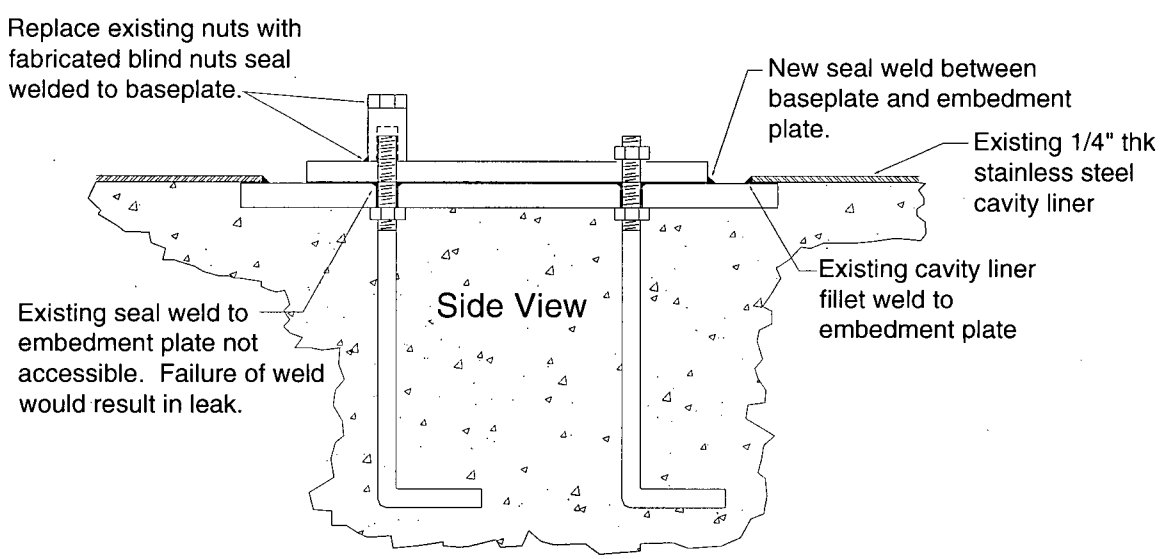
General Arrangement of Change Fixture Supports

The RCE concluded that the most likely refueling cavity leakage points are where the anchor studs for the reactor internals stands and the Rod Control Cluster (RCC) Change Fixture penetrate the associated embedment plates. The studs for these fixtures pass through holes in the embedment plates and are seal welded on the underside for the internals storage stands, and on top (then ground flush) for the RCC Change Fixture. Pinhole leaks or small cracks in one or more of the seal welds would result in a leak path through the embedment plate along the threads of the studs, allowing water under the cavity liner.

The plant management review of the Root Cause Evaluation considered the value, need and sufficiency of each recommendation. The current repair plan that emerged from these reviews is to replace the existing anchor nuts with new fabricated blind nuts that are seal welded to the existing baseplates. In addition, the existing baseplates will be seal welded to the embedment plates. The new welds will be readily accessible for examination to ensure the existing anchors and baseplates are leak tight. The following sketch depicts a typical RCC change fixture support showing the planned repairs. Similar repairs will be made to the internals stands supports.

This repair strategy effectively accomplishes the goals of recommended steps 1 through 3, the intent of which is to permanently repair refueling cavity leakage, but in a more focused and dose-effective manner. The guide tube supports which are mounted to the refueling cavity wall were concluded to be unlikely sources of leakage and will not be sealed in a similar manner. Although the guide tube supports are of similar construction, past success at mitigating leakage by sealing the supports of the internals stands and RCC change fixture suggests that leakage occurs only at those locations.
