Subject: Response to NRC Bulletin 2001-01, "Circumferential Cracking of Reactor Pressure Vessel Head Penetration Nozzles"

DAVIS-BESSE NUCLEAR POWER STATION

Response to NRC Bulletin 2001-01 for the Davis-Besse Nuclear Power Station

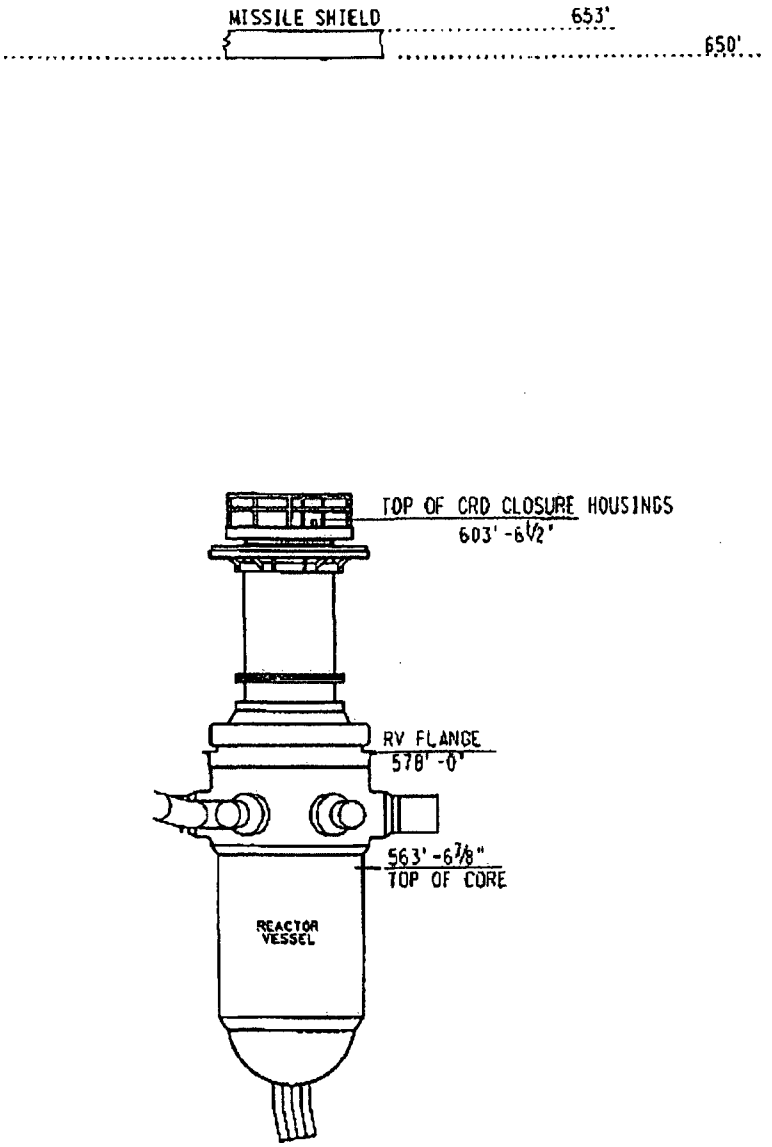
The elevations for the Reactor Coolant System (RCS), including the top of the CRD Closure Housings at the top of the service structure, are shown in the attached Figure 1 and Figure 2. The top of the missile shield over the service structure is at elevation 653'0". The missile shield is comprised of six concrete removable panels, each 31' 5" x 6' 6" x 3'. It spans the refueling canal and is supported on both sides by the Steam Generator "D-Ring" walls.

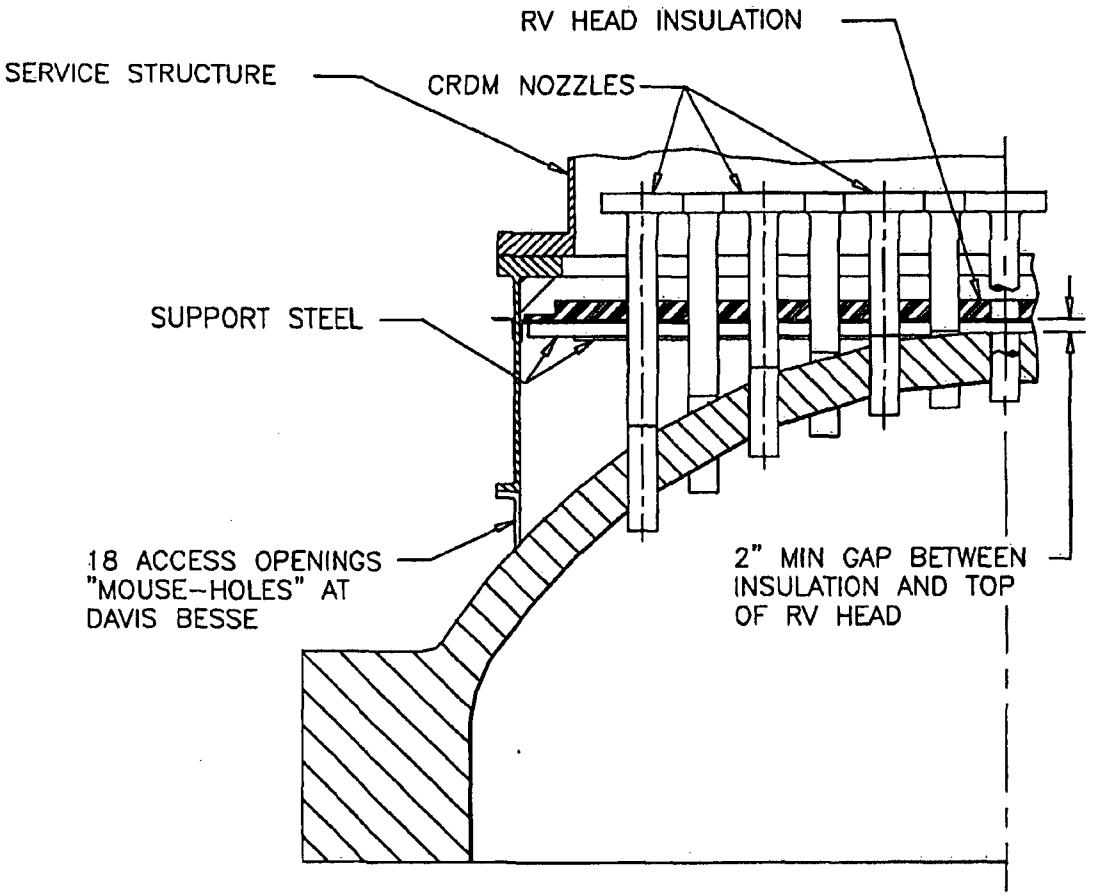
Figure 2.
Side View Schematic of Davis-Besse Reactor Vessel Head, CRDM Nozzles, and Insulation.
