Subject: Advanced copy of Serial 2731, Response to Bulletin 2001-01, Cracking in CRDM Nozzles

Subject: Response to NRC Bulletin 2001-01, "Circumferential Cracking of Reactor Pressure Vessel Head Penetration Nozzles"

RESPONSE TO

DAVIS-BESSE NUCLEAR POWER STATION

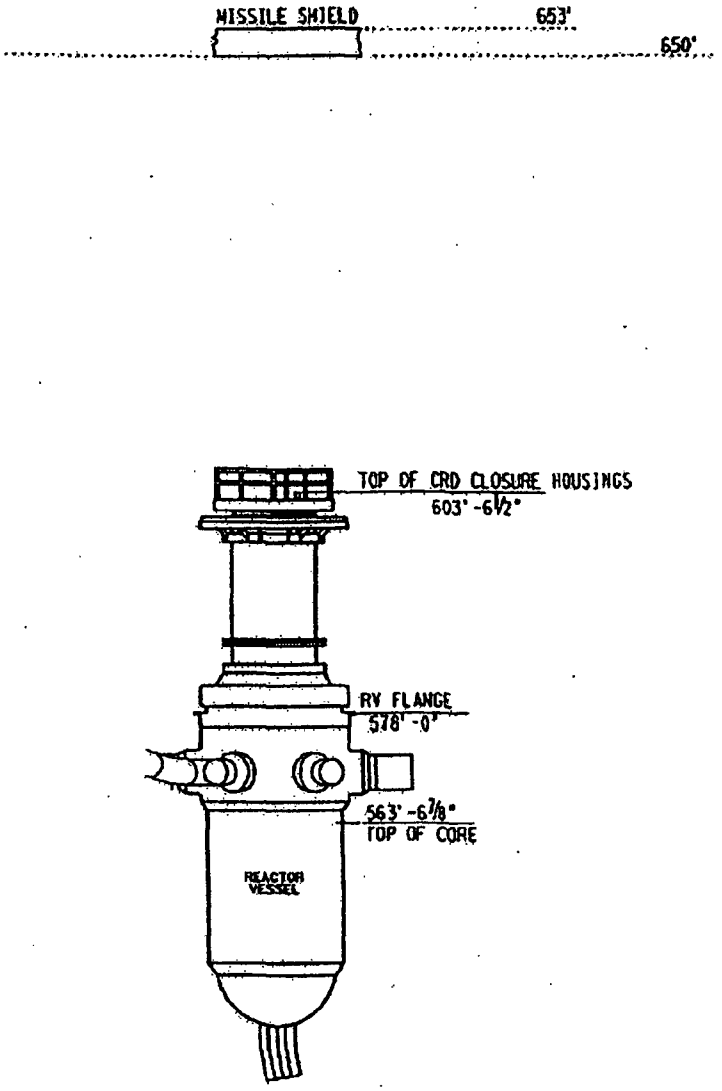
Figure 1

The service structure bolts to the reactor vessel head. (The lower section of the service structure is welded to the head. The service structure then bolts to this lower section) Fan holes are provided to allow forced air cooling of CRDMs. Ductwork connected to two remotely mounted, 100 percent capacity cooling fans is mounted over the fan holes in the service structure. The lower portion of the service structure is also provided with ledges to support the RPV head insulation. The upper portion of the service structure cylinder is provided with a monorail to accommodate chain hoists that are required for stud tensioner handling. A deck is provided on the service structure to provide a work platform for servicing the CRDMs. This deck also provides the support for the CRDM cooling water manifolds and electrical cables. The deck is composed of individual butted plates with openings to accept seismic clamps provided with the

CRDMs. These seismic plates provide stability for the upper portion of the CRDM. They are field-aligned to the reactor vessel control rod nozzles.

MISSILE SHIELD
653'
650'
TOP OF CRD CLOSURE HOUSINGS
603' -6½"
RV FLANGE
578' -0"
563' -6⅞"
TOP OF CORE
REACTOR VESSEL

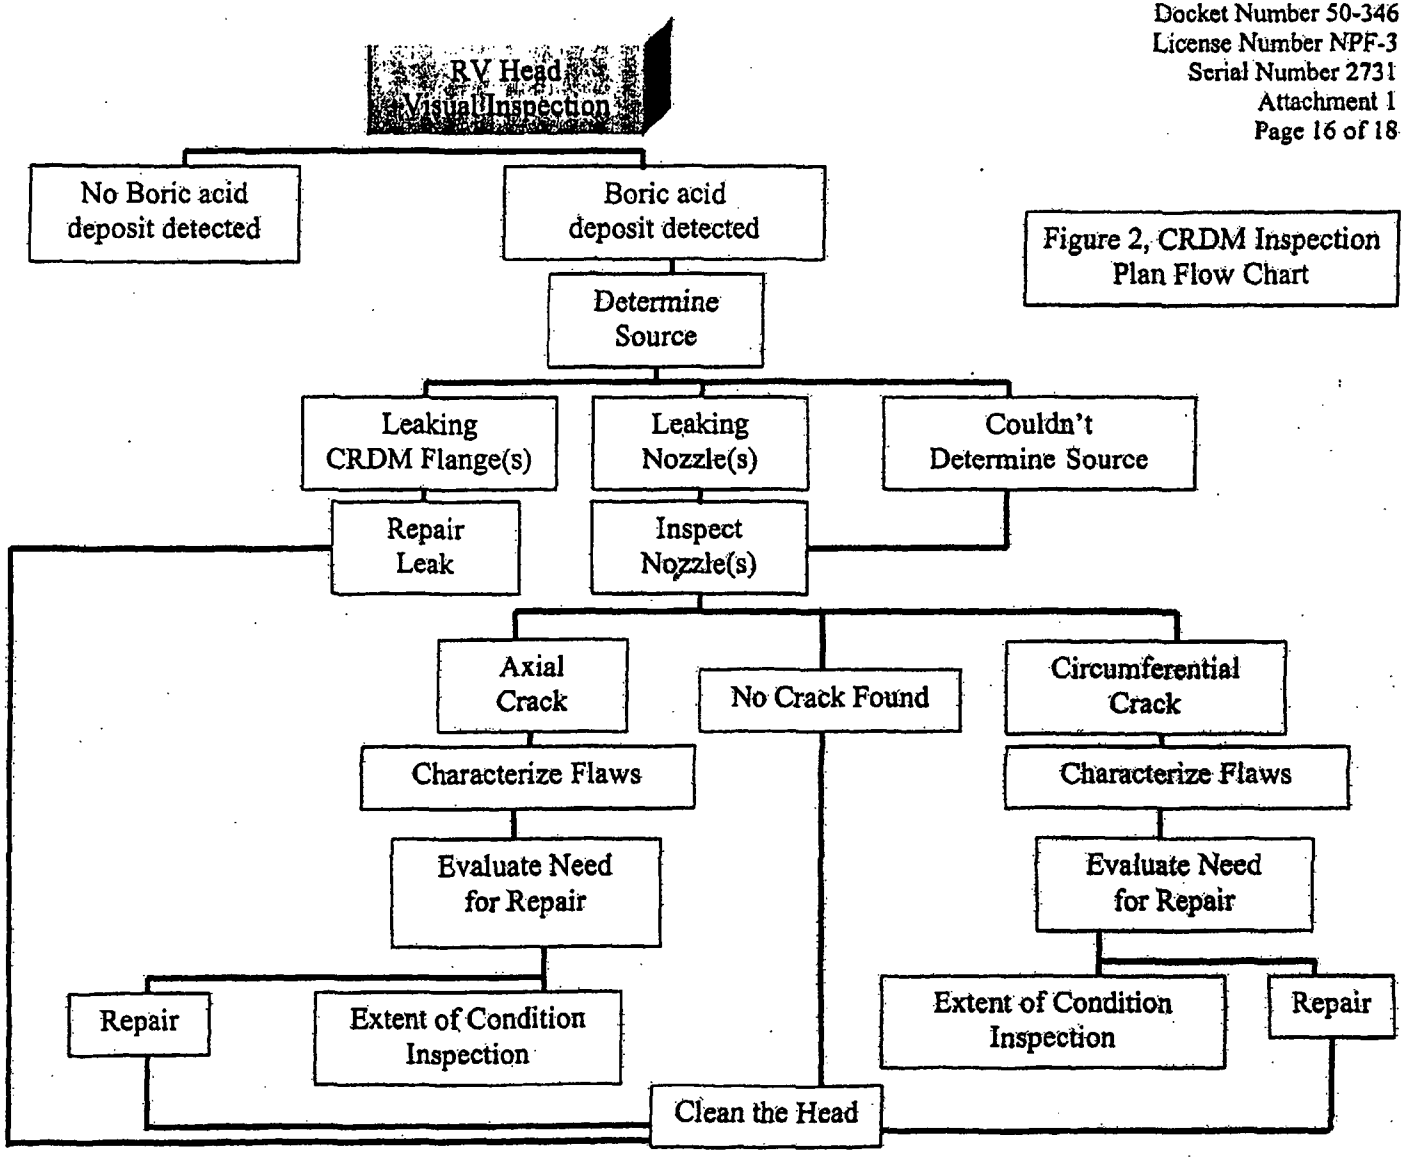
Figure 2, CRDM Inspection Plan Flow Chart

The acceptance criteria to be used will consist of comparative evaluations of any as-found boric acid crystal deposits to photographs of leaking CRDM nozzles observed at ONS3 and Arkansas

Nuclear One-Unit 1 (ANO-1) and evaluation against any identified leaking CRDM nozzle flanges. A flow chart of the inspection plan is shown in Figure 2. Details of the inspection plan will be developed prior to the 13RFO.

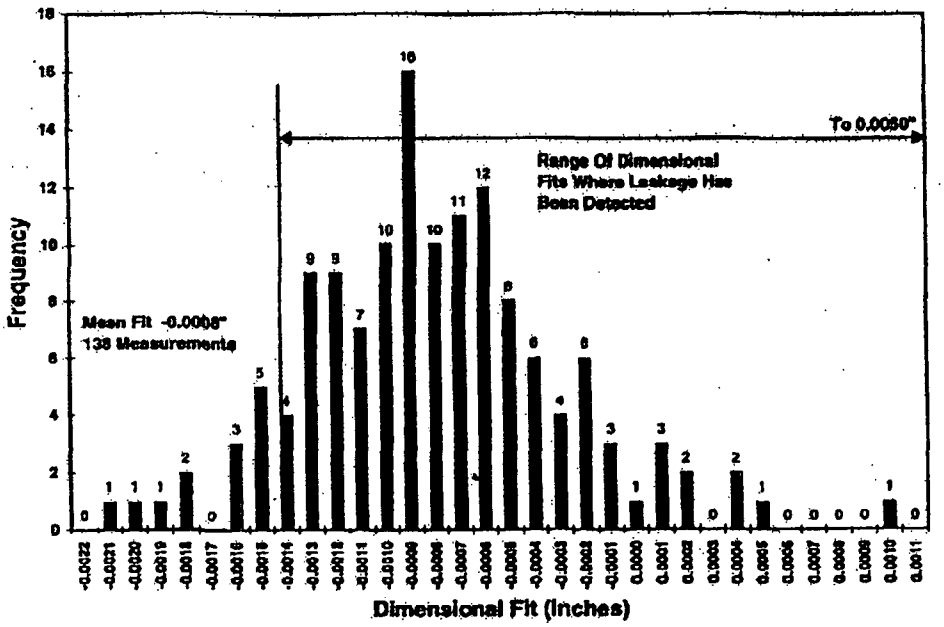
In 1993, the B&WOG performed a safety evaluation for CRDM nozzle cracking (reference: previously cited BAW-10190P). In this evaluation, a 3D finite element model of all major components of a hillside CRDM nozzle-to-head welded structure was constructed. The B&WOG calculation includes the maximum 0.010 inch diametric counterbore at the top and bottom locations (typical for most B&WOG plant designs), which tends to increase the stresses in the nozzle and is bounding for the DBNPS. During operation, an interference fit is calculated to release to become a gap due to temperature and pressure dilation, which provides a leak path for a through-wall crack that allows detection by visual inspection. The B&WOG calculation assumes a nominal 0.001 inch interference fit, which will open to a maximum gap of 0.0033 inches during operation.

As noted earlier, leakage from this gap has been demonstrated at both ONS and ANO-1, for which interference fits of up to 0.0014 inches have been calculated from the final QA inspection data (as documented in MRP-44, Part 2). Figure 3 provides a graphical representation of these data. The largest interference fit at the DBNPS occurs on nozzle number 50 which, as stated previously, has been calculated at 0.0021 inches at the top. This same nozzle also has an interference fit of 0.0010 inches at the bottom. Thus, the 0.0033 inch gap during operation would be somewhat less for the DBNPS, assuming the 0.0021 inch interference fit (instead of the nominal 0.001-inch). This gap would still be expected to provide a leak path to the top of the RPV head in the event of a cracked CRDM nozzle or J-groove weld. The DBNPS has not observed any leakage from these paths during its past inspection activities.

Distribution of Dimensional Fits in DBNPS RPV Head
