Dresden Nuclear Power Station, Unit 2
Renewed Facility Operating License No. DPR-19
NRC Docket No. 50-237

Subject: Request for Approval of Pipe Flaw Evaluation

PROJECT NAME:
Dresden Unit 2 Recirculation Line Flaw Evaluation

CALCULATION TITLE:
Crack Growth Analysis for Weld PD1A-D14

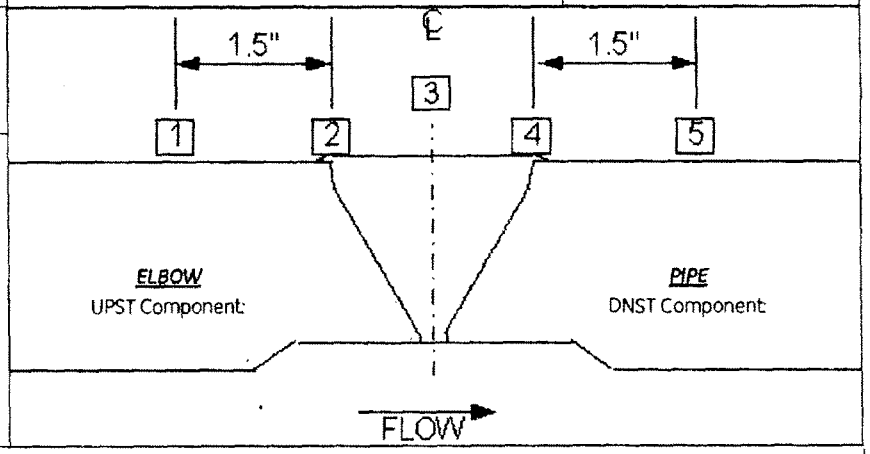
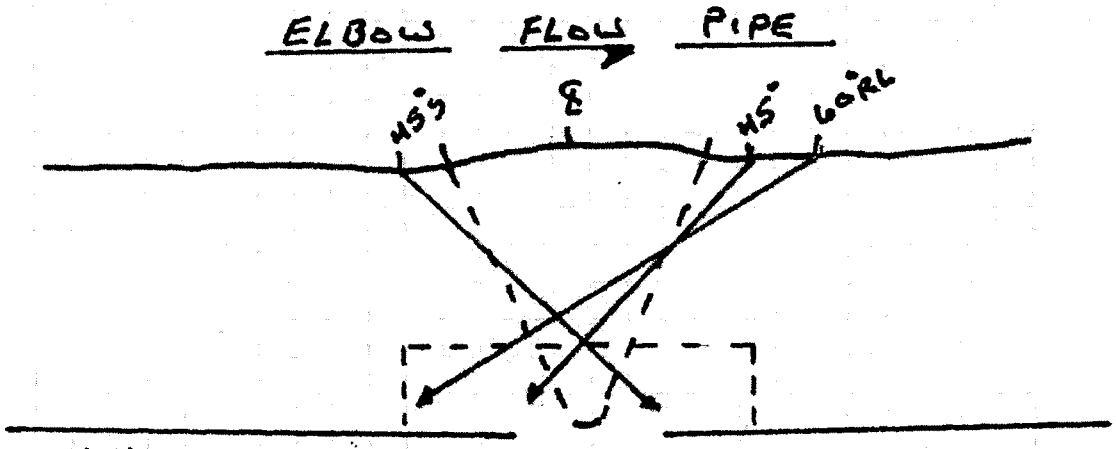
* NOTE: SEE CAL. SHTS FOR EXAM PARAMETERS DUE TO WELDED RESTRAINT ON UPSTREAMSIDE.

Upstream Scan (Elbow Side) limited by Whip Restraint located approximately 2.1" upstream of weld. Whip restraint is not centered around pipe, with distance from pipe to whip restraint ranging from 0.8" to 2.8". Due to this condition, the area from 26.0" cw to 70.0" cw could not be examined.

Axial Upstream Scan: 51% of 25% = 12.75%
Axial Downstream Scan: 100% of 25% = 25.00%
Clockwise Scan: 100% of 25% = 25.00%
Counter-Clockwise Scan: 100% of 25% = 25.00%
Total coverage achieved = 87.75%

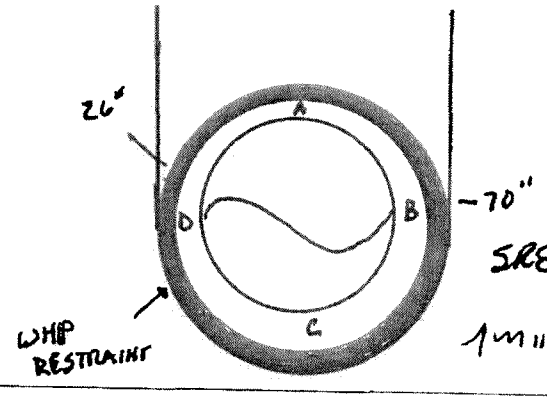
A = 0.8" C = 2.8"
B = 1.7" D = 1.7"
