Failure Analysis of Insulated Sheet Metal Siding Following An MSLB in The Steam and Feedline Penetration Area Indian Point Unit 3

June 1984

Prepared by: K. J. Iepson
K. J. Iepson, Principal Engineer

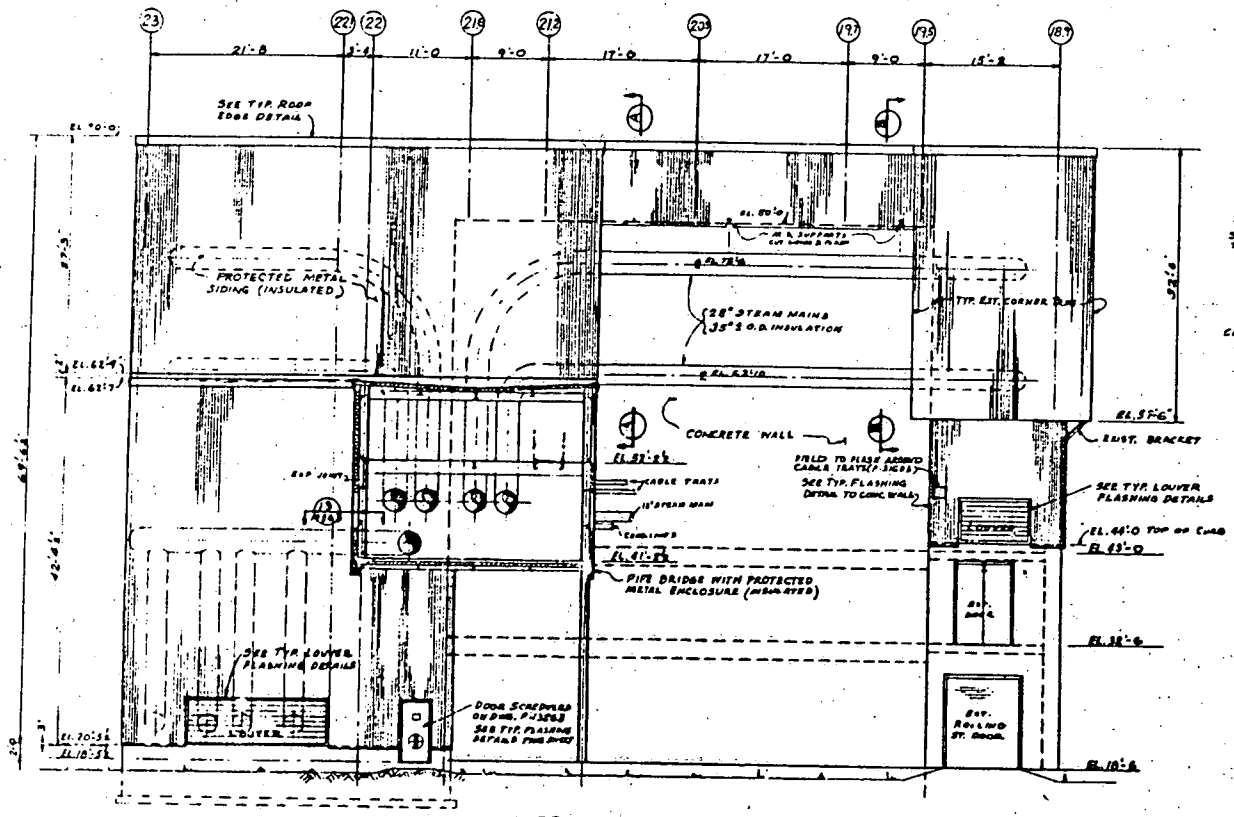
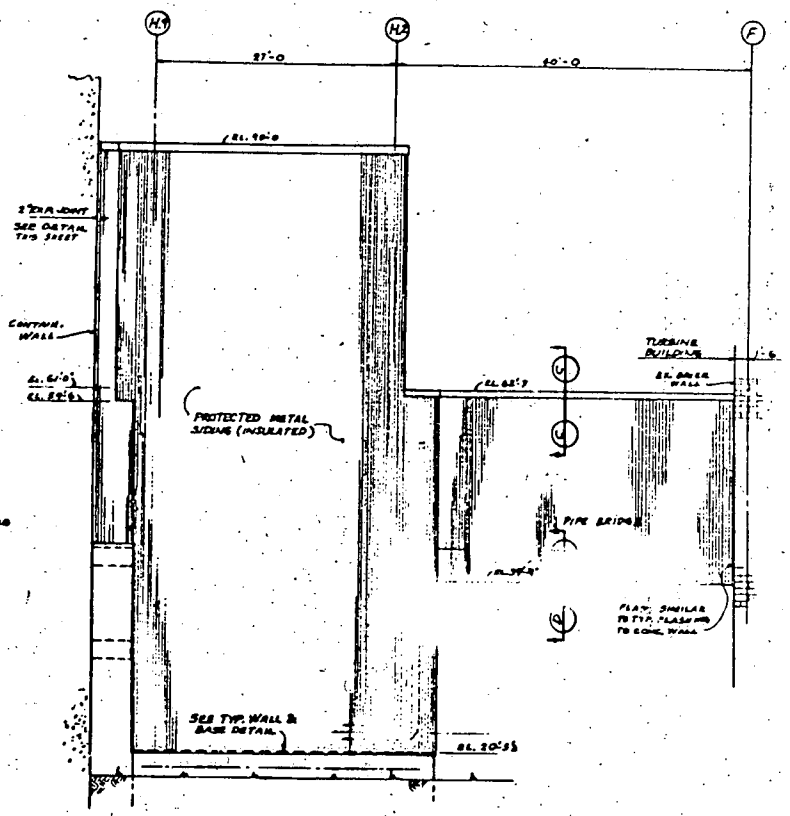
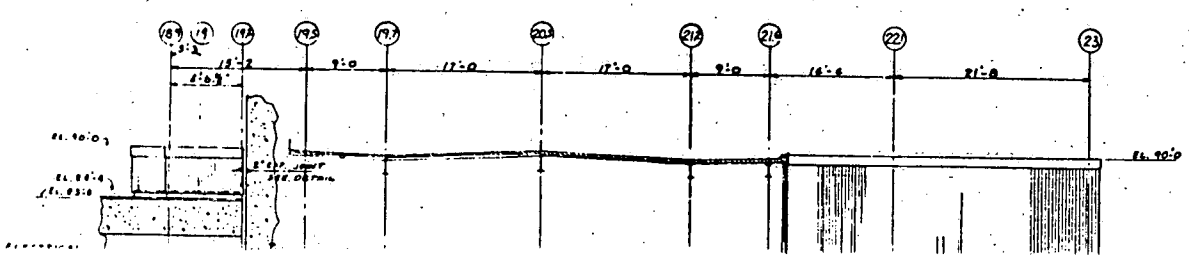
WEST ELEVATION
(LOOKING EAST)
SCALE: 1/8"=1'-0

The steam and feedline penetration area is a building located on the West side of the reactor containment building which houses the main steam and feedwater piping and associated isolation valves, safety valves, and supports. The building consists of a concrete shield wall at the West end (which provides biological shielding for streaming paths associated with the containment penetrations for the steam and feedwater pipes) and a steel structure covered with insulated metal siding on the North and South ends. Figure 1 shows the configuration of the building exterior.

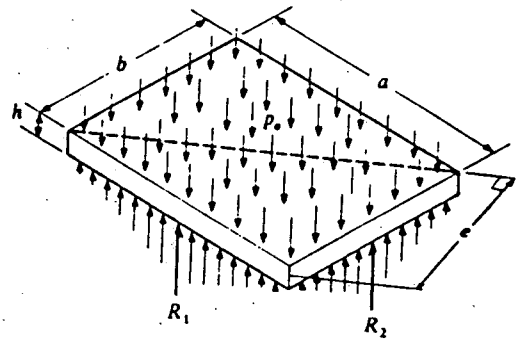
Figure D. Schematic Model

The pressure loads on the plate produce reaction forces which act axially on the fasteners. Table 1 summarizes the reaction forces for fasteners located at each mid-span (joints 12, 231, 253, 449) and the joint with the highest bending moment (joint 184). The manufacturer's data states that pull-over occurs at 1500 lbs. at Interface 1. The results show that significant (25%) pull-over (shear in +Z direction) occurs at 200 PSF. At the same pressure load, more than half of the fasteners will experience shear out (shear in $\pm x$, $\pm y$ direcitons) as shown in Table 2.

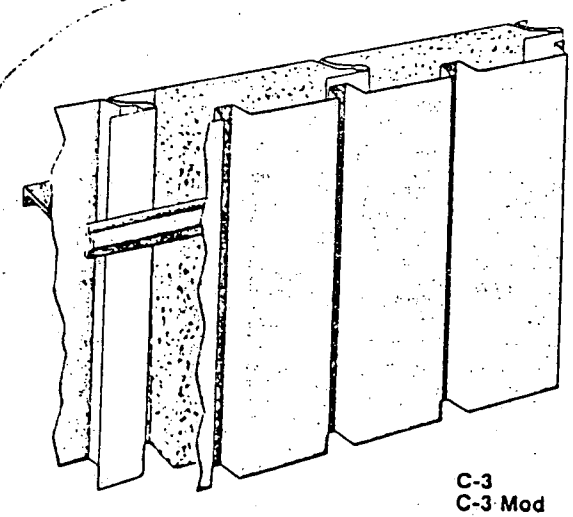
C-3
C-3 Mod

With these assumptions noted, the conclusion of this report is that the PLASTEEL C-3 siding section will fail by a combination of liner material shearing and fastener pull-out to an extent which relieves the pressure (1.26 psi) load which caused the failure.

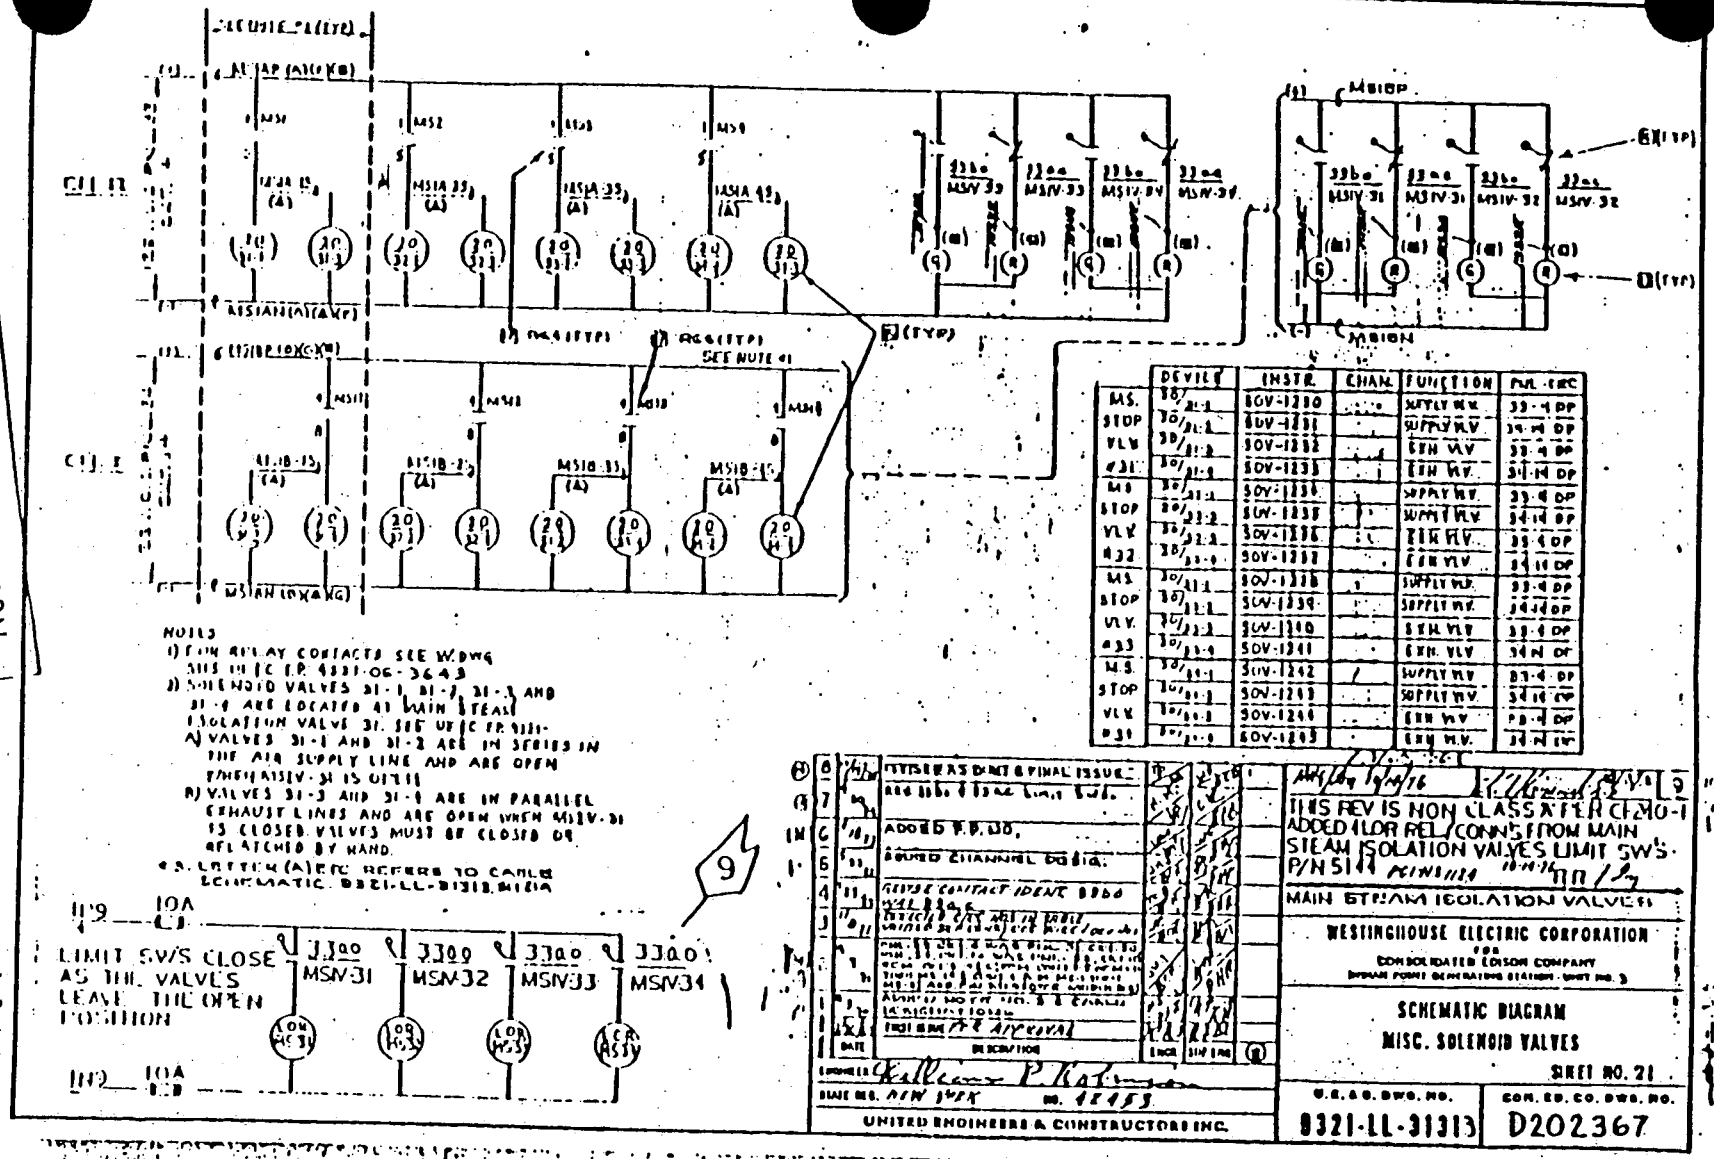
FIGURE 2

The Laurence SOV's are part of a packaged operating system supplied with the main steam isolation valves (MSIVs). Figure 1 shows the configuration and provides a description of the system operation. Figure 2 shows schematically the power supplies for the solenoid valves, demonstrating that the redundant SOV's shown on Figure 1 are powered from separate buses, and that the system, therefore, is not subject to a single disabling failure.
