A. B. Holt, Chief
Technical Assistance Branch, SS

S. Pawlicki
Technical Assistance Branch, SS

INDIAN POINT NO. 2 - REACTOR VESSEL EMBRITTLEMENT

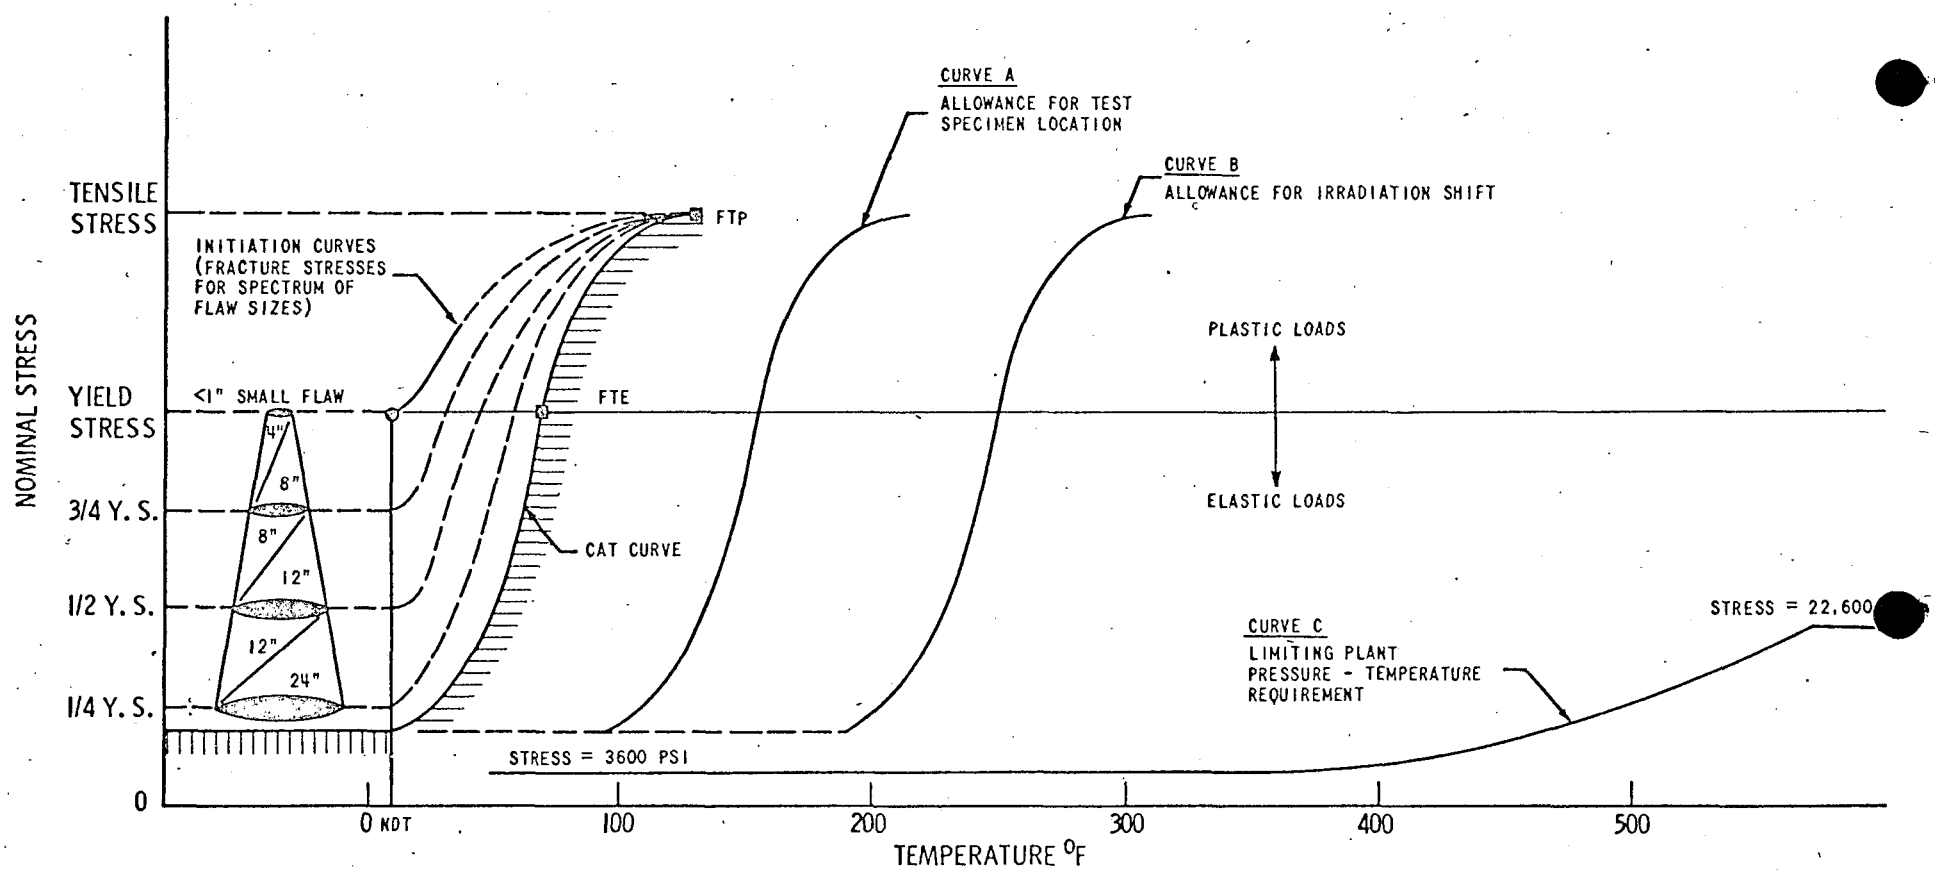
FIGURE 3-1

The fracture analysis diagram, used by the applicant to estimate his safety margin with respect to neutron embrittlement of the reactor vessel, was obtained from the NRL Report 5920 (Ref. 2). Using this diagram, and assuming a total NDT shift of 170°F (85° due to reduced impact properties at plate center and 85°F due to irradiation), the applicant found a margin of well over 200°F between limiting plant operating conditions (Curve C) and the nearest point on the Crack Arrest Curve, adjusted for the NDT temperature shift (Curve B). It seems significant that the available safety margin was estimated using the CAT curve, rather than the 20% yield stress point at the (NDT + 60) temperature.

FRACTURE ANALYSIS DIAGRAM

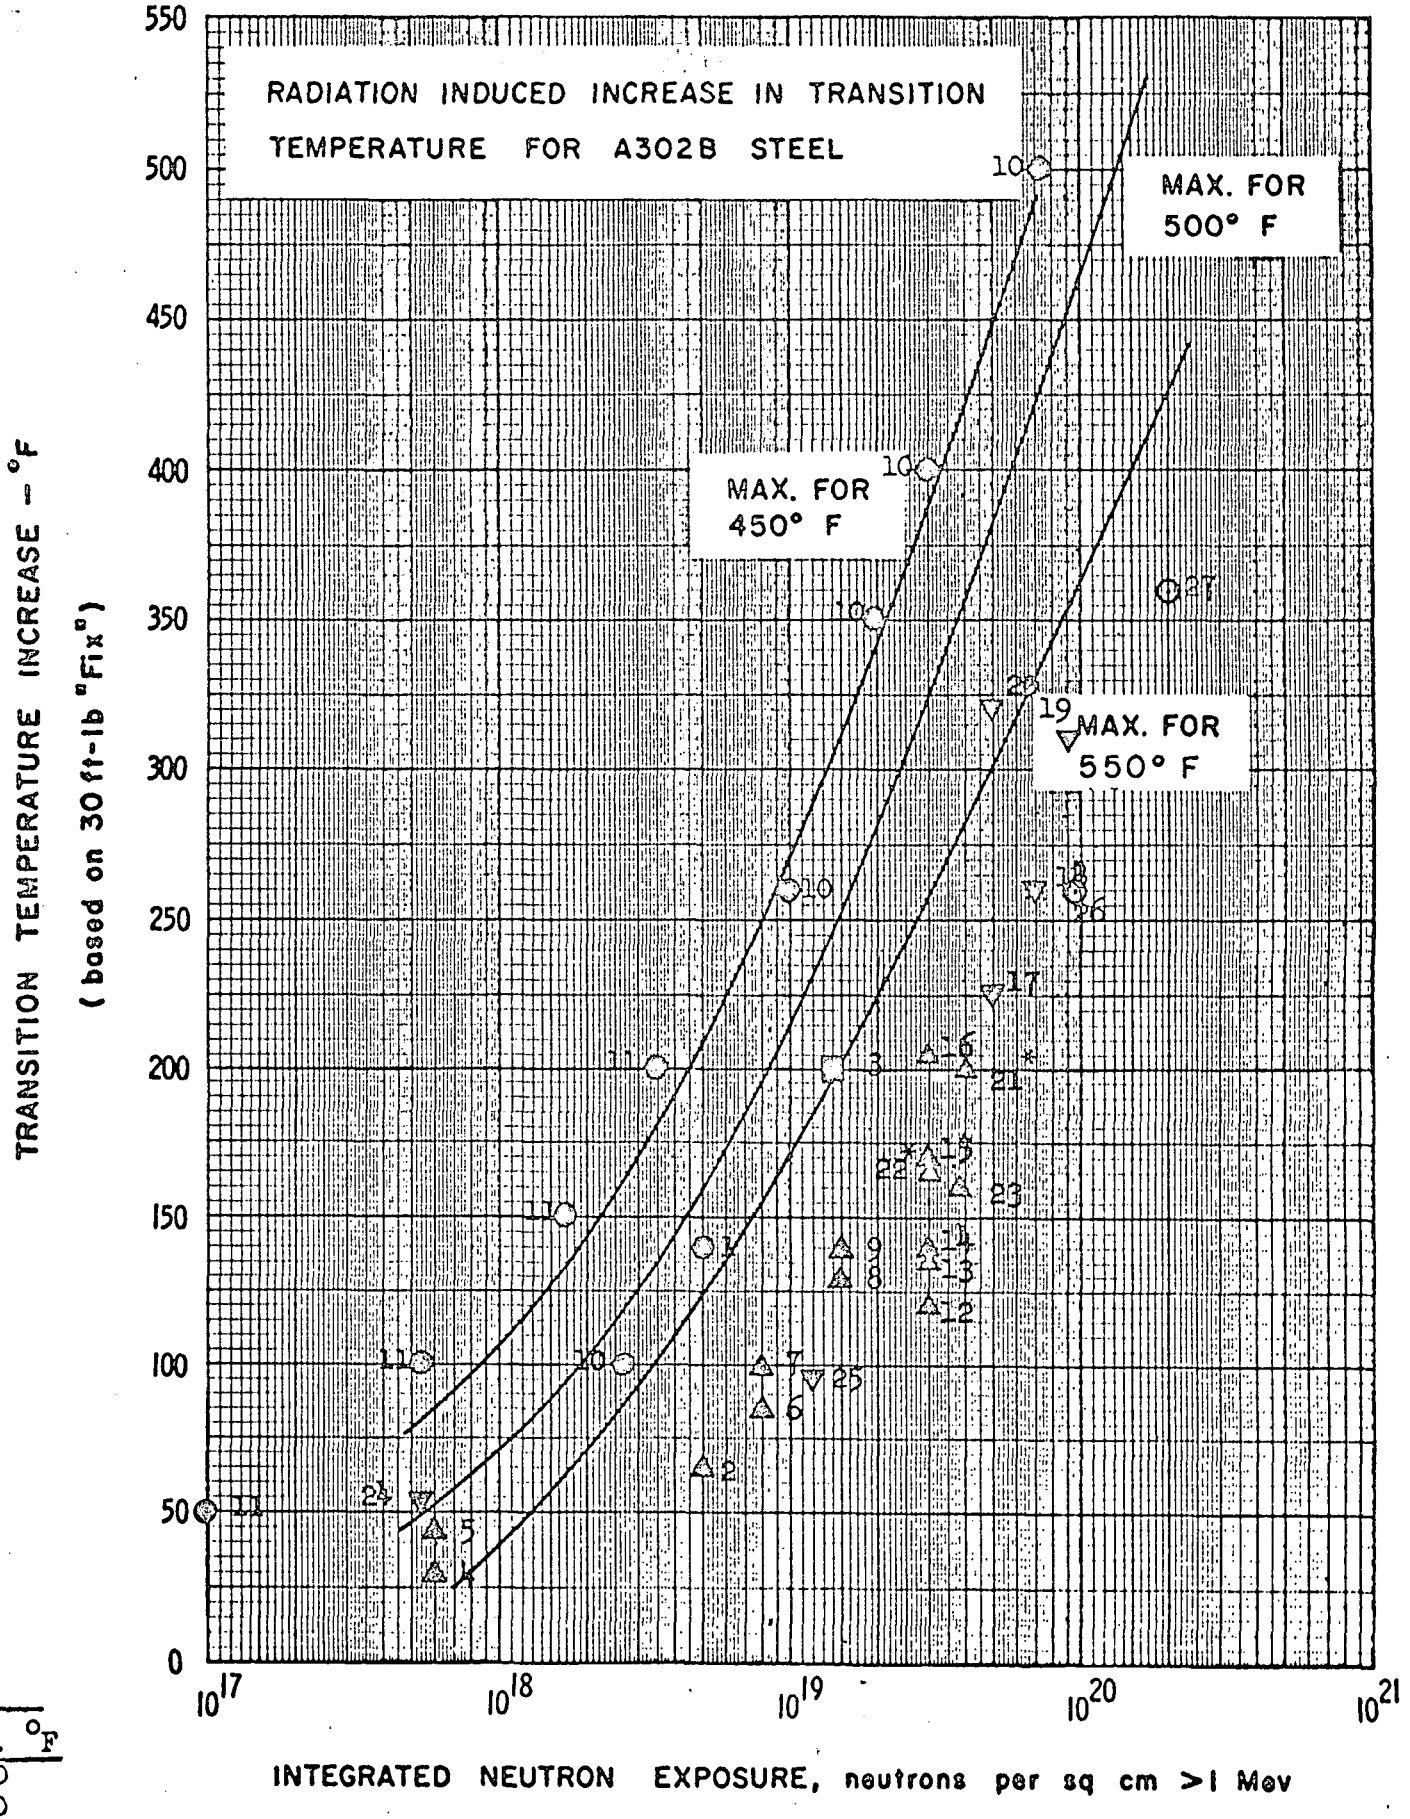
RADIATION INDUCED INCREASE IN TRANSITION TEMPERATURE FOR A302B STEEL

The shift in the NDT temperature at the inner surface of the vessel wall, due to fast neutron exposure, was estimated as 160°F using the 550°F curve (attached). To account for the variation of NDT temperature across plate thickness, the applicant assumed (most likely based on Yankee measurements) that the initial NDT temperature at plate center may be up to 85°F higher than that at quarter thickness. However, while the impact properties are lowest at plate center, the transition temperature shift there was calculated to be only 85°F. Curve A in the attached Fracture Analysis Diagram represents the initial NDT temperature at plate center, and curve B the corresponding shift of 85°F.
