50-247

FEEDWATER LINE VIBRATION PROBLEMS

Subject: Florida Power & Light Company
Turkey Point Units 3 & 4
Steam Generator Feedwater Piping

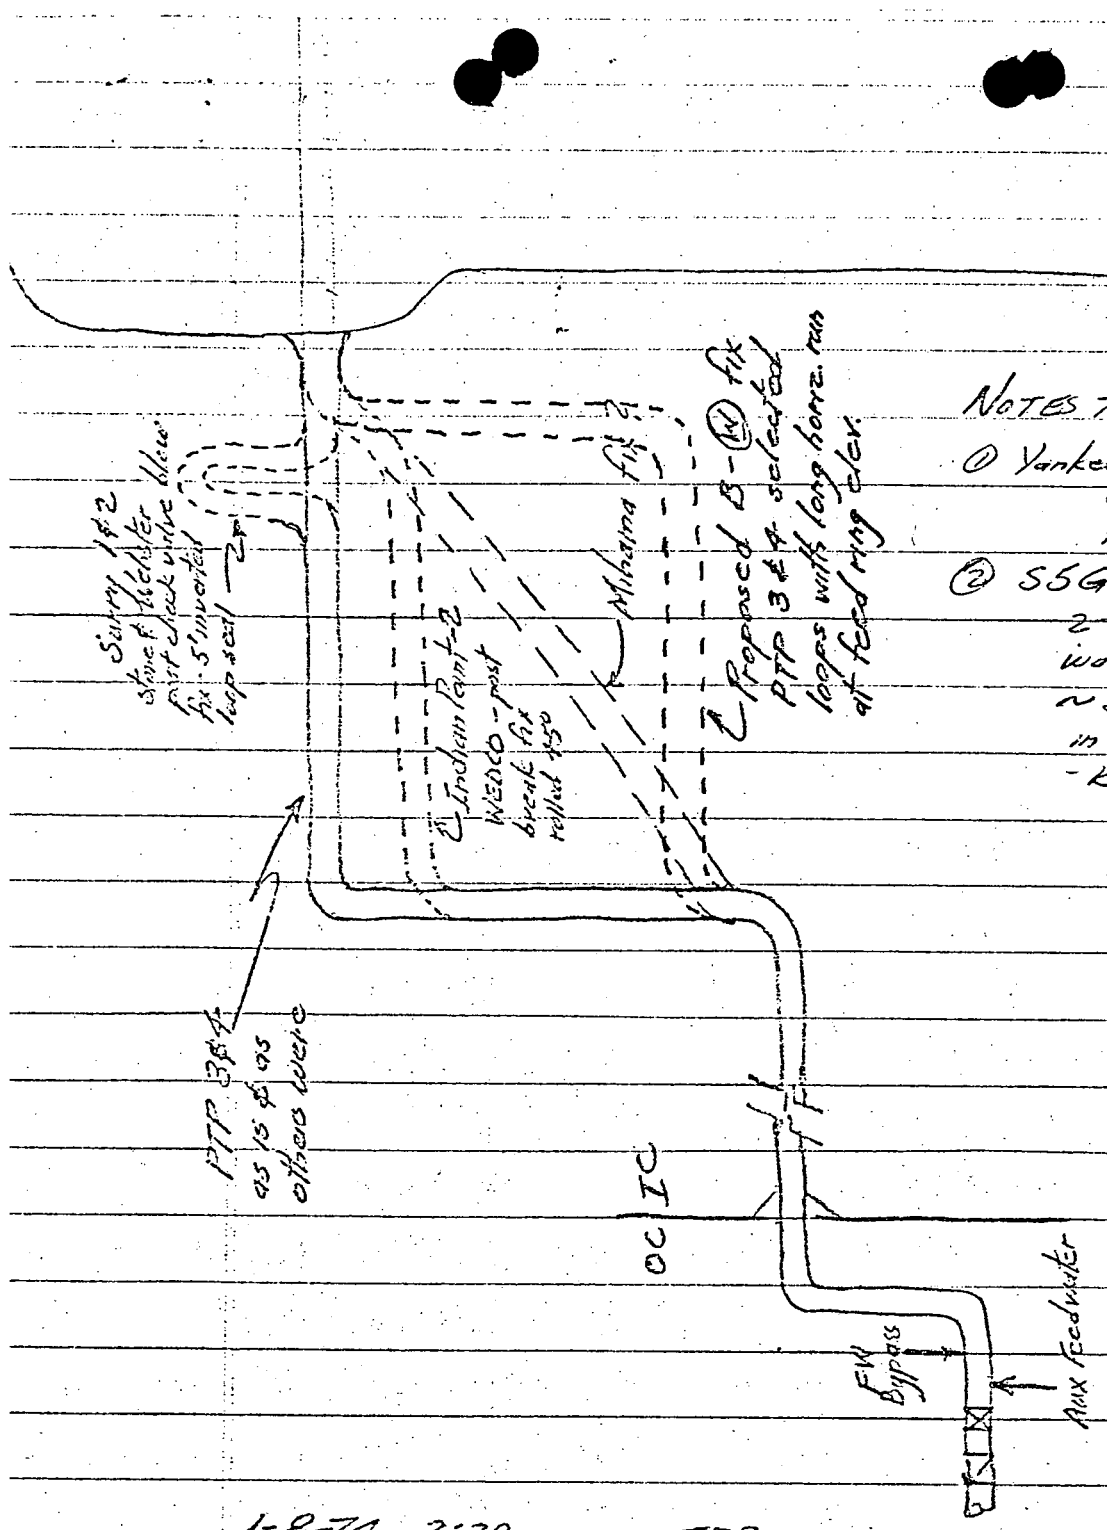
NOTES TO SELF:

① Yankee Rowe FW lines modified some time ago for water hammer prob. – T. Lordi 1-9-74

② SSG plant - Idaho - 5" FW lines 2-loop sub prototype - had water hammer probs & added ~3' loop seal type mod. at SG in 1968 - fix solved water hammer - K.E. Beatty 1-9-74

Eliminate potential for steam entering horizontal run of feedwater line at the SG feedwater ring elevation by - in order of pref.

1. 90° down at SG, vertical as far as possible, then run to existing line.
2. 45° or some ∠ down at SG, run on slope to existing line.
3. Install conventional loop seal (i.e. loop down) at SG.
