Condition Assessment of Belted PILC Cables After 7 To 68 Years of Service

Vitaliy Yaroslavskiy, *Member, IEEE*, Carlos Katz, *Life Fellow, IEEE*, and Matthew Olearczyk, *Member, IEEE*

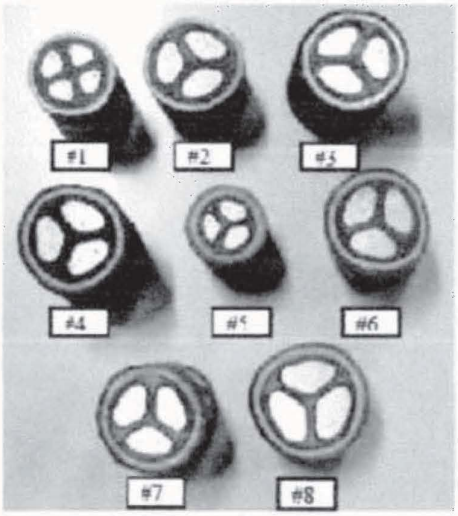
Fig. 1. Cross section of cables tested.

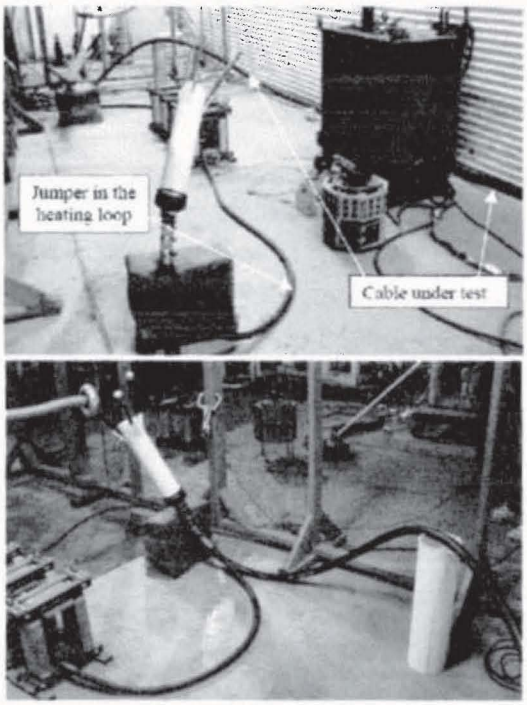
Fig. 2. Test set up.

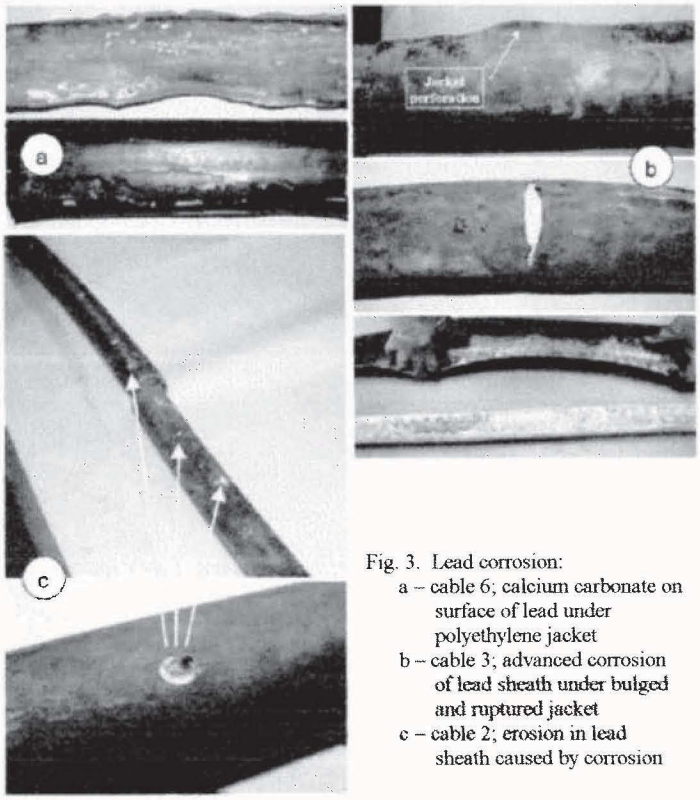
Fig. 3. Lead corrosion:
a – cable 6; calcium carbonate on surface of lead under polyethylene jacket
b – cable 3; advanced corrosion of lead sheath under bulged and ruptured jacket
c – cable 2; erosion in lead sheath caused by corrosion

sheaths. Figure 3 provides examples of different degrees of corrosion, from mild (cable 6, relatively young in the population examined, with a polyethylene jacket) to well pronounced (cable 3, of 1957 vintage, having rubber jacket and covered overall with insulating tapes). The inside of the sheath of these cables was clean and shiny.

The worst condition was that of cable 2, the only sample that incorporated a field failure. Figure 3c shows severely corroded (pitted) spots in the lead sheath, found in cable sections adjacent to either side of the failure.

Corrosion of metals can be divided into two major types: uniform and localized. Uniform corrosion involves oxidation of metal in the presence of a small amount of water (for example, moist air). In this case corrosion products cover the metal with a uniform layer of usually hydrogenated metal oxide, which protects the metal underneath from further corrosion. The other type is characterized by discreet pitting. It occurs when the metal is immersed in water and corrosion never stops. All cases shown in Figure 3 represent the second type, at different stages of corrosion progress.

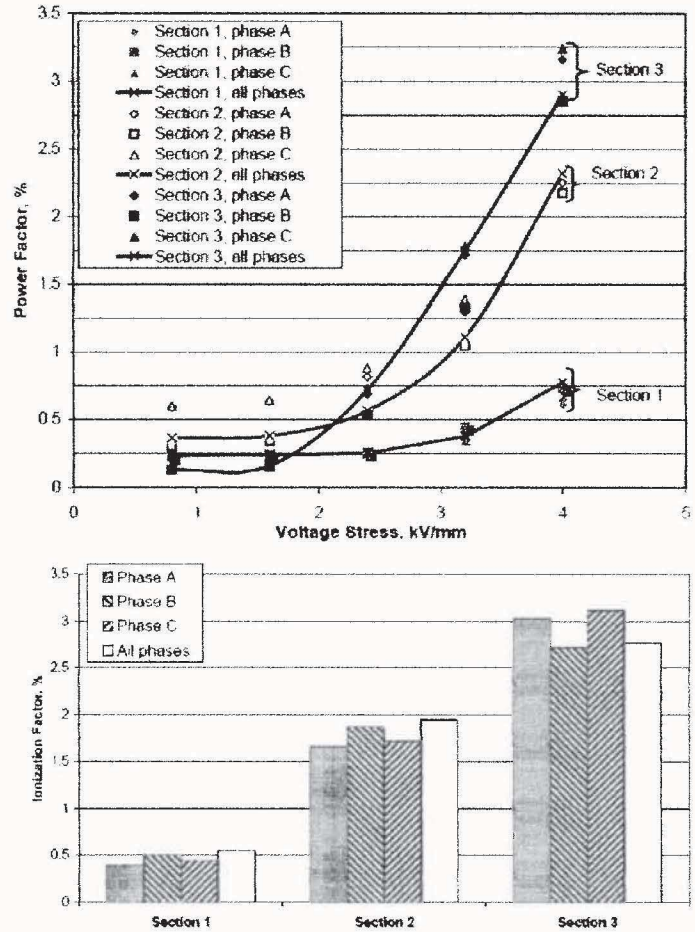
Table III summarizes the maximum power factors, measured at room temperature and nominal operating voltage stress of 1.6 kV/mm on different phases and sections of the same cable, as well as the maximum differences between sections and phases within the same cable (the difference between phases might be helpful in distinguishing bad performers during on-site diagnostic testing). Figure 4 provides a visual presentation of the data for cable 4 that had the highest ionization factor.

Fig. 4. Power factor at room temperature (upper picture) and ionization factor (lower picture) in cable 4 (worst performer of all cables).
