December 8, 2009

Subject: **Report of Petrographic Observations**
Crystal River Containment Wall and Dome Concrete Samples
Steam Generator Replacement Project
Crystal River Nuclear Generating Facility, Florida
MACTEC Project No. 6468-09-2535

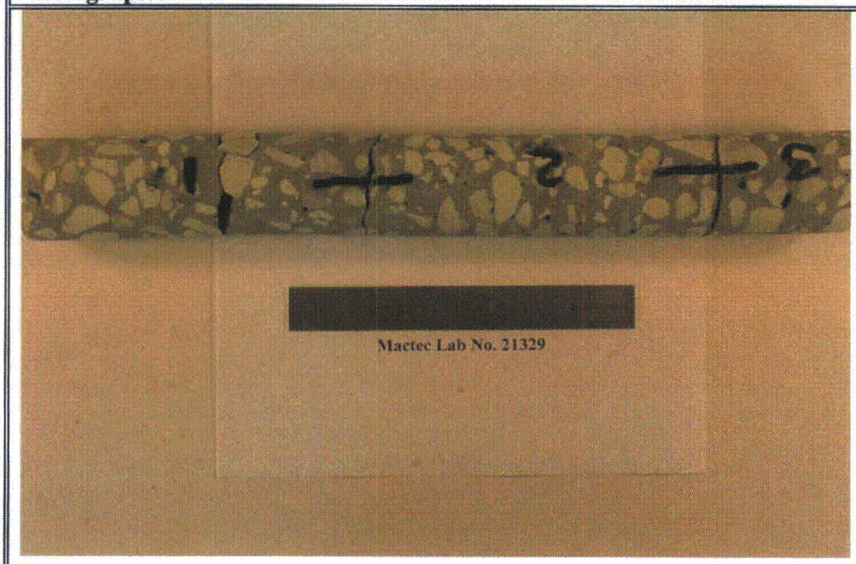
Photograph #1	**Remarks**

Photograph of core as received.

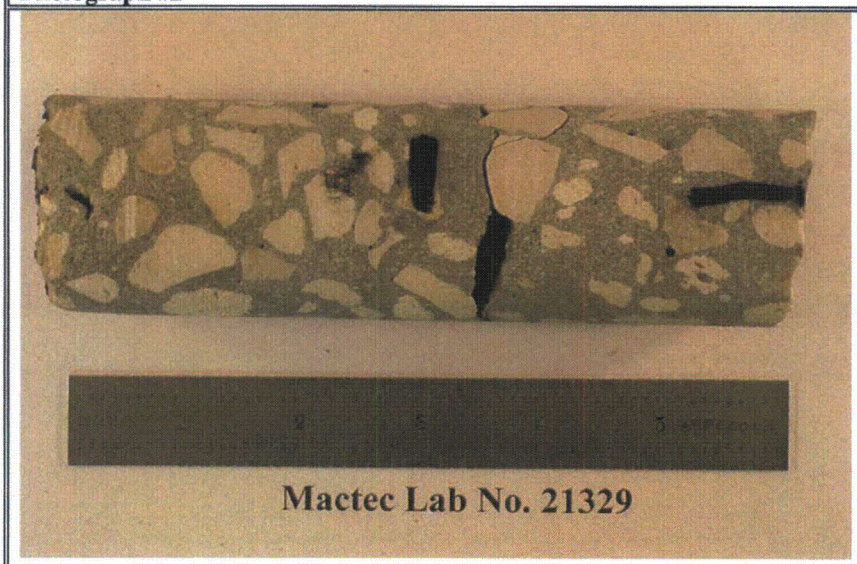
Photograph #2	**Remarks**

Photograph of core as received.

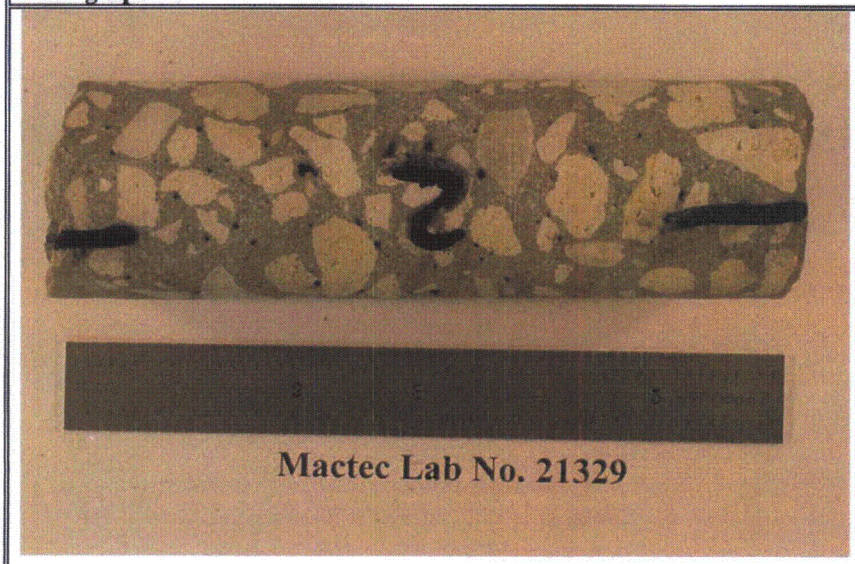
Photograph #3	Remarks

Photograph of core as received.

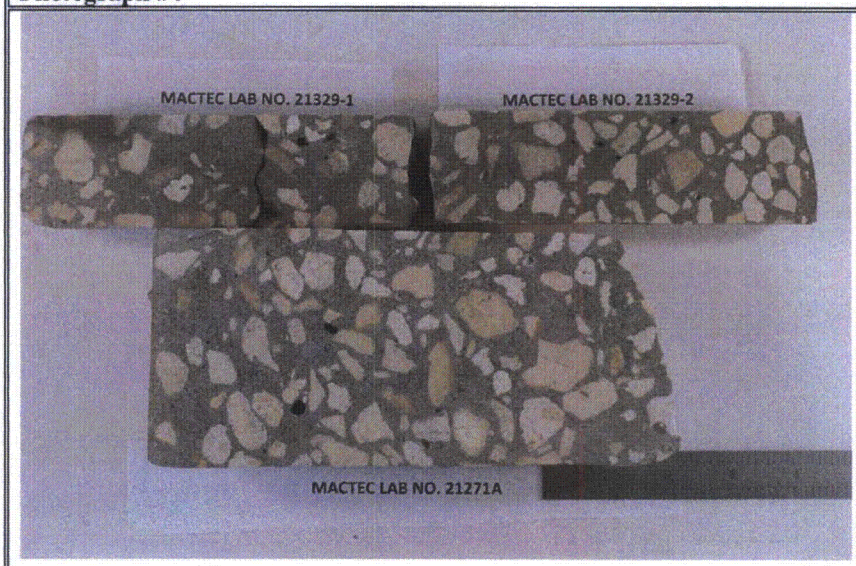
Photograph #4	Remarks

Photographs of polished sections.

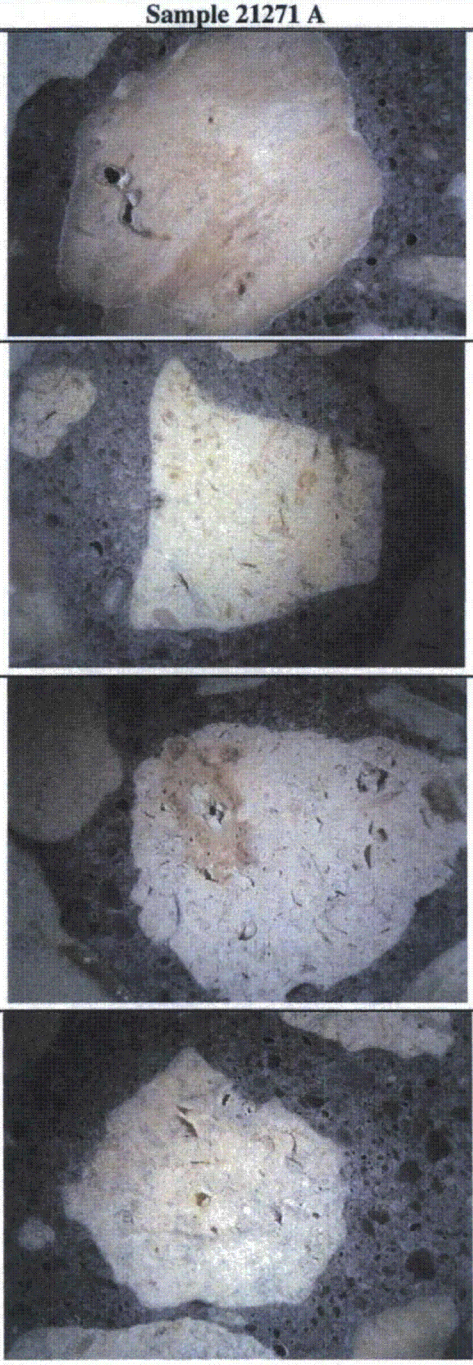
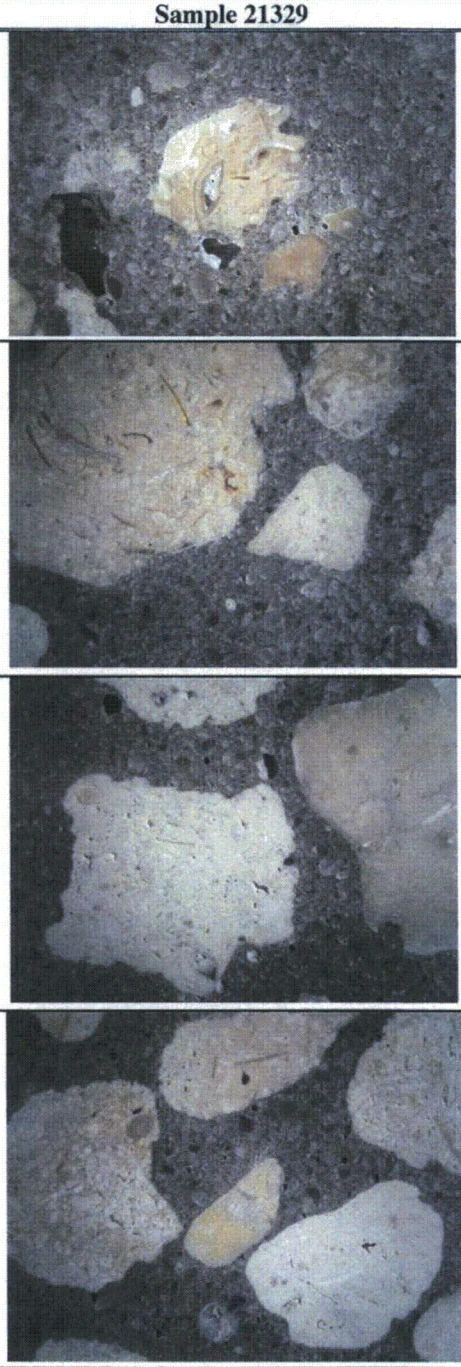
Sample 21271 A	Sample 21329

The aggregates from both samples have the same general similarities.

- Both coarse aggregates have a Moh's hardness of about 3
- Both coarse aggregates are a fosiliferous limestone with similar fossils
- Both coarse aggregates have some particles with a moderate amount of void space
- Both fine aggregates are predominately quartz with a similar particle shape

Photomicrographs of both samples (polished sections) showing similarities in aggregates.

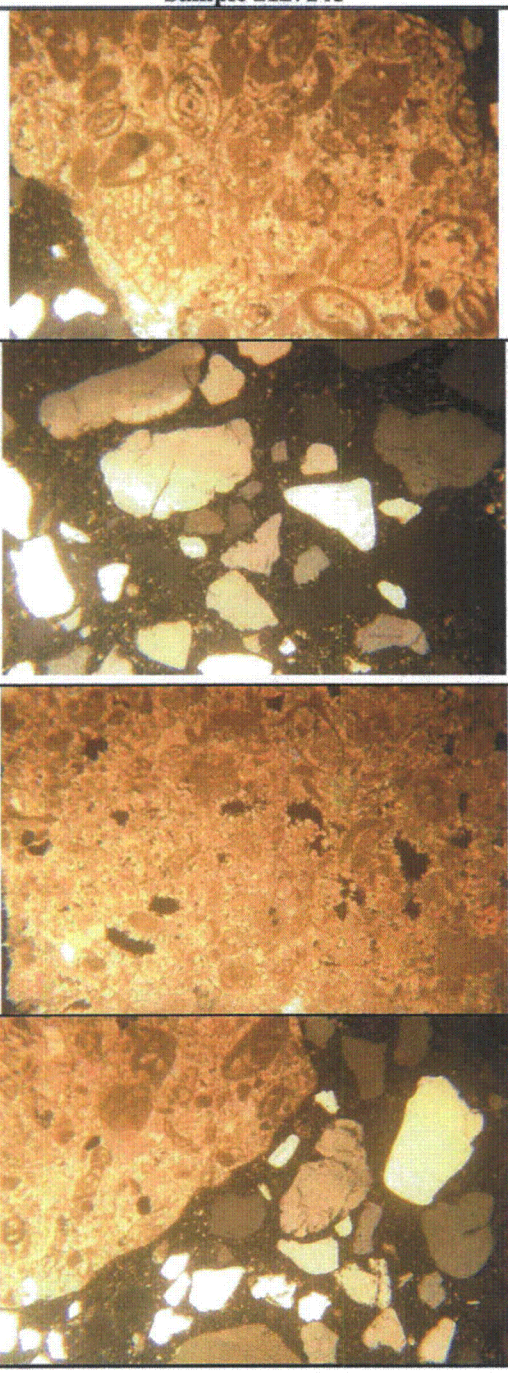
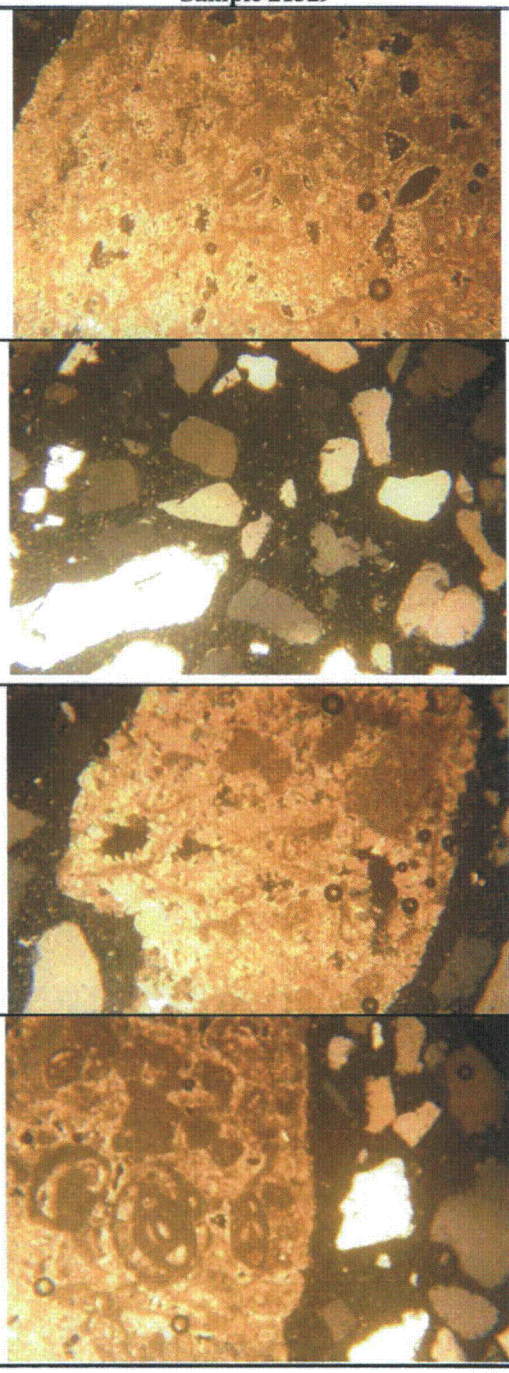
Sample 21271 A	Sample 21329

A few limestone particles were observed in sample 21271A that contained microcrystalline quartz and radial silica (chert). Chert was not observed in sample 21329. Chert is found in association with some limestones in Florida. The material is formed by the replacement of calcium carbonate with silica that is carried in the ground water. The lack of chert in sample 21329 does not necessarily mean that the coarse

Photomicrographs of (thin sections in cross-polarized light) showing similarities in aggregates.
