Report for
Progress Energy

CTLGroup Project No. 059169

Petrographic Examination of Concrete Half Core from Delaminated Containment Wall, Crystal River, Florida

November 2, 2009

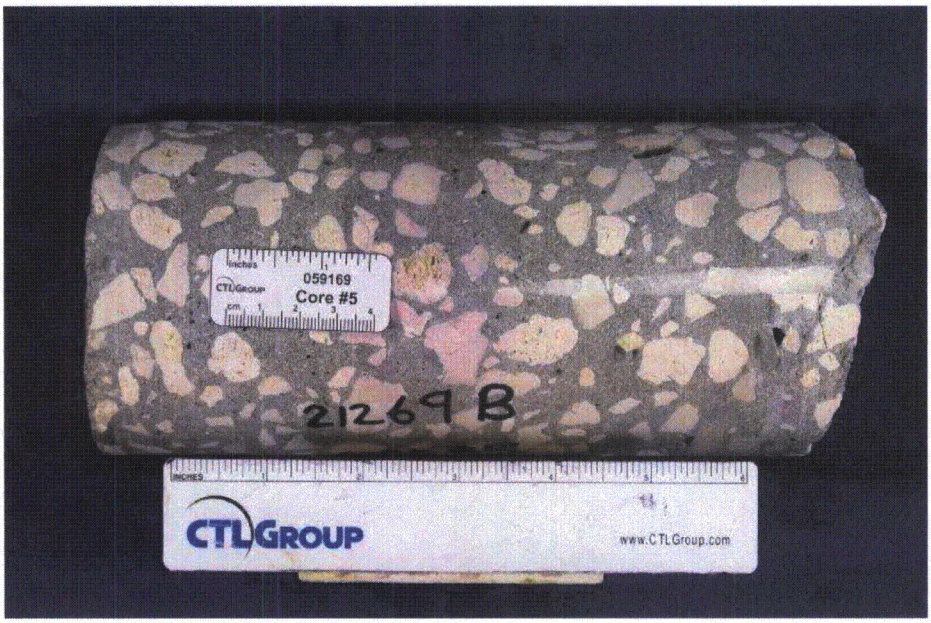
1a. Curved surface. Outer end is to the left.

Fig. 1 Side views of Core #5, as received for examination.

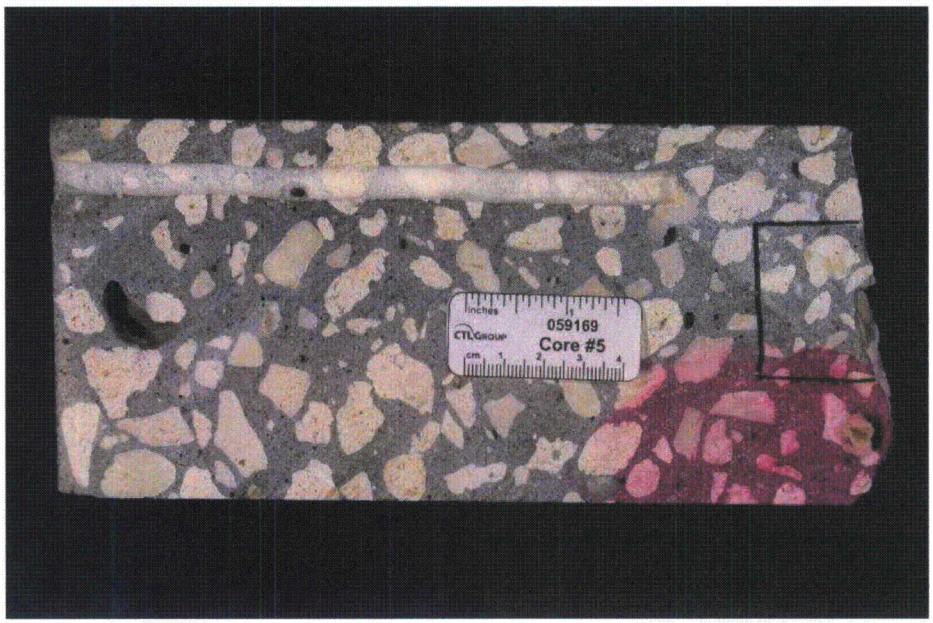
Carbonation to any significant depth from the fracture surface into the outer concrete is not observed (Fig. 3). Incipient carbonation is exhibited in thin section at the immediate fracture surface (Fig. 6a). However, an older delamination surface that was not exposed to air due to the depth of outer concrete, and other possible wall coverings, may also have such an absence of carbonation.

3a. Saw cut side. Outer surface is to the left.

3b. Fractured inner end.

Fig. 3 Views of the portions of Core #5 treated with phenolthalein, a pH indicator. All the pink regions exhibited denote the limits of where the indicator was applied. No colorless, low pH (carbonated) regions were observed at the fractured end regions.

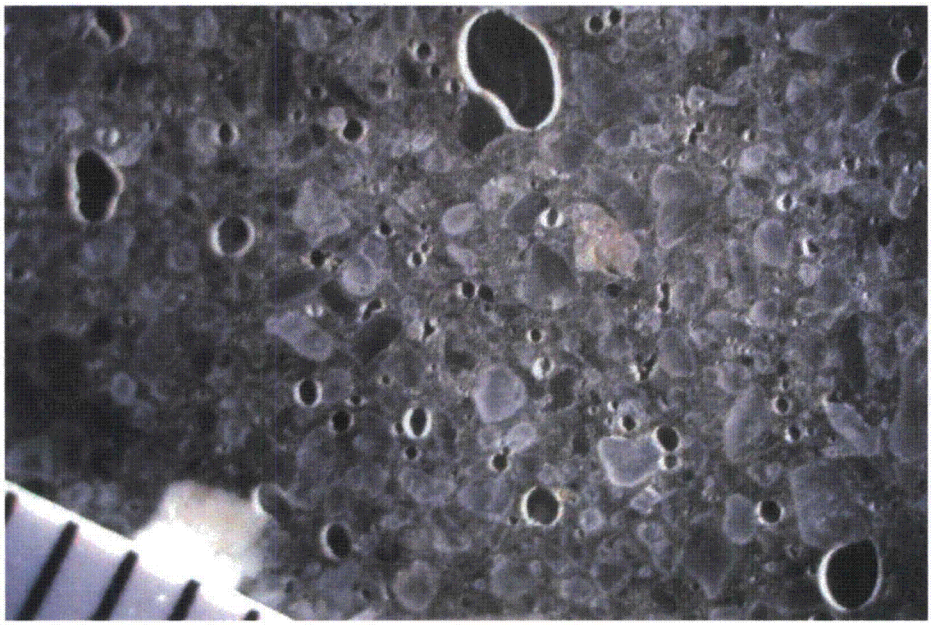
The concrete represented by Core #5 is well consolidated and free of any cracks or excessive microcracks (Fig. 4). The concrete consists of crushed carbonate rock coarse aggregate and natural sand fine aggregate, well distributed in a portland cement paste. No evidence is exhibited of any deleterious chemical reactions involving the cement paste and / or aggregates. The concrete could be considered marginally air entrained based on an approximate volume of 1 to 2% of small, spherical entrained air voids in the hardened cement paste (Fig. 5).

Fig. 5 View of the concrete hardened air-void system of Core #5 illustrating the moderate quantity of both coarse and fine air voids. Scale is millimeter increments.

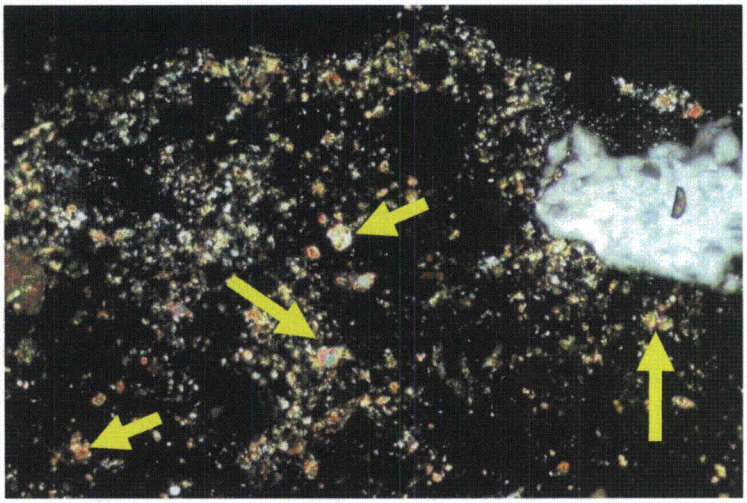
6a. Crossed-polarized light view of the paste adjacent to the inner fractured surface. Only incipient carbonation is indicated by the speckled high birefringence colors in the paste. Carbonate fines are arrowed yellow. Width of view is approximately 0.5 mm.

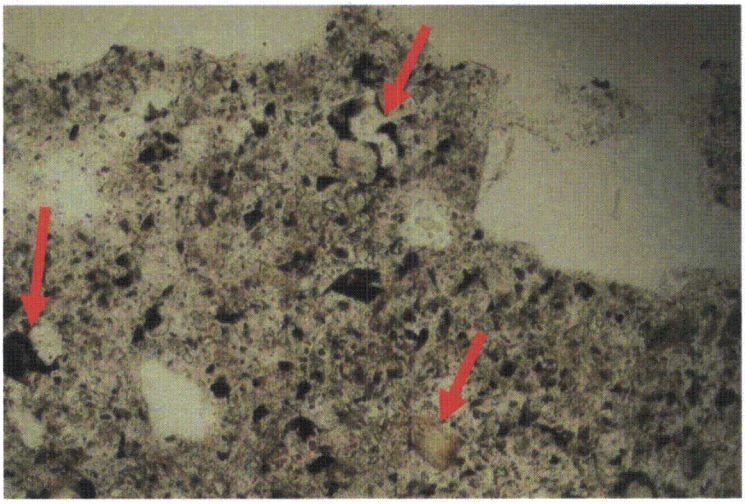
The cement hydration adjacent to the fracture is well advanced and comparable to that of the body of the core (Figs. 6b and 6c). This suggests that there was no moisture ingress to the fracture surface, over a period of time long enough, to change the general degree of hydration. This is supported by an absence of secondary deposits within air voids adjacent to the fracture surface.

6b. Plane-polarized light view of the paste adjacent to the inner fractured surface (same field of view as 6a.). A low to moderate number of unhydrated and partially hydrated cement particles (arrowed red) are exhibited by the paste. The amount is comparable to that in the body of the core in Fig. 6c. below. Width of view is approximately 0.5 mm.

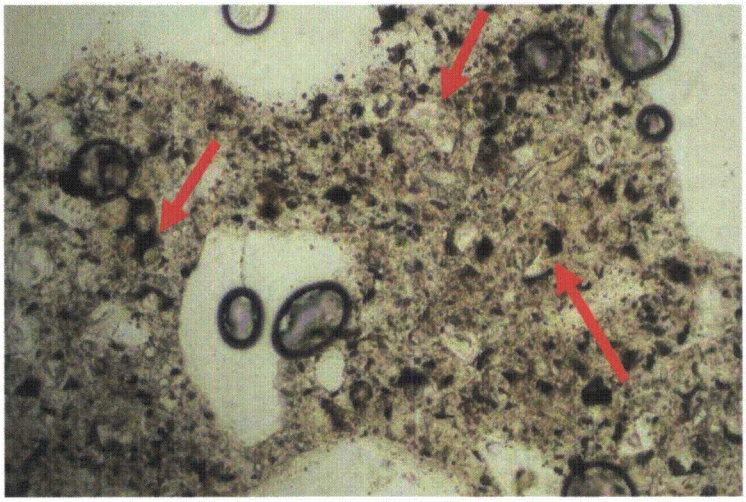
6c. Plane-polarized light view of the paste in the body of the core. A low to moderate number of unhydrated and partially hydrated cement particles (arrowed red) are exhibited by the paste. The amount is comparable to that near the fracture surface in Fig. 6b. above Width of view is approximately 0.5 mm.
