Florida Power
A Progress Energy Company

SUBJECT: Qualification of RoboProbe Parallel Laser Projector

Visual Examination of IWL (VT-3C)

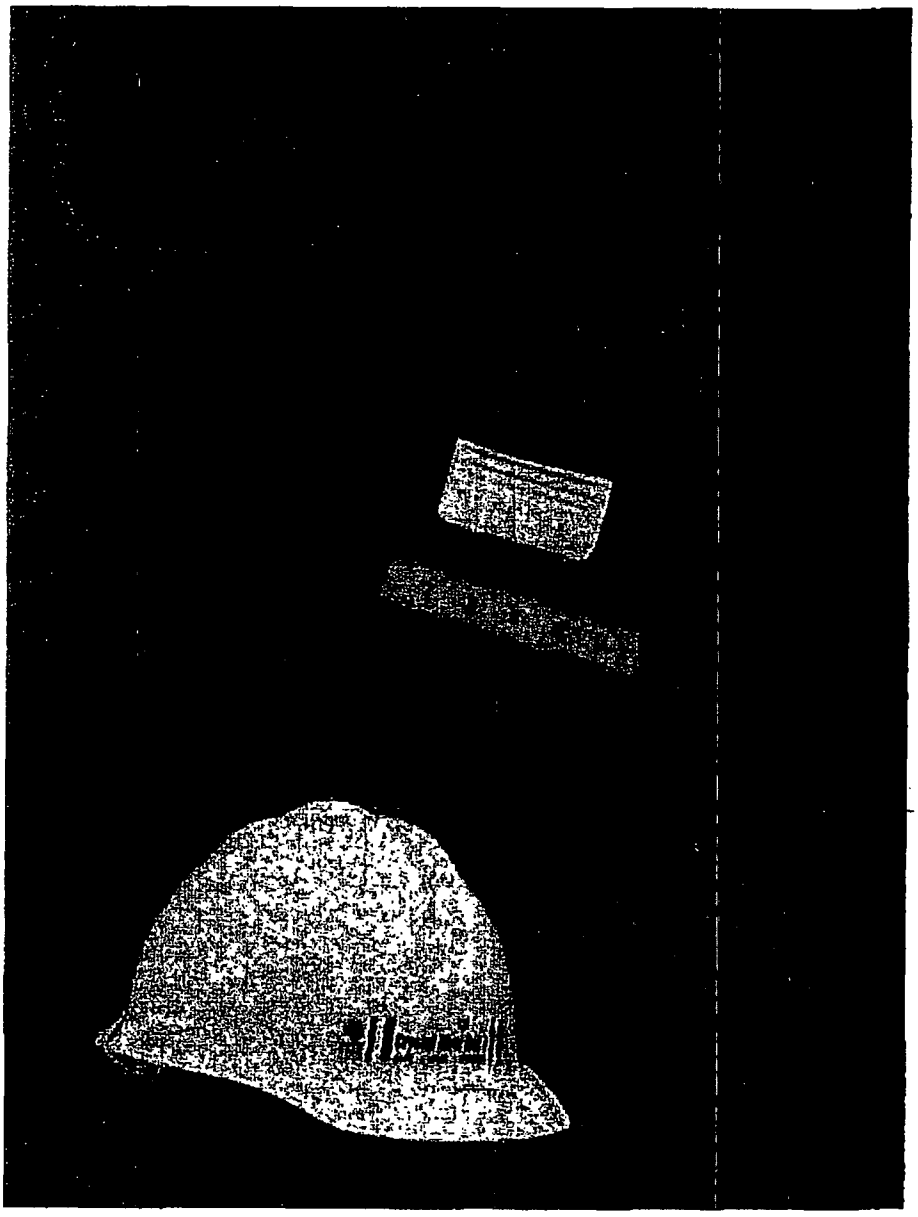
IOC - NPTS01-0106
Attachment 3

Photo taken at a distance of 137' with Sony Mavica, set on 20X full zoom.

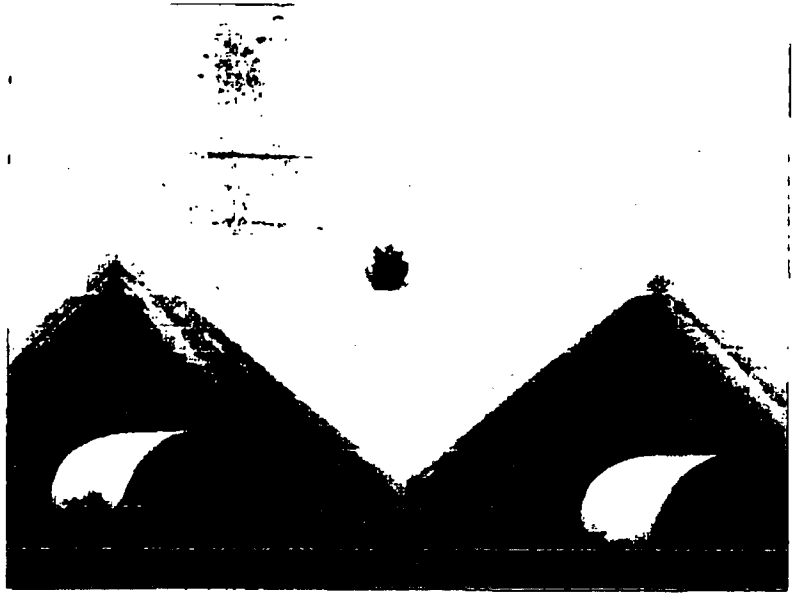
Sketch or Photo: L:\Shared\SIdata\Data\RFO12_SUPPS\VT_01_293_pic73.JPG

Item #1 (Reference Page 1 - Condition 17): Void, approximately 5" diameter, unknown depth, with possible exposed rebar (reference pic #73).

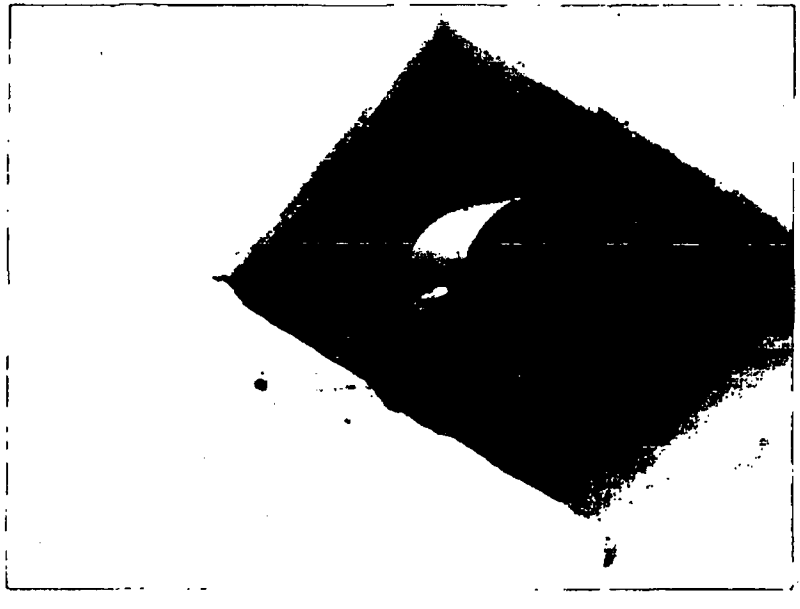
L:\Shared\SIdata\Data\RFO12_SUPPS\VT_01_293_pic74.JPG

Item #2 (Reference Page 1 - Condition 1): Spall > 8" and 3/4" depth with no exposed rebar (reference pic #74).

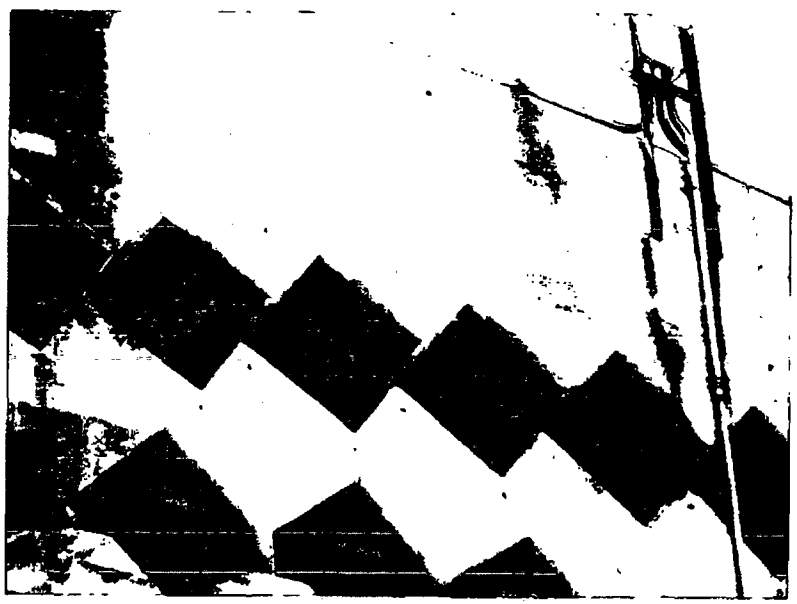
Sketch or Photo: L:\Shared\SIdata\Data\RFO12_SUPPS\VT_01_294_pic69.JPG

Item #10 (Reference Page 1 - Condition 1): Spalls > 8" and 3/4" depth @ top row, 2nd, 3rd, and 4th tendon pockets left of Buttress #6 CL (reference pic #69).

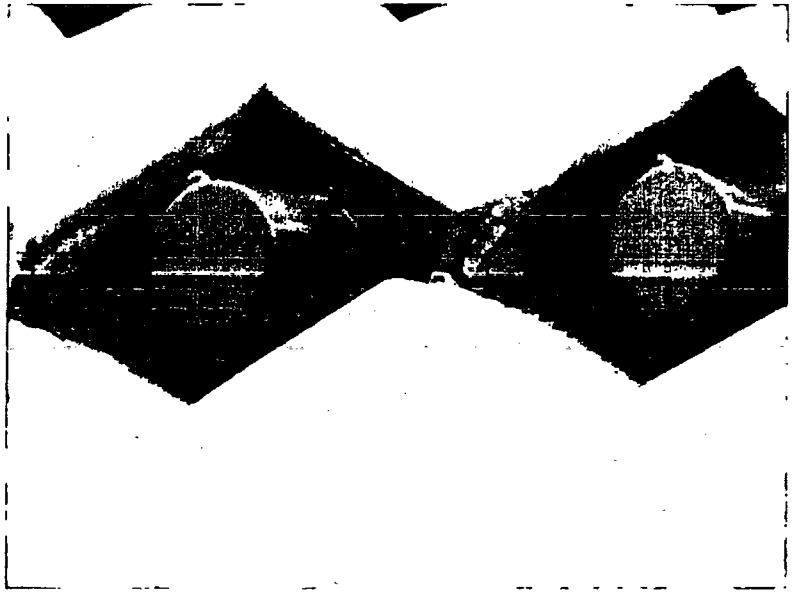
Sketch or Photo: L:\Shared\ISIdata\Data\RFO12_SUPPS\VT_01_297_pic2.JPG

Item #12 (Reference Page 1 - Condition 1): Two (2) spalls > 8" and 3/4" depth with no exposed rebar (reference pic #3 - Disk 2).

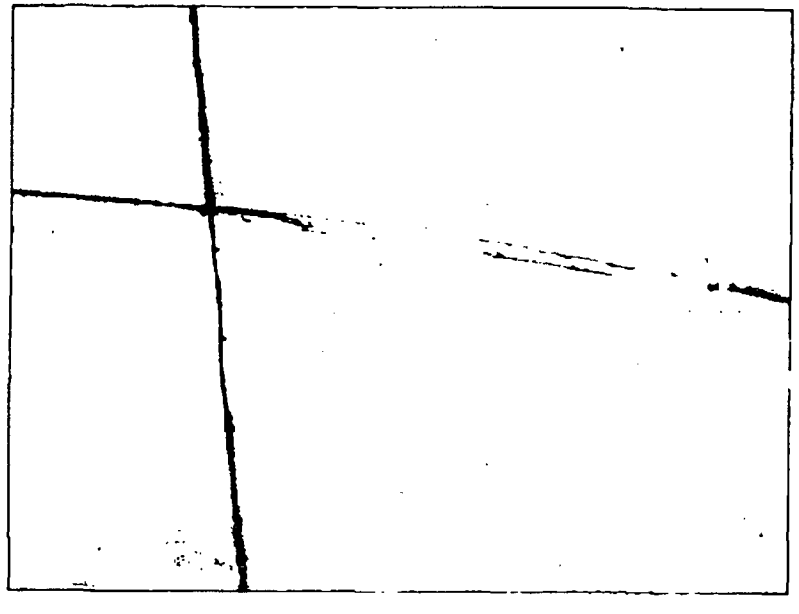
Sketch or Photo: L:\Shared\Sldata\Data\RFO12_SUPPS\VT_01_297_pic86.JPG

Item #15 (Reference Page 1 - Condition 2): Crack > .040" @ pour line 3C / 4C adjacent to left side of Buttress #3 (reference pic #6 - Disk 2).

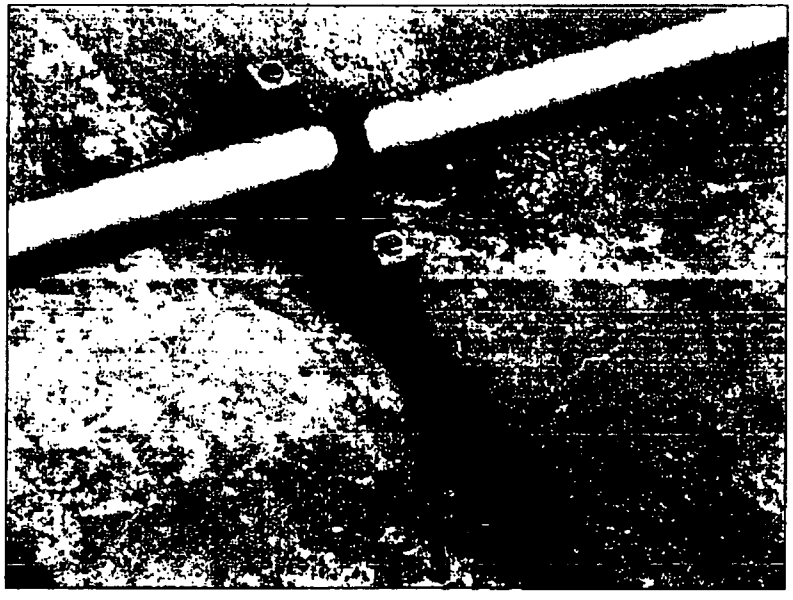
Sketch or Photo: L:\Shared\SIdata\Data\RFO12_SUPPS\VT_01_306_pic15.JPG

Comments: **Item #3 (Reference Page 1 - Condition 13): Intermittant areas of rust staining over dome area (reference pic #15).**

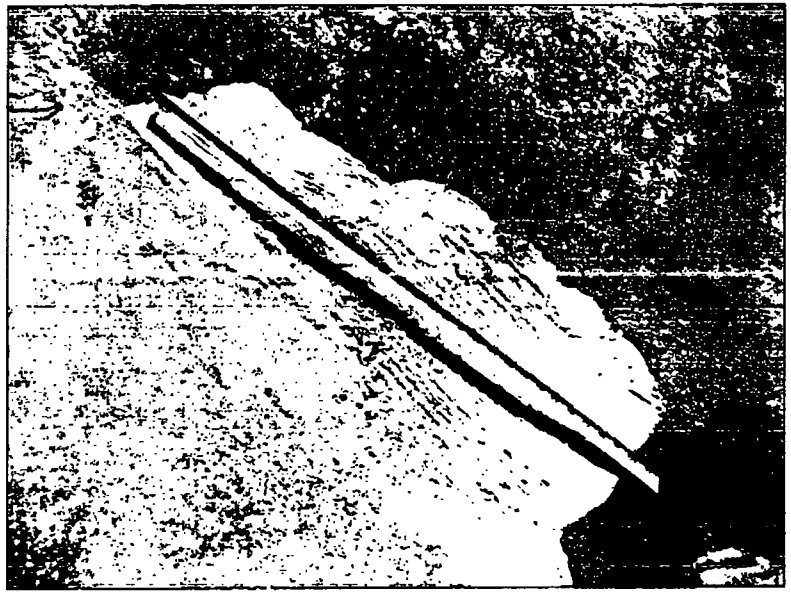
Sketch or Photo: L:\Shared\ISIdata\Data\RFO12_SUPPS\VT_01_299_pic56.JPG

Comments: Item #5 (Reference Page 1 - Condition 22): Deteriorating grout patch (reference pic #56).

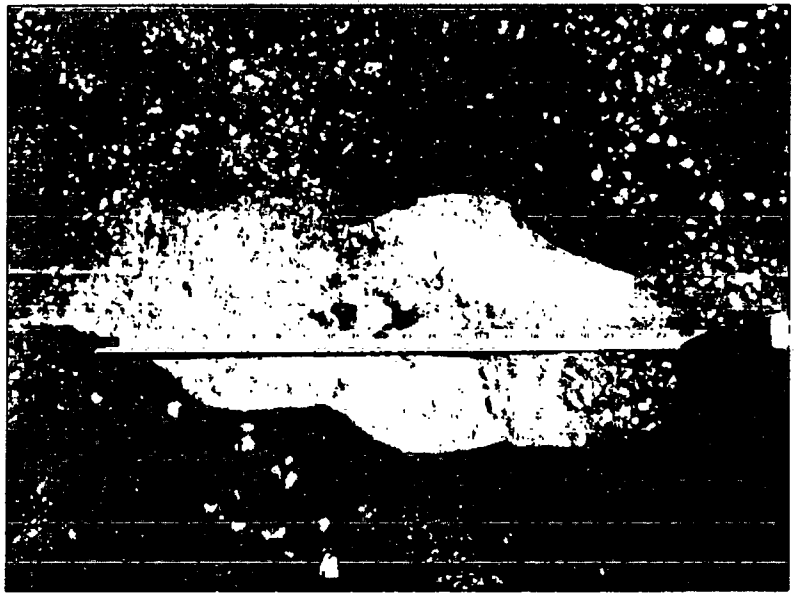
Sketch or Photo: L:\Shared\ISIdata\Data\RFO12_SUPPS\VT_01_299_pic58.JPG

Comments: **Item #7 (Reference Page 1 - Condition 22): Deteriorating grout patch (reference pic #58, #59 & #60).**

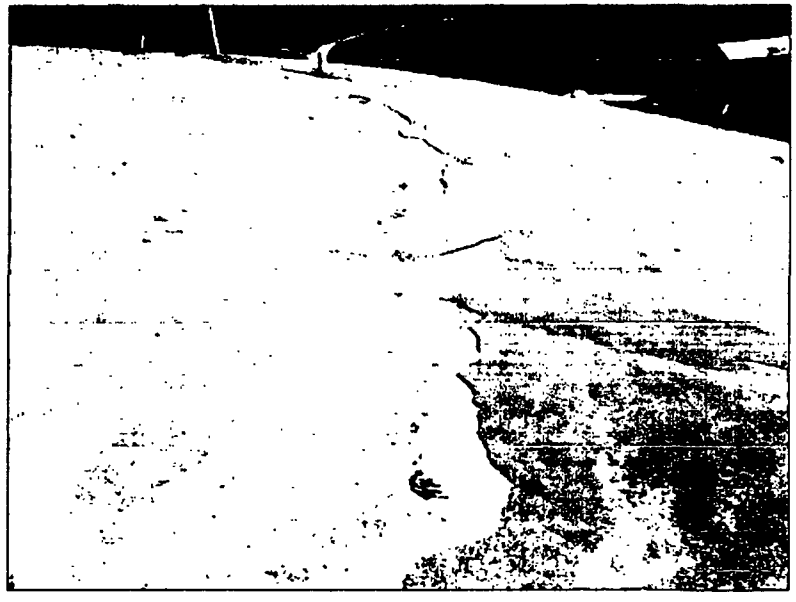
Item #1 (Reference Page 1 - Condition 22): Deteriorating grout patch and general concrete aggregate composition (reference pic #61).

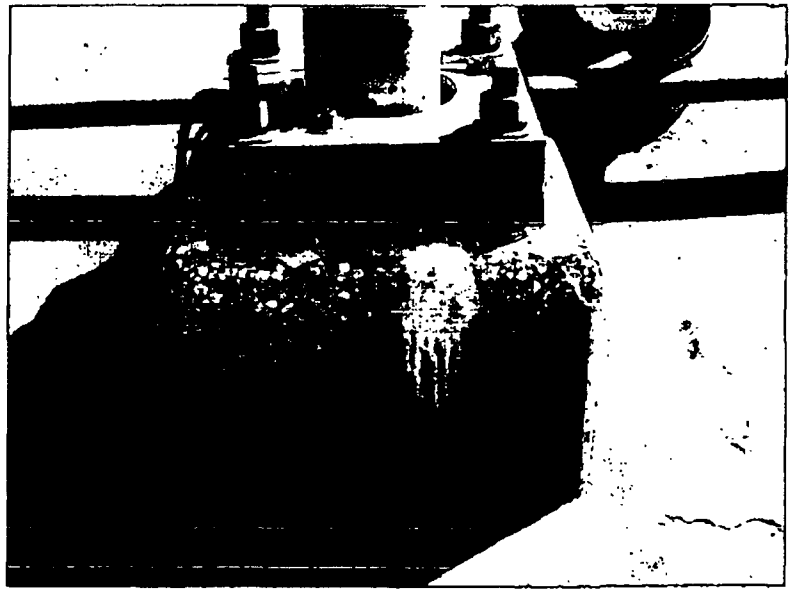
Sketch or Photo: L:\Shared\ISIdata\Data\RFO12_SUPPS\VT_01_304_pic29.JPG

Comments: Dome concrete surface between CL of Buttress #3 and CL of Buttress #4. See attached pages for referenced photo locations (approx.)
Item #1 (Reference Page 1 - Condition(s) 1 and 15): Efflorescence and corner spalling > 8" and 3/4" depth with no exposed rebar (reference pic #29).
Item #2 (Reference Page 1 - Condition 22): Deteriorating grout patch (reference pic #30).

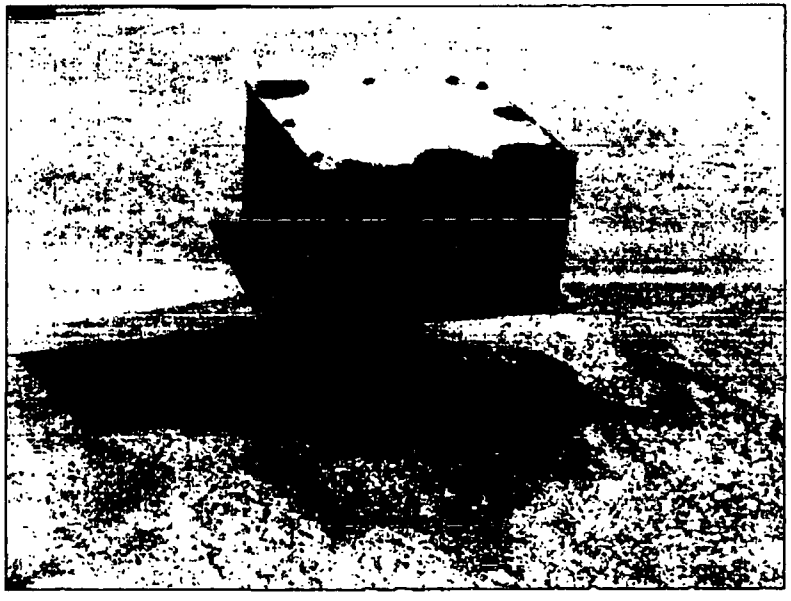
Sketch or Photo: L:\Shared\SIdata\Data\RFO12_SUPPS\VT_01_304_pic33.JPG

Comments: Dome concrete surface between CL of Buttress #3 and CL of Buttress #4.
Item #5 (Reference Page 1 - Condition 22): Exposed/protruding conduit with attached box (reference pic #33).
Item #6 (Reference Page 1 - Condition 22): Deteriorating grout patch (reference pic #34).

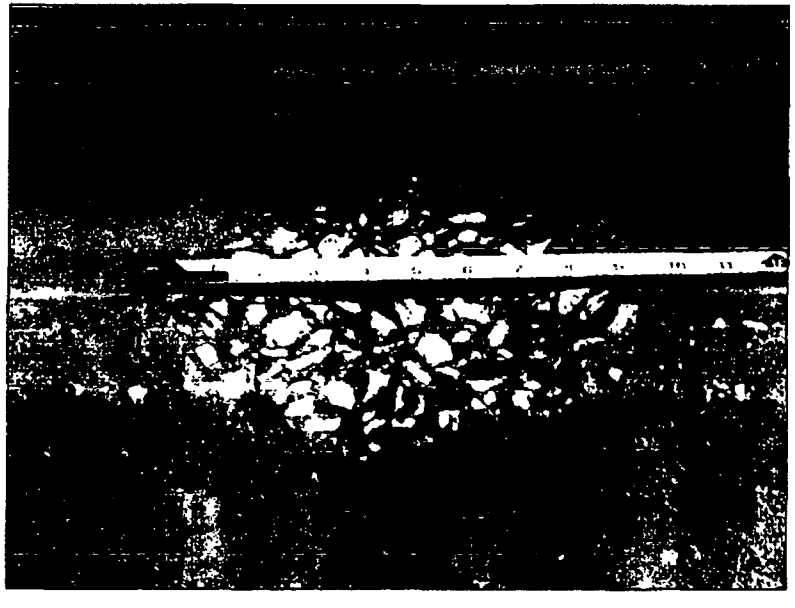
Item #4 (Reference Page 1 - Condition 1): Spall > 8" and 3/4" depth with no exposed rebar (reference pic #11).

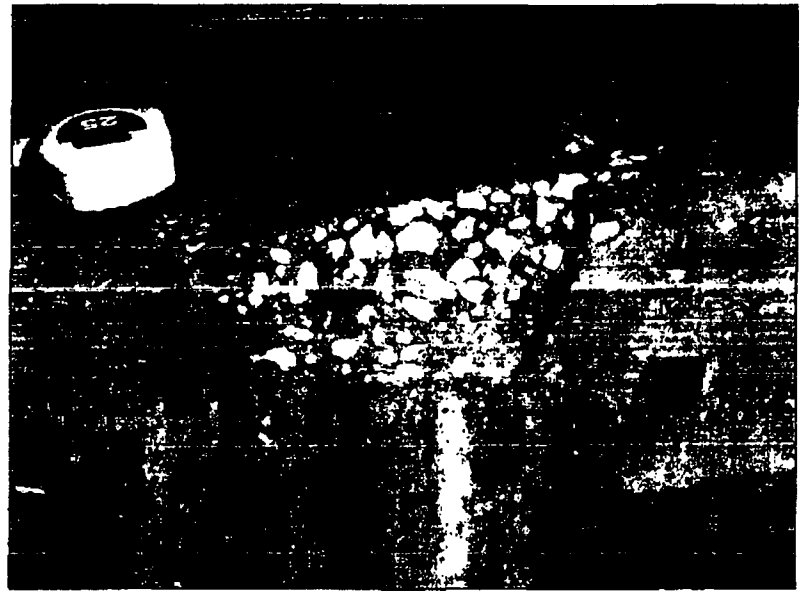
Item #6 (Reference Page 1 - Condition 1): Spall > 8" and 3/4" depth with no exposed rebar (reference pic #13).

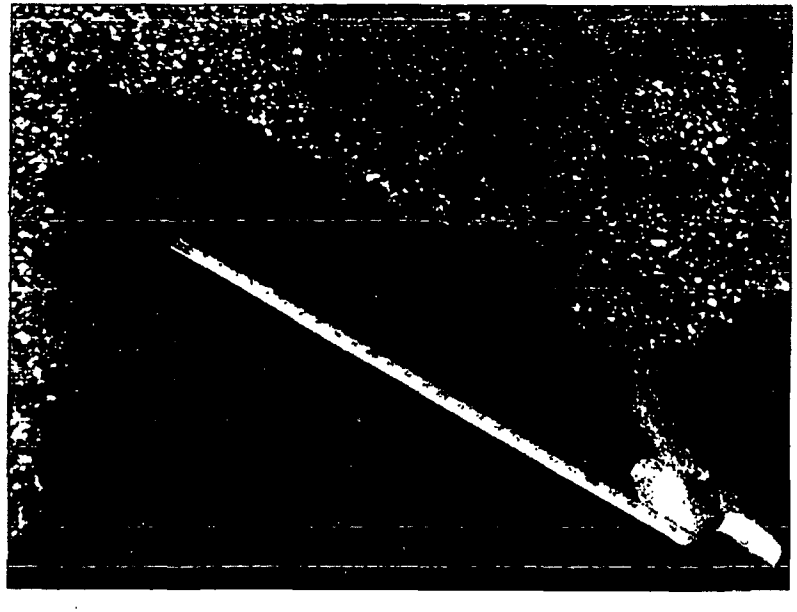
Sketch or Photo: L:\Shared\ISIdata\Data\RFO12_SUPPS\VT_01_302_pic25.JPG

Item #18 (Reference Page 1 - Condition 2): Cracks > .040" in grout patch (reference pic #25).

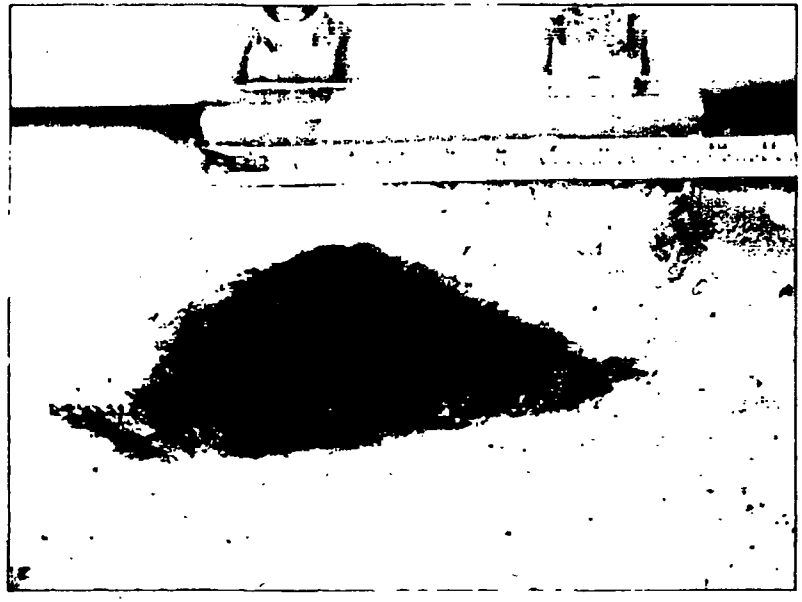
Item #2 (Reference Page 1 - Condition 1): Spall > 3/4" depth with no exposed rebar (reference pic #36).

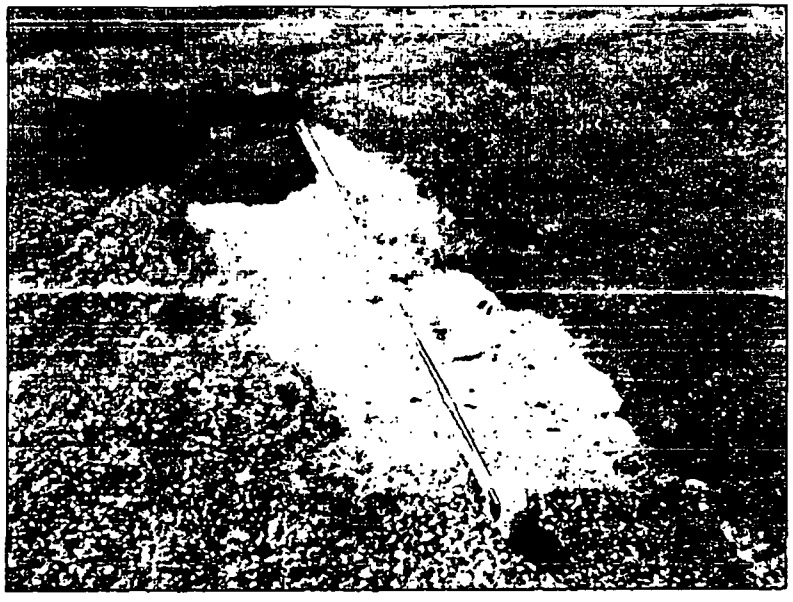
Sketch or Photo: L:\Shared\ISIdata\Data\RFO12_SUPPS\VT_01_301_pic39.JPG

Item #5 (Reference Page 1 - Condition 22): Deteriorating grout patch (reference pic #39).

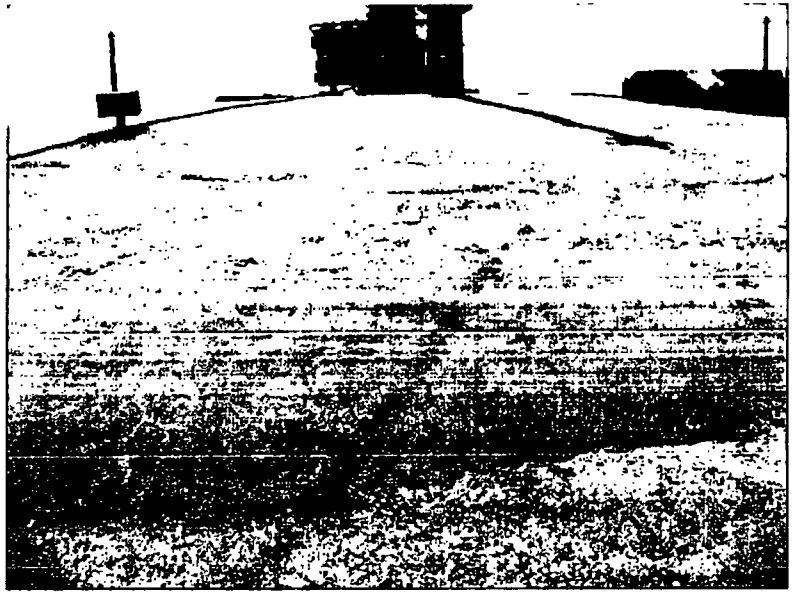
Sketch or Photo: L:\Shared\ISIdata\Data\RFO12_SUPPS\VT_01_301_pic41.JPG

Item #7 (Reference Page 1 - Condition 22): General concrete aggregate composition (reference pic #41, #42 & #43).

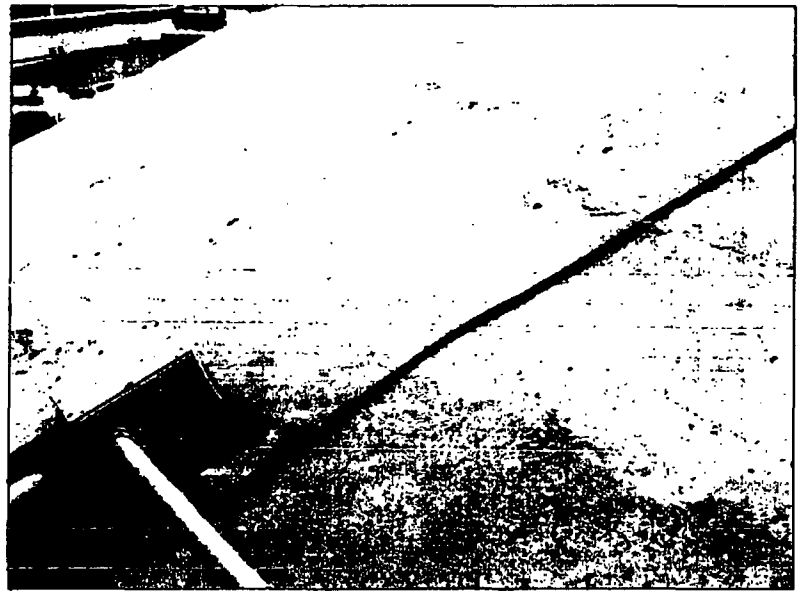
Item #1 (Reference Page 1 - Condition 22): Deteriorating grout patch (reference pic #44).

Item #2 (Reference Page 1 - Condition 22): General concrete aggregate composition (reference pic #45).

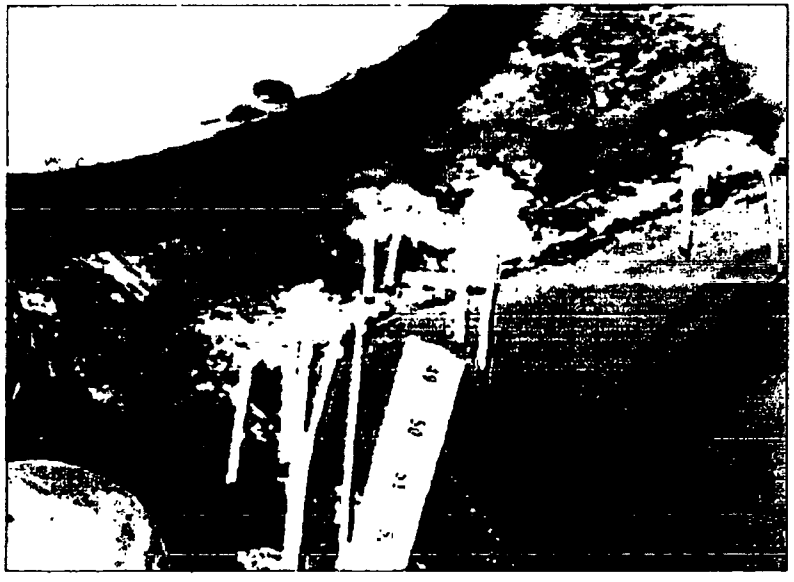
Sketch or Photo: L:\Shared\ISIdata\Data\RFO12_SUPPS\VT_01_315_item1a.jpg

Comments: **Item #1 (Reference Page 1 - Conditions 6 and 15): Four (4) areas of efflorescense (reference pic(s) #item1a, #item1ba, and #item1cb following page).**

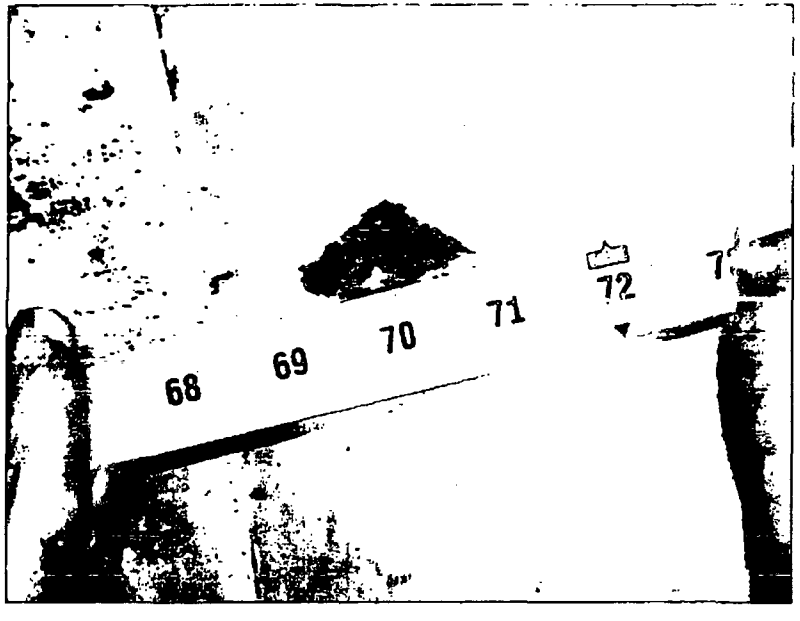
Comments: **Item #2 (Reference Page 1 - Condition 22): Two (2) areas of exposed metal (reference pic(s) #item2a and #item2b).**

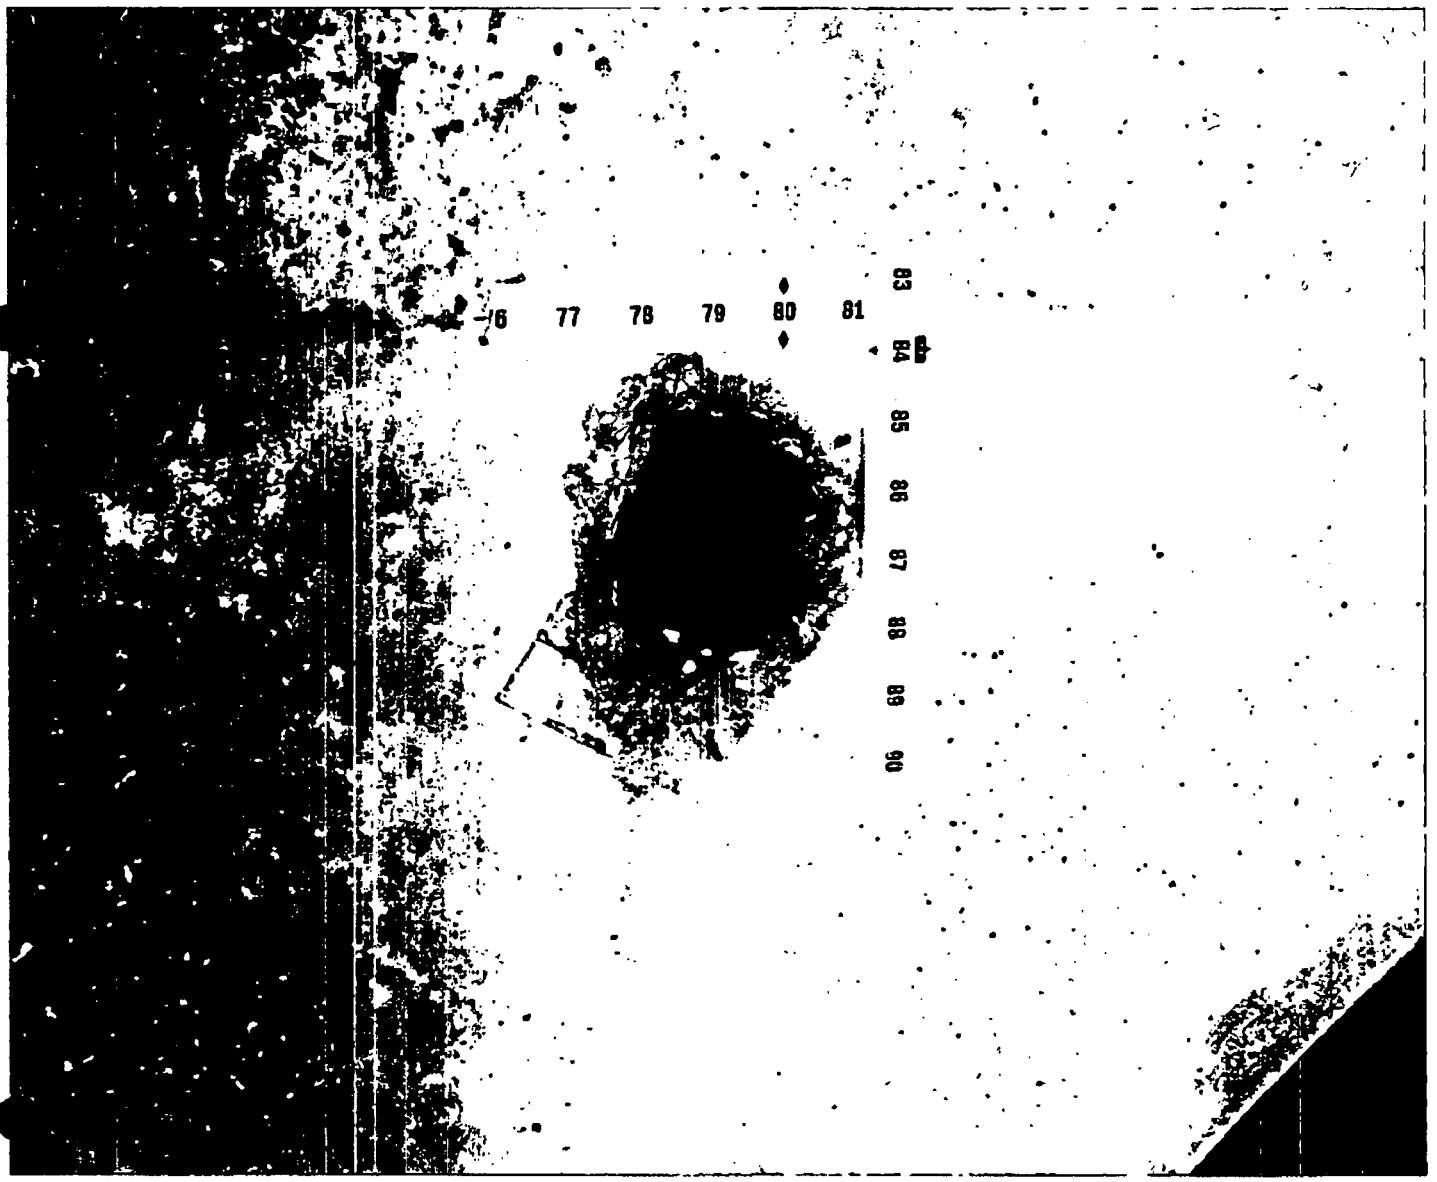
Sketch or Photo: L:\Shared\SIdata\Data\RFO12_SUPPS\VT_01_305_item1a.jpg

Comments: Item #1A (Reference Page 1 - Conditions 7and 12): 4" diameter popout 2 1/16" deep with expose metal in center, probably rebar (reference pic #item1A).

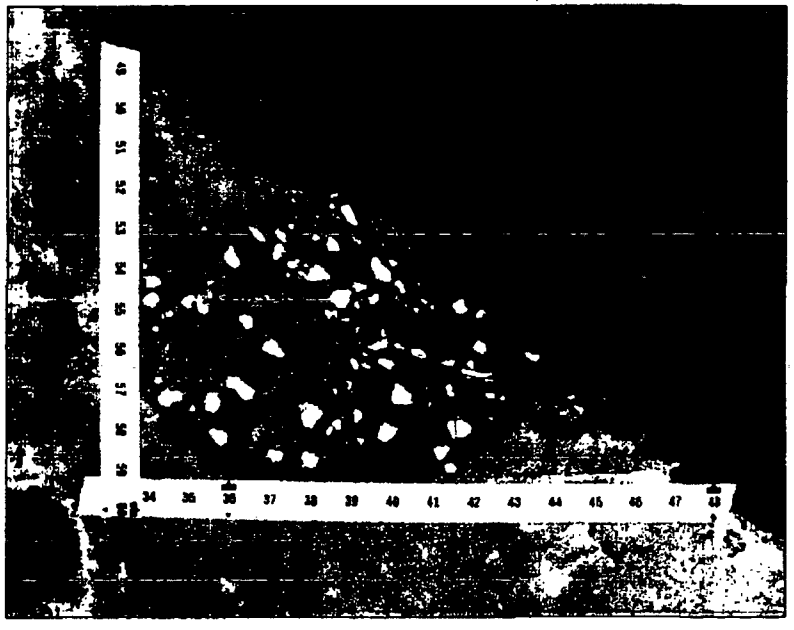
Sketch or Photo: L:\Shared\SIdata\Data\RFO12_SUPPS\VT_01_307_item2a.jpg

Comments: **Item #2A/B (Reference Page 1 - Condition 1): Spall at anchorage edge 12" x 7" x 1 1/4" deep (reference pic(s) #item2A and #item2B).**

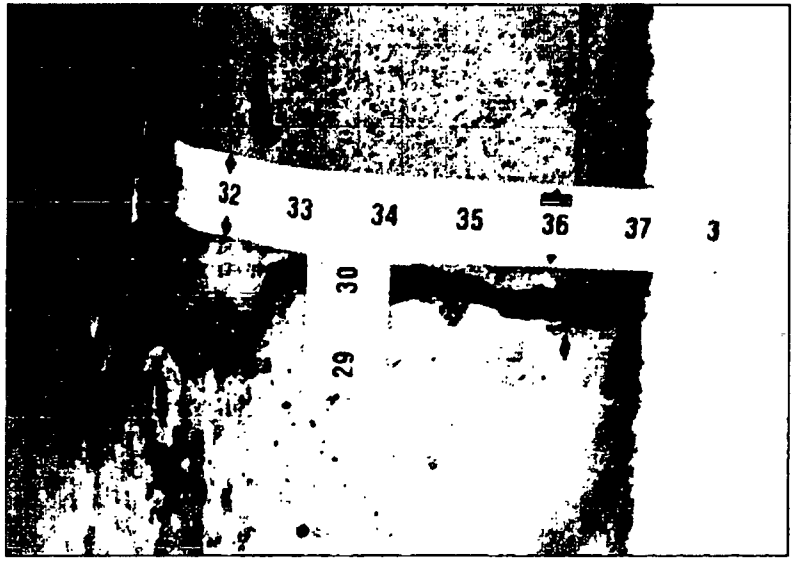
Sketch or Photo: L:\Shared\SIdata\Data\RFO12_SUPPS\VT_01_308_item4a.jpg

Comments: Item #4 (Reference Page 1 - Condition 17): Void 7" long, 3/8" wide, 1/4" deep. No other concerns found above Item #4 (reference pic(s) #item4A, #item4B, #item4C next page, and #item 4D next page).

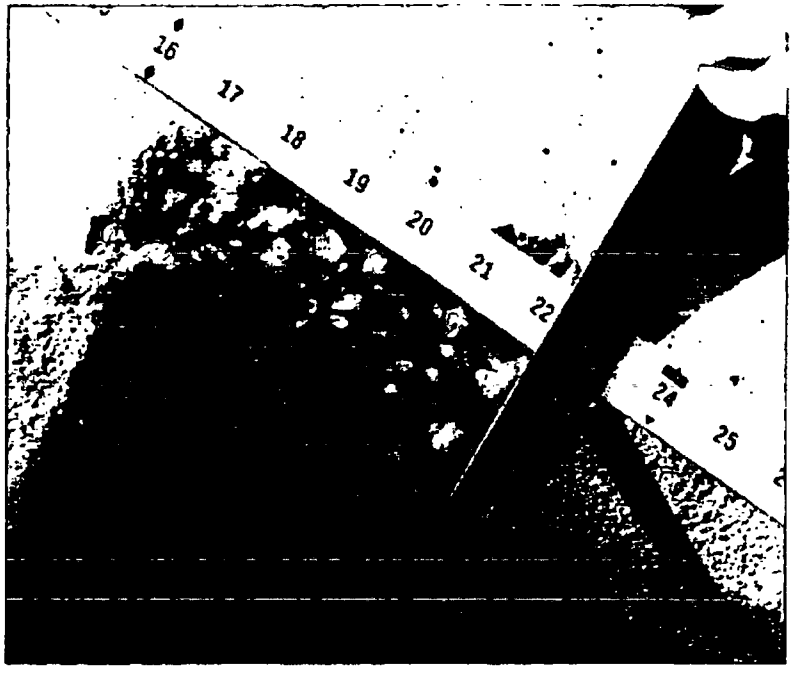
Sketch or Photo: L:\Shared\SIdata\Data\RFO12_SUPPS\VT_01_309_item10c.jpg

Comments: **Item #10 (Reference Page 1 - Condition 1): Spalls in upper corners of tendon pockets (reference pic(s) #item10A previous page, #item10B previous page, #item10C, #item 10D1, #item10D2 following page, and #item10E following page).**

Item #10C - 6" x 4" x 1" deep.
Item #10D1 - 3" diameter spall, 1" deep.

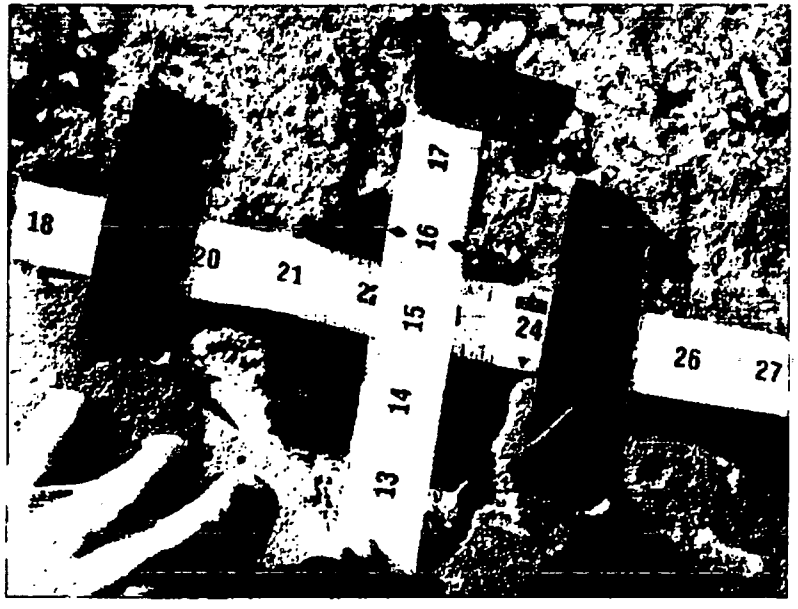
Sketch or Photo: L:\Shared\SIdata\Data\RFO12_SUPPS\VT_01_309_Item10d2.jpg

Comments: Item #10 (Reference Page 1 - Condition 1): Spalls in upper corners of tendon pockets (reference pic(s) #item10A previous page, #item10B previous page, #item10C previous page, #item 10D1 previous page, #item10D2, and #item10E).

Item #10D2 - 3" diameter spall, 1" deep.
Item #10E????

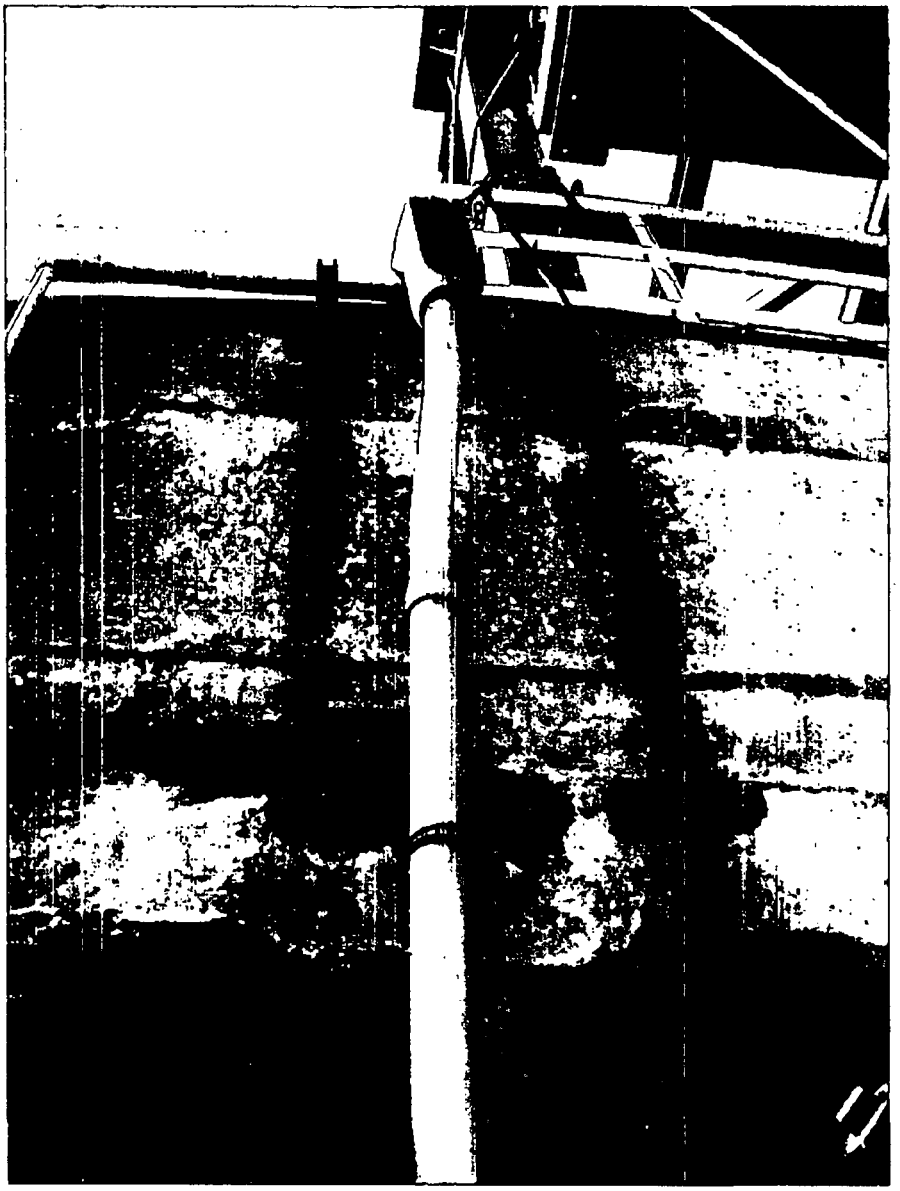
Sketch or Photo: L:\Shared\SIdata\Data\RFO12_SUPPS\VT_01_311_item2c.jpg

Comments: **Item #2 (Reference Page 1 - Condition 22): Examples of ungrouted form tie holes (reference pic(s) #item2A previous page, #item2B previous page, #item2C, #item2 following page, #item2G following page). Rust stains are from roof (dome) conduit supports.**

Item #2C is an example of ungrouted form tie holes.

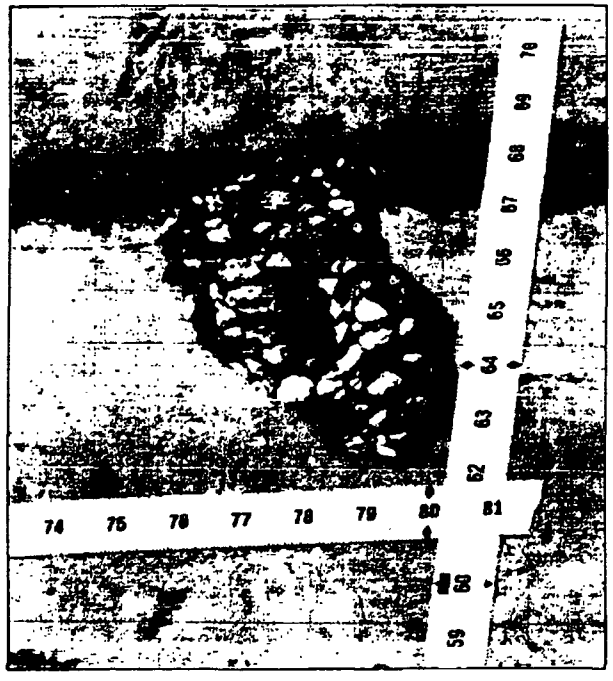
Sketch or Photo: L:\Shared\Sldata\Data\RFO12_SUPPS\VT_01_313_item13.jpg

Comments: Item #13(R) (Reference Page 1 - Condition 1): 6" x 3" x 3/4" deep spall. No rebar exposed (reference pic #item13).

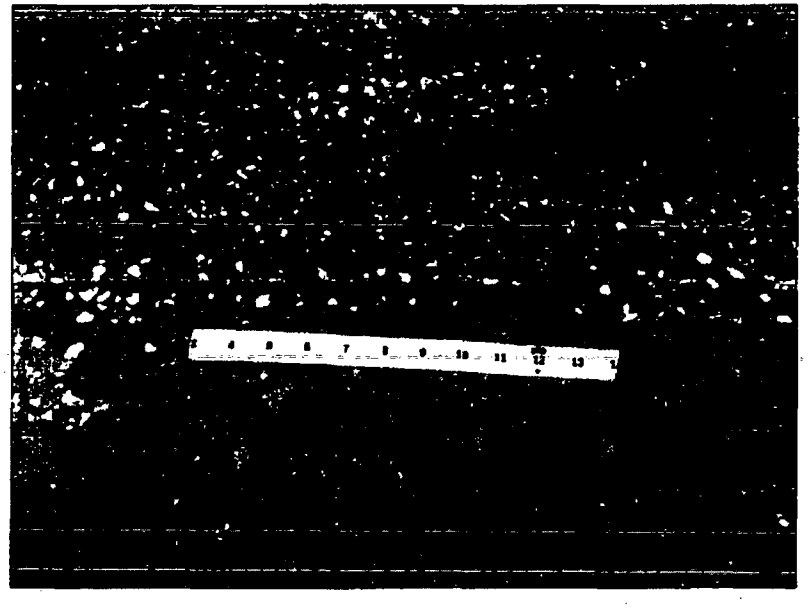
L:\Shared\SIdata\Data\RFO12_SUPPS\VT_01_317_item99.jpg

Item c #99 (Reference Page 1 - Condition 22): Exposed wire (reference pic #item99).

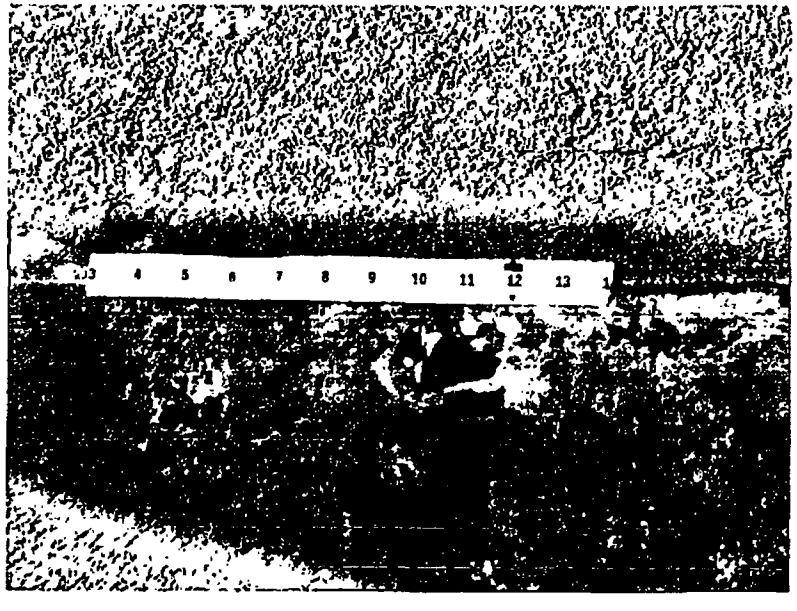
Sketch or Photo: L:\Shared\SIdata\Data\RFO12_SUPPS\VT_01_317_item20a.jpg

Comments: **Item d #20 (Reference Page 1 - Condition 1): Exposed form tie and spall area, 3/4" deep with exposed metal rod in center (reference pic(s) #item20a and #item20b).**

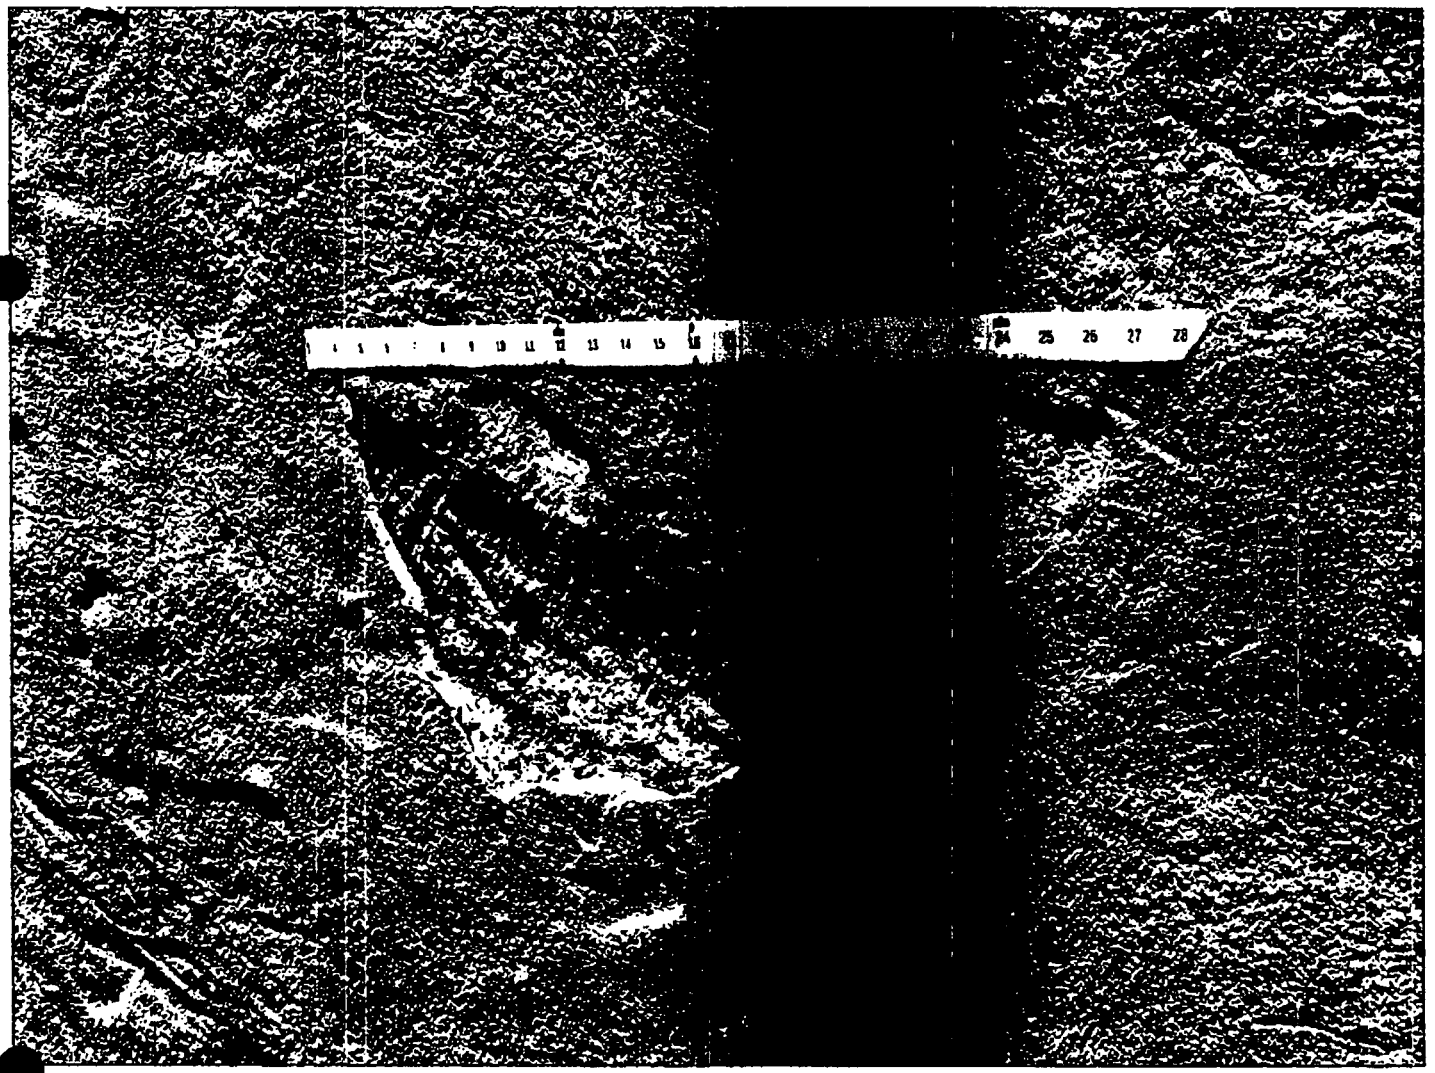
Sketch or Photo: L:\Shared\SIdata\Data\RFO12_SUPPS\VT_01_316_item1b.jpg

Comments: **Item b #1 (Reference Page 1 - Conditions 2, 3, and 16): Deteriorating grout patch (reference pic #item1b).**
