University of Missouri
Pickard Hall
Characterization Report
Gamma Scans

CHASE Environmental Group

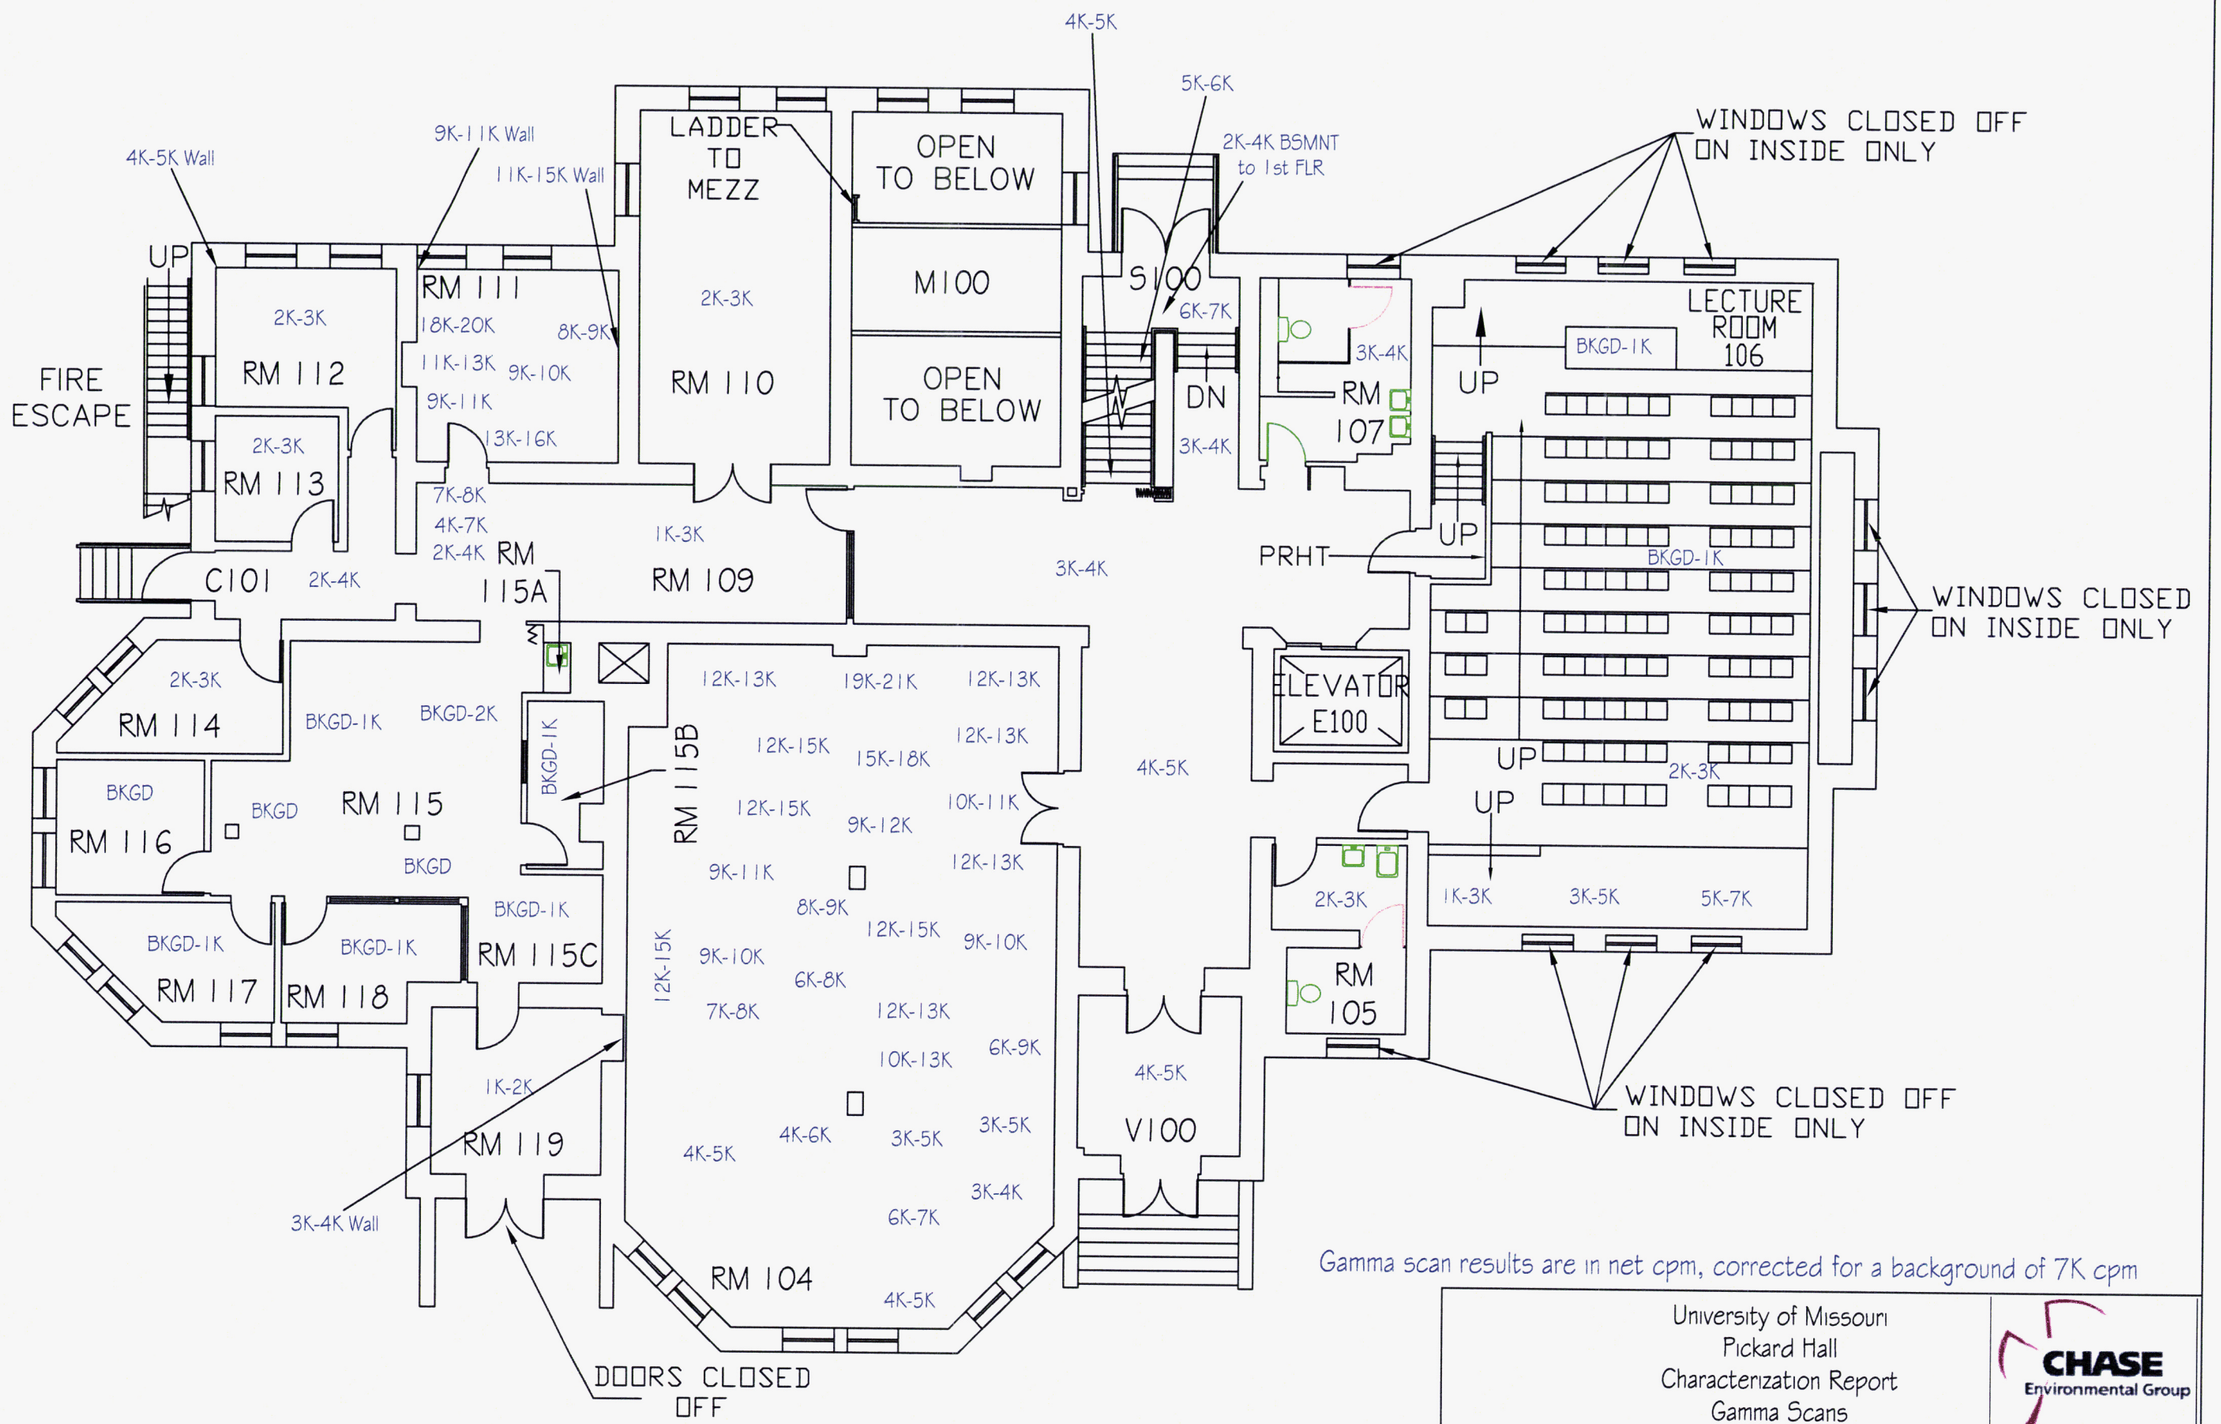
University of Missouri Pickard Hall Characterization Report Gamma Scans		CHASE Environmental Group
Building: Pickard Hall	Elevation: 1st Floor	Page: F.2 of F.4

Gamma scan results are in net cpm, corrected for a background of 7K cpm

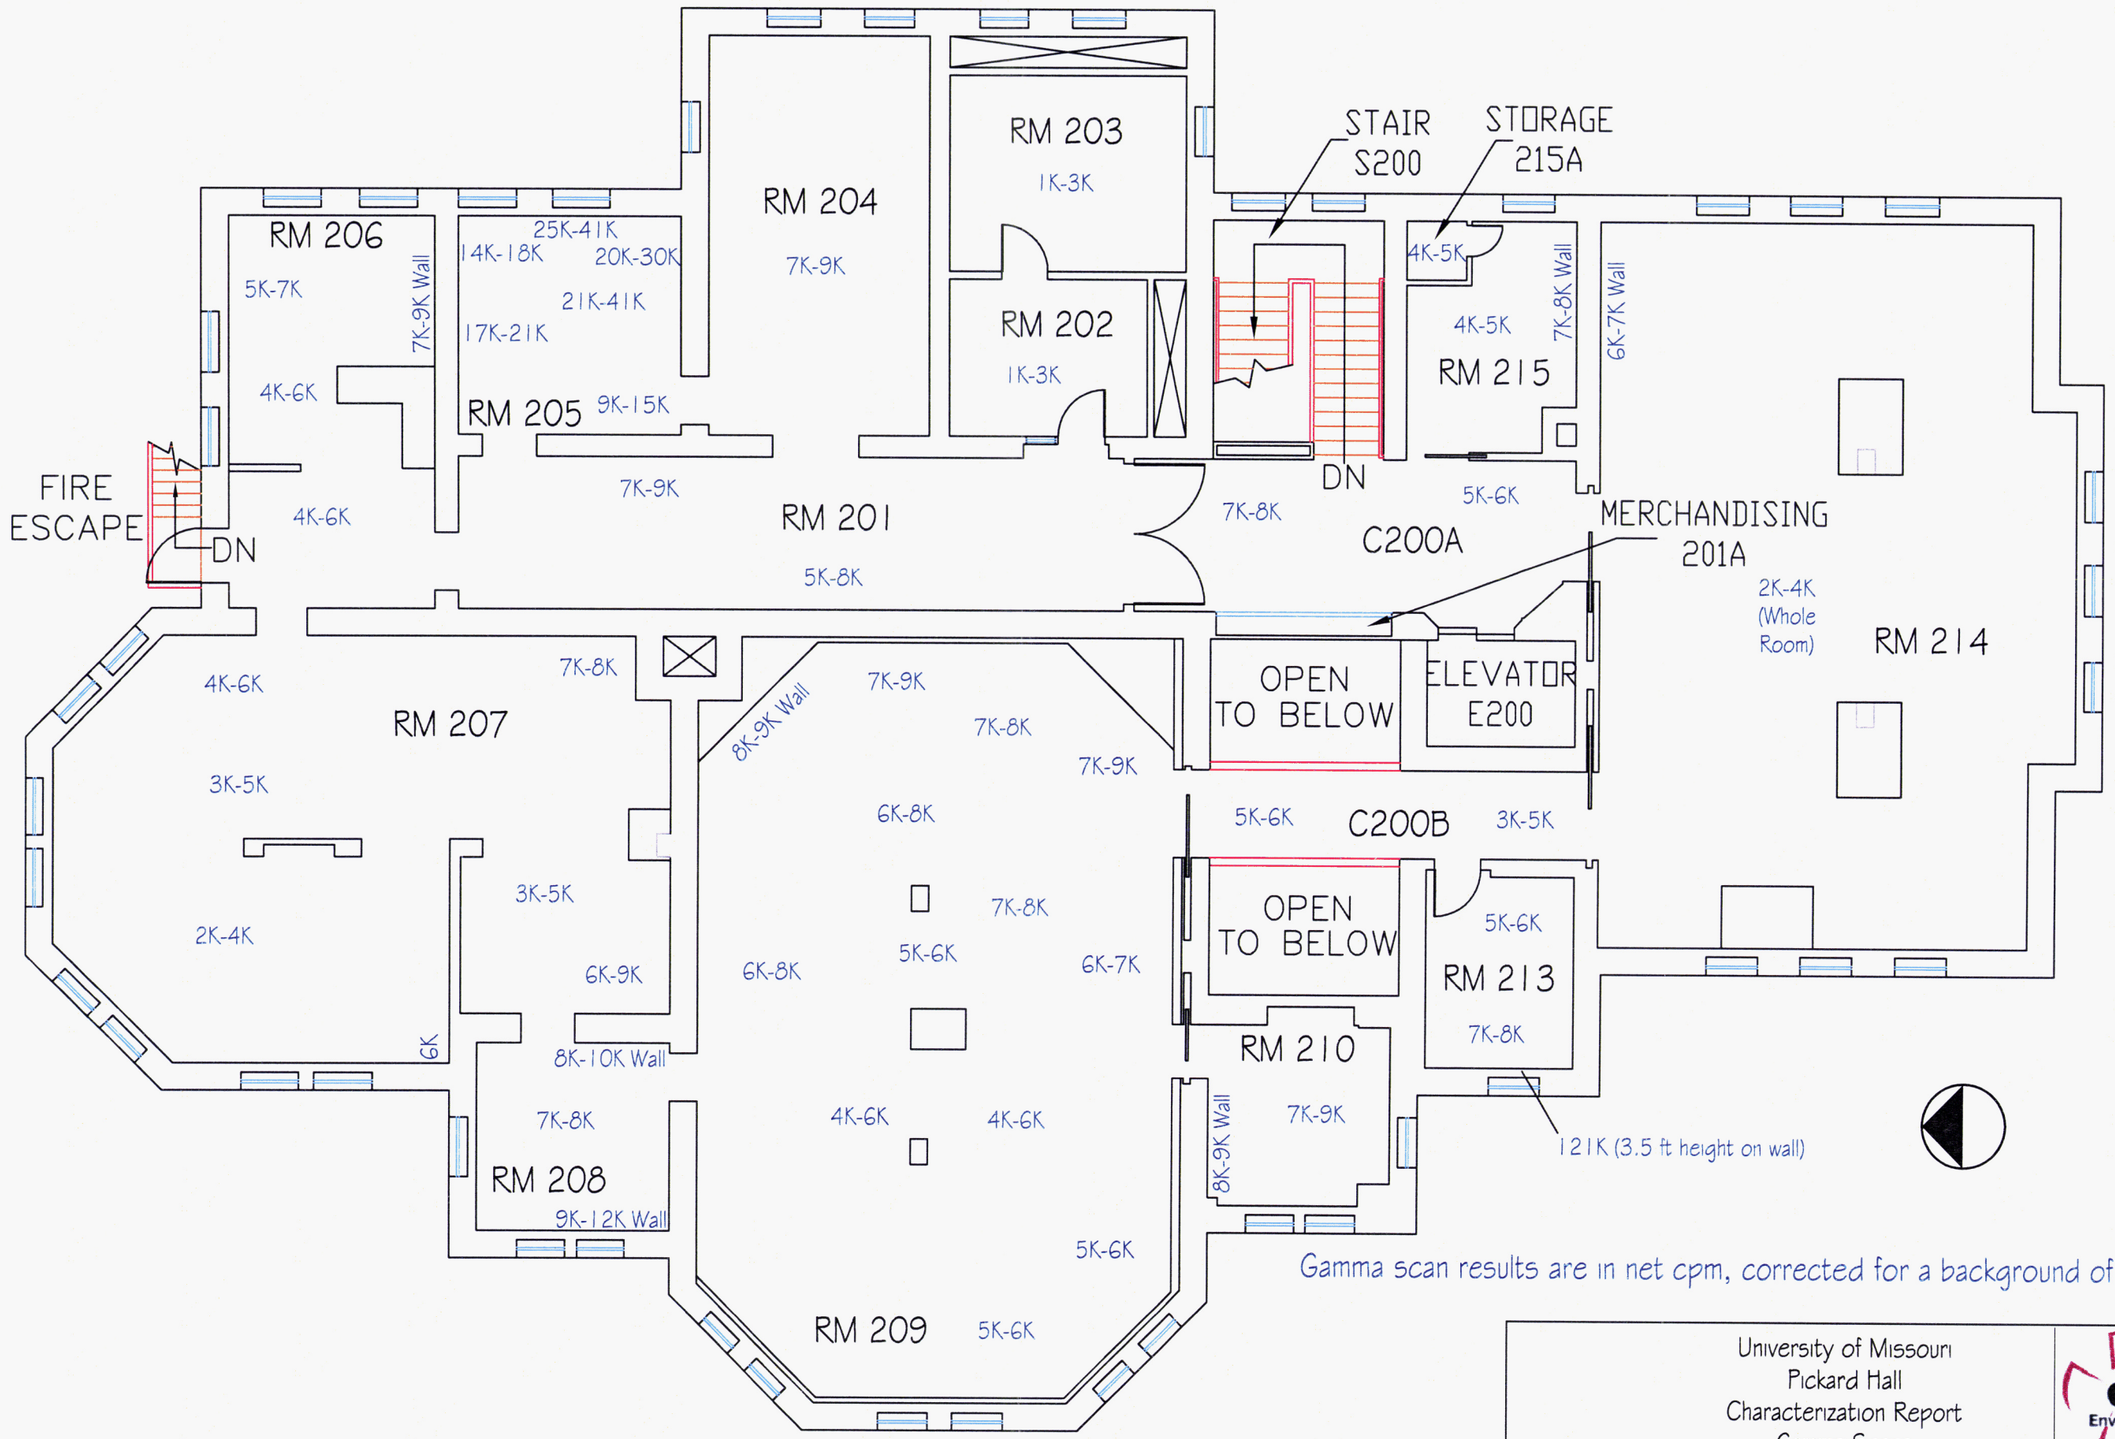
University of Missouri Pickard Hall Characterization Report Gamma Scans		CHASE Environmental Group
Building: Pickard Hall	Elevation: 2nd Floor	Page: F.3 of F.4

Gamma scan results are in net cpm, corrected for a background of 7K cpm

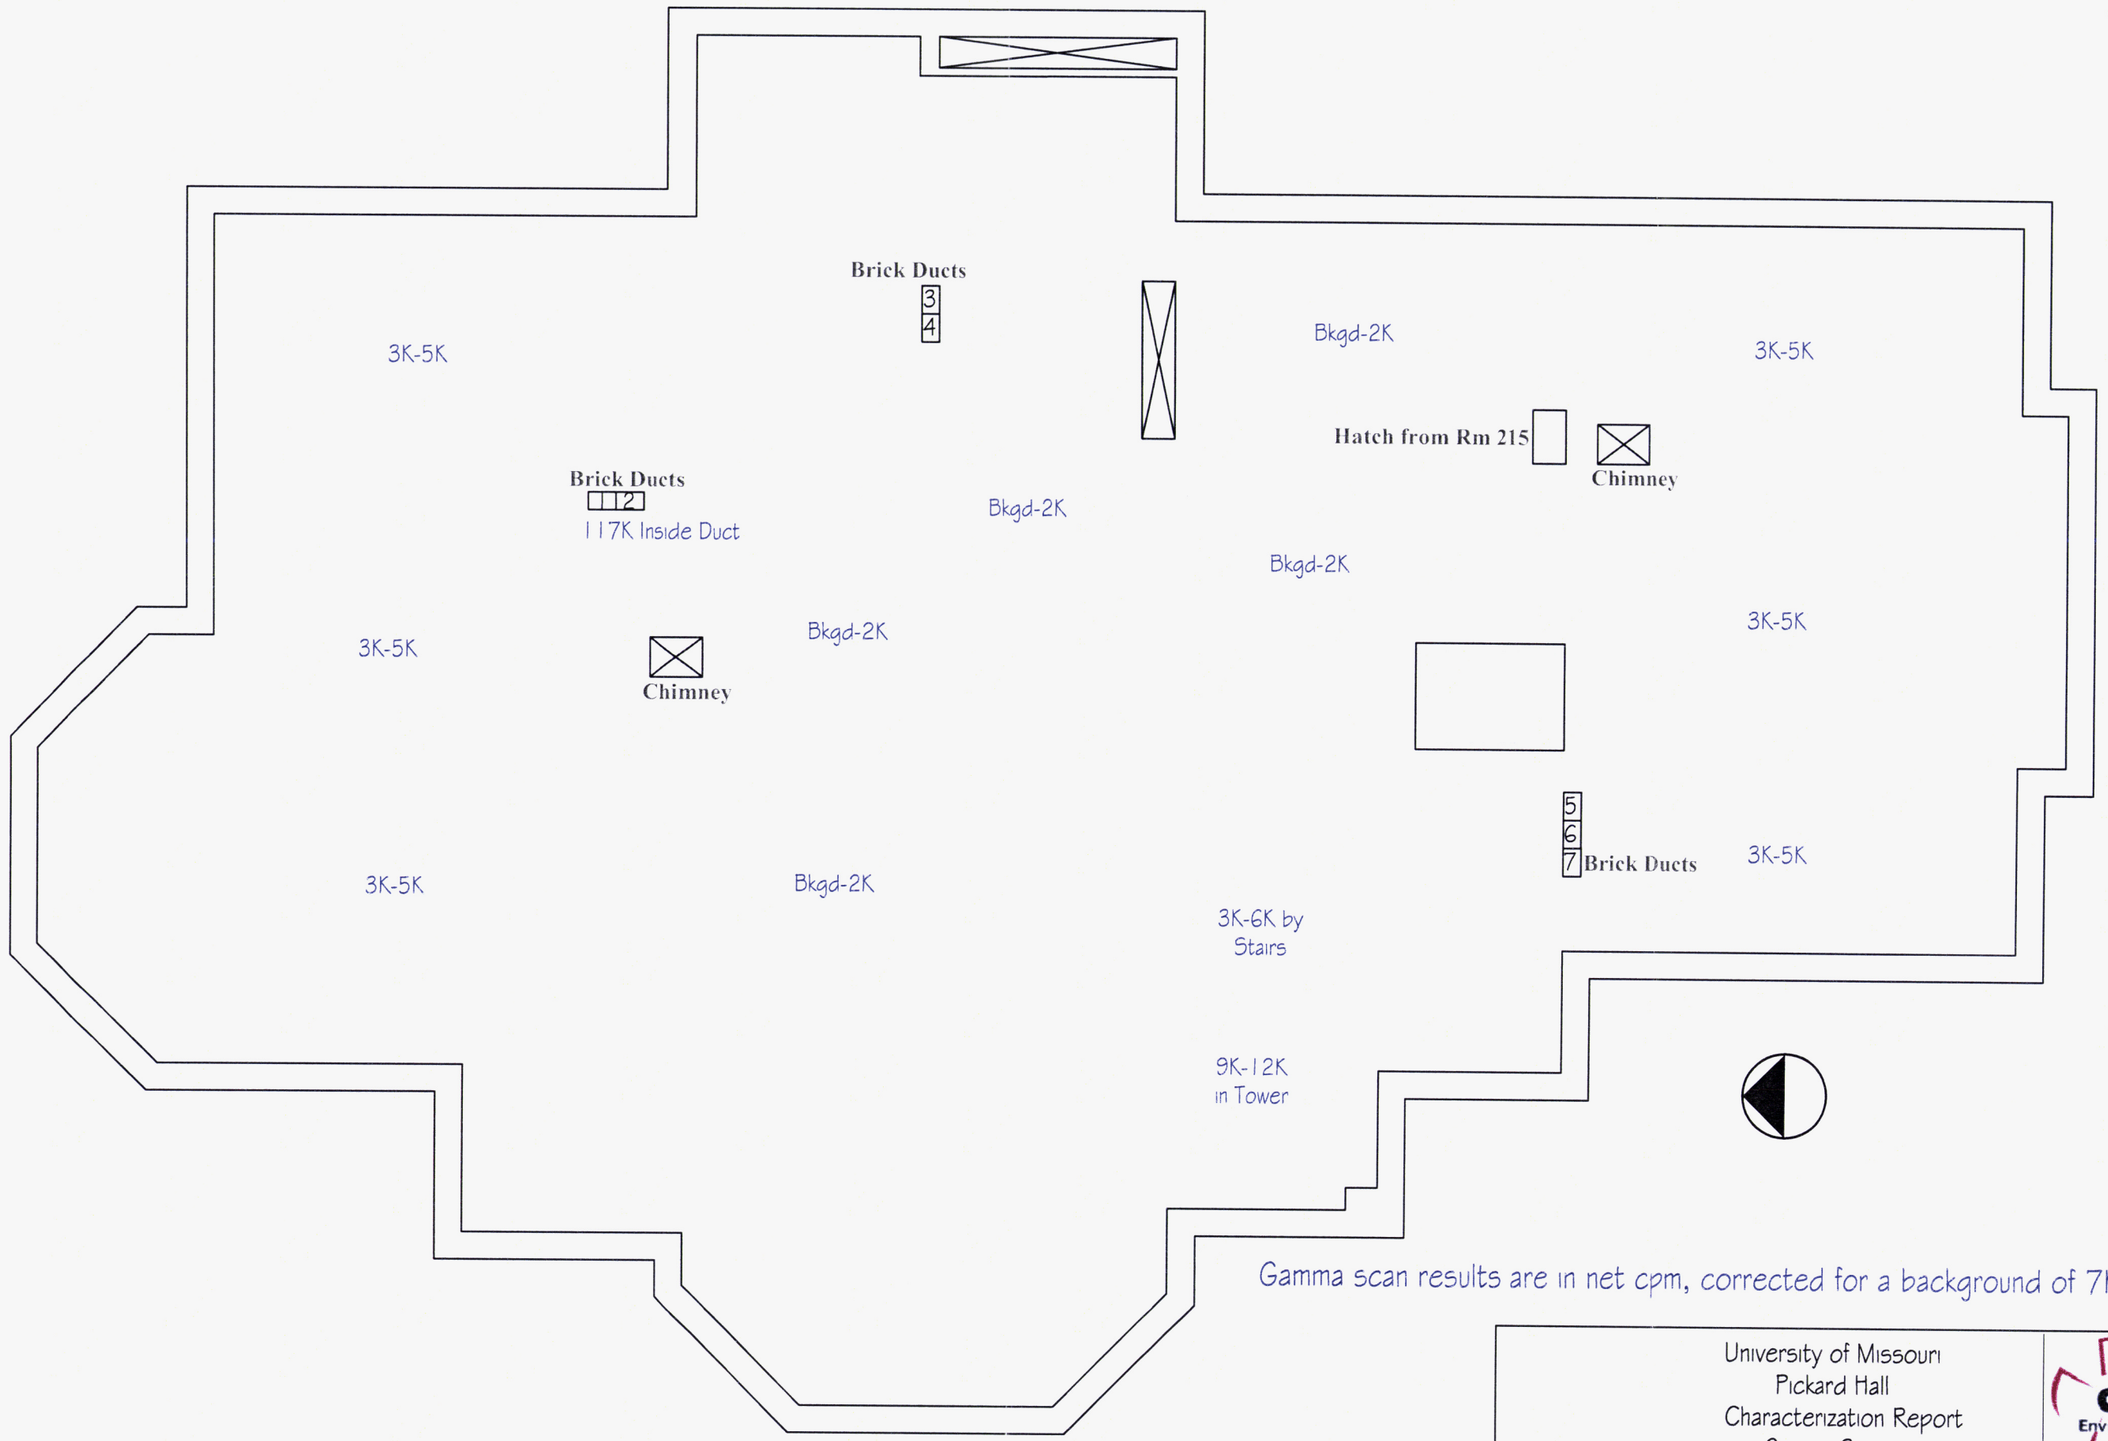
Building: Pickard Hall	Elevation: Attic	Page: F.4 of F.4

Gamma scan results are in net cpm, corrected for a background of 7K cpm
