6.6 Inadequate Original Tensioning of Tendons

NUCLEAR OPERATIONS ENGINEERING
CRYSTAL RIVER UNIT 3

CRYSTAL RIVER UNIT NO. 3
REACTOR BUILDING PRESTRESSING SYSTEM
TENDON HISTORY

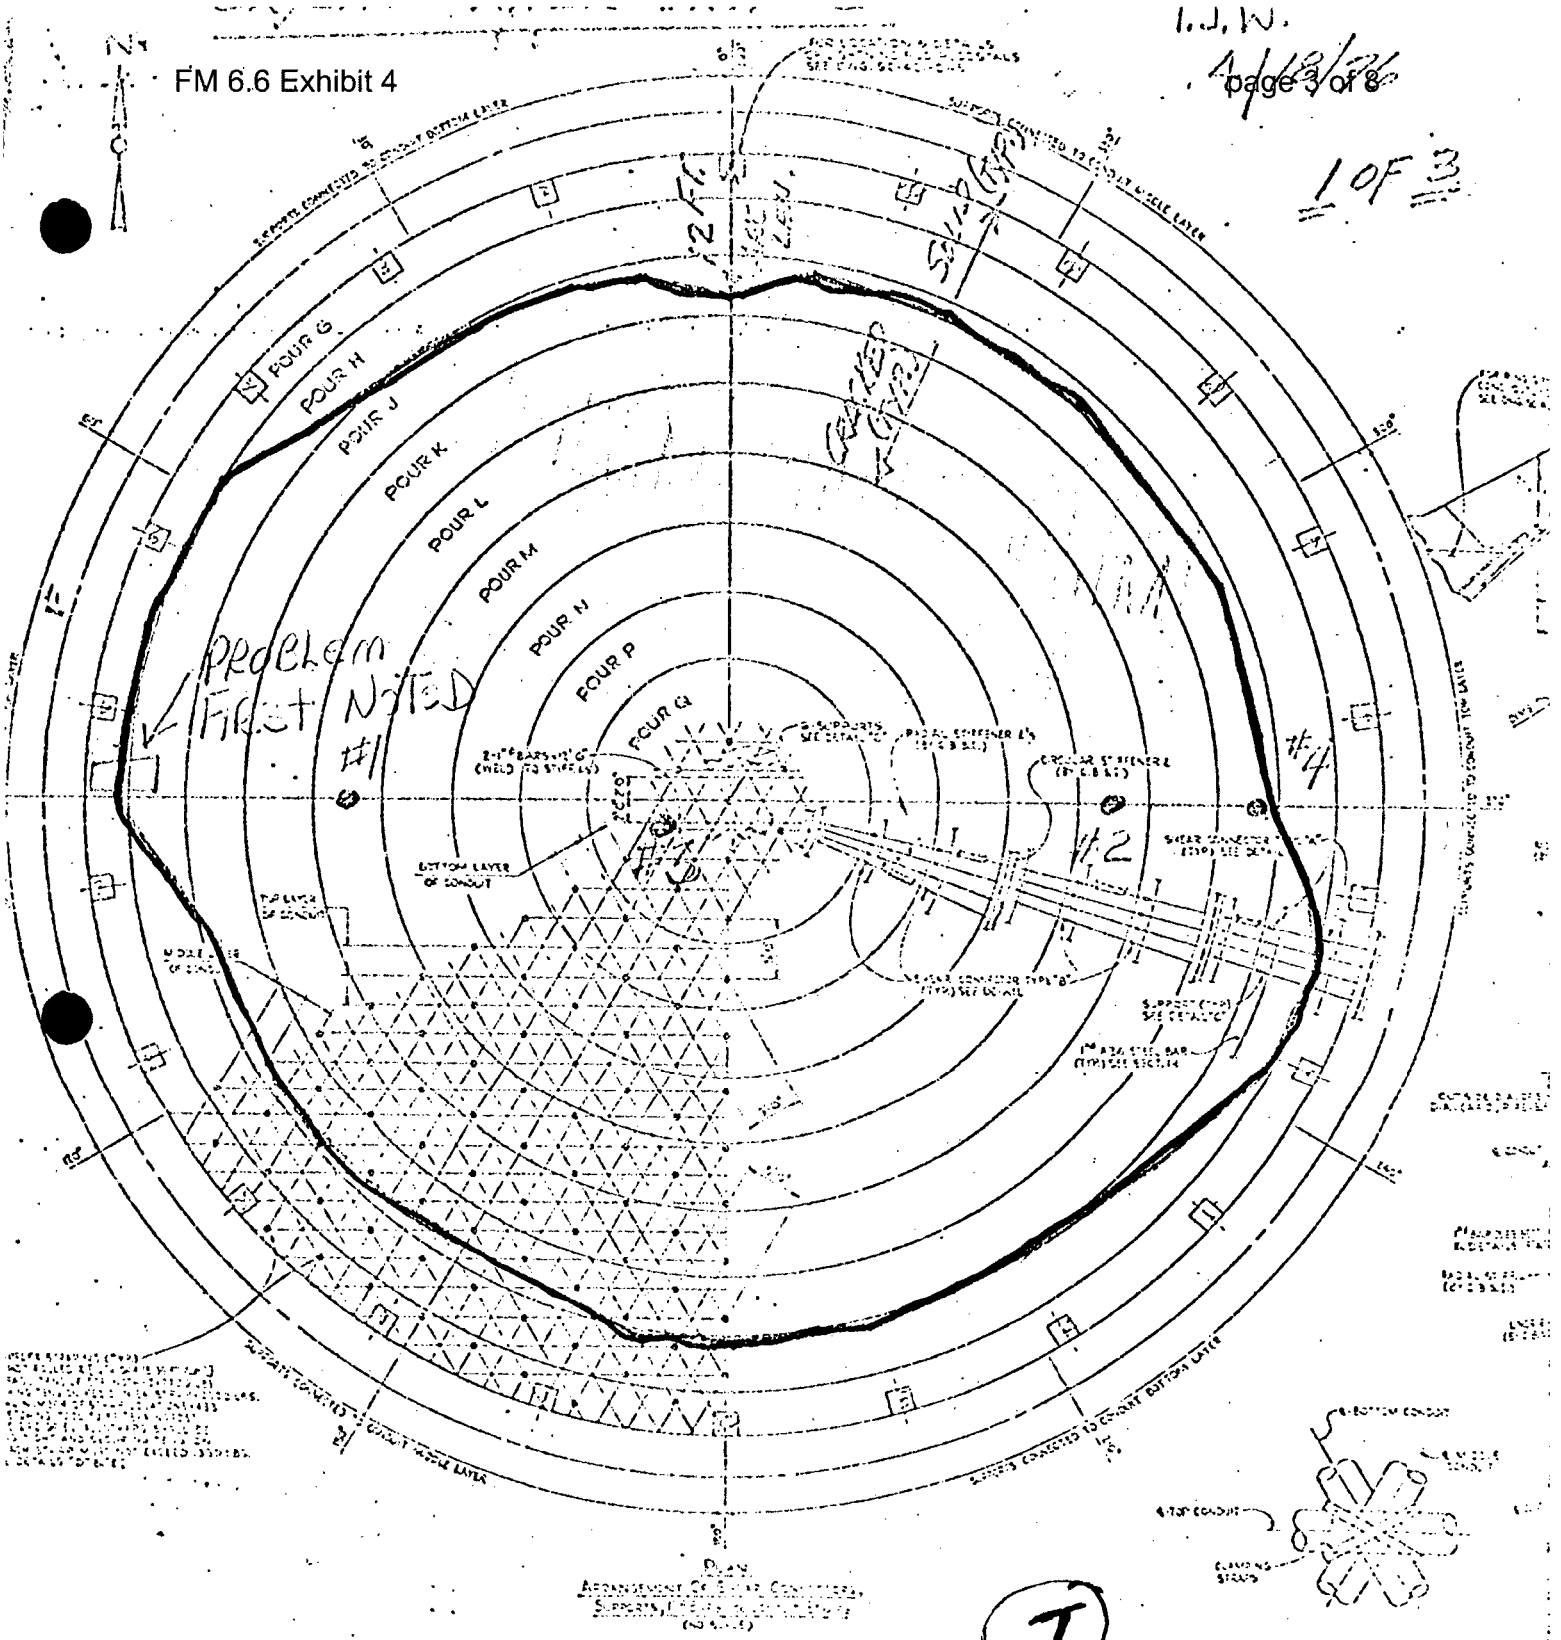
PLAN VIEW

On Wednesday, April 14, 1976, while placing cinch anchors in the dome concrete of the Reactor Building, it was noted that there appeared to be a hollow area about one inch beneath the surface. Investigation on Friday, April 16, by saw cutting and removing a section of concrete approximately one foot wide by three feet long, showed that the depth of the hollow area went deeper as it went higher on the dome. By core drilling on Saturday and Sunday, April 17 and 18, it was further determined that the separation continued across the dome and went as deep as 15" and separated as much as 1-3/4 inches. By using acoustic methods, the lower perimeter of the separated area was determined to extend all around the dome in pours "G", "H" and "J".

LINE BETWEEN SOUND & CRACKED PORTION OF REACTOR BLDG. DOME

AZIMUTH R.B.	ARC DIST. FROM TOP OF LEDGE TO WHERE HOLLOW SOUND BEGINS (FT.)
0°	12 FT.
8°-8'	10
16°-18'	9.5
24°-29'	9.0
32°-40'	8.5
40°-51'	8.5
49°-02'	7.5
57°-13'	4
65°-24'	4
73°-35'	3
81°-46'	3.5
90°-0'	3.5
98°-08'	7.5
106°-19'	9.5
114°-30'	10
122°-41'	9.5
130°-52'	10
139°-03'	10
147°-14'	10
155°-25'	10
163°-36'	9.5
171°-47'	8
180°-0'	8
	8

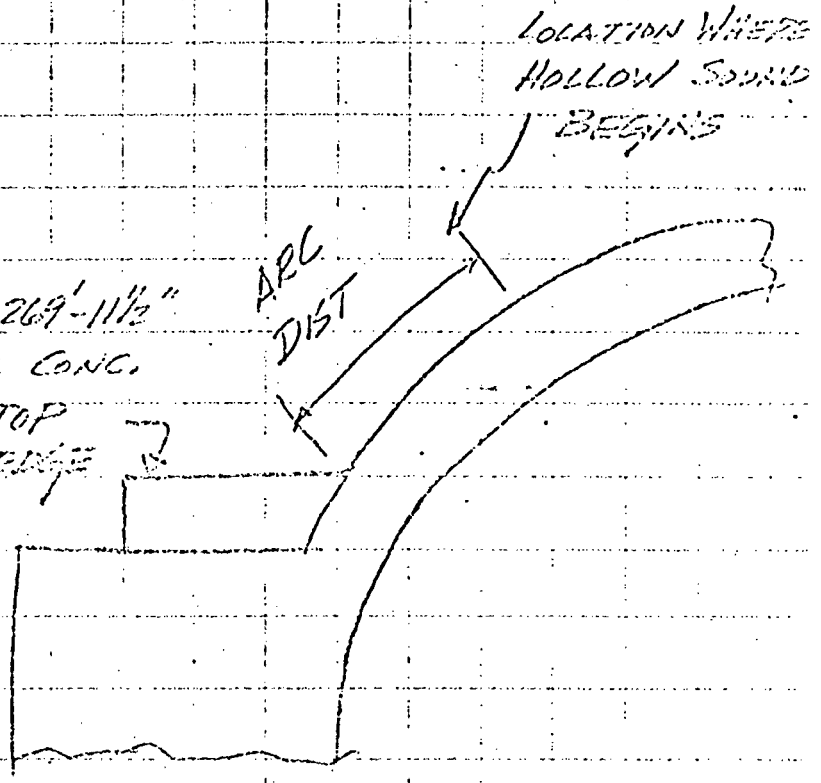
II

AZIMUTH R.B.	ARC, DIST FROM TOP OF LEDGE TO LOCATION WHERE HOLLOW SOUND BEGINS (FT.)
196°-22'	8 FT.
204°-38'	8
212°-44'	8
220°-45'	8
229°-06'	7
237°-17'	5.5
245°-28'	4
253°-39'	3.5
261°-50'	6
270°-0'	9
278°-12'	9.5
286°-23'	10
294°-34'	9.5
302°-45'	10.5
310°-56'	10.5
319°-07'	10
327°-18'	10
335°-29'	9.5
343°-40'	10
351°-48'	9.5

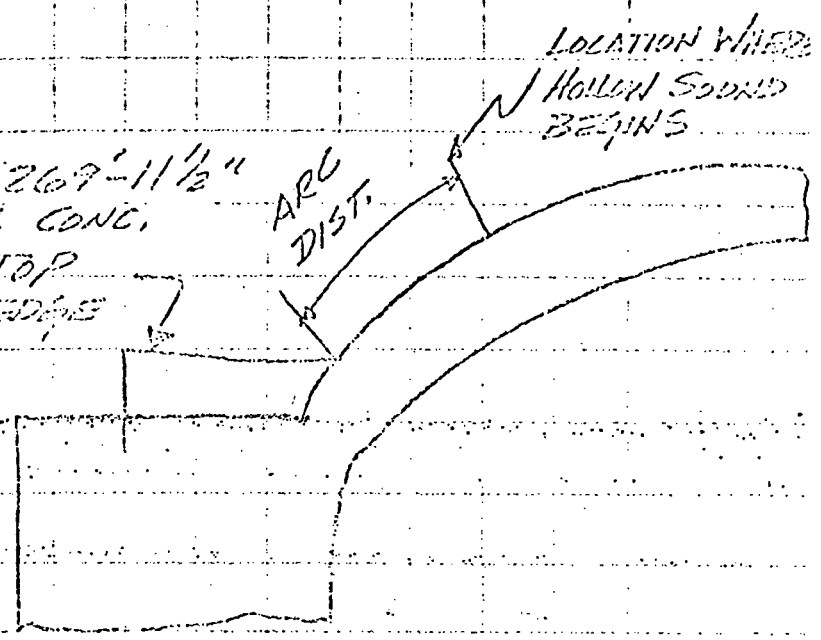
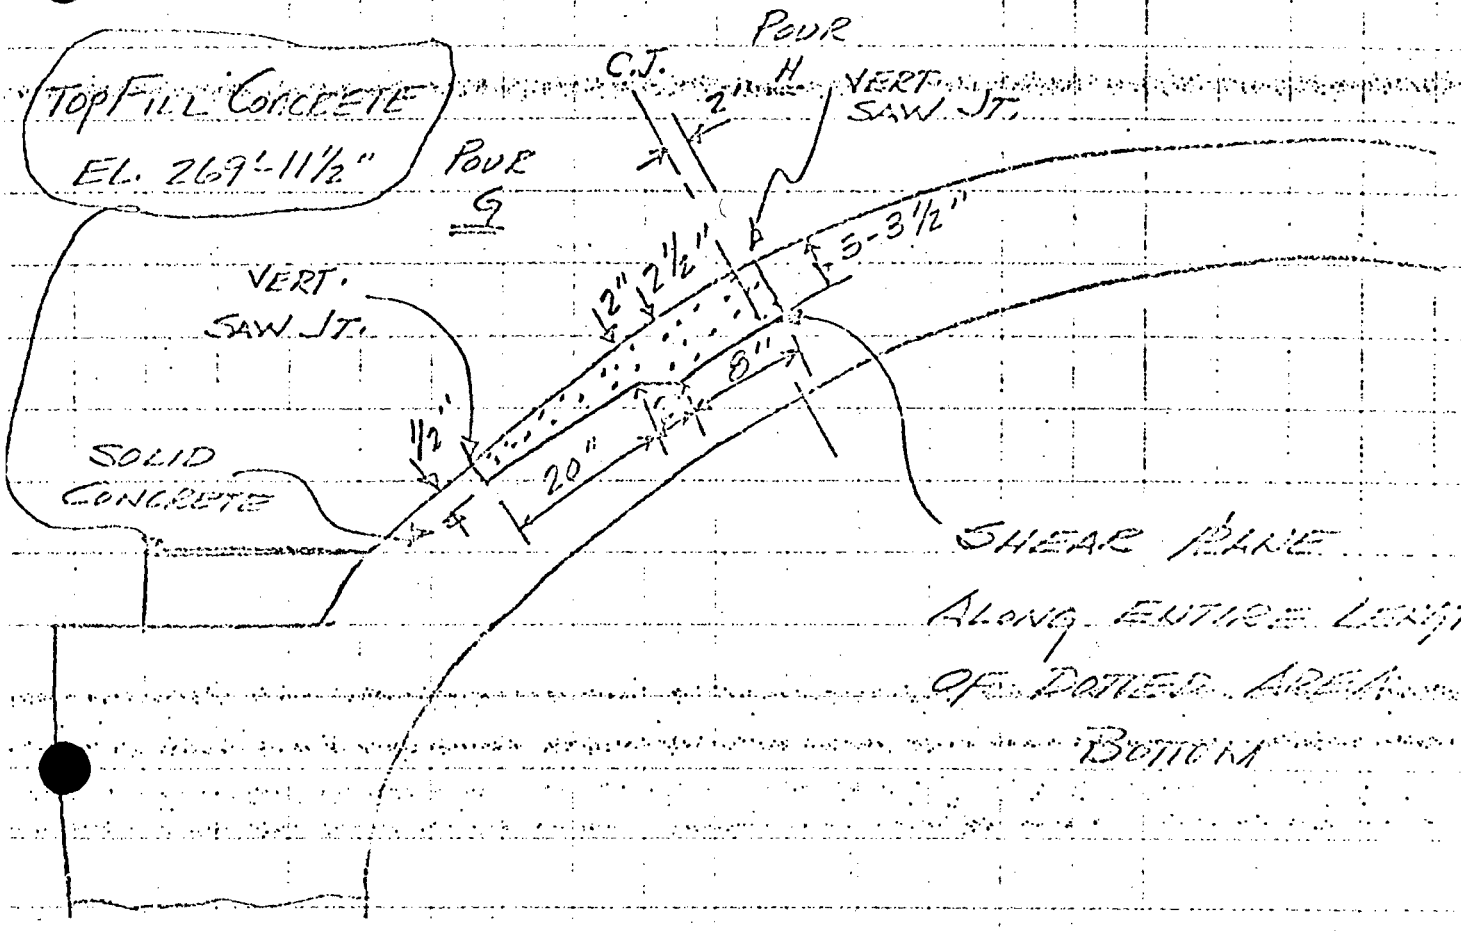
SECTION THRU DOME

DOTTED AREA REPRESENT CONCRETE REMOVED BY SAWING AROUND THE PLAN PERIMETER OF THE SECTION.
REFER TO ENCLOSED PHOTOGRAPHS.

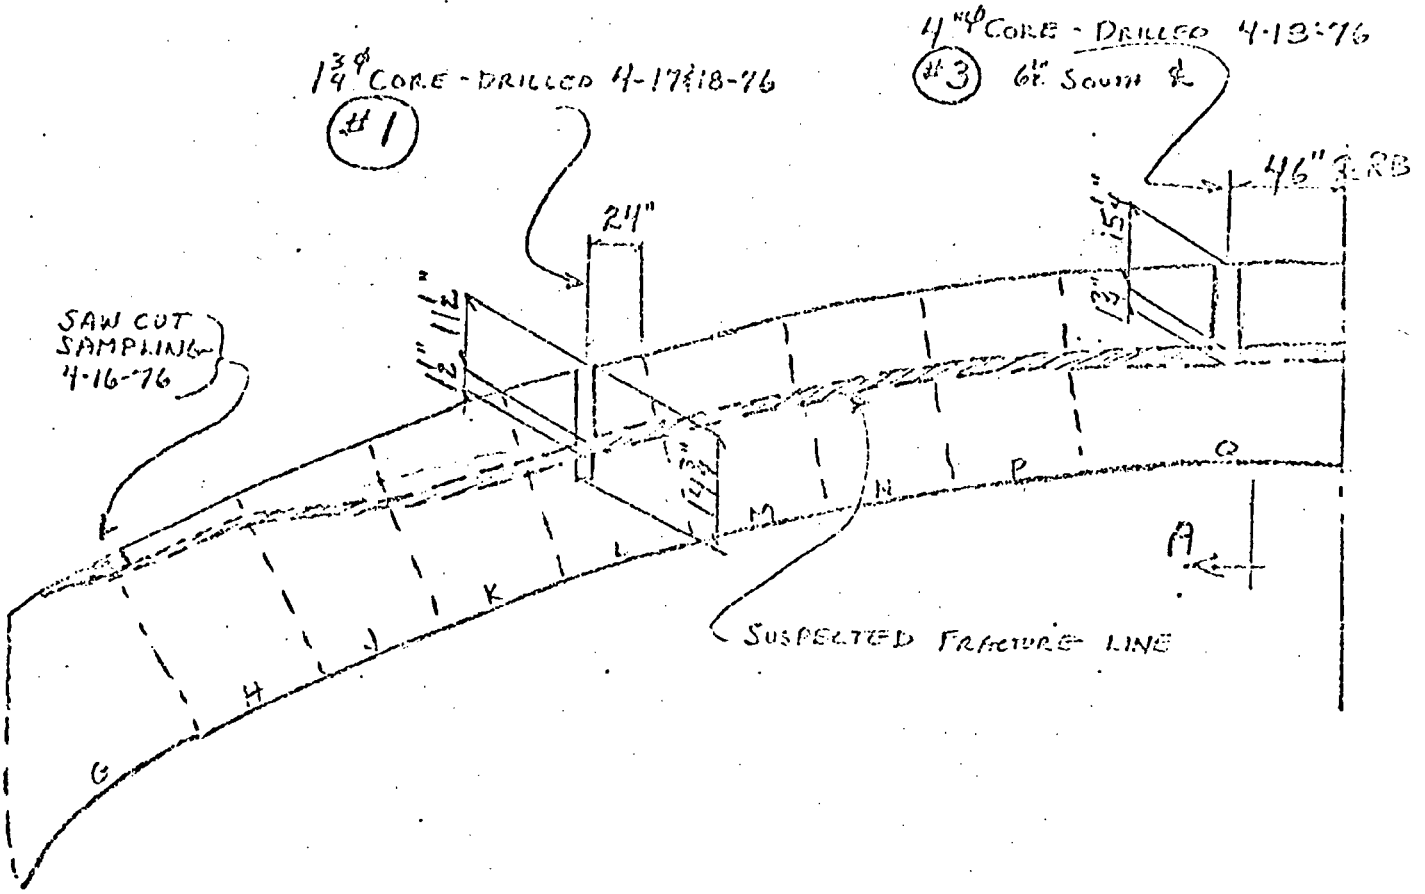
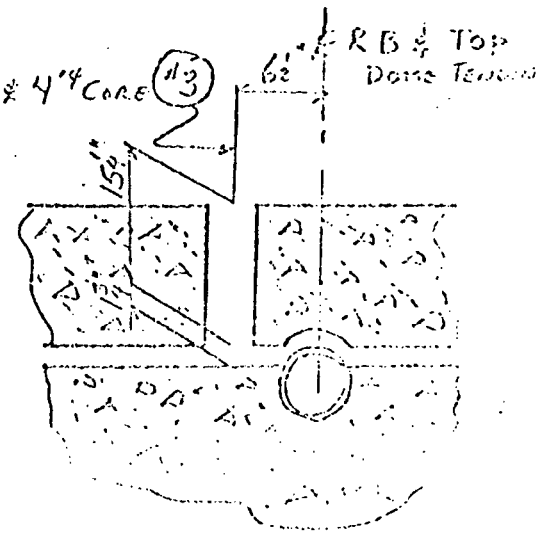
DOME SECTION - WEST HALF ON AZ 90°-270°

NOTE:
CORE #1 & #2 WERE DRILLED AT SAME LOCATION AS TEST CORES TAKEN IN 1974 AT TIME OF POUR.
