6.1 Uneven Force Distribution along the Tendon due to Duct Friction

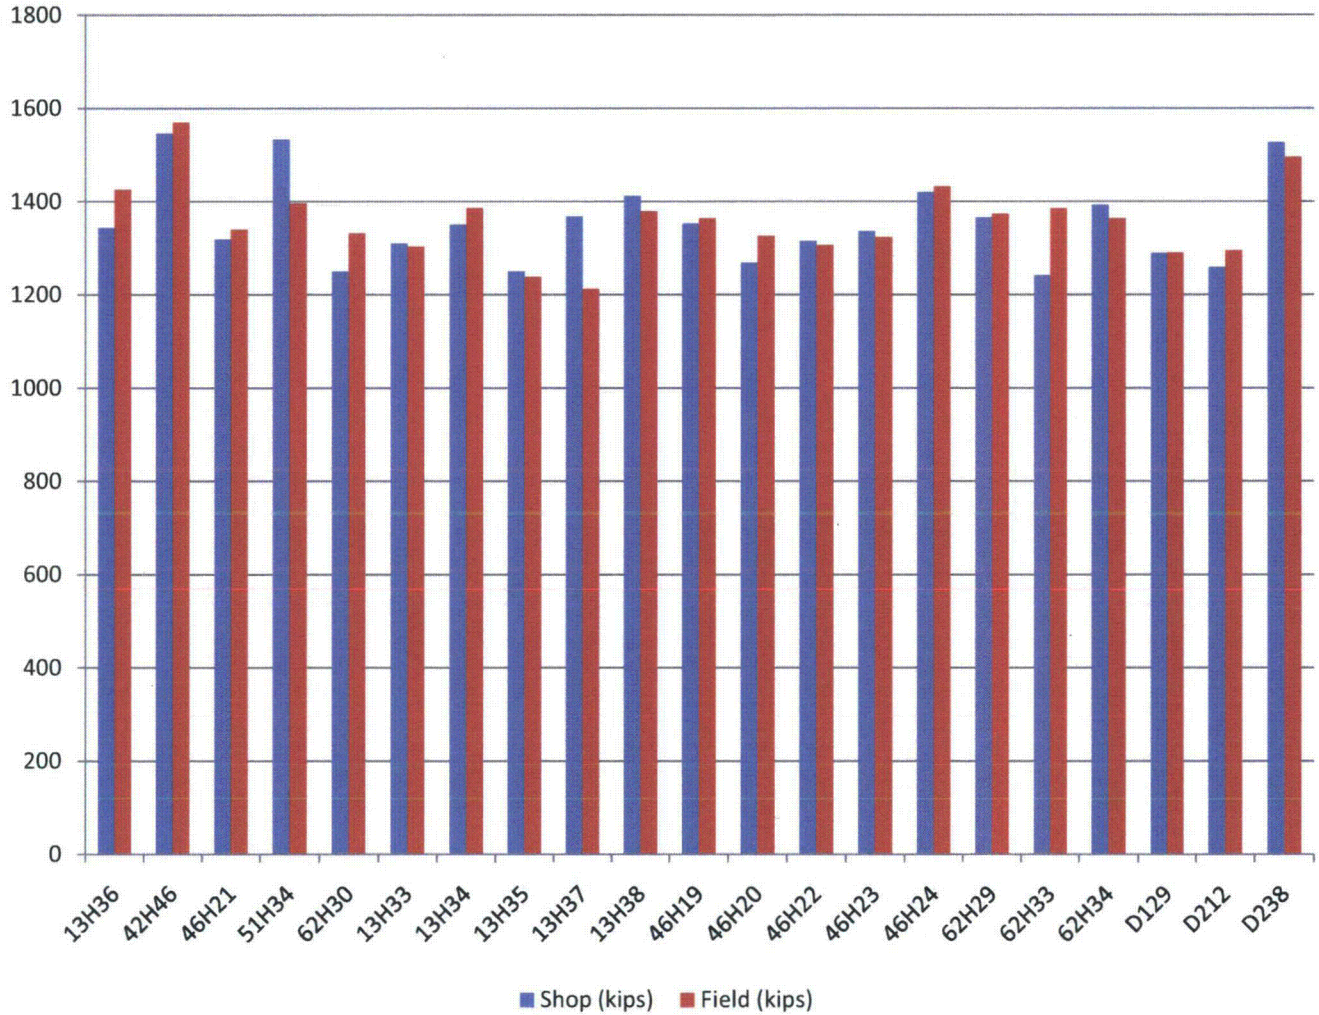
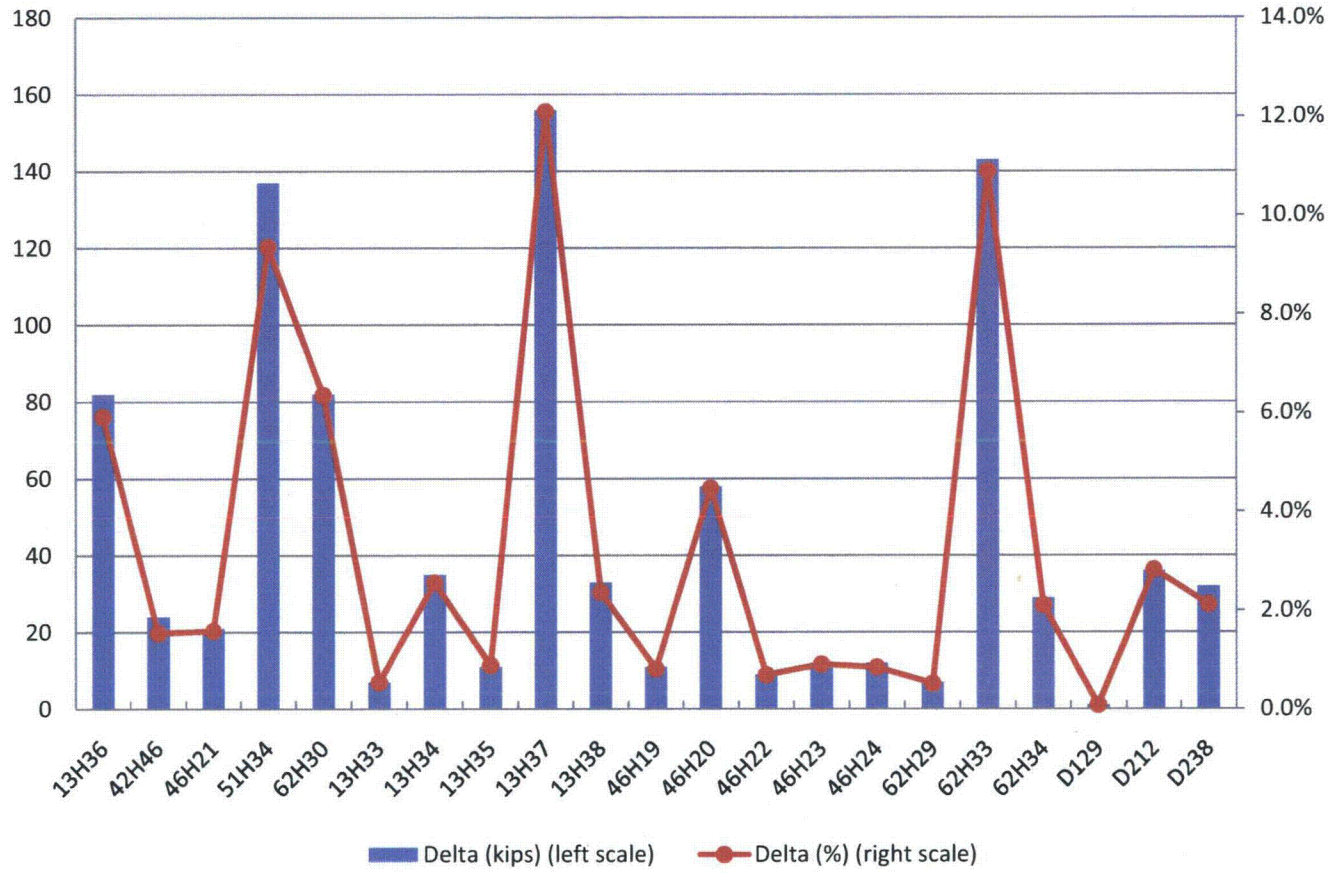
Tendon Lift-off Forces (Survey 8)

a. Differences of 2-3% between the shop and field lift-off data are expected. CR3 surveillance data show much larger differences, up to 8% in survey 2 tendon 53H44, up to 12% in survey 4 tendon 13H40, up to 18% in survey 5 tendon 46H30, up to 20% in survey 6 tendon 42H33, up to 11% in survey 7 tendon 62H02, and up to 12% in survey 8 tendon 13H37 (FM 6.1 Exhibit 3 and FM 6.1 Exhibit 4);

The differences between shop and field lift-off measurements are high at CR3.
The uneven force along the tendons did not initiate the delamination.

Lift-off forces measured at the Shop end (blue) and at the Field end (red)

Delta = Difference between lift-off forces at Shop and Field ends

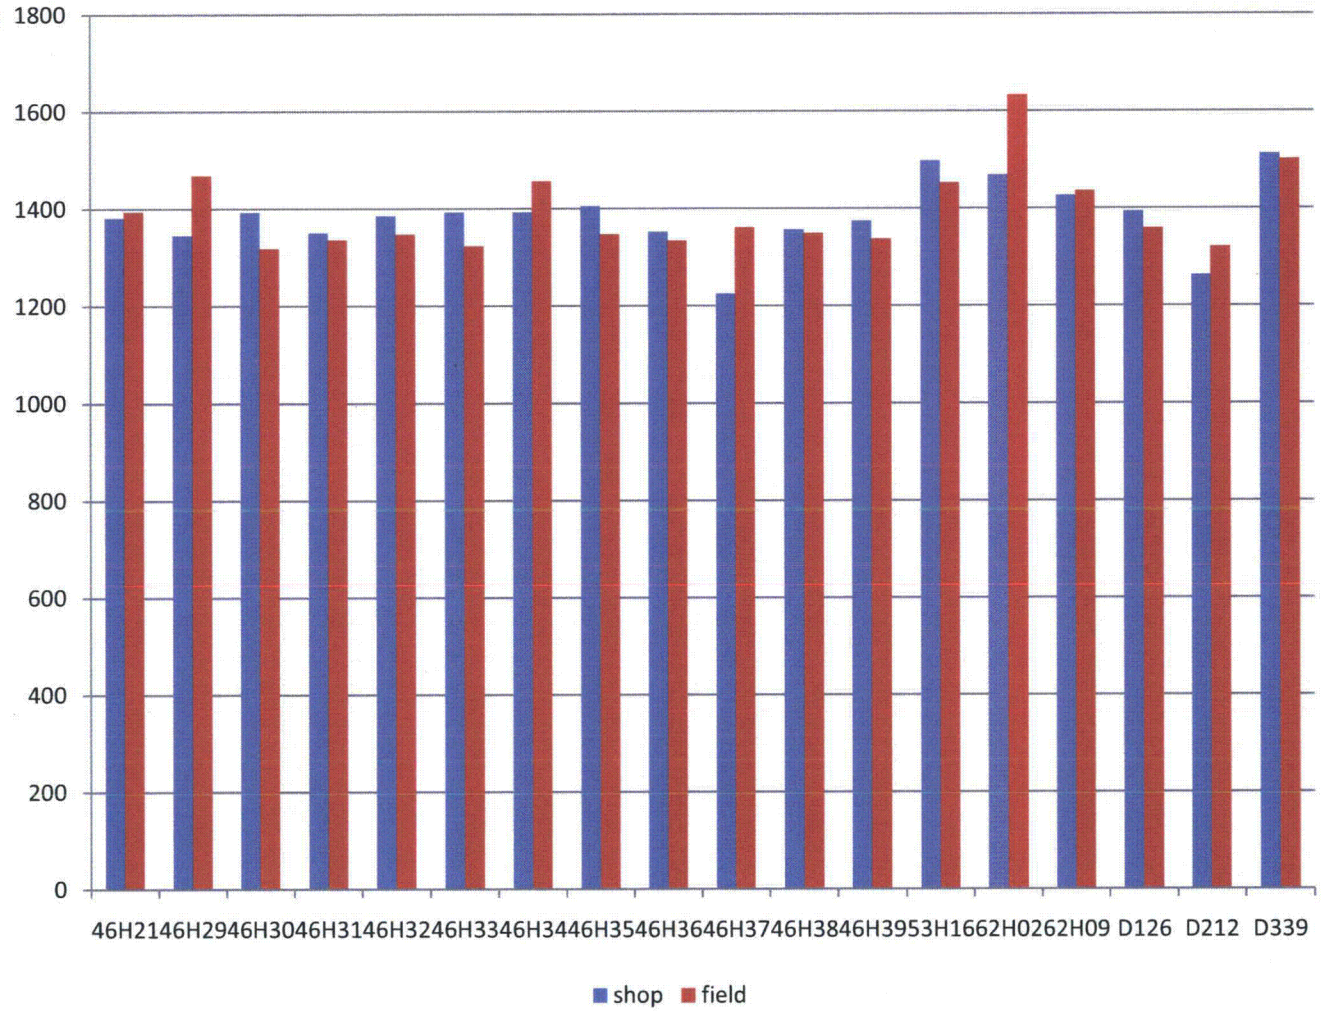
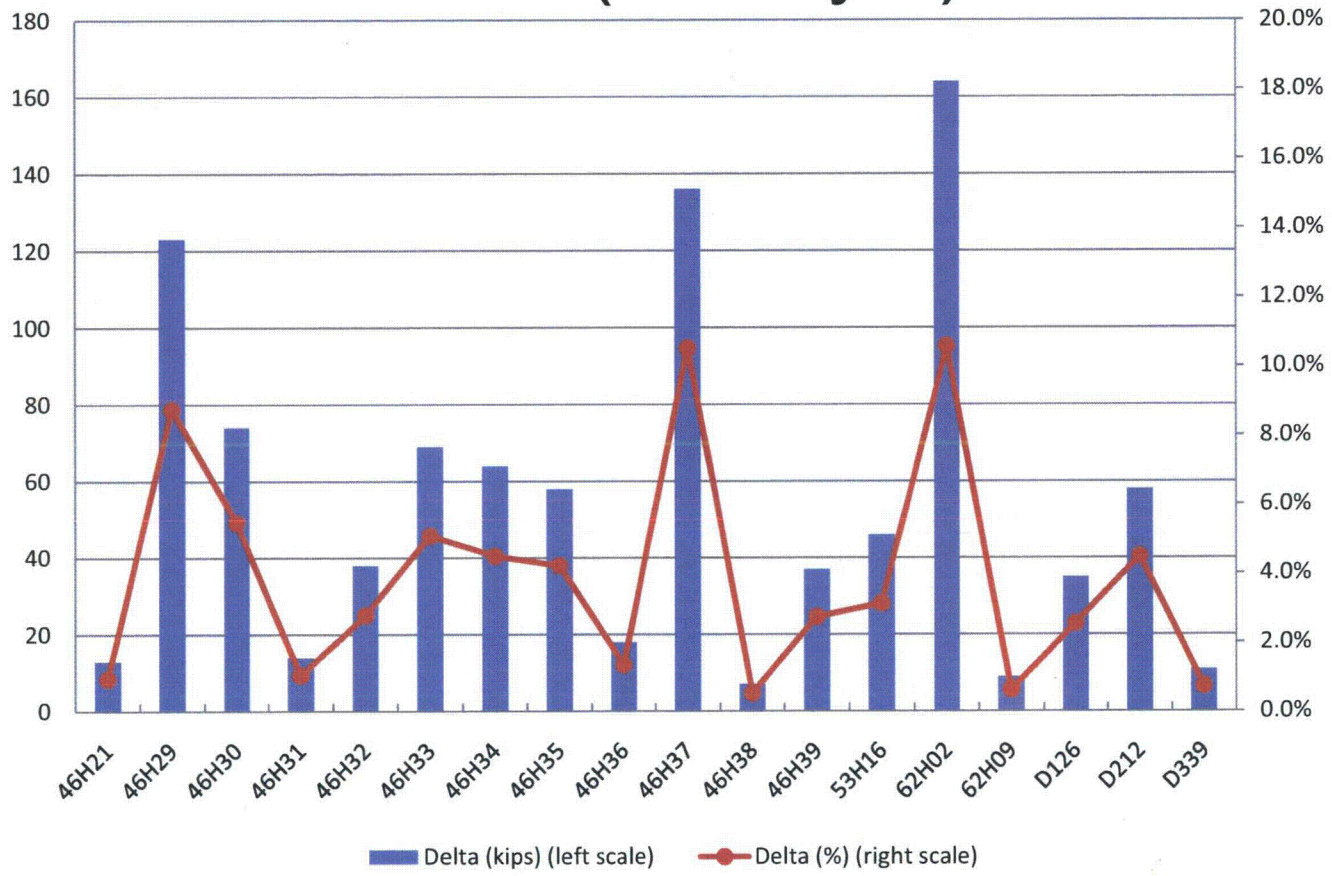
Tendon Lift-off Forces (Survey 7)

Lift-off forces measured at the Shop end (blue) and at the Field end (red)

Delta = Difference between lift-off forces at Shop and Field ends

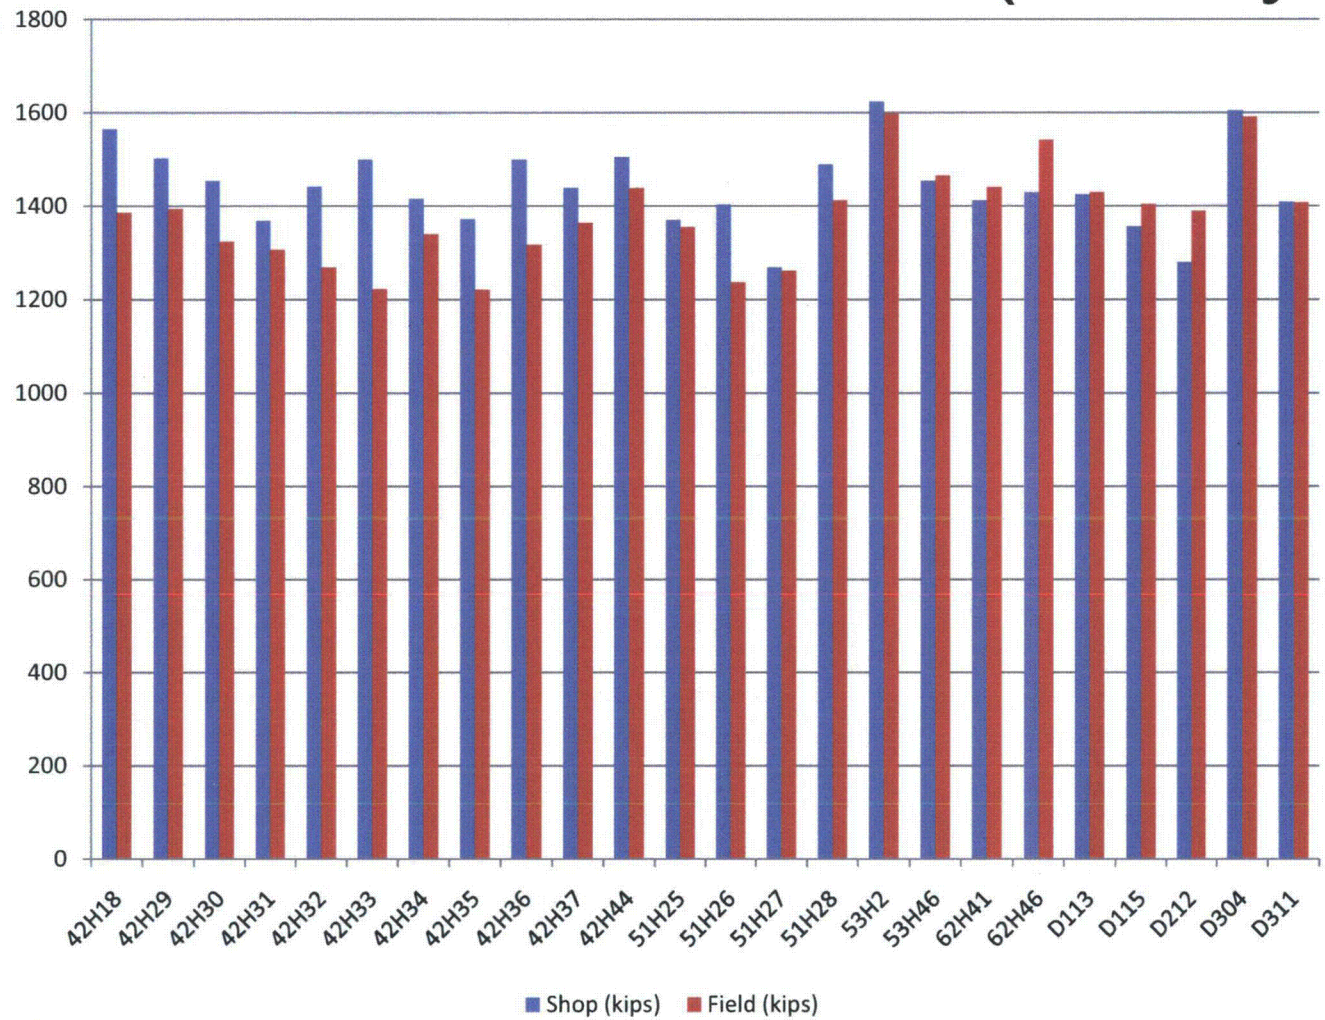
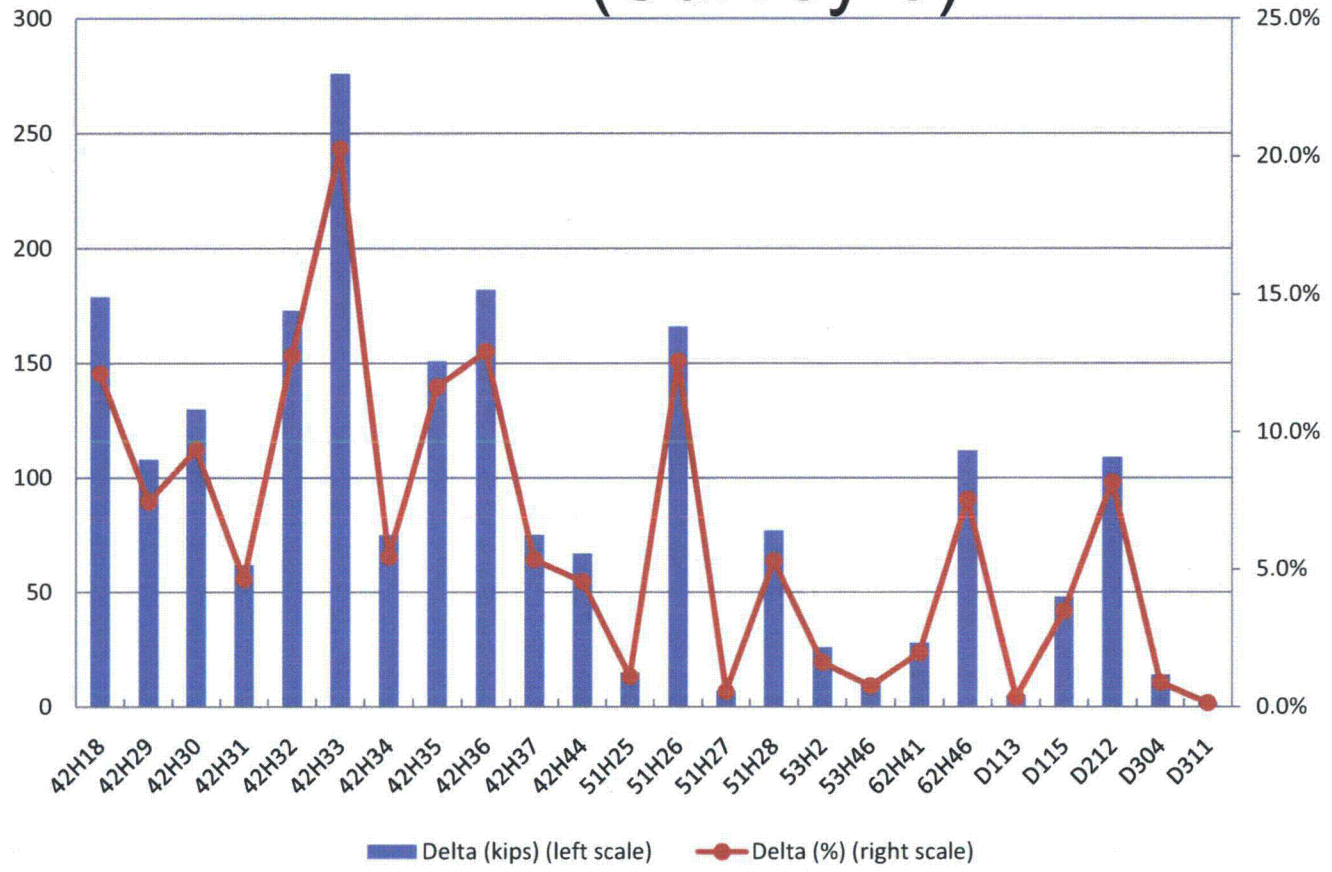
Tendon Lift-off Forces (Survey 6)

Lift-off forces measured at the Shop end (blue) and at the Field end (red)

Delta = Difference between lift-off forces at Shop and Field ends

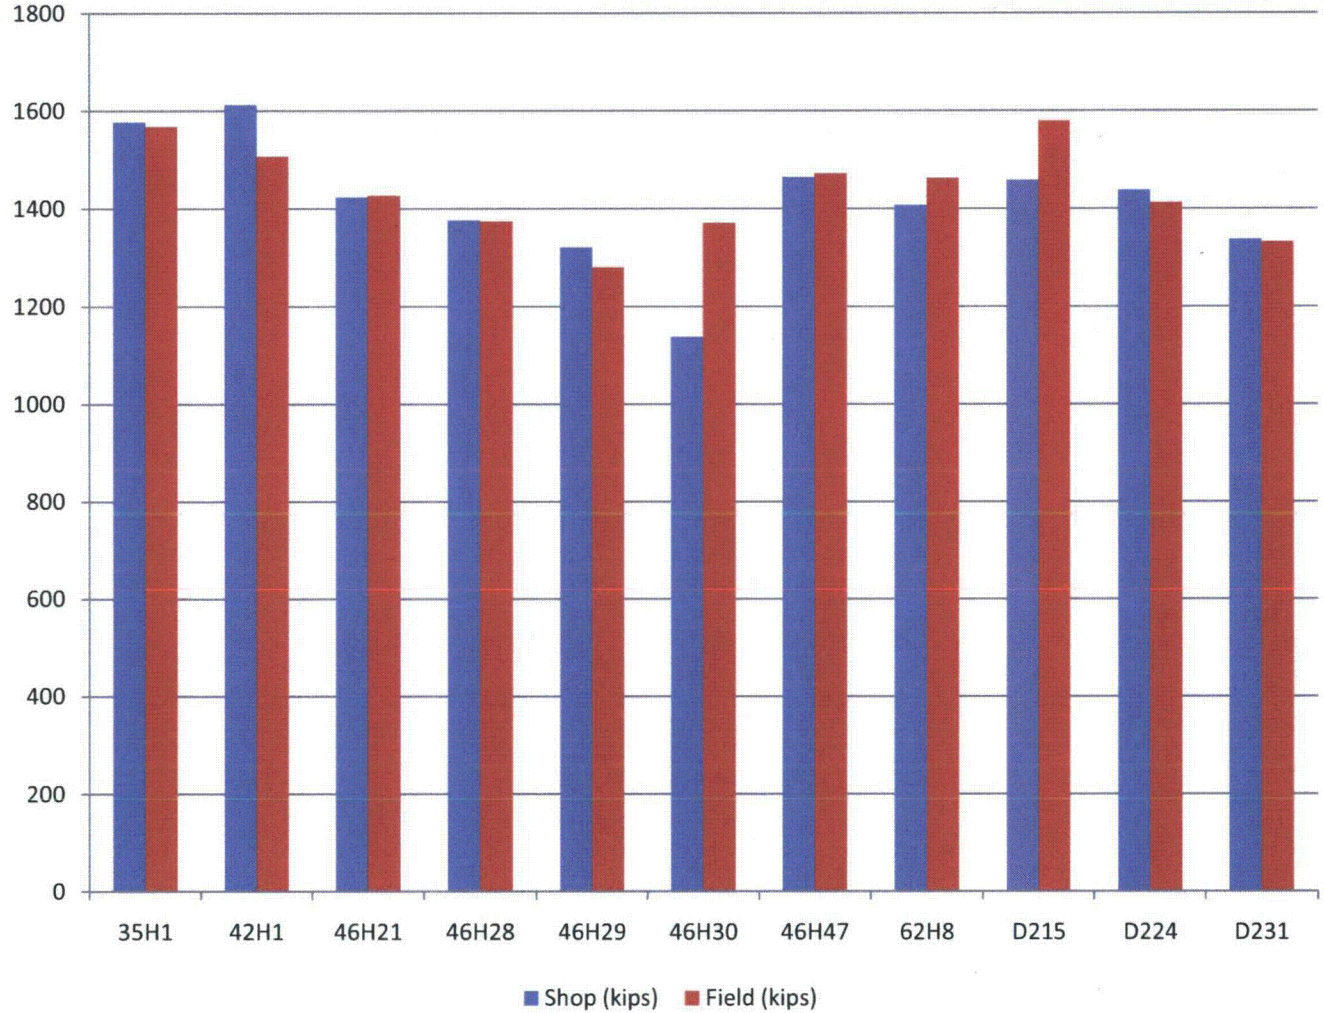
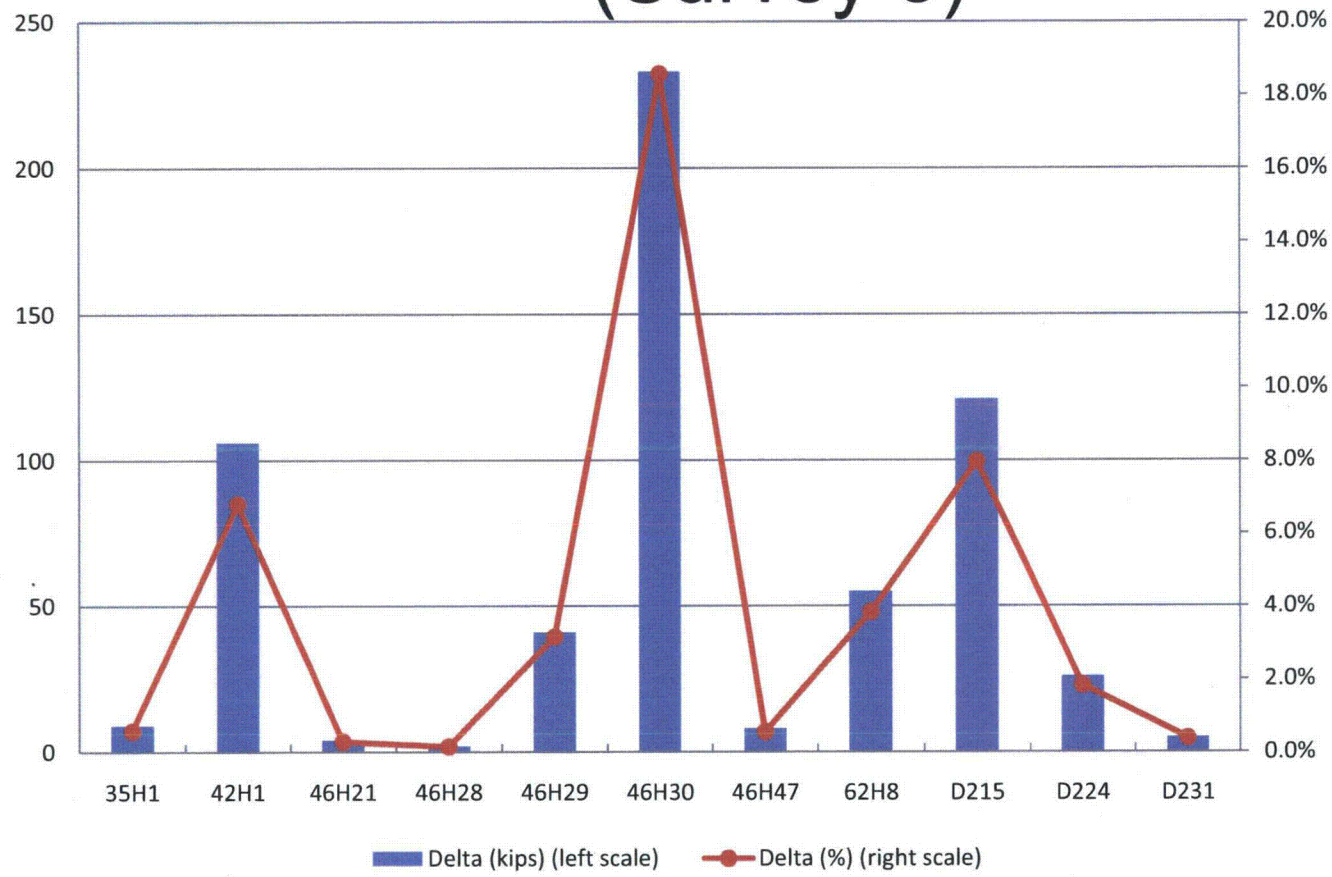
Tendon Lift-off Forces (Survey 5)

Lift-off forces measured at the Shop end (blue) and at the Field end (red)

Delta = Difference between lift-off forces at Shop and Field ends

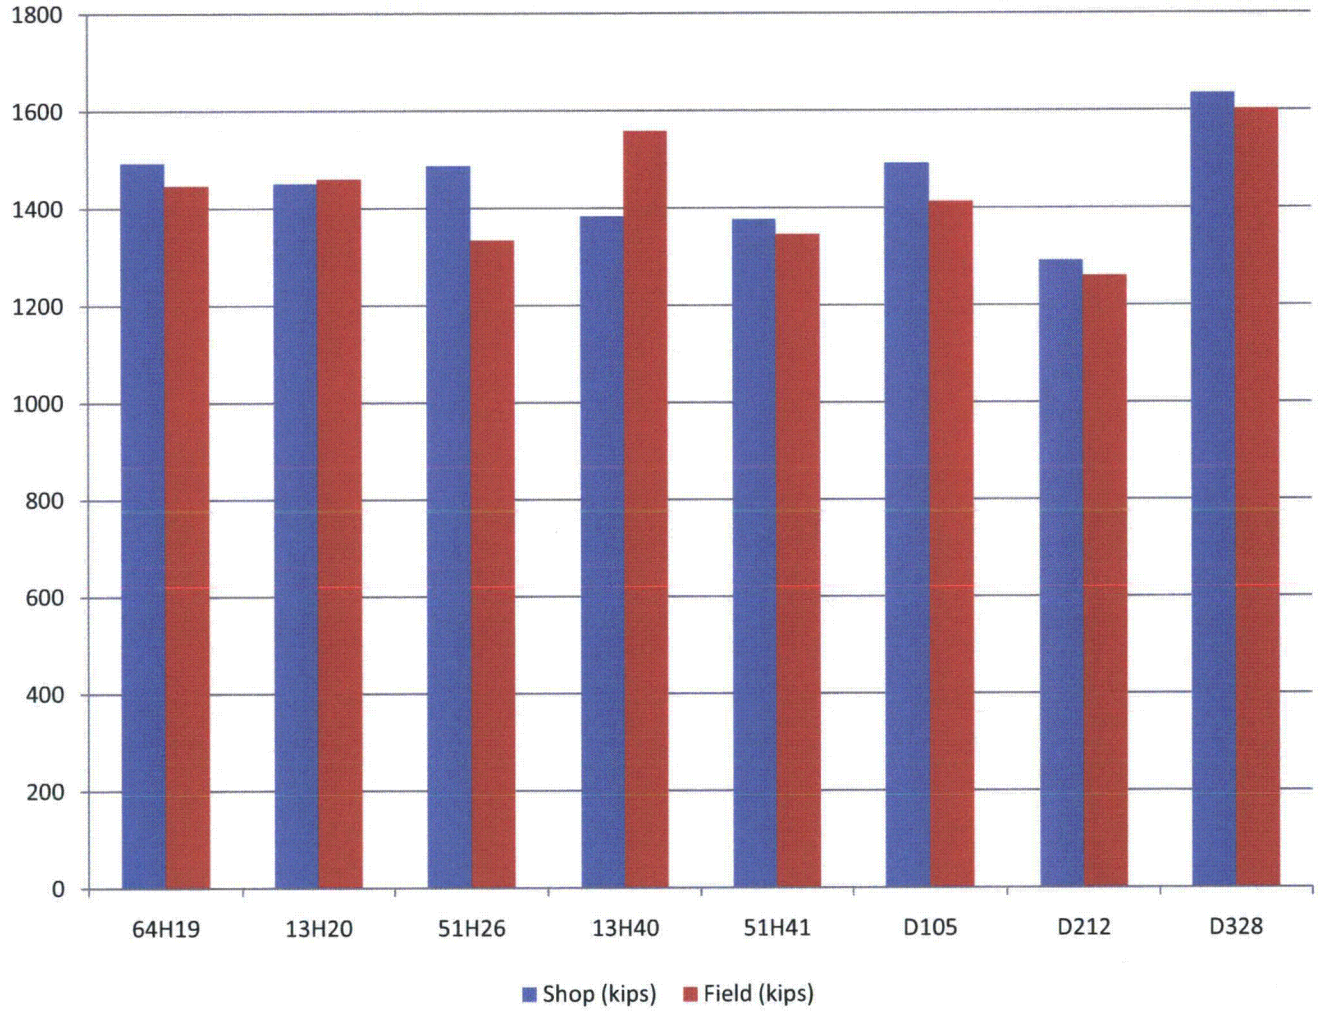
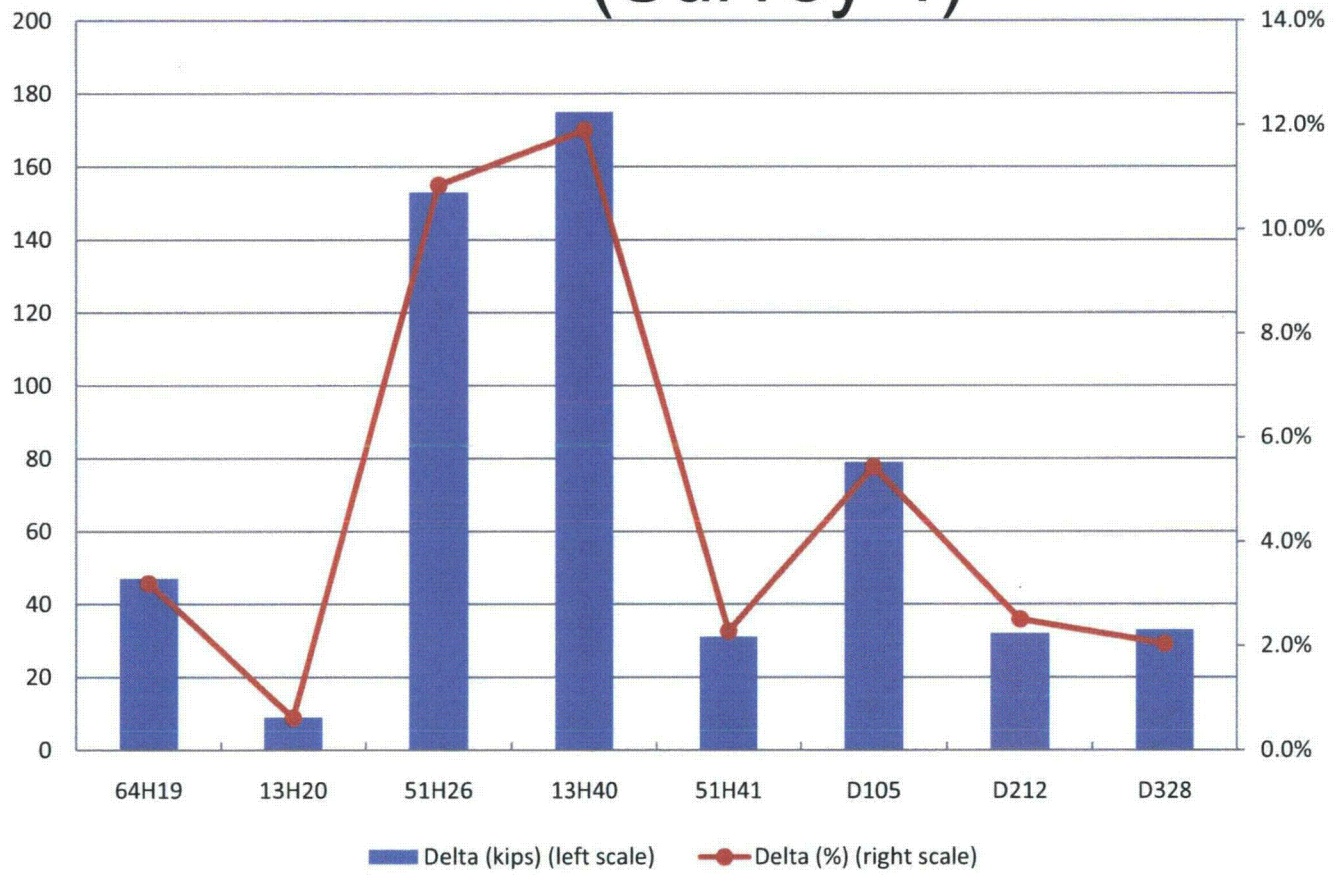
Tendon Lift-off Forces (Survey 4)

Lift-off forces measured at the Shop end (blue) and at the Field end (red)

Delta = Difference between lift-off forces at Shop and Field ends

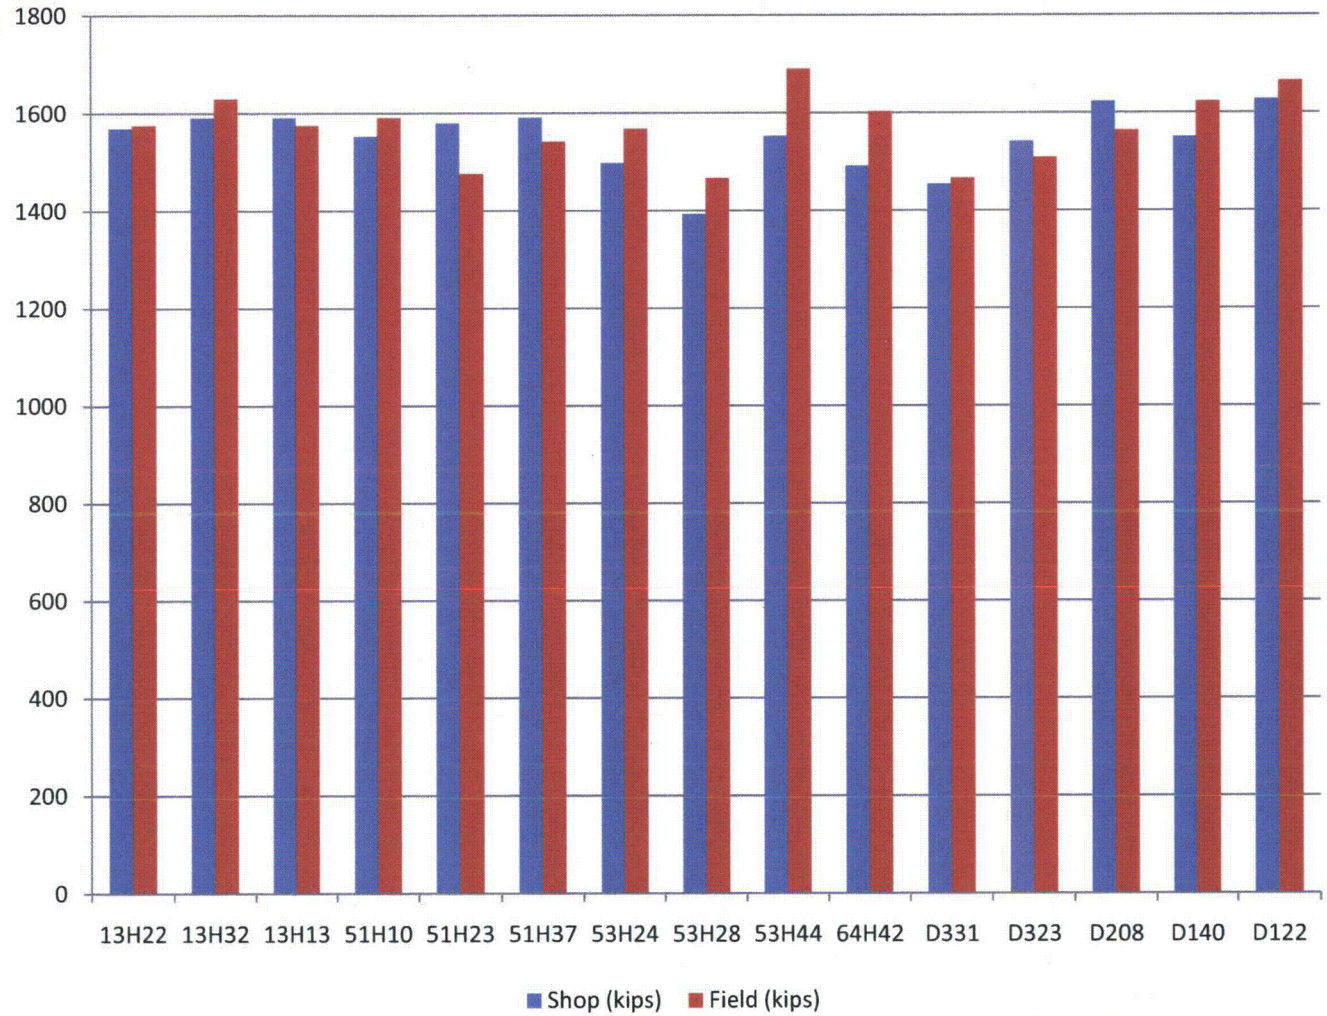
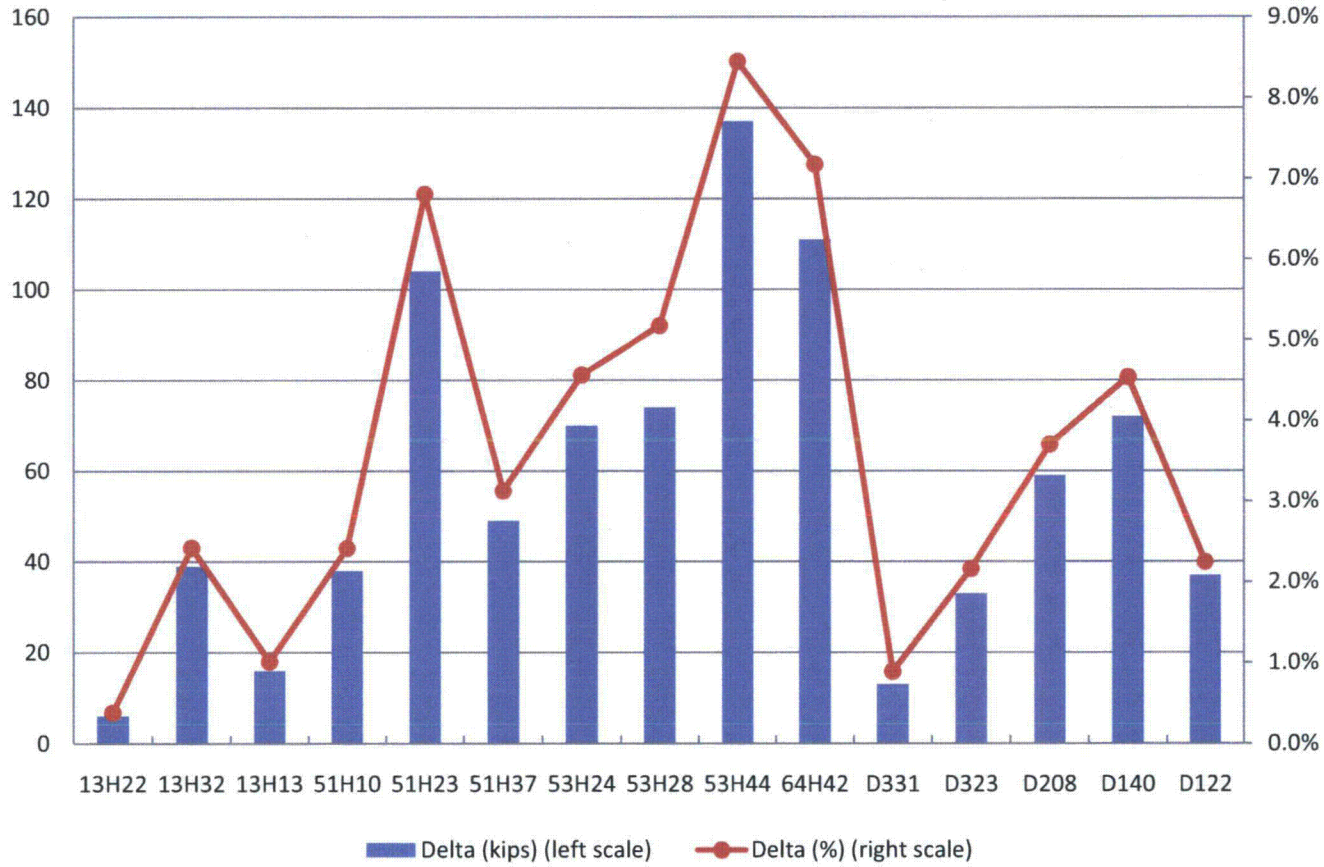
Tendon Lift-off Forces (Survey 2)

Lift-off forces measured at the Shop end (blue) and at the Field end (red)

Delta = Difference between lift-off forces at Shop and Field ends

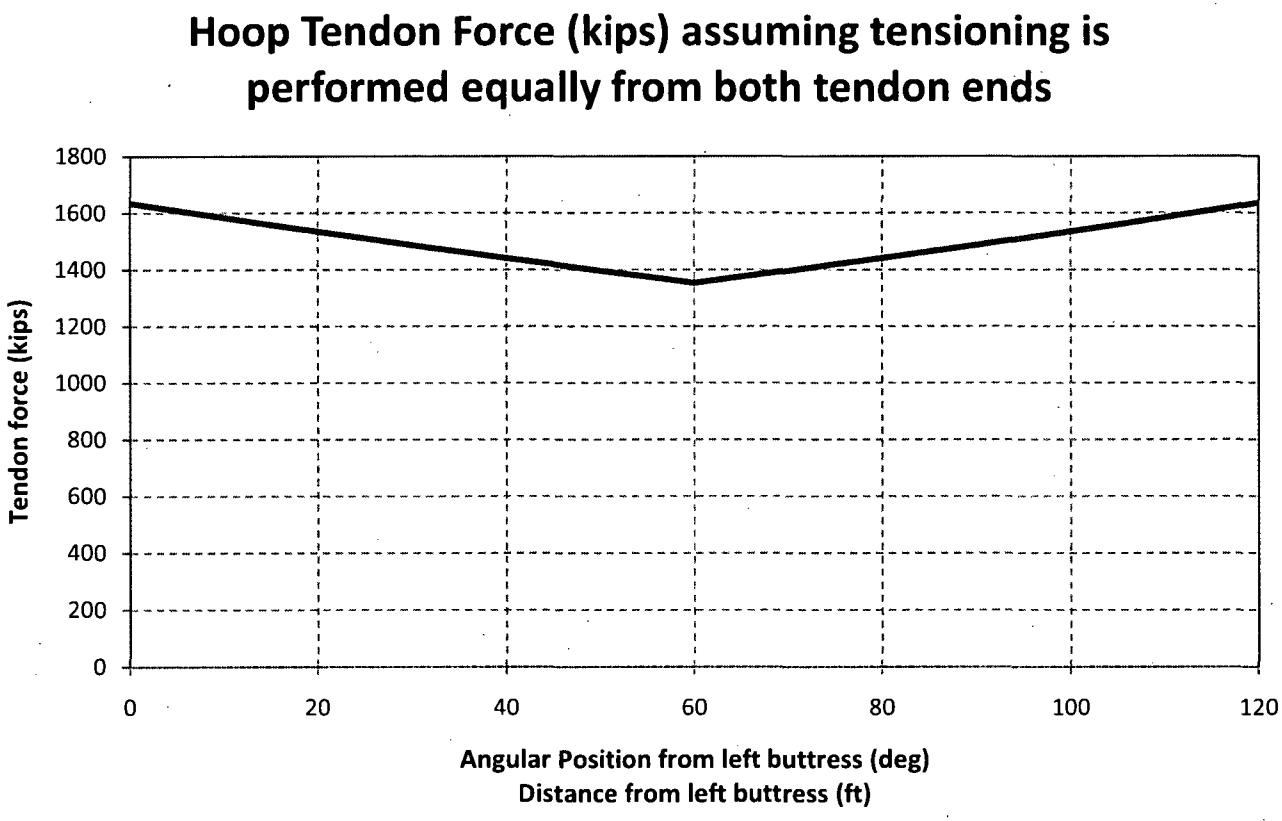
Force Along Hoop Tendon

2. Draw expected tendon force along the 120' long tendons (FM 6.1 Exhibit 5 is a curve of the force along a hoop tendon drawn using the equation and numerical values in the above description);

b. The friction contributes to an un-even load distribution (FM 6.1 Exhibit 5). In particular around penetrations, the variation in the tendon force is large. For example, the difference between T1 = 172 ksi and T4 = 135 ksi (page 1 of 3 in FM 6.1 Exhibit 10) is equivalent to 25% variation;

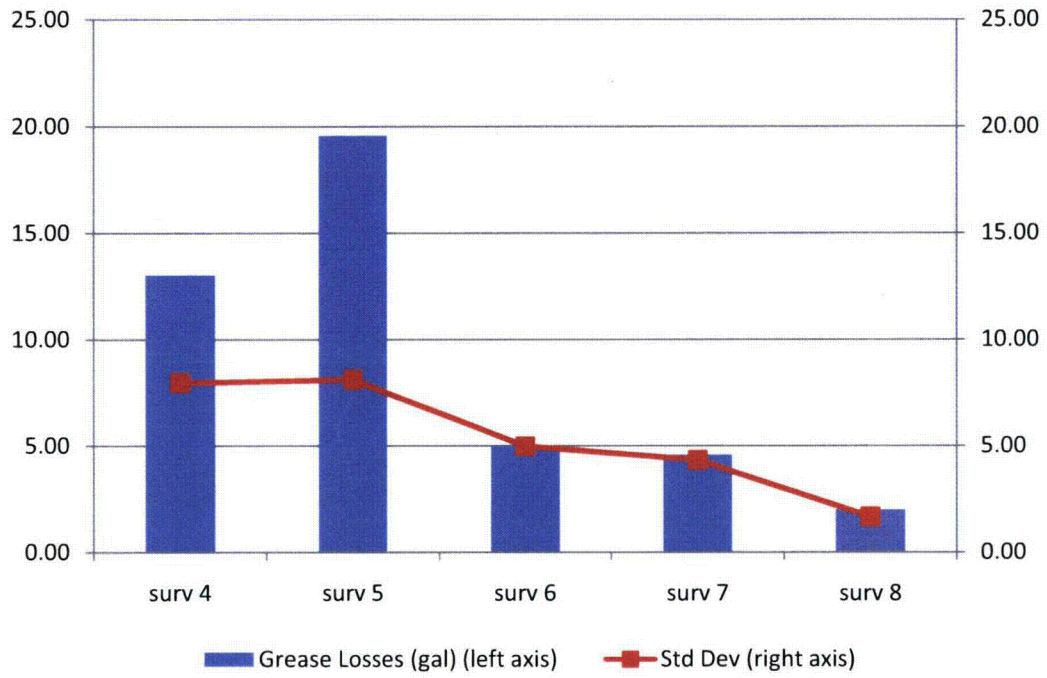
Grease losses from tendon sleeves

3. Review grease losses in tendon sleeves (FM 6.1 Exhibit 6 displays the field measurement for grease losses for the various surveys and FM 6.1 Exhibit 7 is a summary of all these data);

Average and standard deviation of grease losses for each surveillance

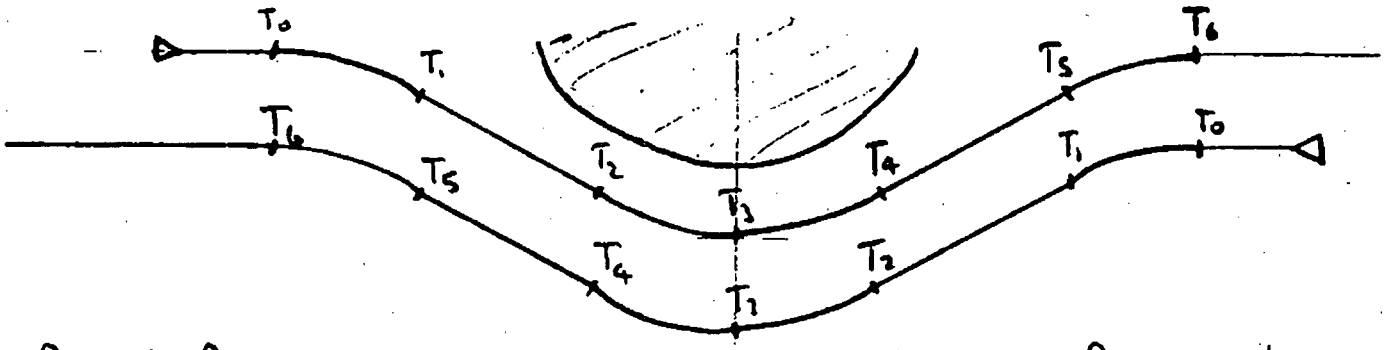
Calculate Friction Losses for Tendons.

Around penetrations, tendon curvatures are larger and friction losses are more important (FM 6.1 Exhibit 10 is an excerpt from the original Gilbert calculation on tendon force friction losses around the equipment hatch penetration).

Radial forces are based on average tendon force between T_2 & T_3 for first tendon, and every alternate tendon. Second and alternate tendons are based on average tendon force between T_4 & T_3
